Inspection Photos

08/22/2024

Operator: BEEMAN OIL & GAS INC - 7125

Location ID: 438248

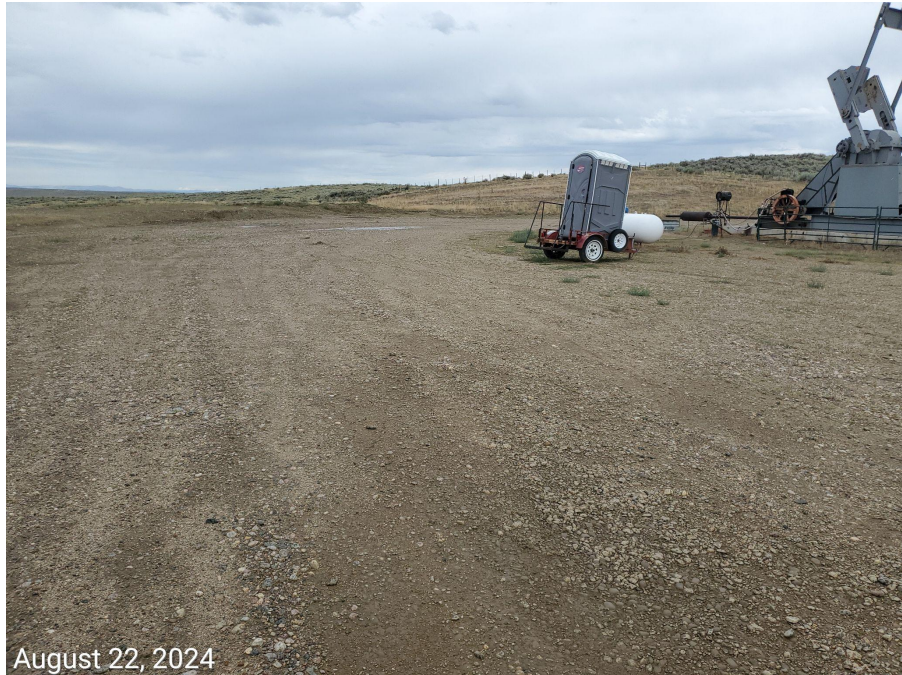
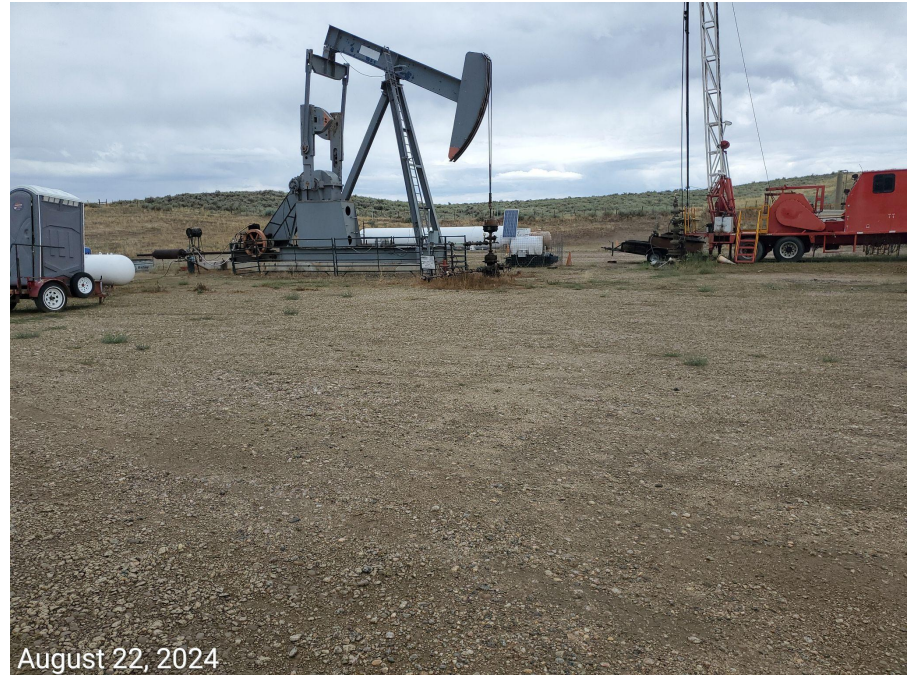
Photo 1: Photos 1-2 taken from the south end of the Location. Photos provide an overview of the working pad surface from west, northwest, northeast to east.

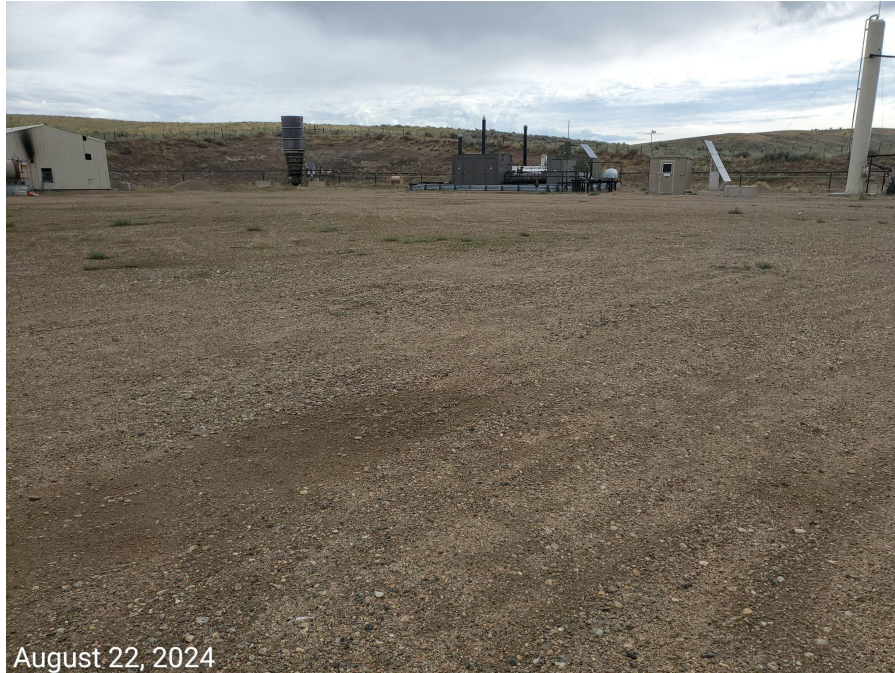
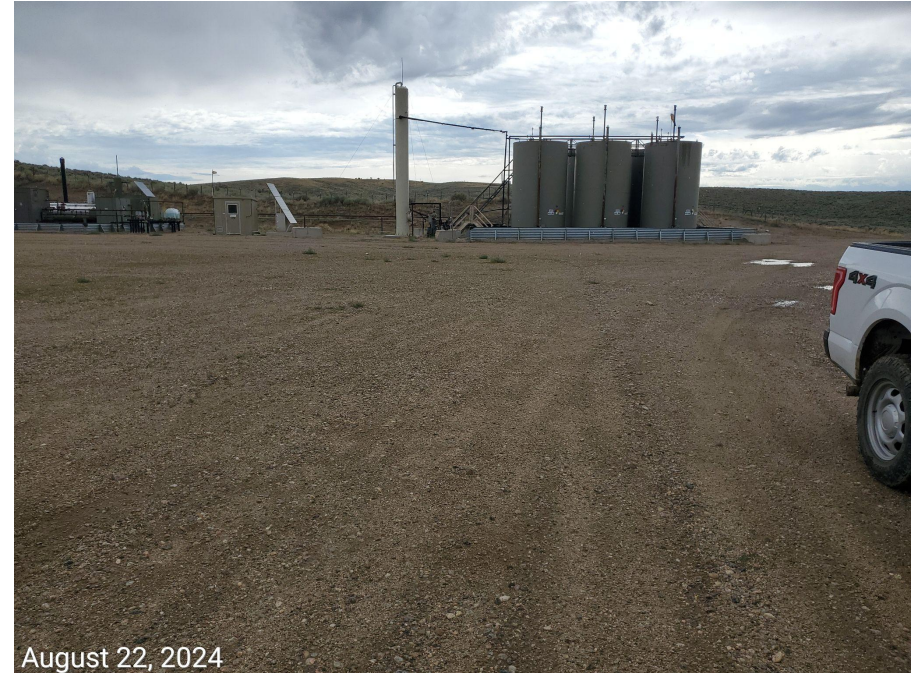
Photo 2: See comments under photo 1.

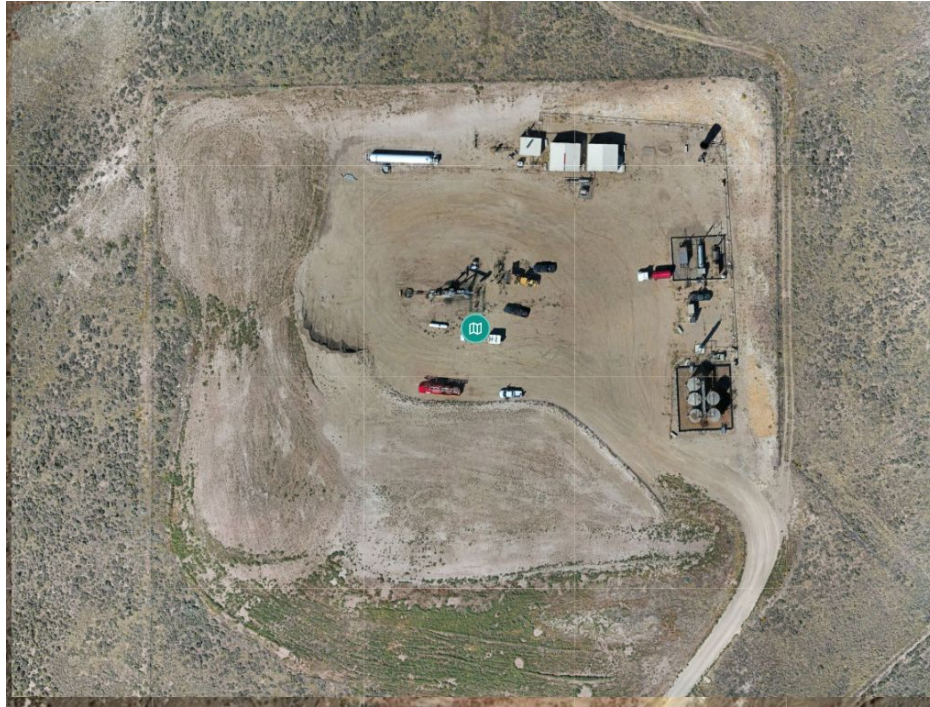
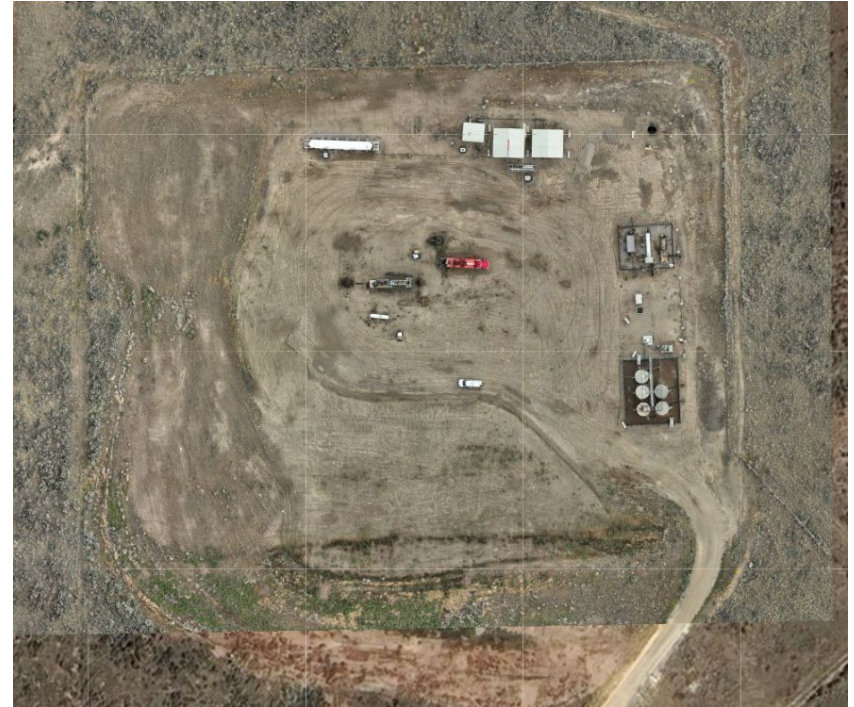
Photo 3: sUAS Aerial Imagery. Photo left dated 9/12/2023; Photo right dated 8/22/2024. Location remain unchanged; topsoil has not been replaced and revegetation efforts not performed.

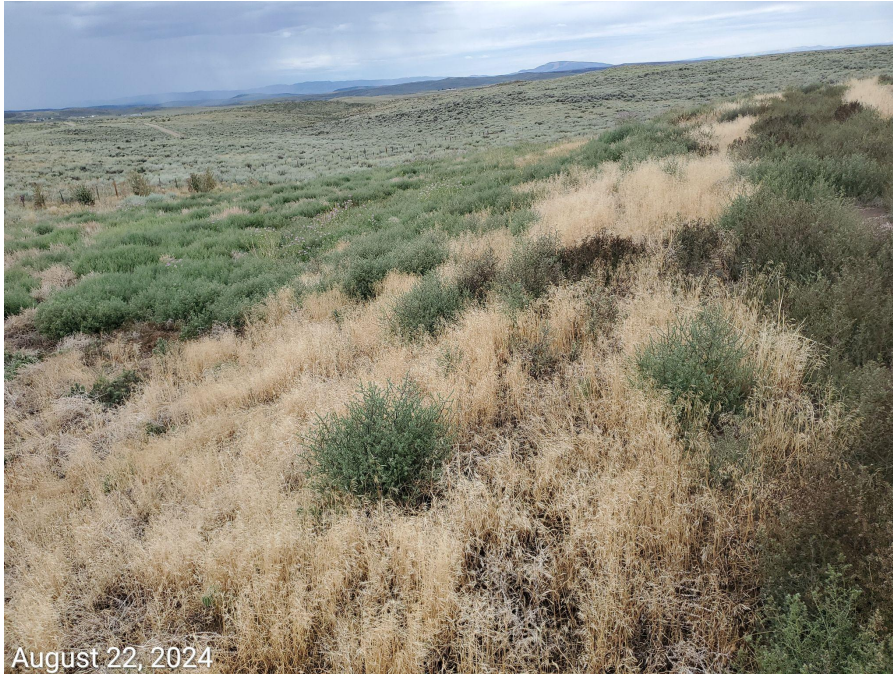
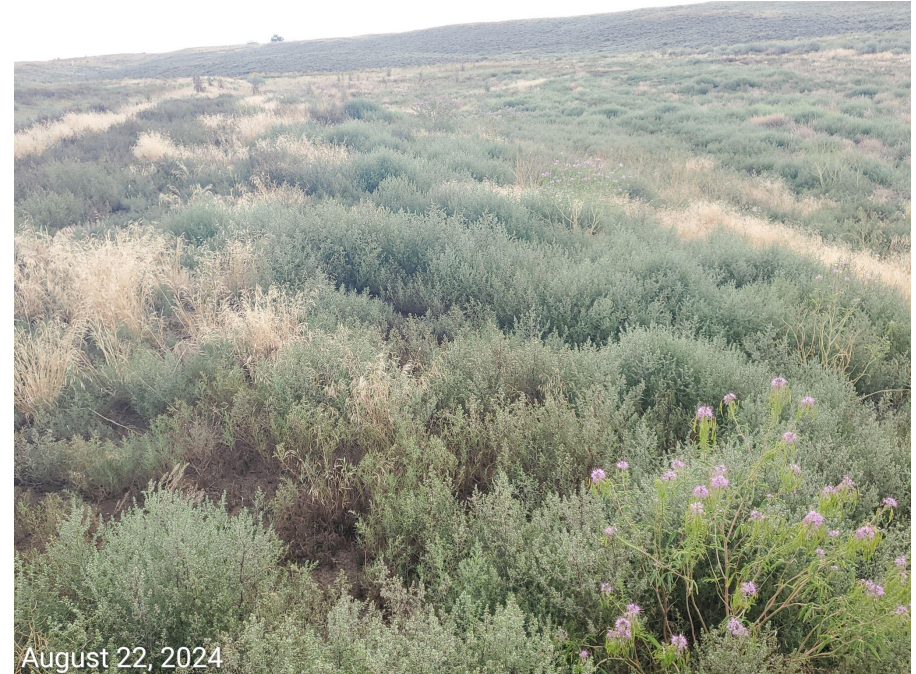
Photo 4: Photos taken from the south end of the Location. Photo left taken from the southeast end of the Location, facing west. Photo right taken from the southwest end of the Location, facing east. Photos show areas where topsoil is stored; topsoil has not been replaced over interim areas. Photos also examples showing weeds (Russian thistle, Kochia) have not been managed.

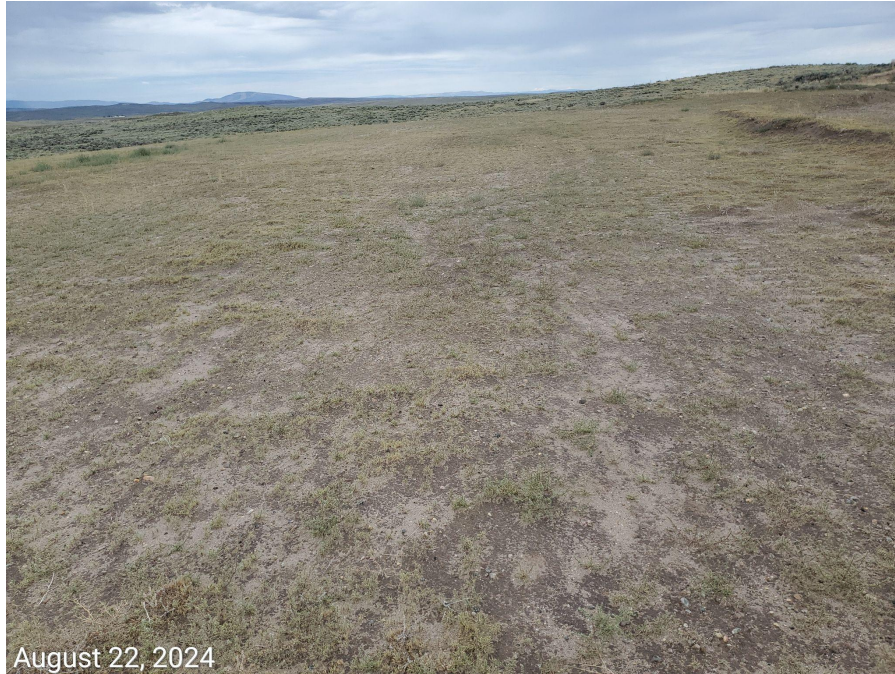
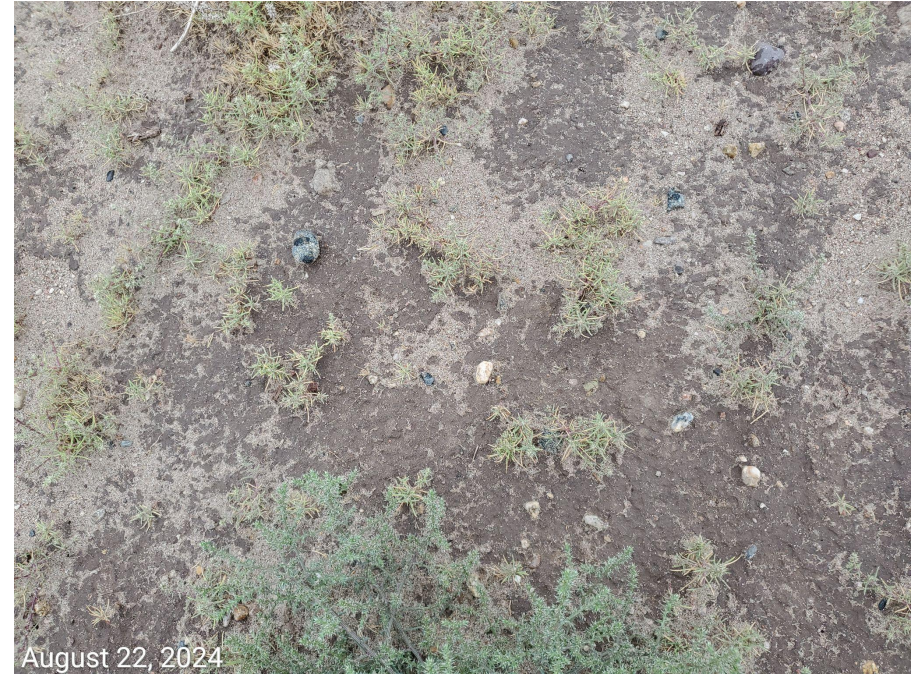
Photo 5: Photos taken from the interim areas on the south end of the Location, facing west. Vegetation observed in photos are weeds such as Russian thistle and Kochia. Desirable perennial vegetative germination and establishment not observed. Topsoil has not been replaced, and unable to find evidence of seeding.

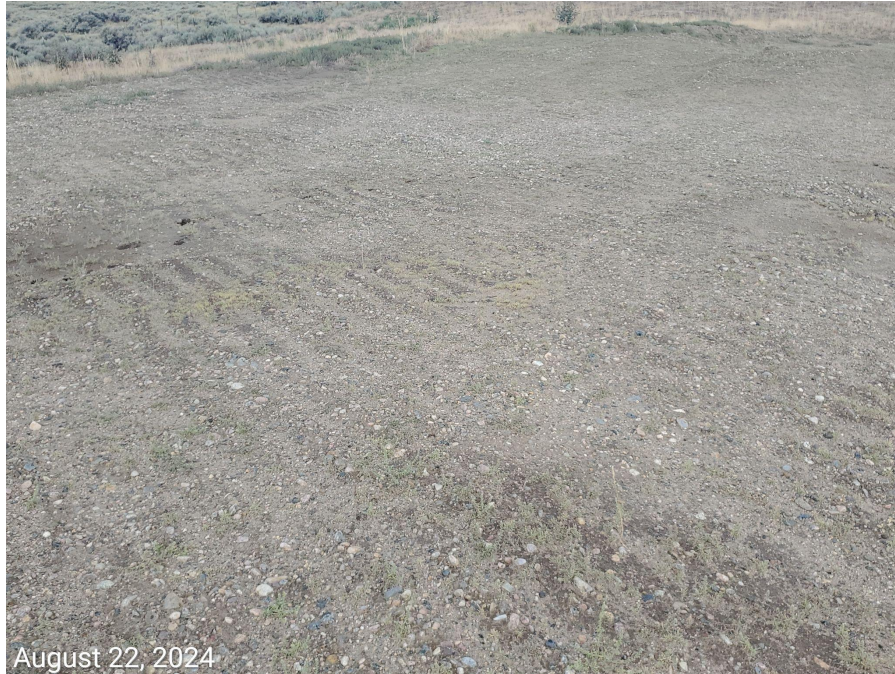
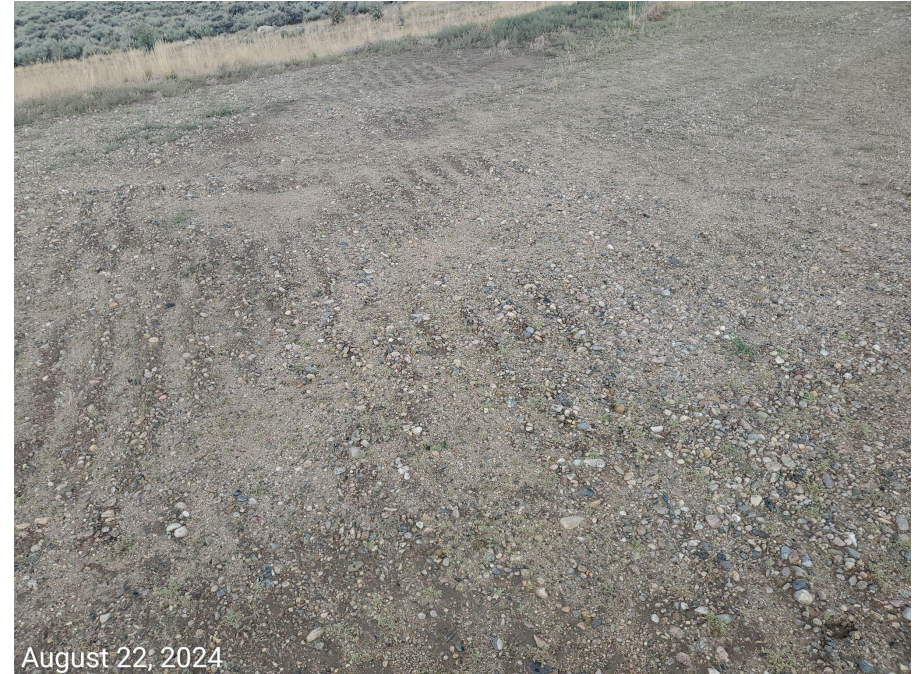
Photo 6: Photos taken from the interim areas on the southwest end of the Location. Photos show topsoil has not been replaced, and areas have not been seeded. Any surface roughening previously applied has not been maintained.

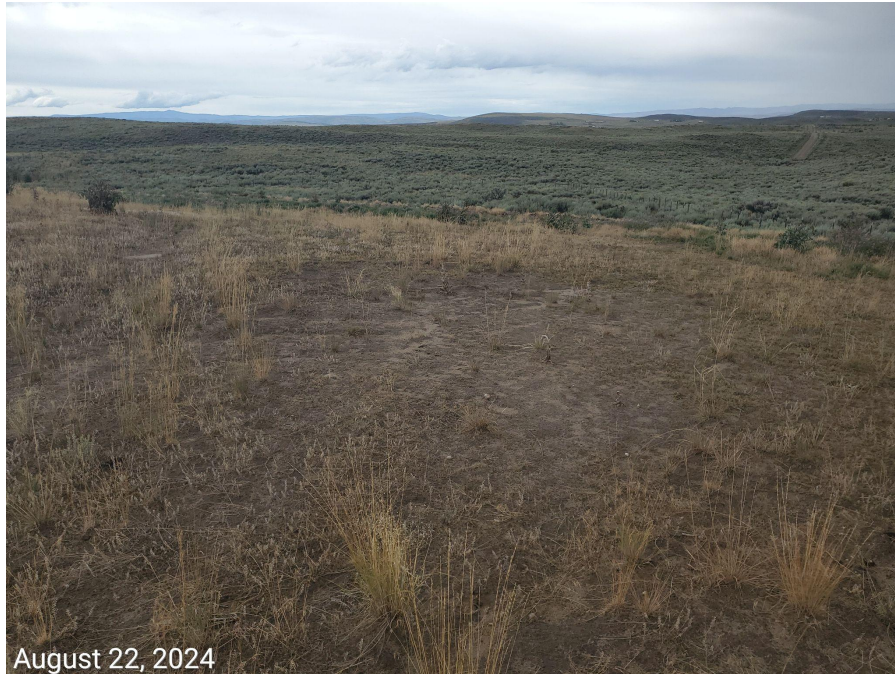
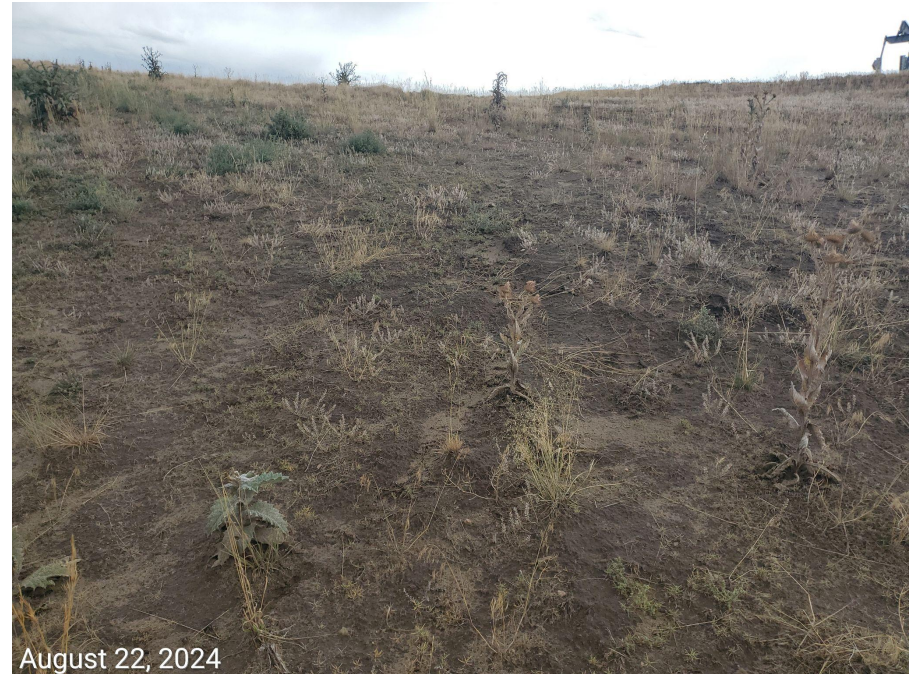
Photo 7: Photos taken from the interim areas on the west/northwest end of the Location. Vegetation remains predominantly Undesirable and Noxious plant species. Erosion degradation/sediment transport is recurring. Soils remain largely bare; BMPs to stabilize soils not observed. Unable to find evidence of additional reclamation/seeding.

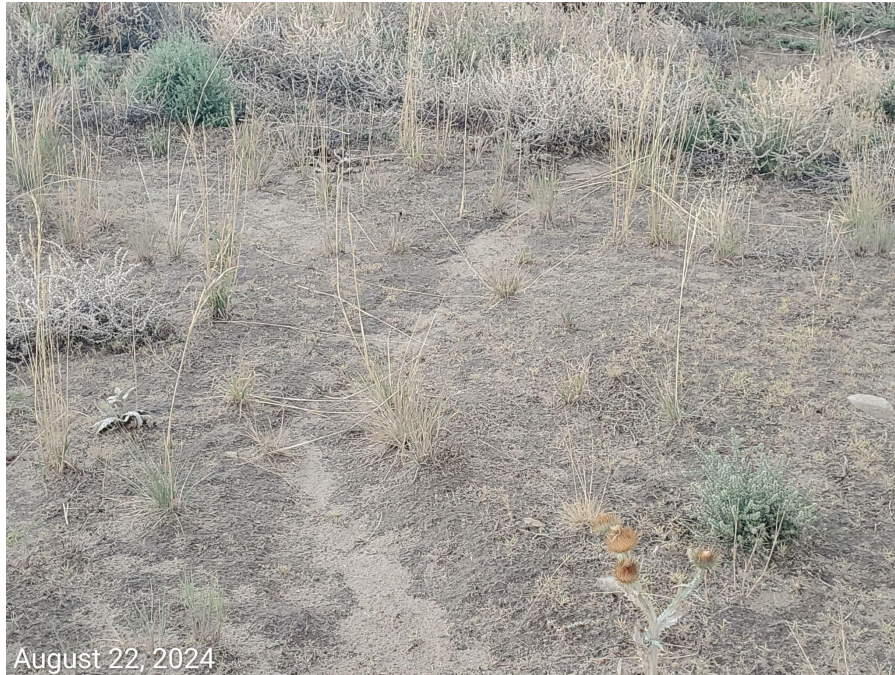
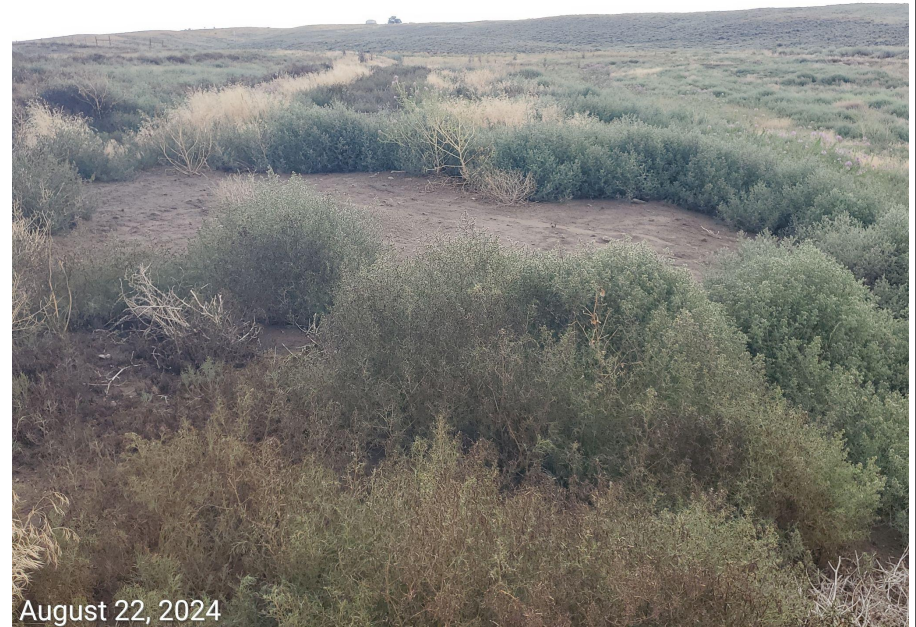
Photo 8: Photos taken from the interim areas of the Location. Vegetation remains predominantly Undesirable and Noxious plant species. Erosion degradation/sediment transport is recurring. Soils remain largely bare; BMPs to stabilize soils not observed.

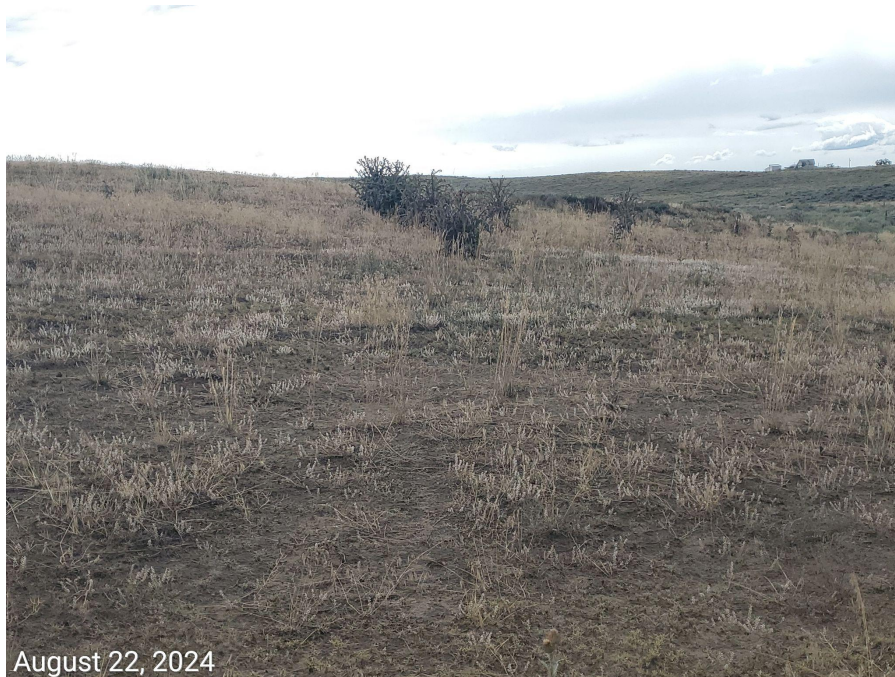
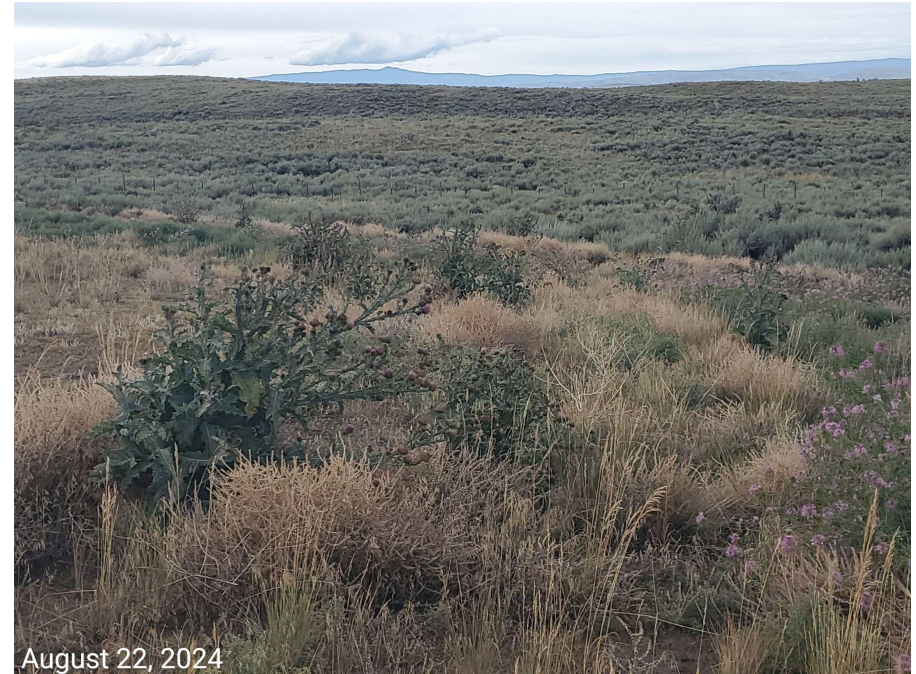
Photo 9: Photos examples showing Noxious weeds (Scotch thistle) has continued to establish and spread throughout the Location.

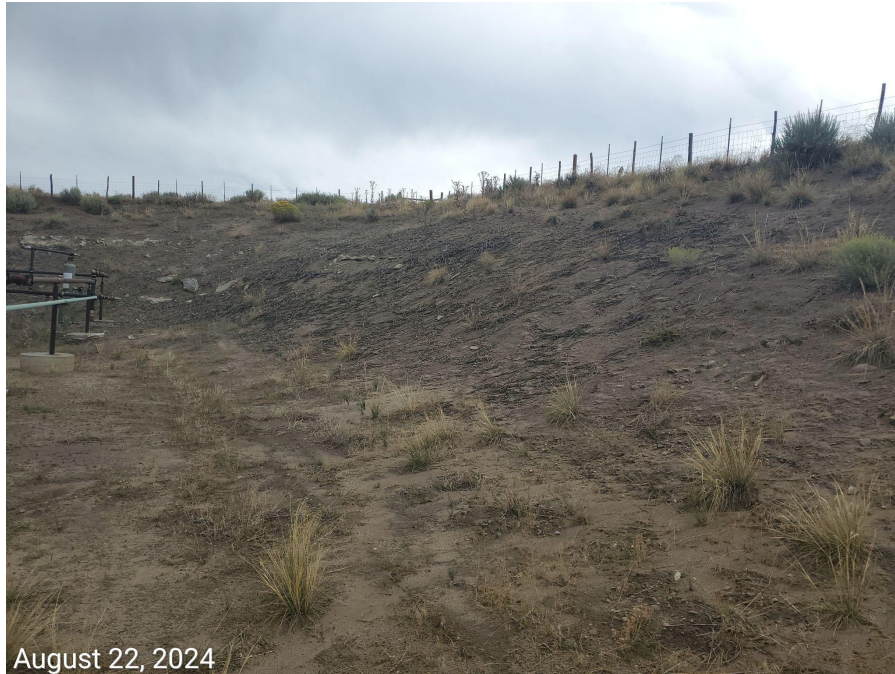
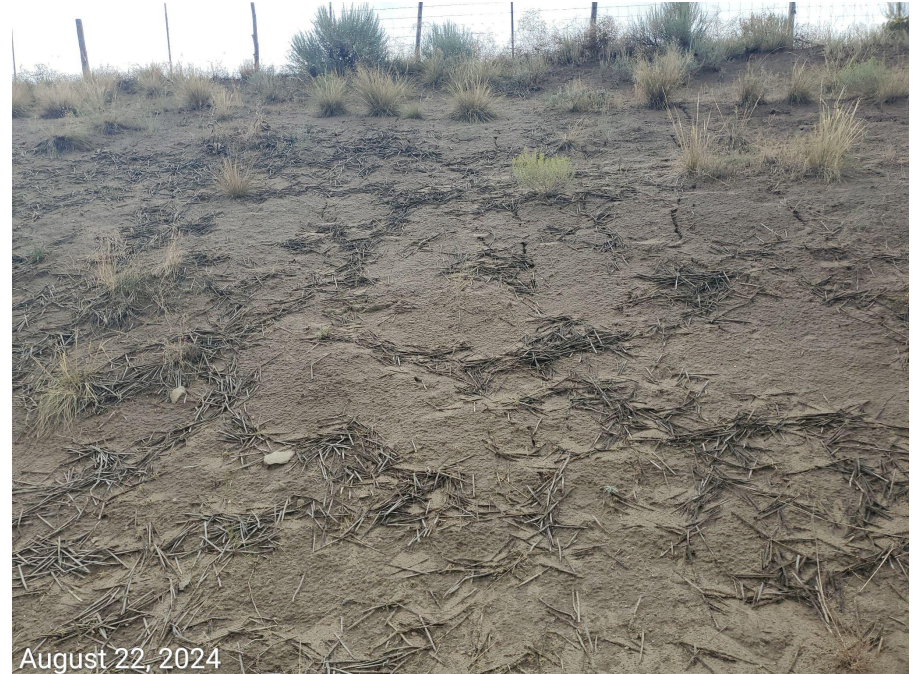
Photo 10: Photos taken from the cut slopes on the northeast end of the Location. Photos show BMPs to stabilize, as well as to minimize erosion, degradation and sediment transport have not been installed per good engineering practice, or maintained in proper functioning condition.

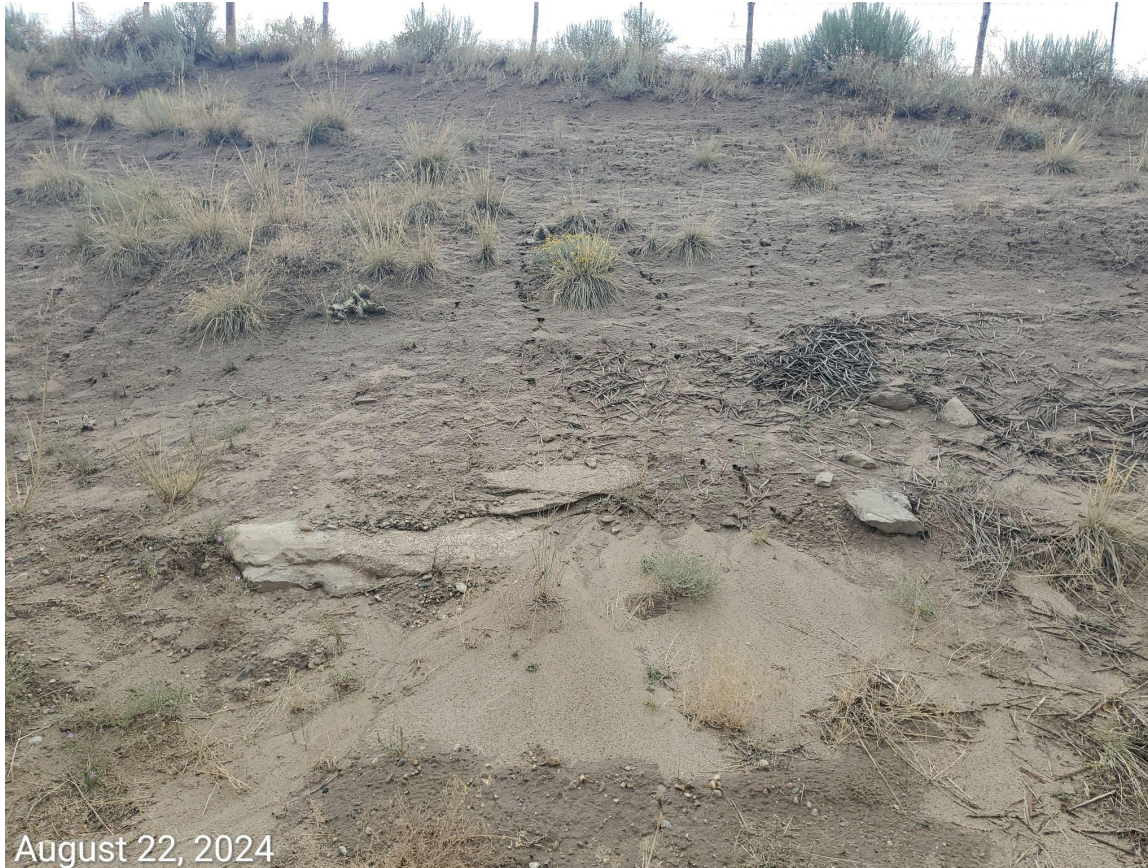
Photo 11: Photos taken from the cut slopes on the northeast end of the Location. Photos show BMPs to stabilize, as well as to minimize erosion, degradation and sediment transport have not been installed per good engineering practice, or maintained in proper functioning condition.

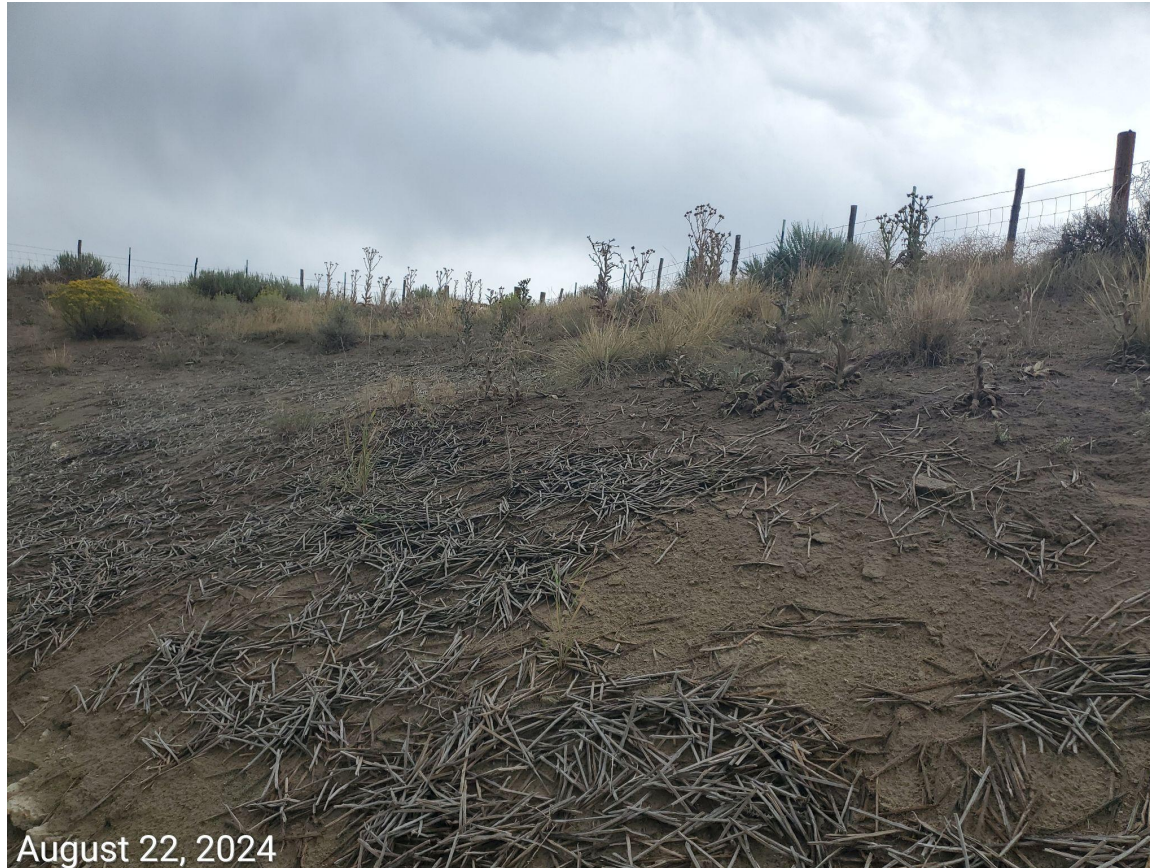
Photo 12: Photos taken from the cut slopes on the northeast end of the Location. Photos show Noxious weeds (Scotch thistle) have continued to spread and establish throughout the Location.

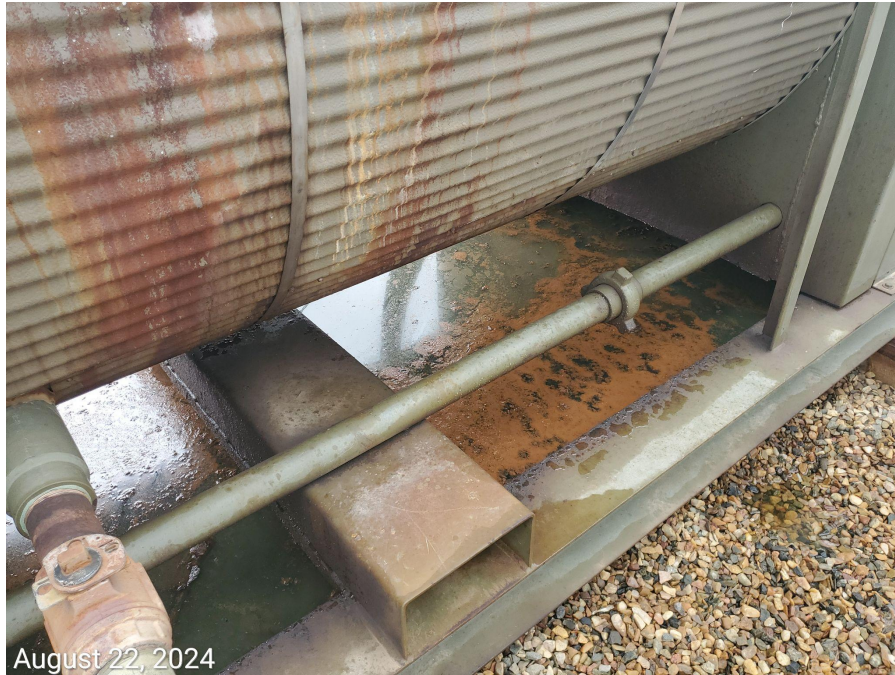
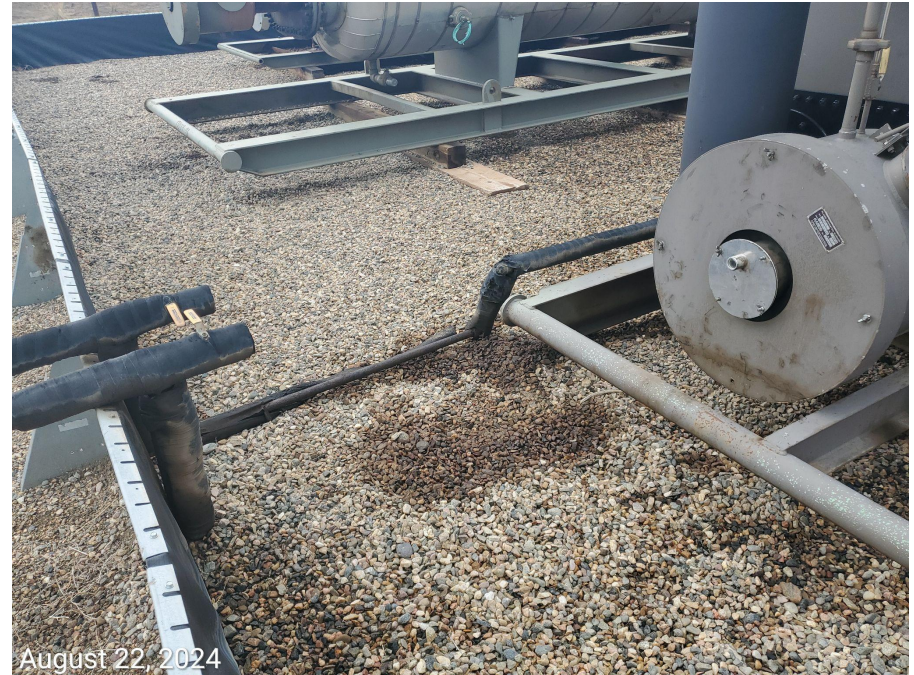
Photo 13: Photos 13-14 taken from the separator equipment on the east end of the Location. Photo show fluids, and impacted materials due to spills at the facility.

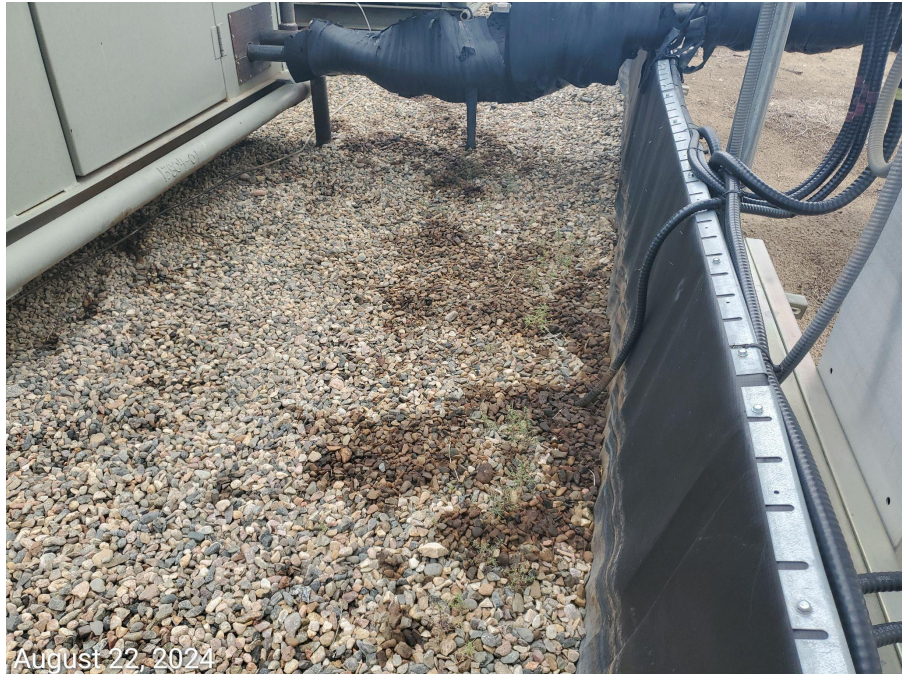
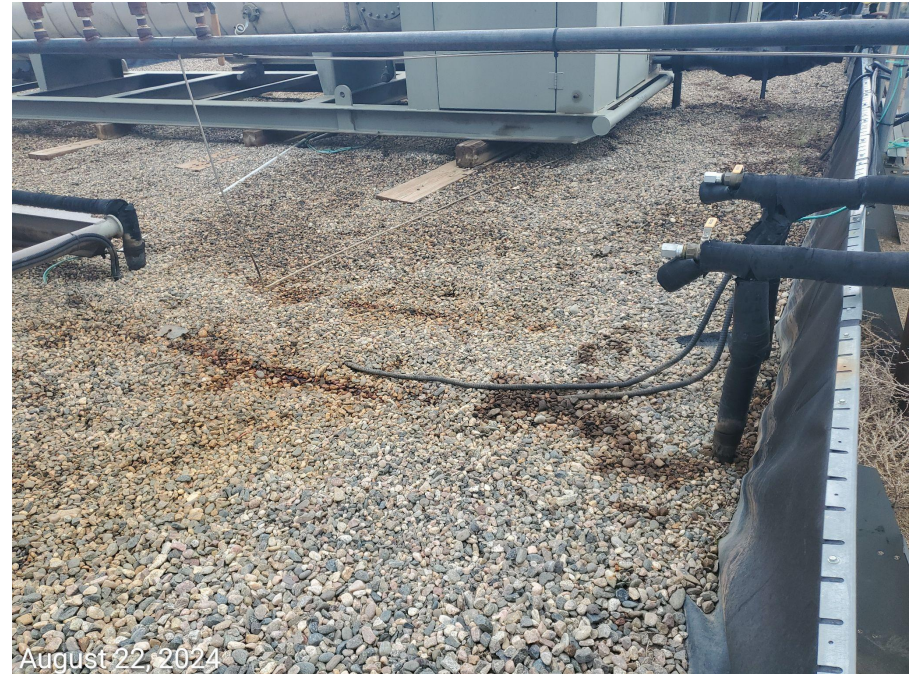
Photo 14: See comments under photo 13.

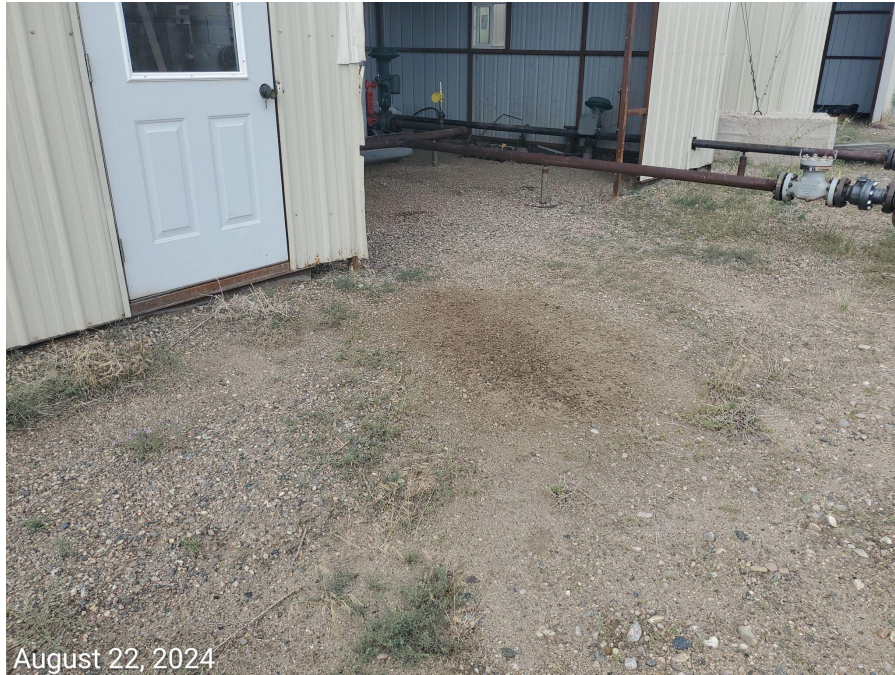
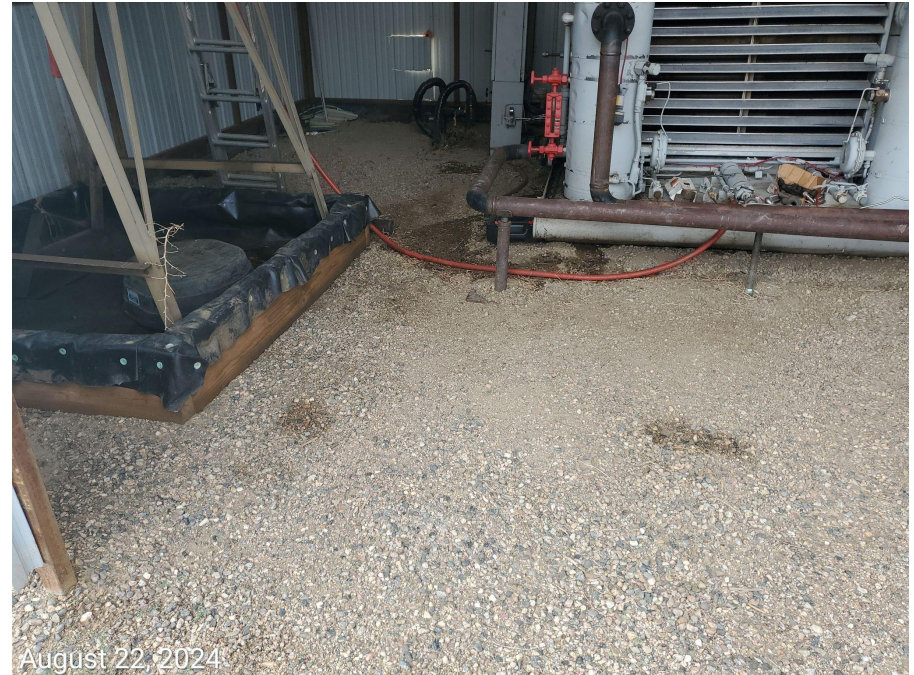
Photo 15: Photos 15-16 taken from around the sheds on the north end of the Location. Photos examples showing stained/impacted soils have not been cleaned/remediation and/or removed.

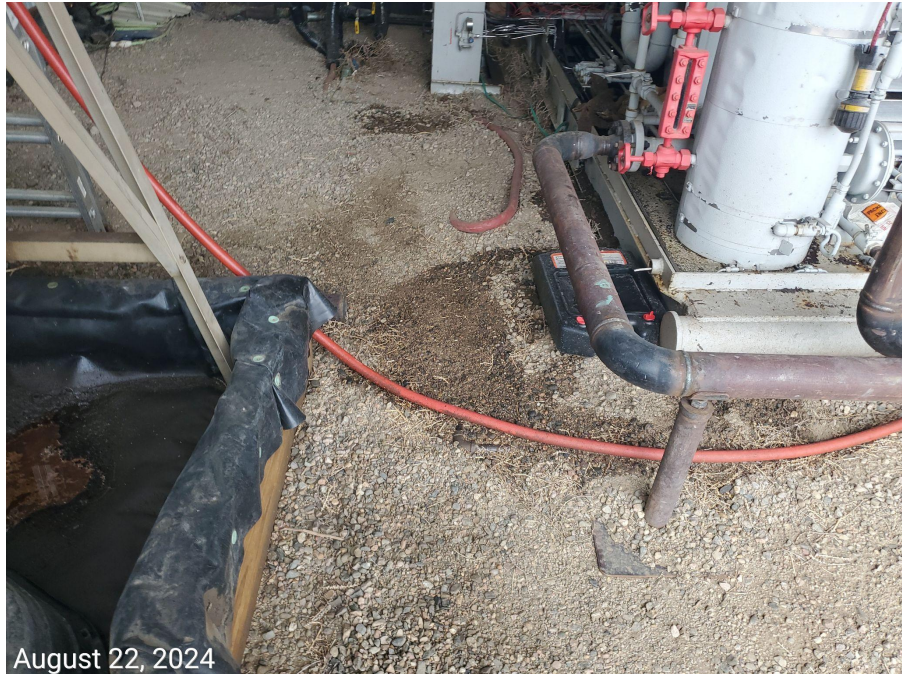
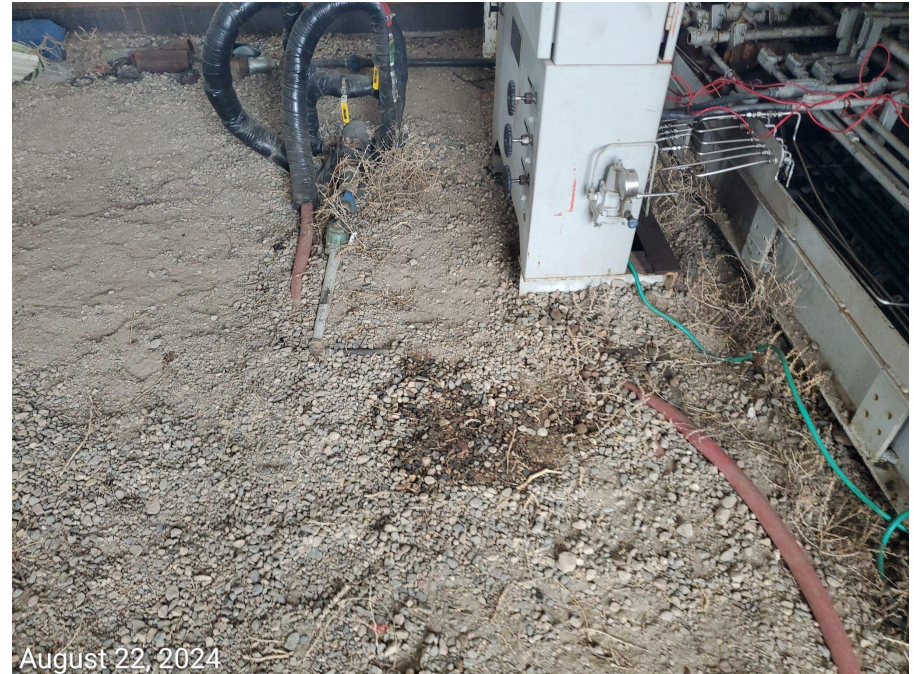
Photo 16: See comments under photo 15.

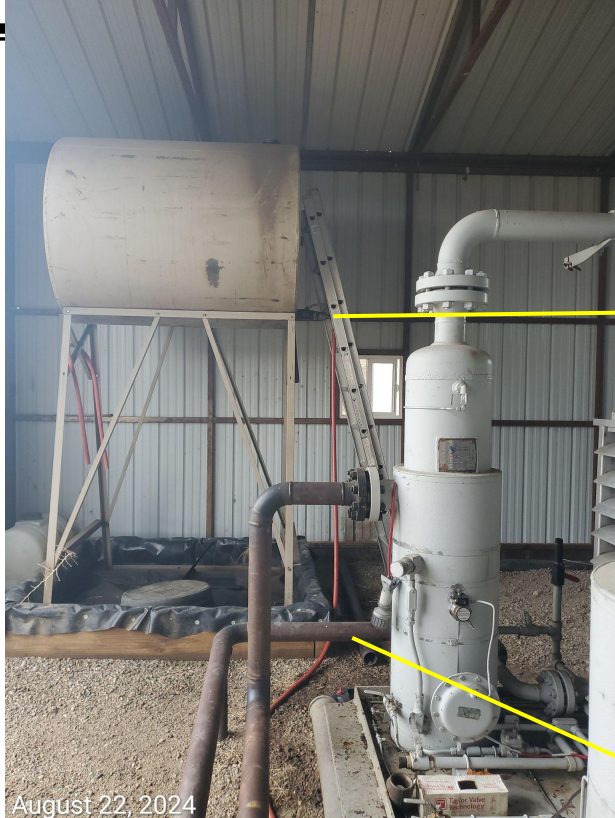
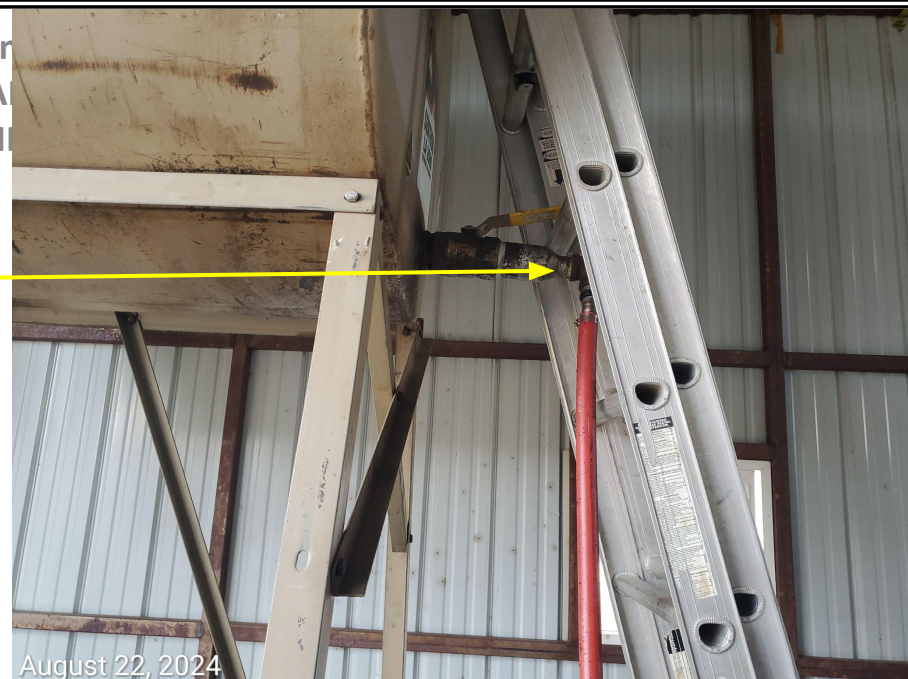
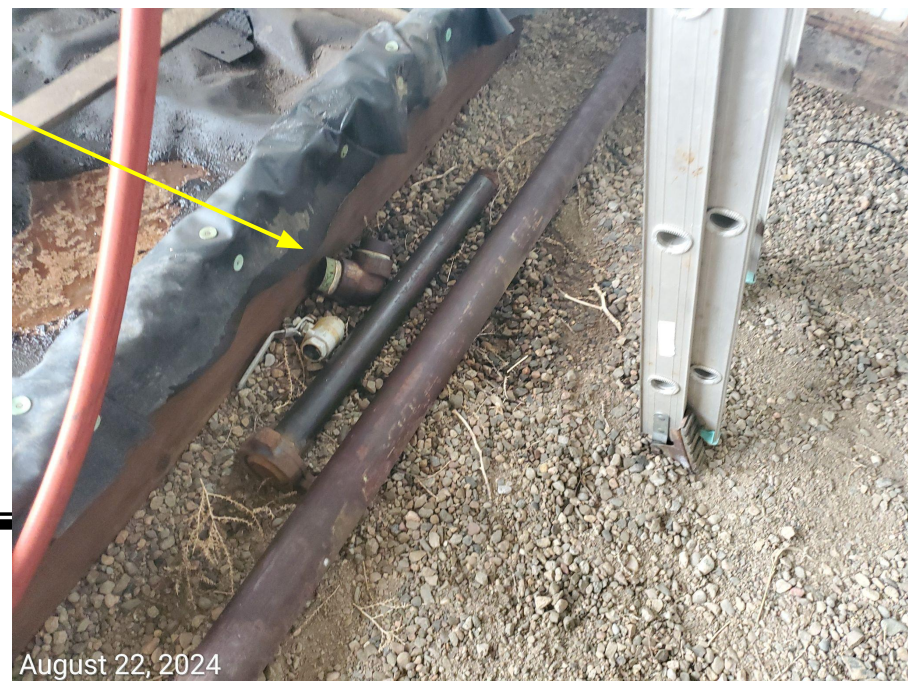
Photo 17: Photo shows containment measure at tank is inadequate in size and volume to contain a spill or release. Line extends beyond containment resulting in leaks and stained soils outside of containment.

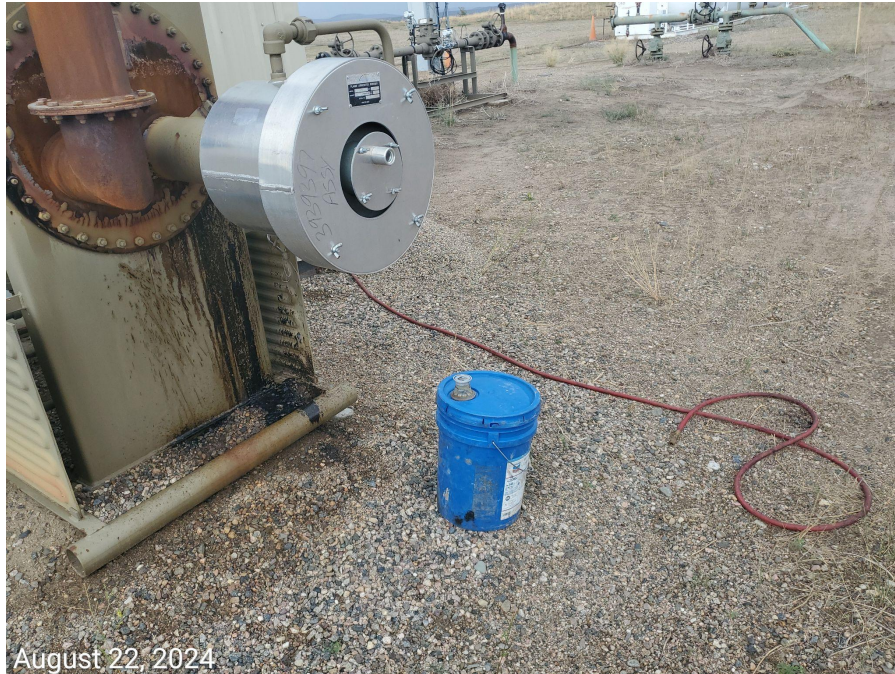
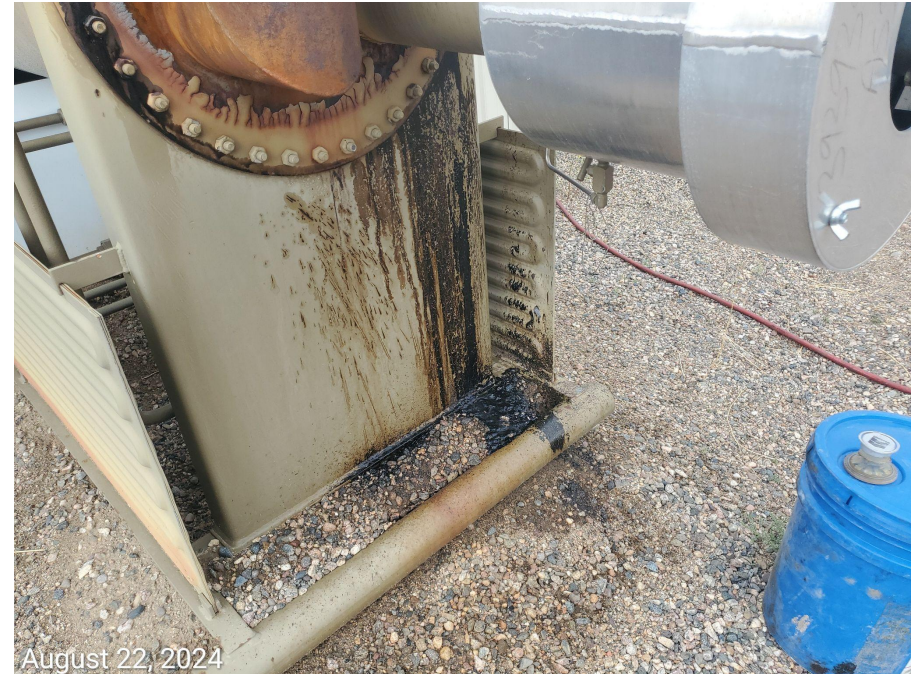
Photo 18: Photo taken from production equipment on the north end of the Location. Photo shows improper storage of a container on the Location. Photo also shows equipment has leaked resulting in a spill and stained soils.
