Inspection Photos

08/22/2024

Operator: BEEMAN OIL & GAS INC - 7125

Location ID: 438248

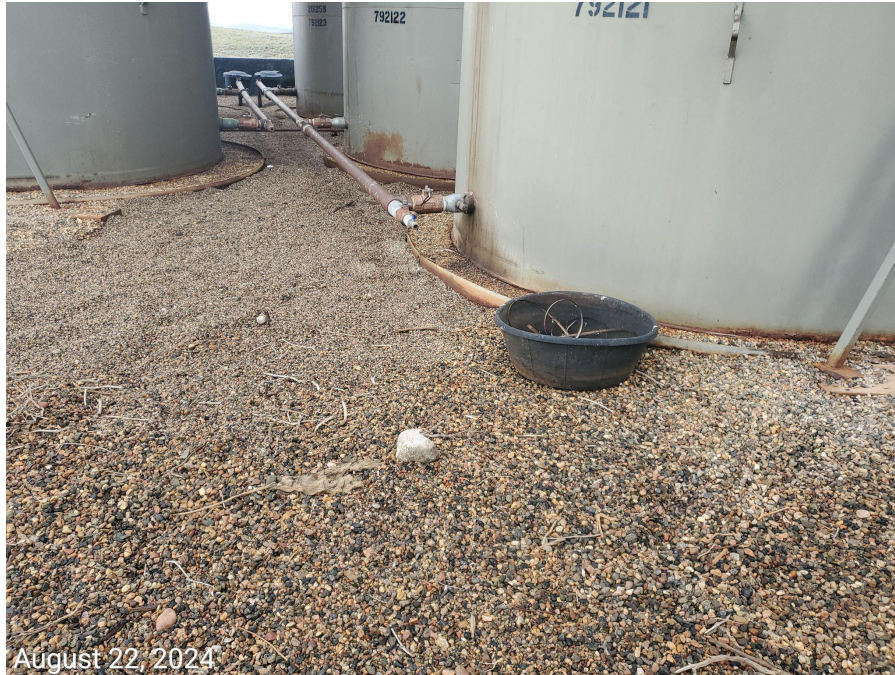
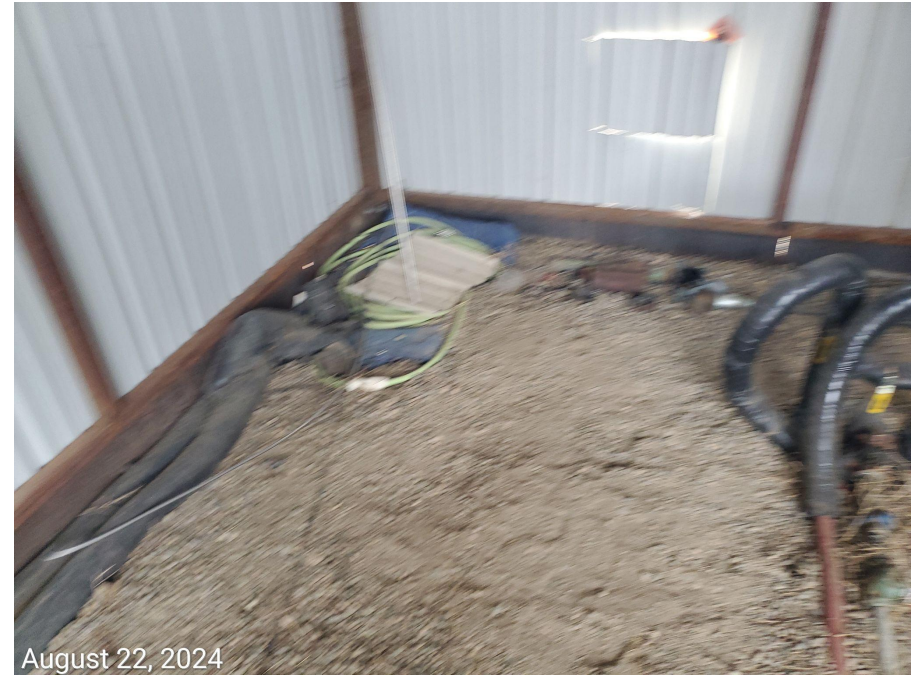
Photo 19: Photos 19- 29 example showing various unused equipment/trash/debris/etc... that remains improperly stored throughout the Location.

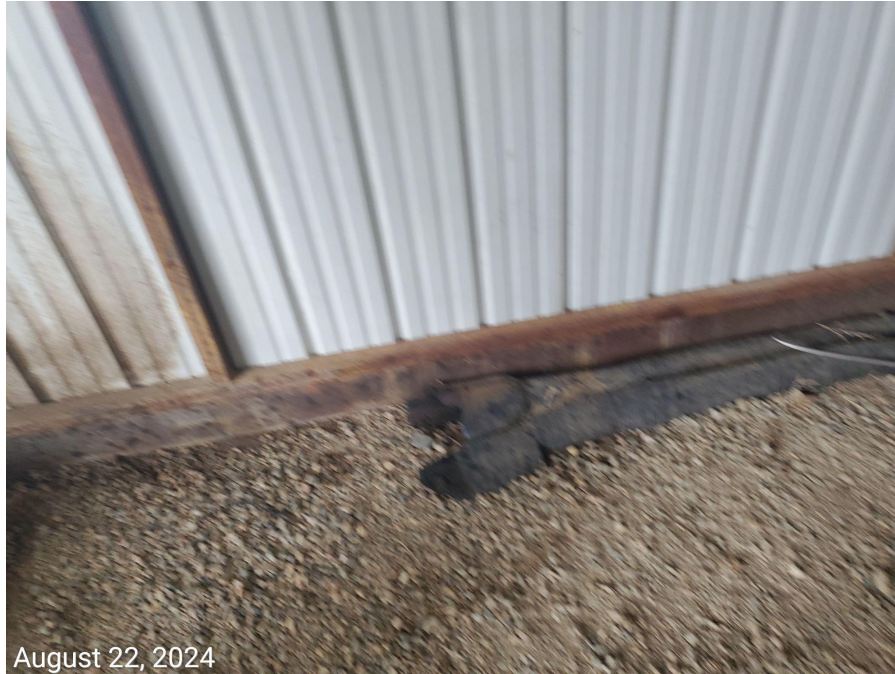
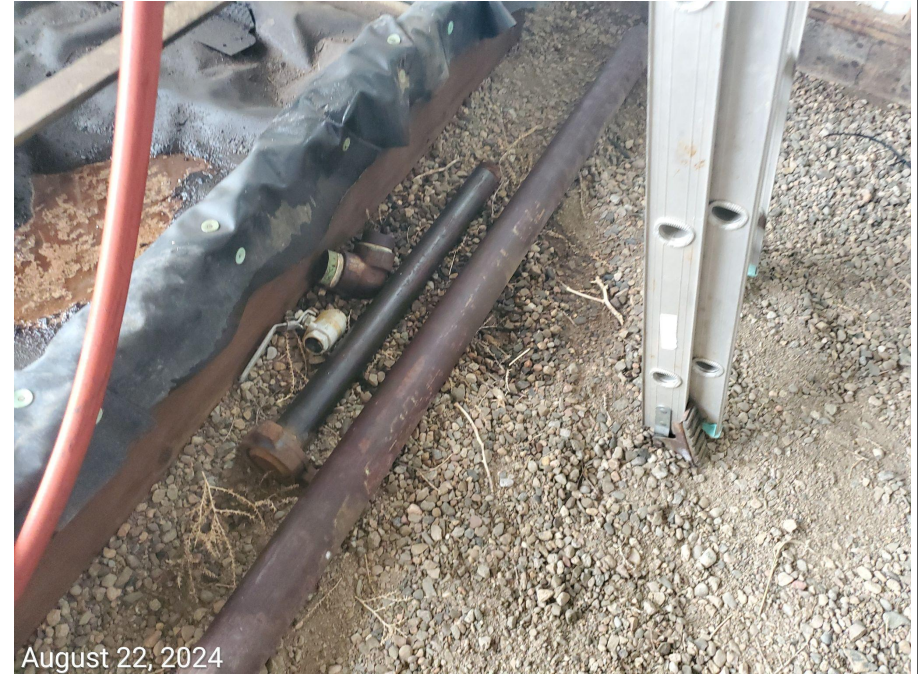
Photo 20: See comments under photo 19.

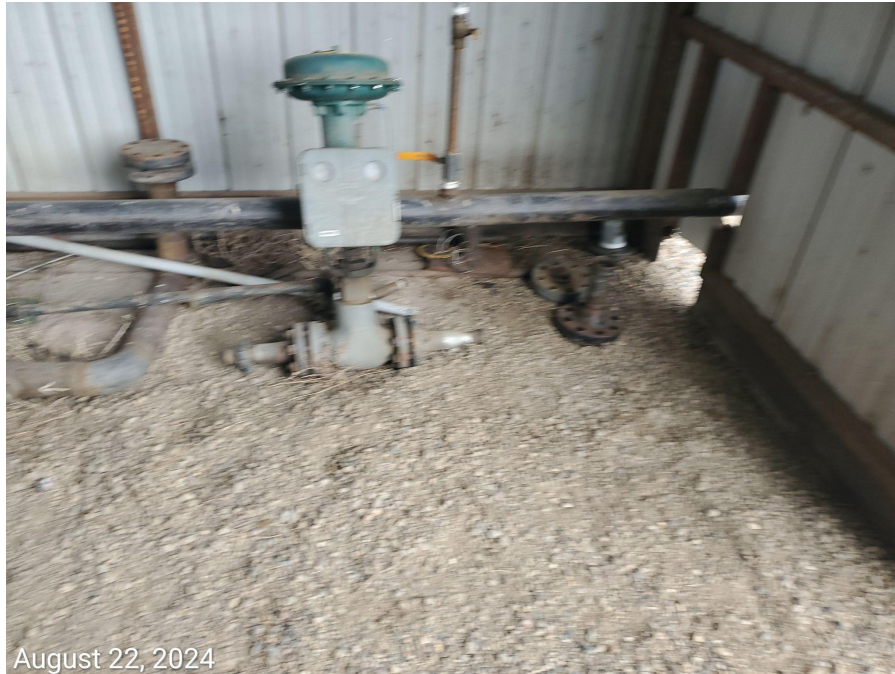
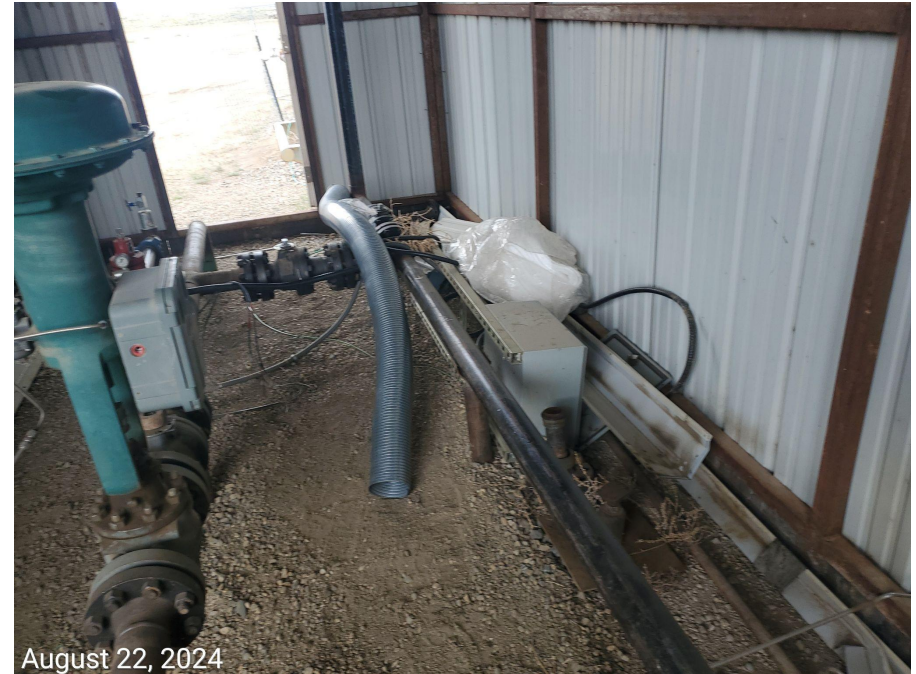
Photo 21: See comments under photo 19.

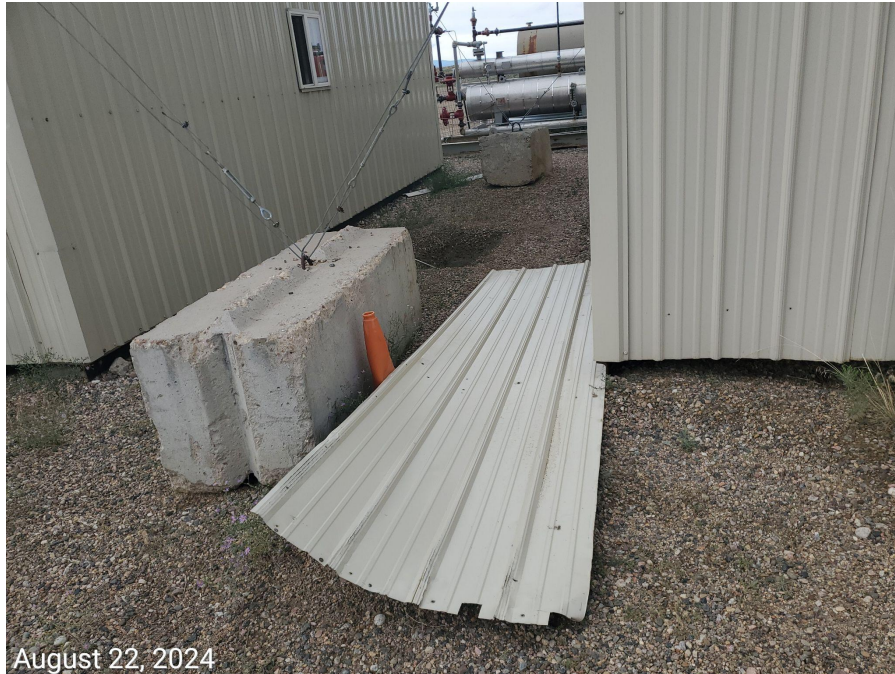
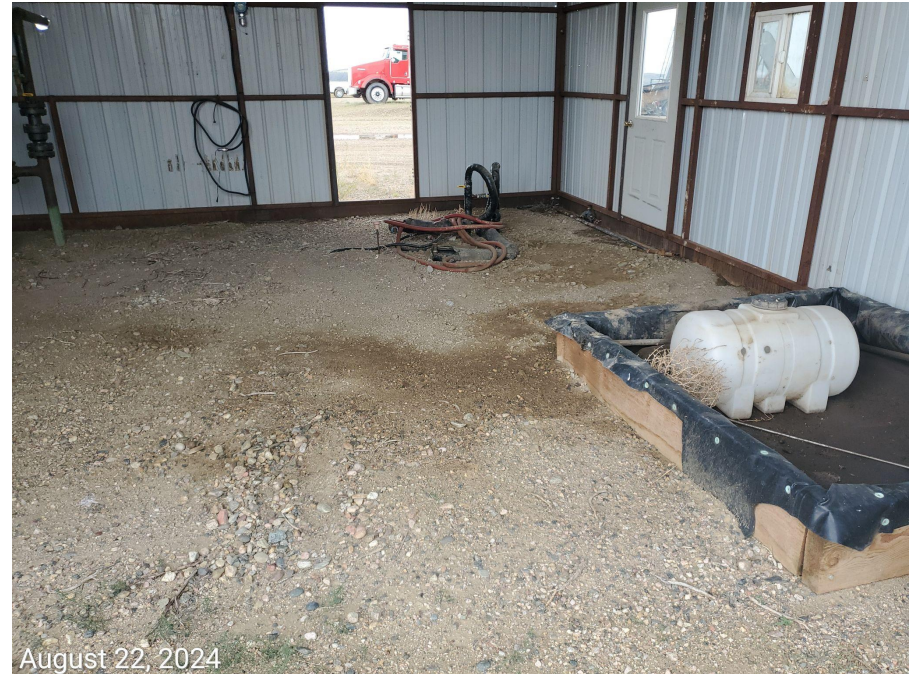
Photo 22: See comments under photo 19. Photo right also shows stained soils remaining around sheds on the north end of the Location.

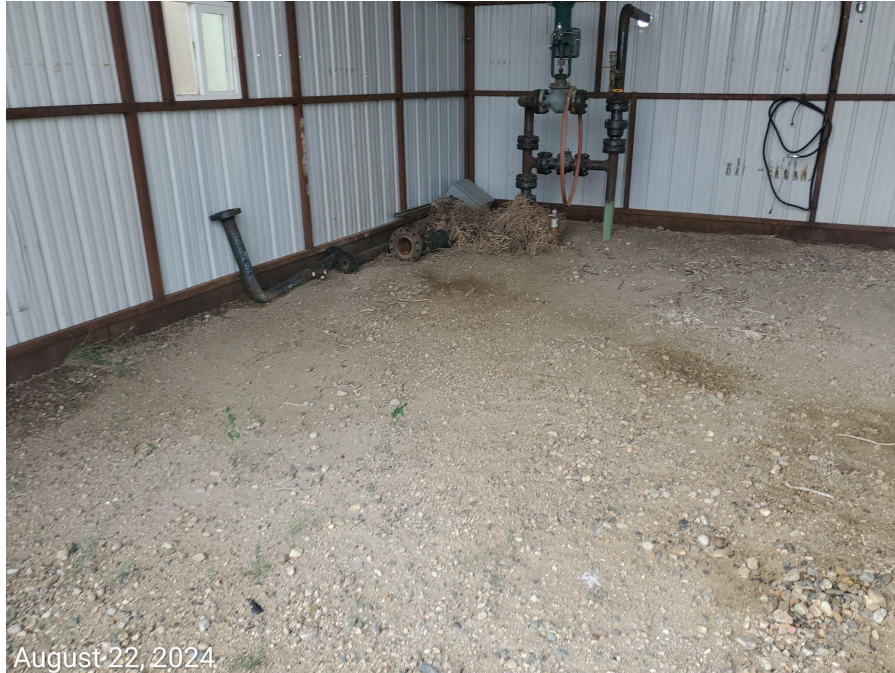
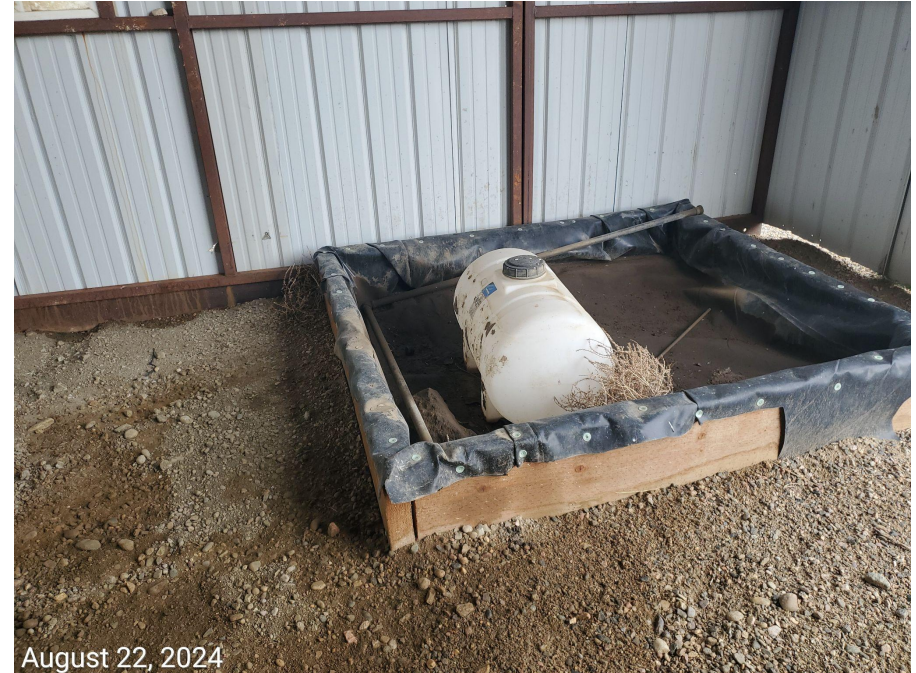
Photo 23: See comments under photo 19. Photos also show stained soils remaining around sheds on the north end of the Location.

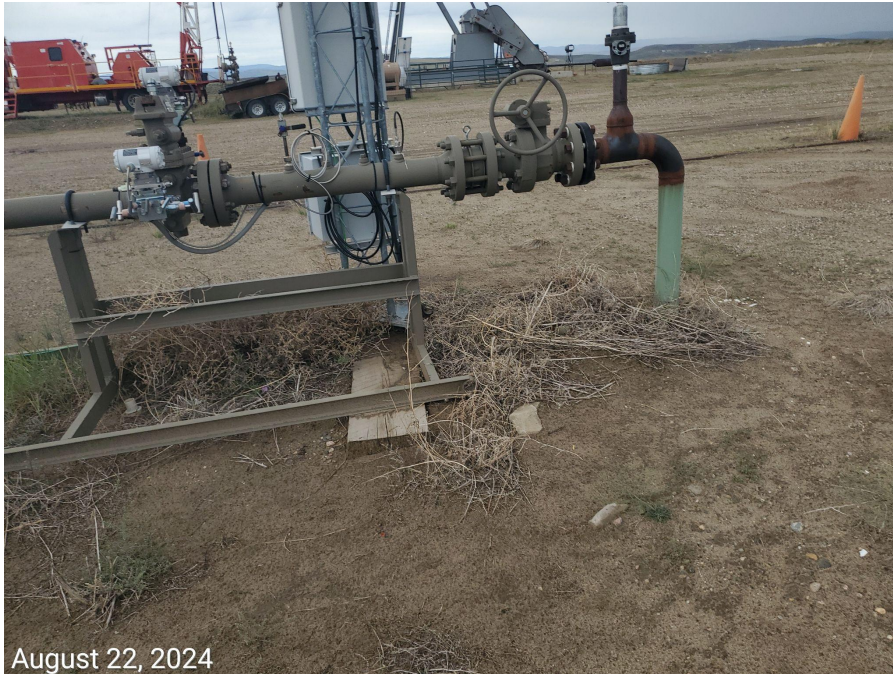
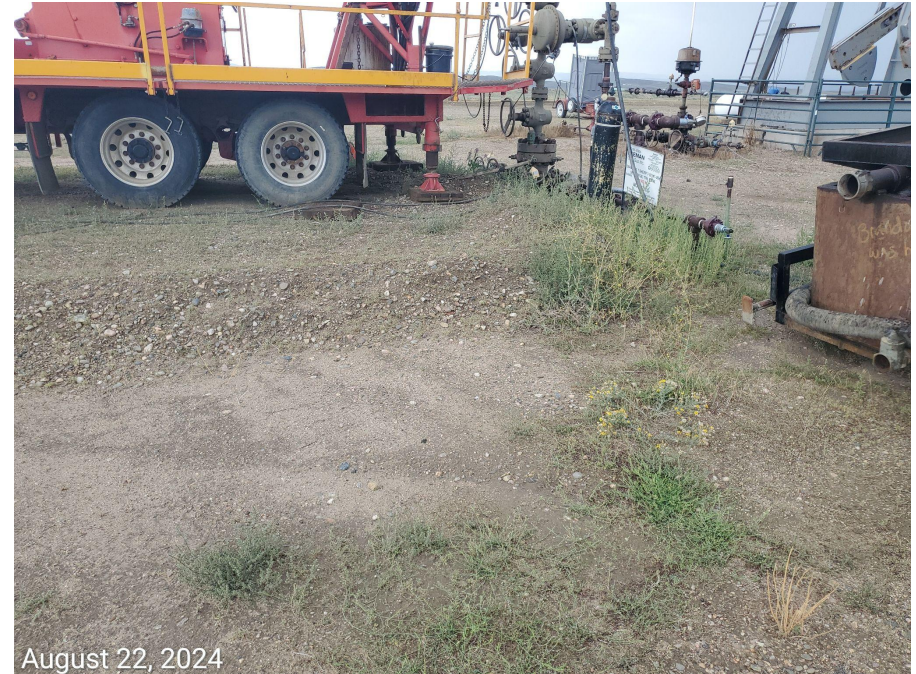
Photo 24: Photos examples showing weed debris, and weed establishment around equipment on the Location.

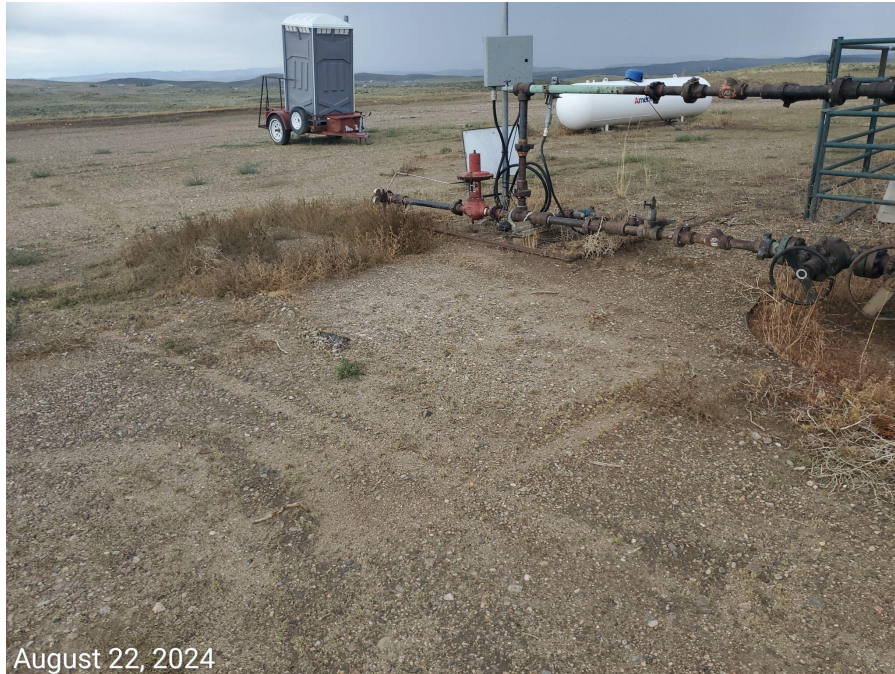
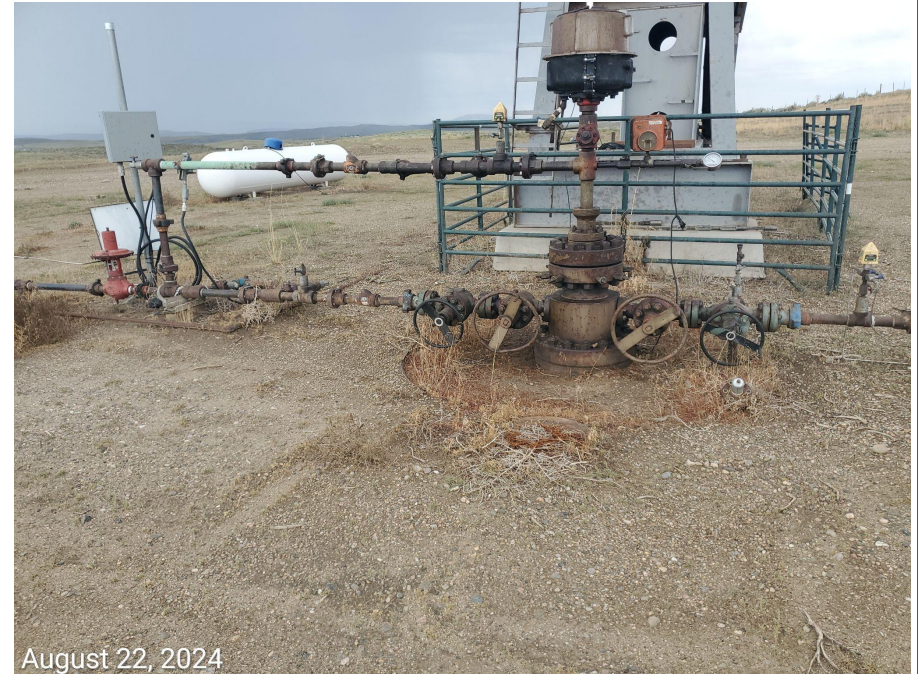
Photo 25: Photos examples showing weed debris, and weed establishment around equipment on the Location.

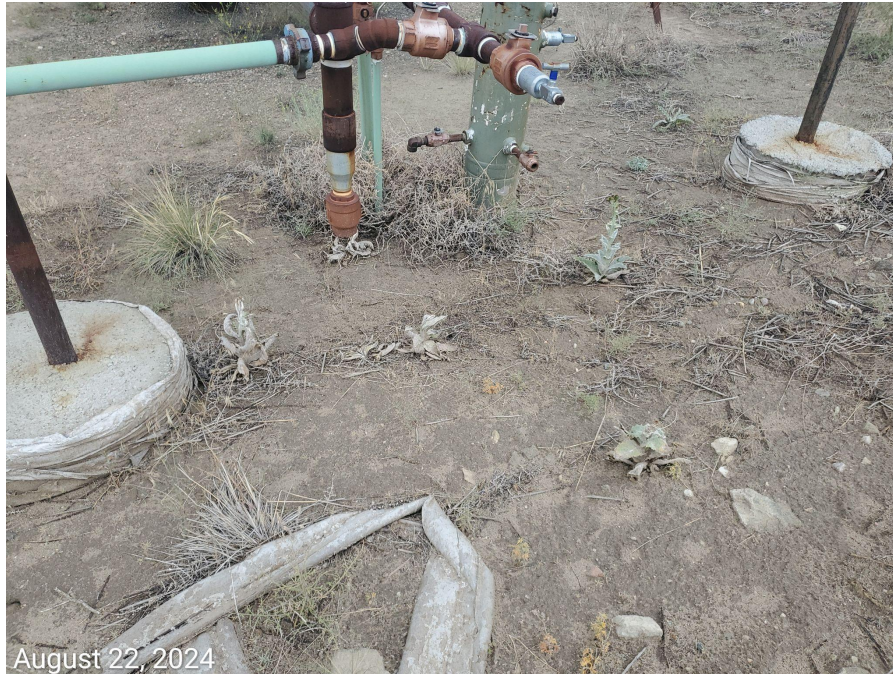
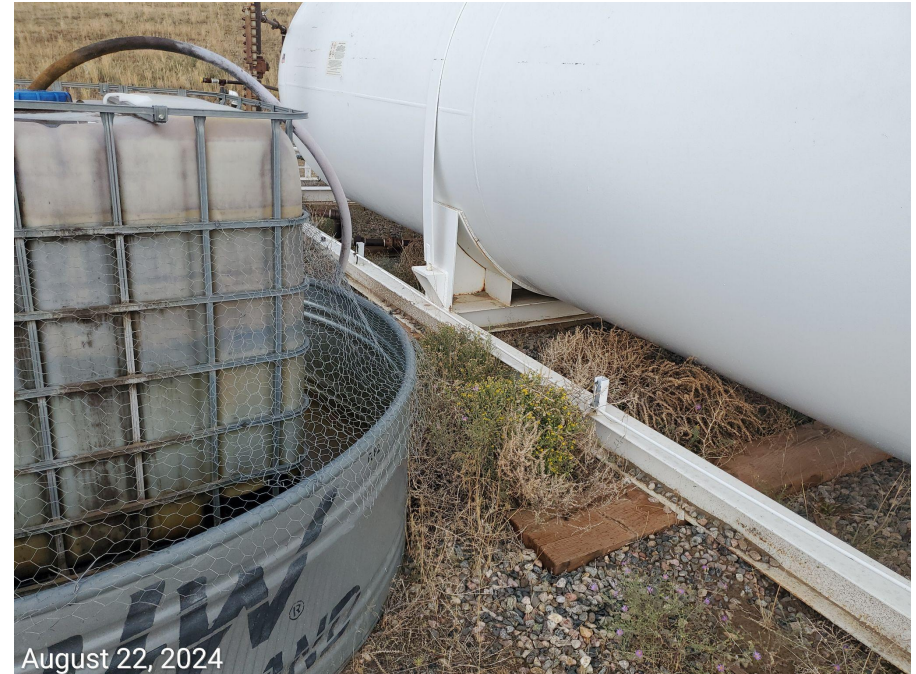
Photo 26: Photos examples showing weed debris, and weed establishment around equipment on the Location.

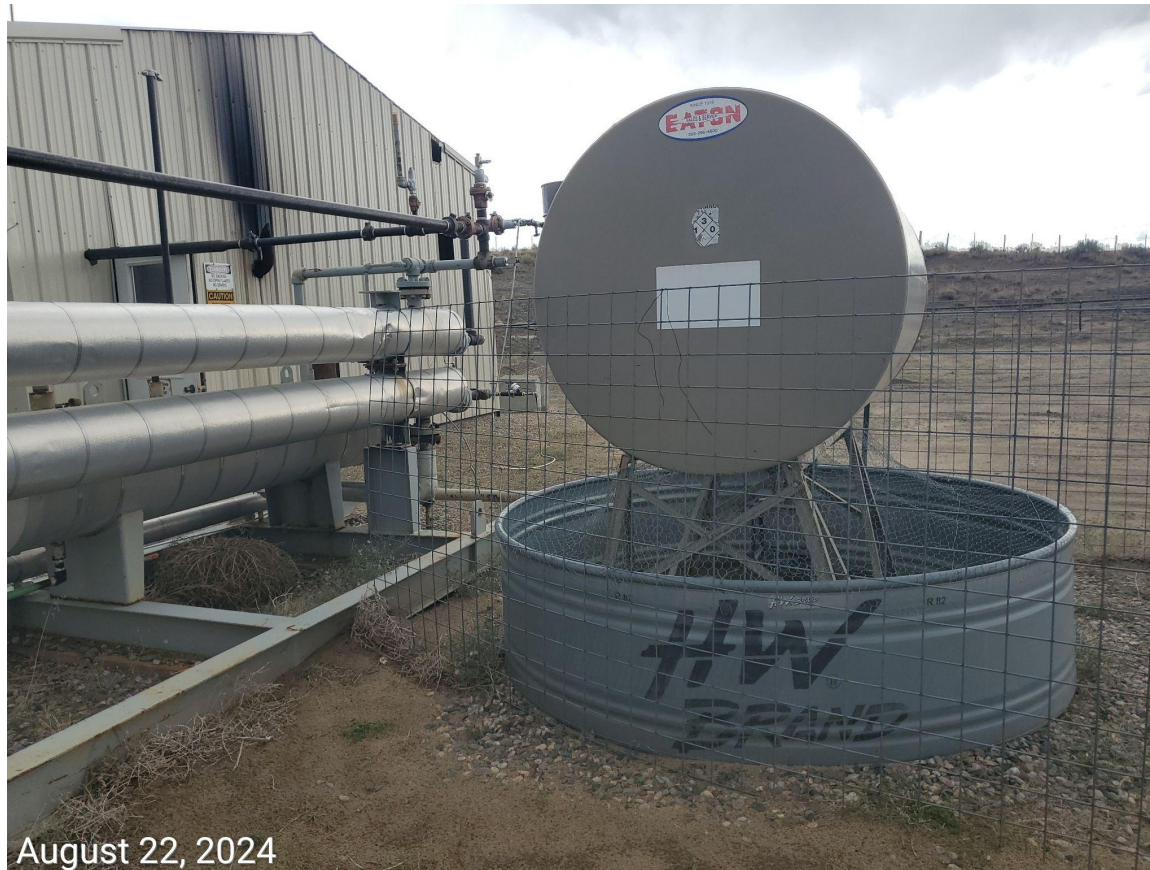
Photo 27: Signage/Labels on containers have not been maintained.

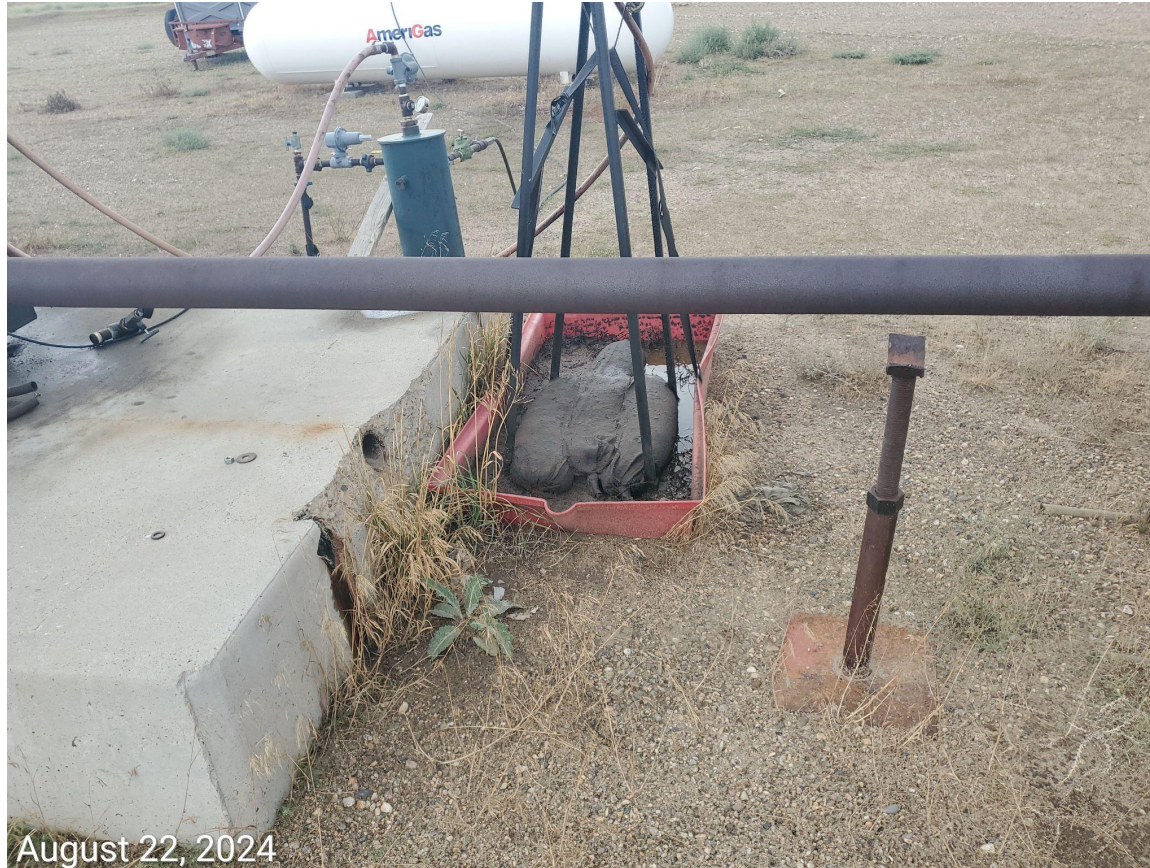
Photo 28: Wildlife protection devices have not been installed or maintained at containment measure.

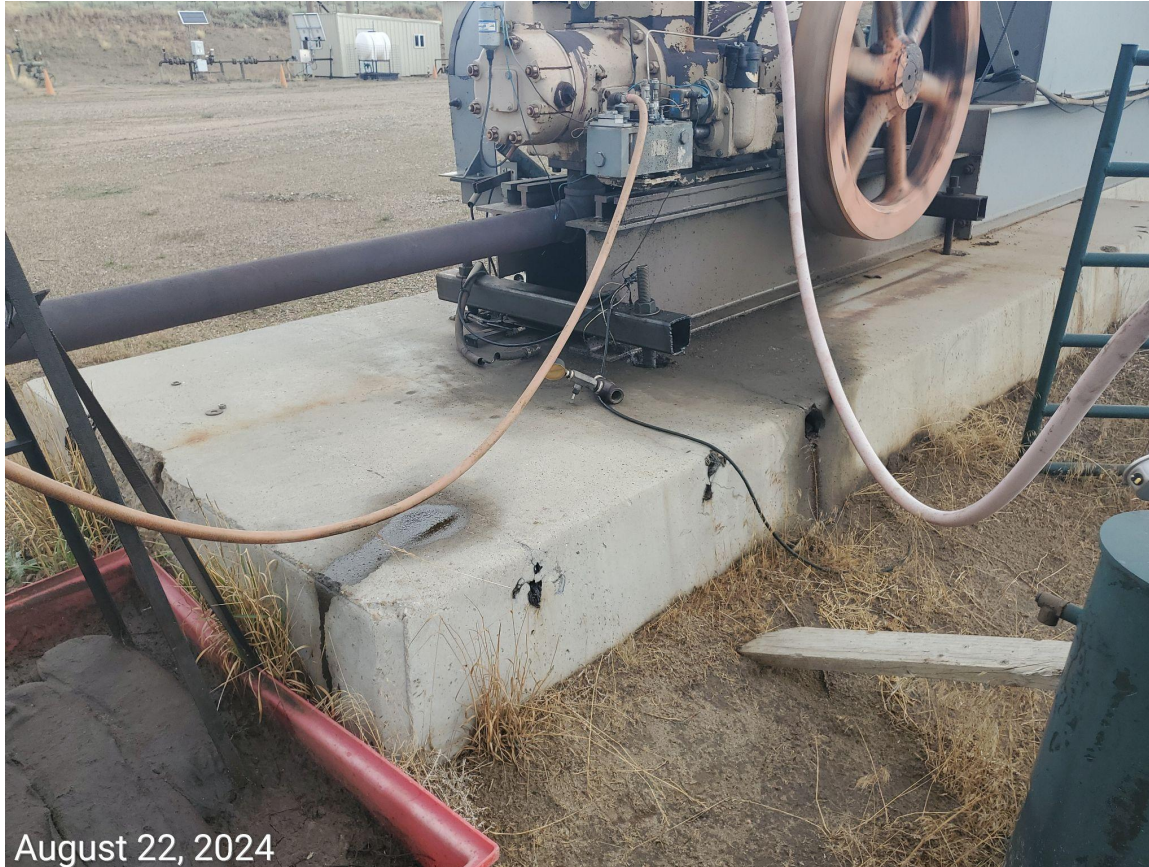
Photo 29: Photo shows leaks have persisted at the pumpjack-
stained soils have not been cleaned/removed.

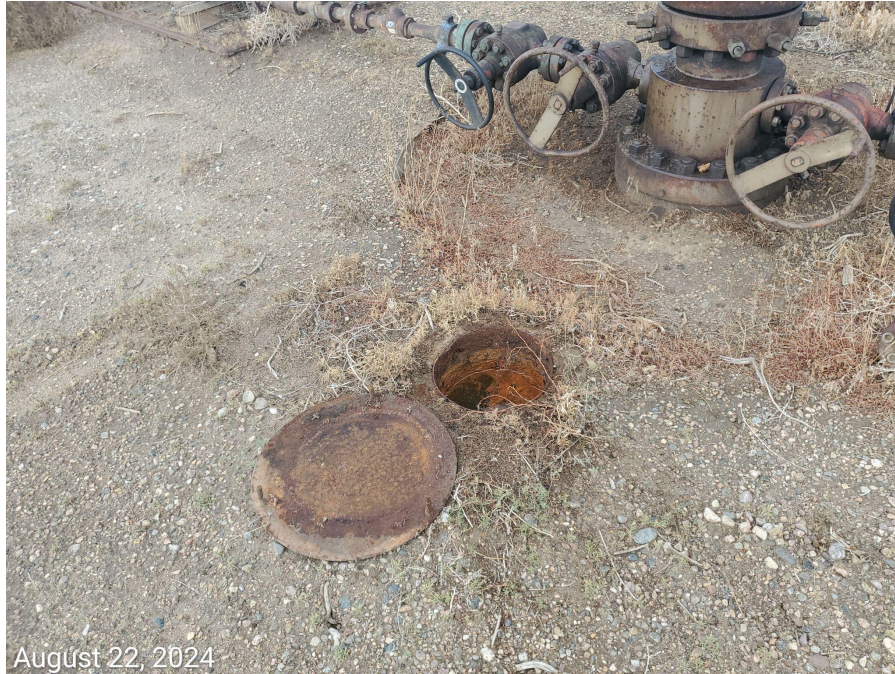
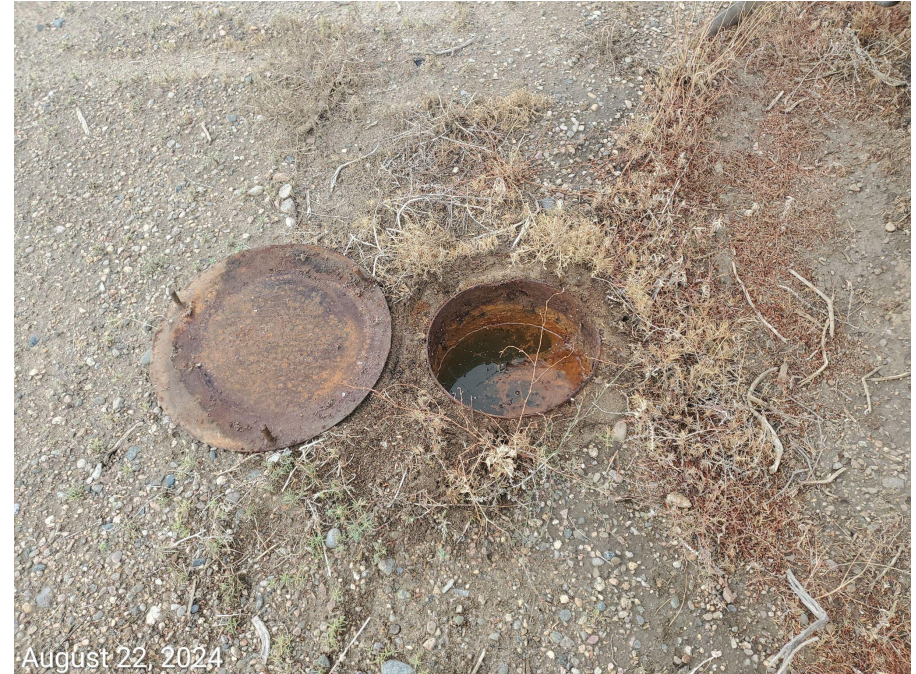
Photo 30: Photo taken from the wellhead, Photo shows what appears to be an open mousehole, or other bore hole, that has not been properly closed and backfilled. Operator has placed unsecured metal plate over the pipe.
