**FORM
INSP**Rev
X/20**State of Colorado
Oil and Gas Conservation Commission**1120 Lincoln Street, Suite 801, Denver, Colorado 80203
Phone: (303) 894-2100 Fax: (303) 894-2109

FIELD INSPECTION FORMLoc ID 316833 Inspector Name: BROWNING, CHUCK On-Site Inspection ☐ 2A Doc Num: _____**Operator Information:**

Name of Operator: AMERICAN HELIUM OPERATING LLC

Facility ID	Type	Status	Status Date	Well Class	API Num	Facility Name	Insp Status
264710	WELL	SI	06/01/2022	GW	113-06109	FOSSIL FEDERAL 1-20	SI

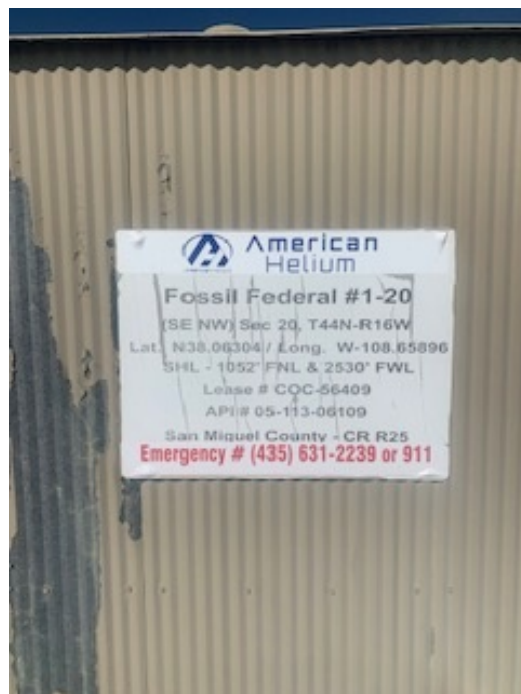
Location ID signage addressed on FF 1-20. Please see photo. New sign on order 9-9-24 for replace.

FF 1-20 location ID signage on meter. 9-8-24

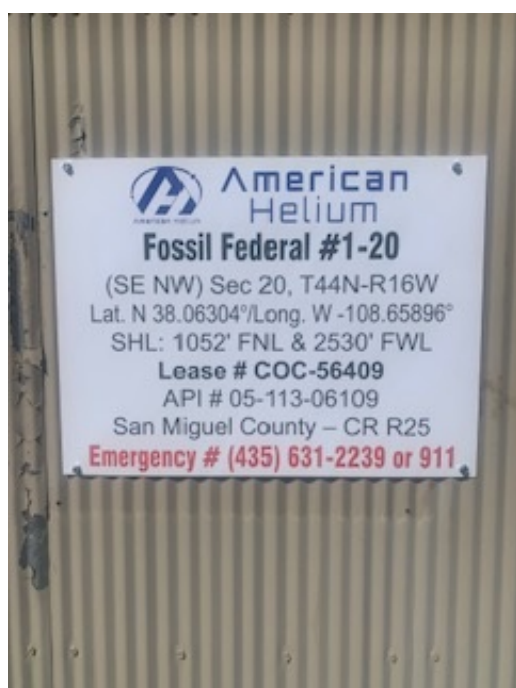
Location ID sign replaced 9-10-24. Please see photo's.

New location Sign installed on meter. 9-10-24

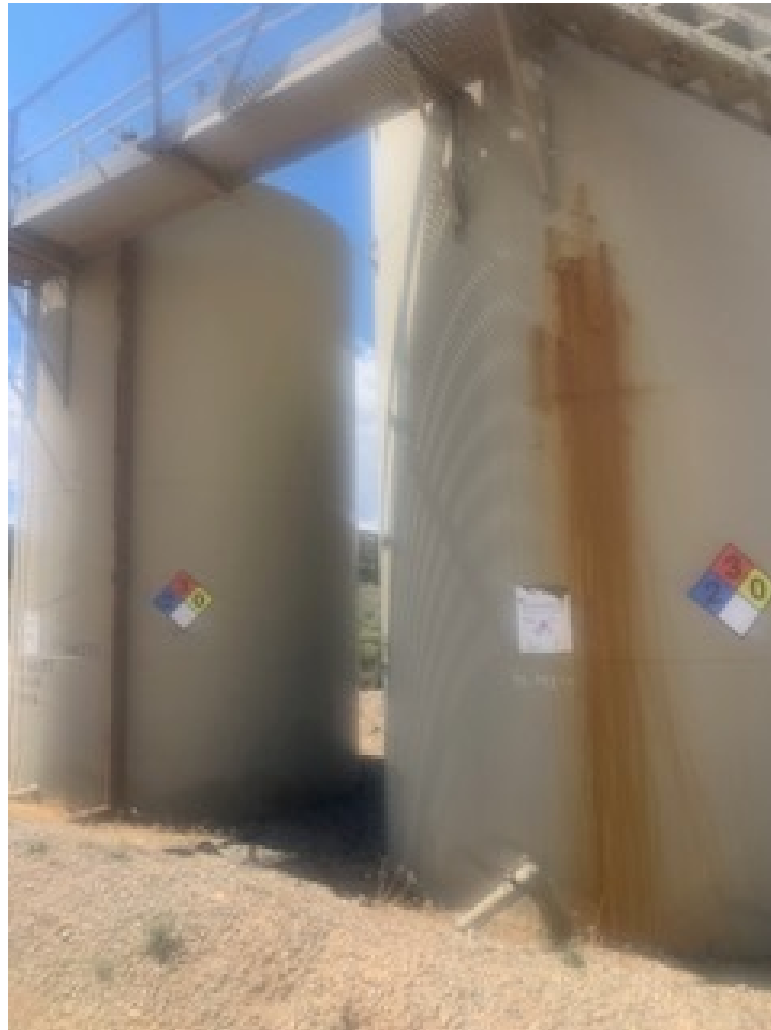
Type	WELLHEAD		
Comment:			
Corrective Action:		Date:	
Type	TANK LABELS/PLACARDS		
Comment:	Sign or label not posted or information inaccurate on tanks or containers or sign/label too small to read at distance or installed in place where not visible.		
Corrective Action:	Install sign to comply with Rule 605.h.	Date:	09/30/2024

Placards installed on FF 1-20 production tank. 9-10-24

Placard installed on FF 1-20 production tank. 9-10-24. Please see photo.
