# Inspection Photos

**Operator:** PETROLEUM RESOURCE  
MANAGEMENT CORP - 10421

**Location ID:** 485573

**Inspection Doc:** 696206210

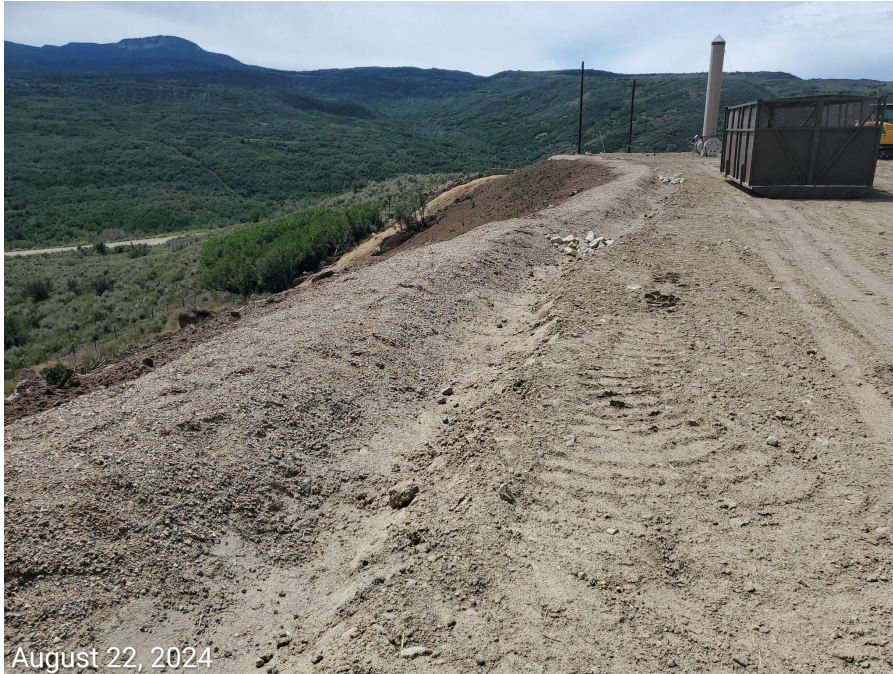
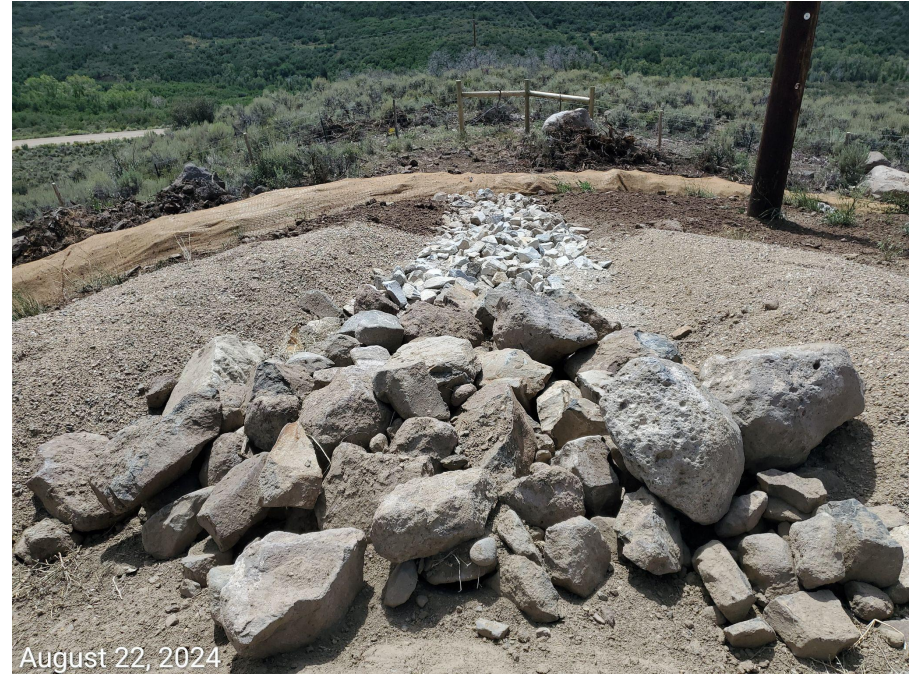
**Photo 1:** Photos taken from the edge of the working pad surface. Photos examples showing a stormwater diversion ditch and berm has been constructed along the perimeter of the pad in. Armored outlets to manage runoff down the slopes have been installed on the Southwest/Northwest corners of the Pad.

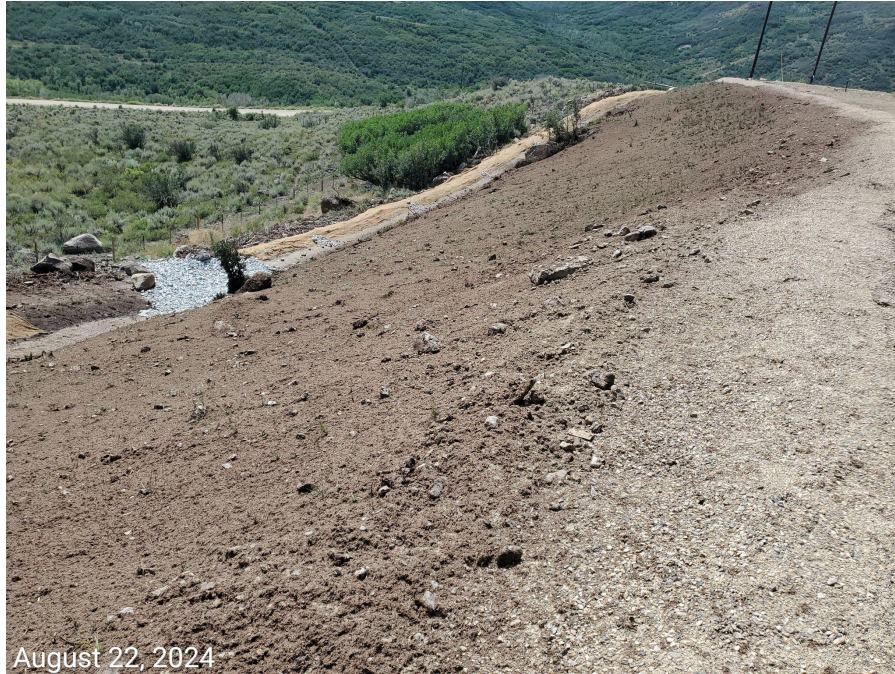
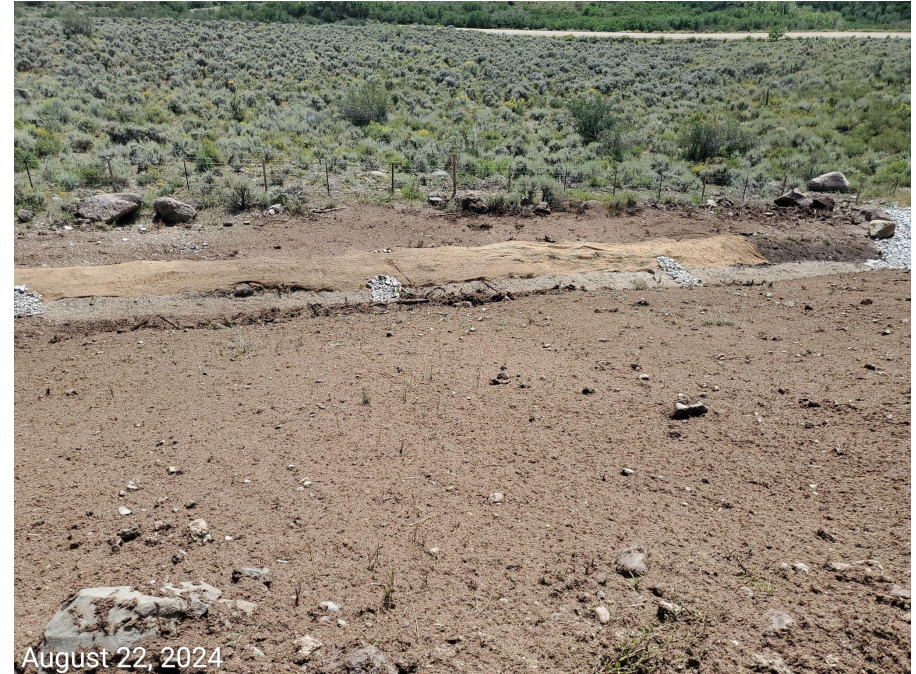
**Photo 2:** Photos examples showing fill slopes on the Location. Erosion degradation identified in the previous inspection has been repaired, the erosion blankets have been removed, and a hydromulch has been applied. As identified in Photo 1, stormwater runoff will no longer travel off the pad onto the fill slopes, but is now being diverted to an armored outlet.

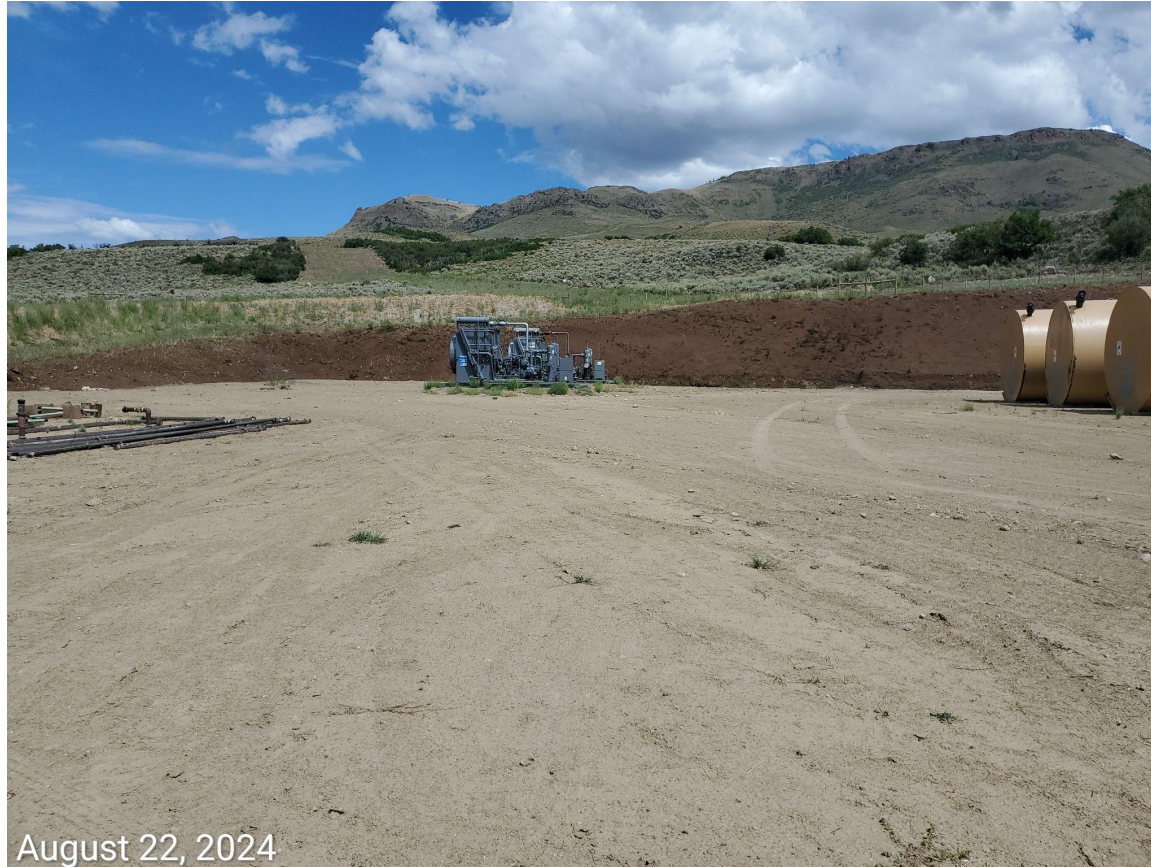
**Photo 3:** Erosion degradation identified in the previous inspection has been repaired, the erosion blankets have been removed, and a hydromulch has been applied.

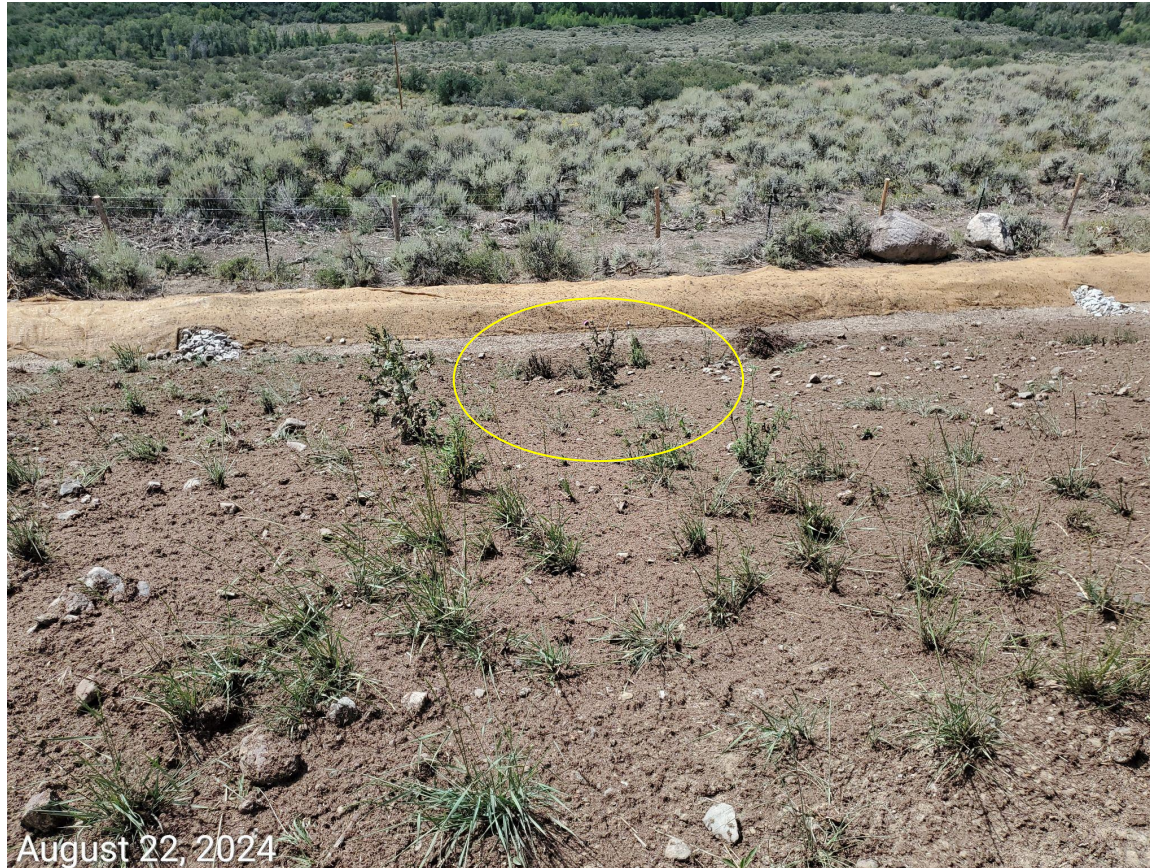
**Photo 4:** Photo taken from the fill slopes. Photo example showing Musk thistle establishing on the Location. Weeds also observed establishing at the cut slope, and along the Flowline System disturbance adjacent to the the Location.

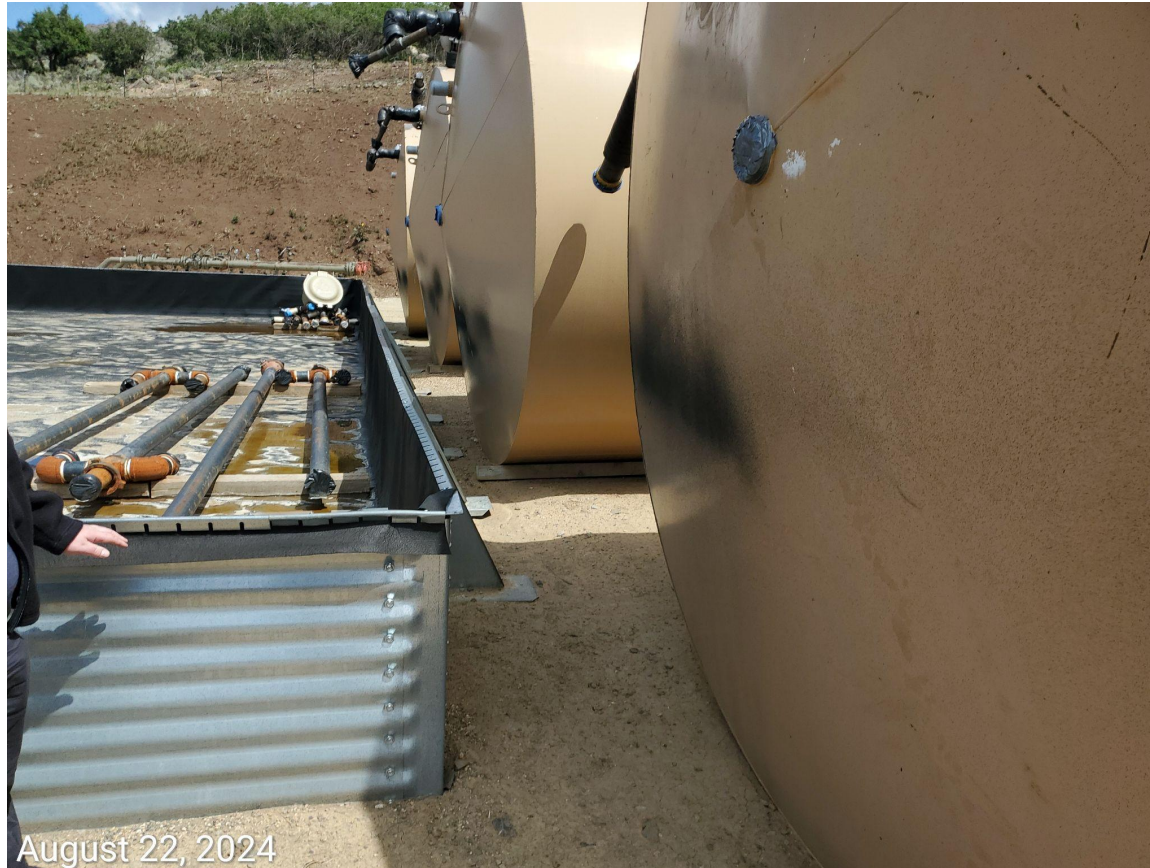
**Photo 5:** Photo example showing tanks stored on location have been covered to prevent wildlife access, including birds and bats.

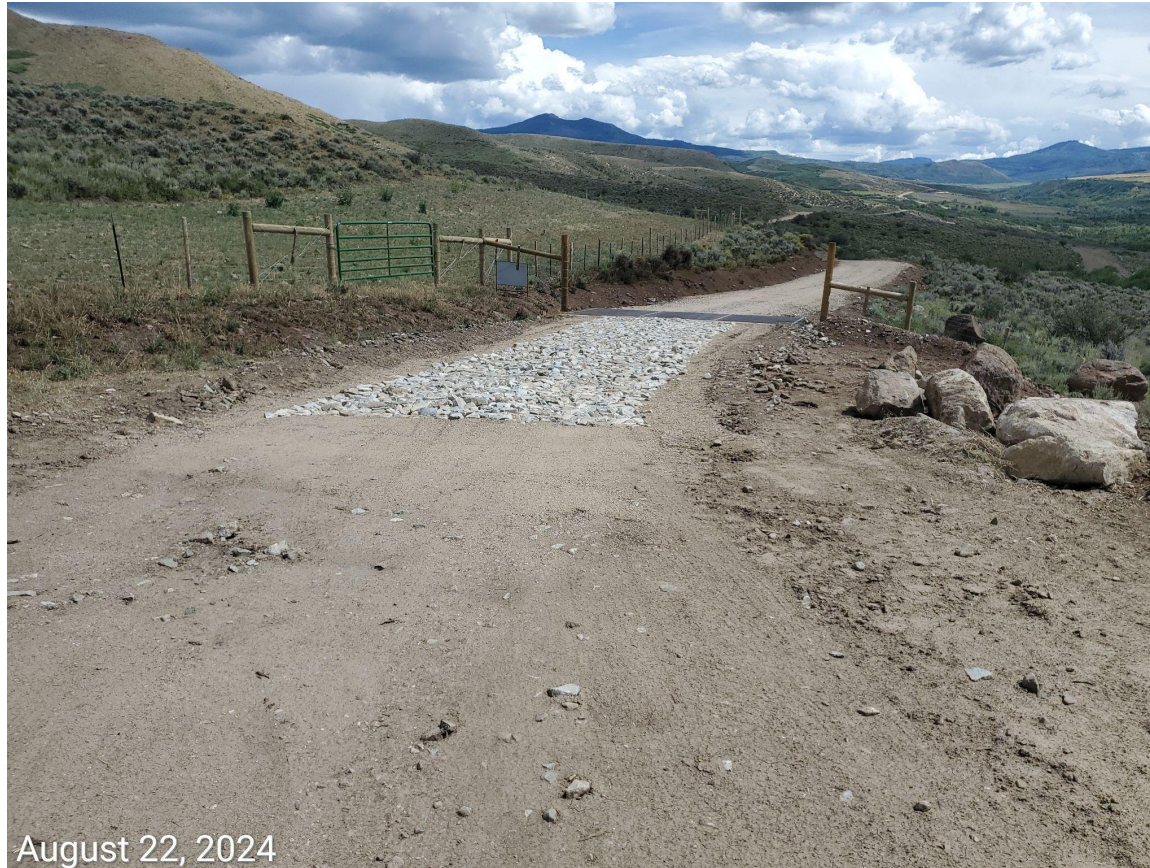
**Photo 6:** Photo taken from the Location entrance, facing south. Photo shows a VTC has been implemented.

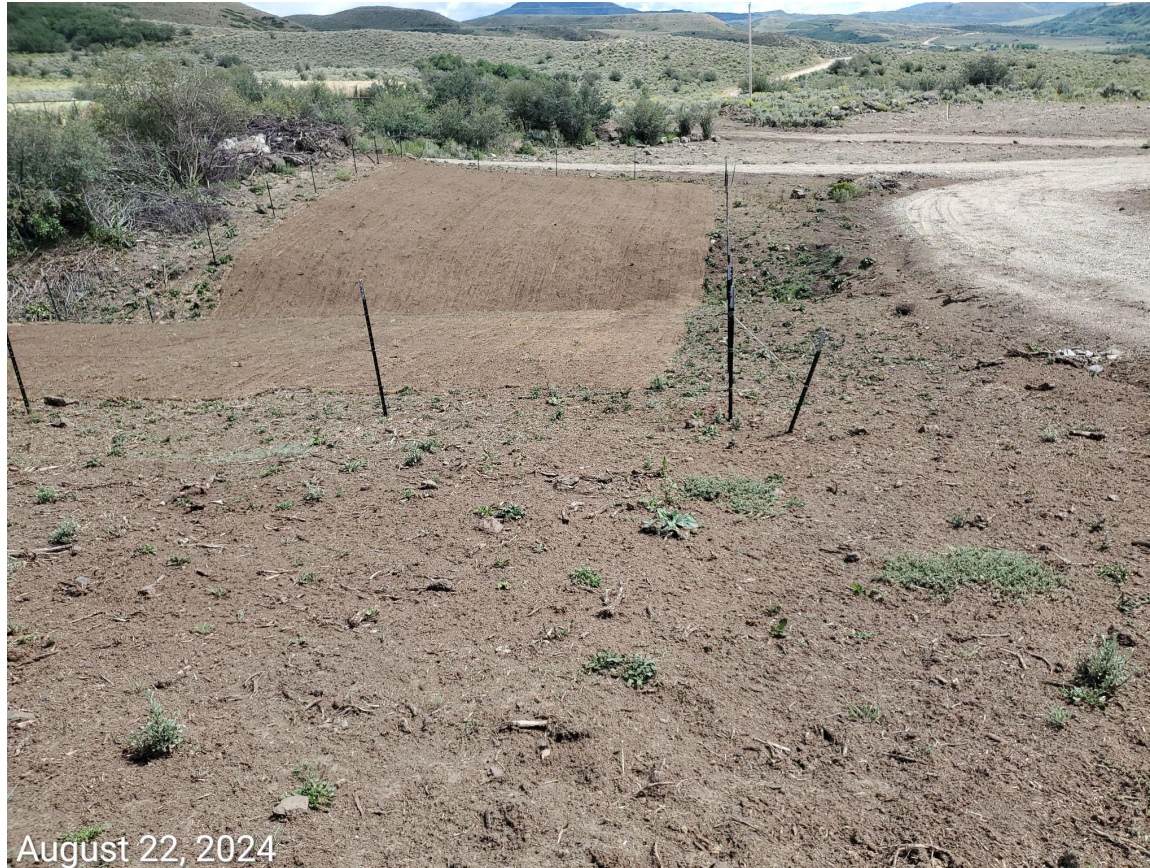
**Photo 7:** Photo taken from the culvert along access road. Flowline disturbance has been hydromulched. Erosion blankets in conjunction with hydromulch implemented at drainage disturbance.

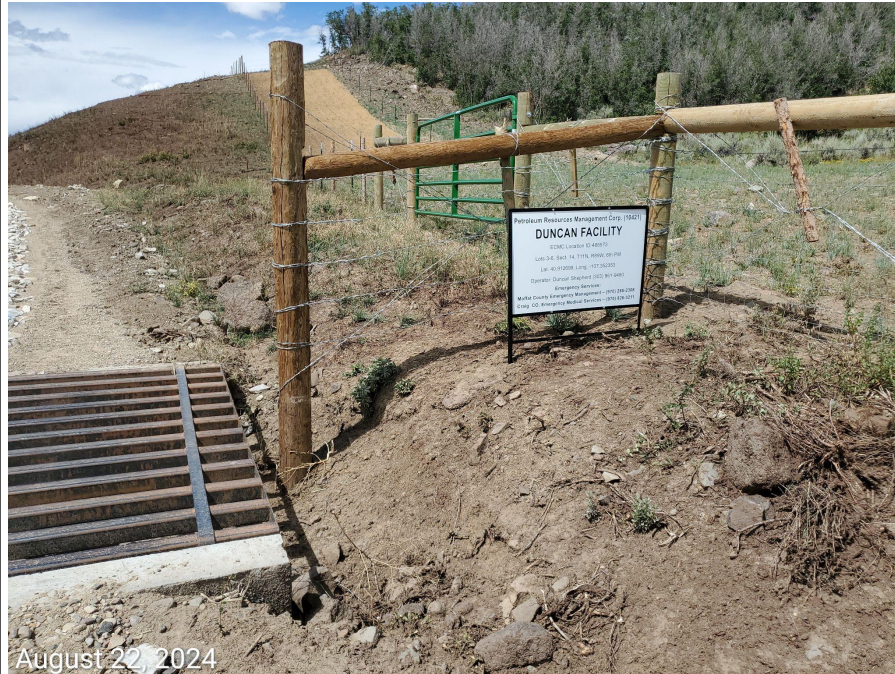
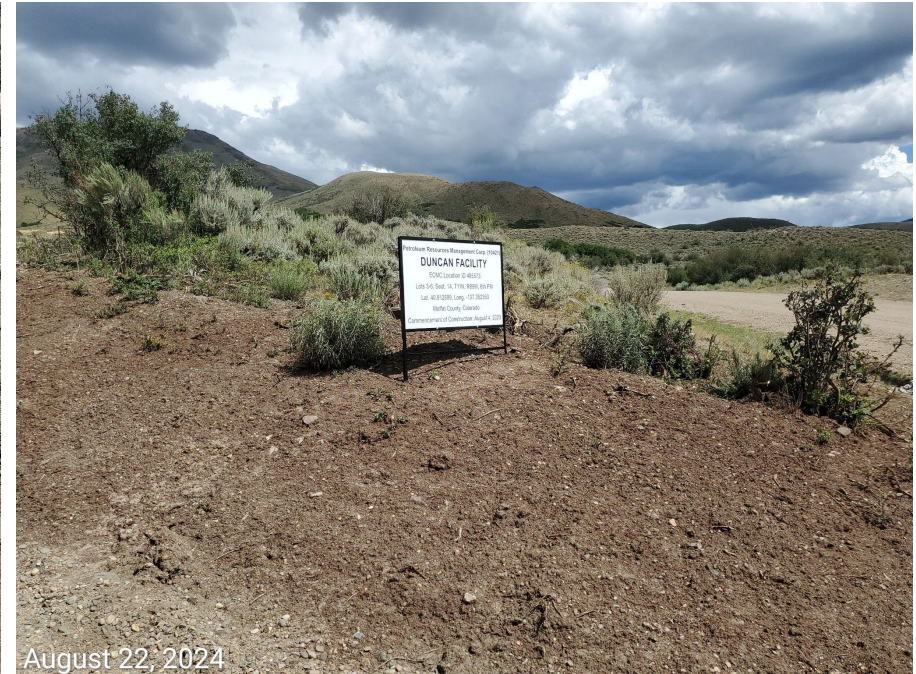
**Photo 8:** Photos show signage has been implemented at the Location entrance and access road/public road intersection.

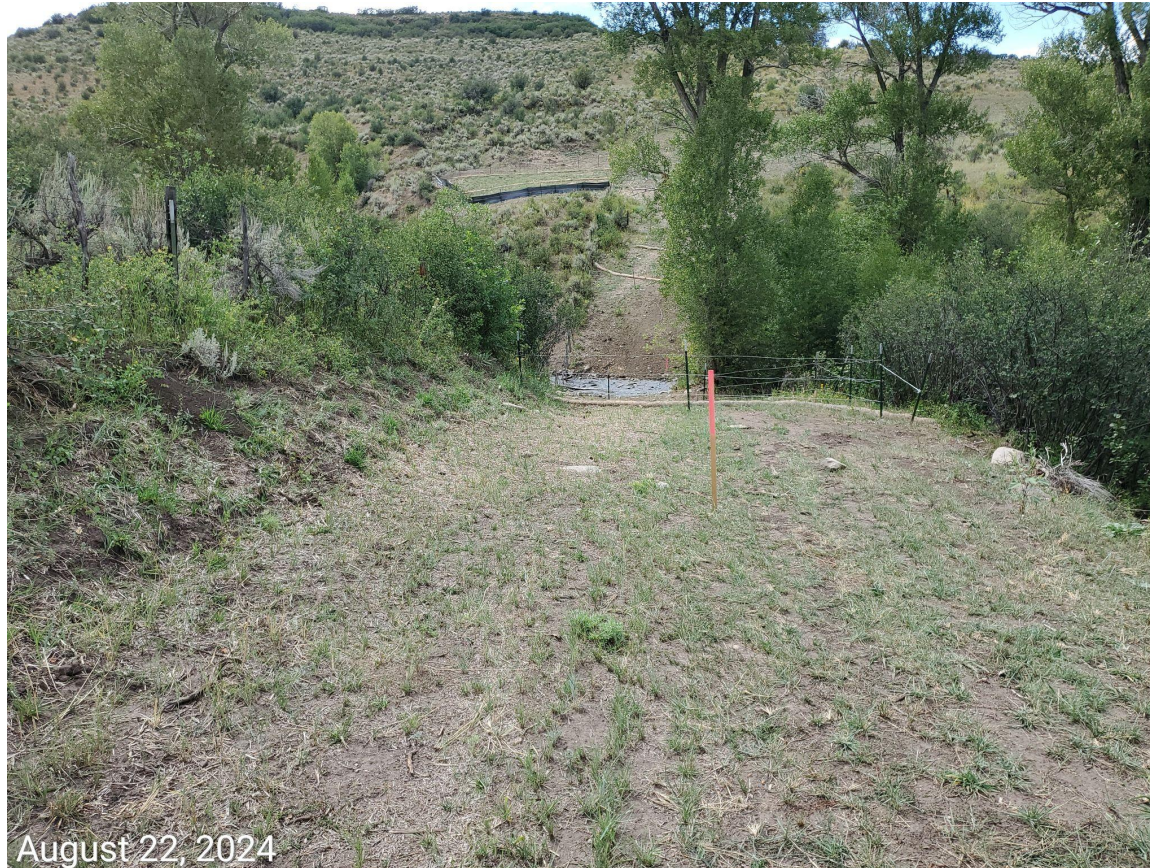
**Photo 9:** Photo taken from the access road and Beaver Creek stream crossing associated with the Flowline System construction. Erosion logs implemented at the road have been maintained, and areas have been fence to restrict livestock from accessing the BMPs; fence also restricts vehicle access to the stream crossing. To date, road has not been constructed with a properly engineered stream crossing.

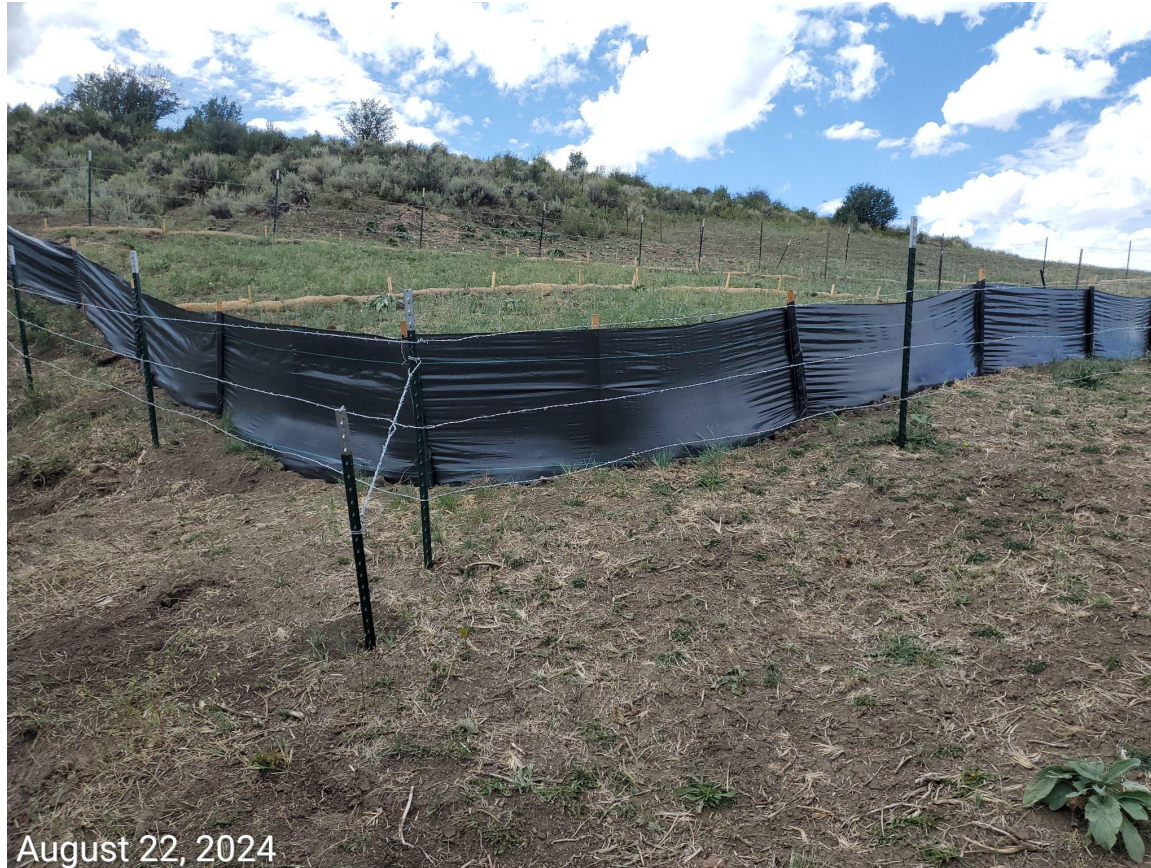
**Photo 10:** Photo taken from the Flowline System disturbance. Photo shows silt fence has been maintained, erosion logs implemented, and areas fenced to restrict livestock access.

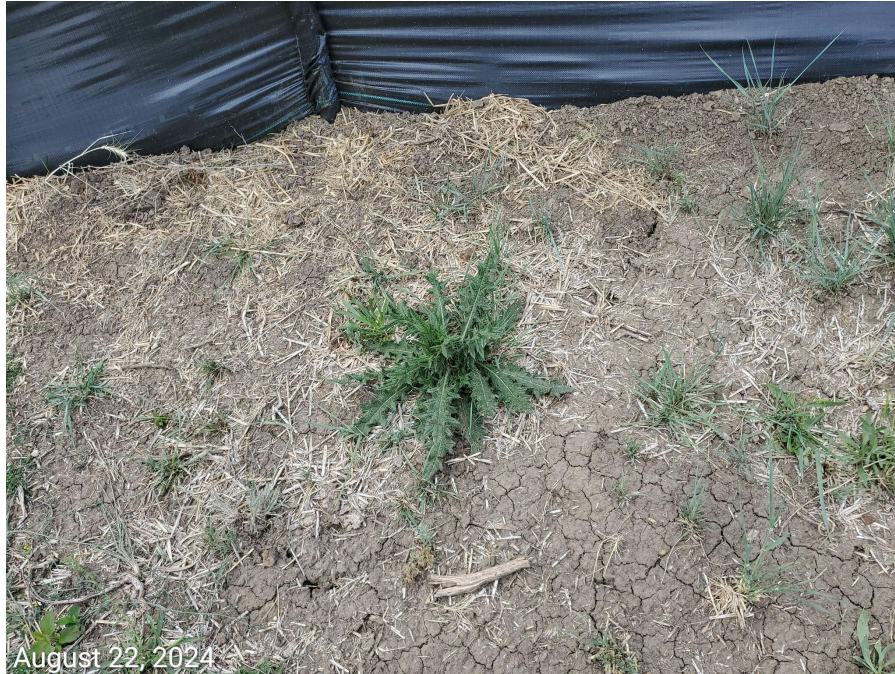
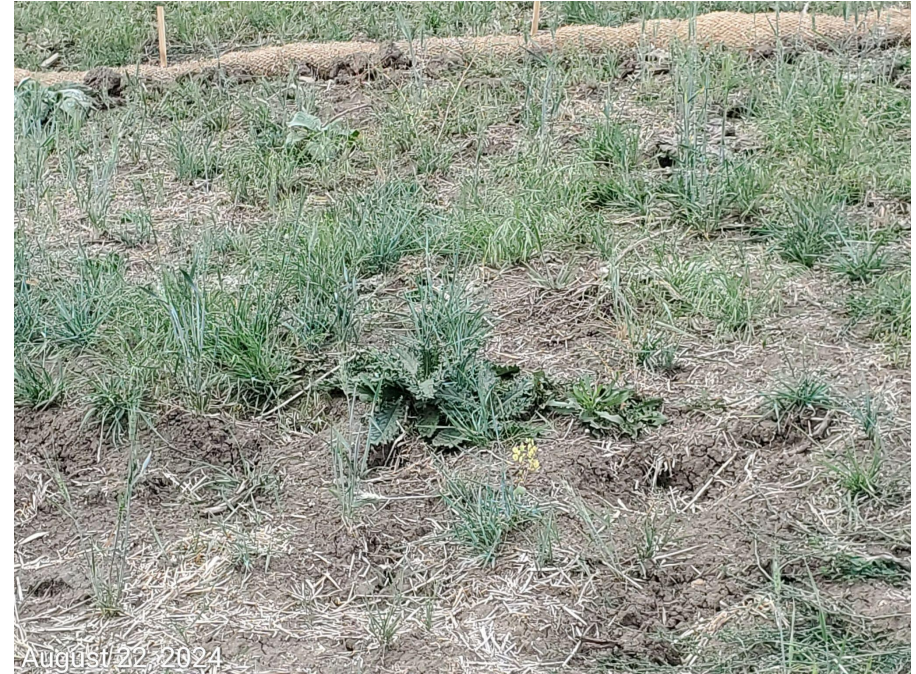
**Photo 11:** Photo taken from the Flowline System disturbance. Photos examples showing Noxious weeds (Bull thistle, Musk thistle) observed establishing with Operator's disturbance areas.
