Inspection Photos

Location Name: CAERUS PICEANCE LLC COUEY 24-6 (F24W) Pad

Location #: 334693

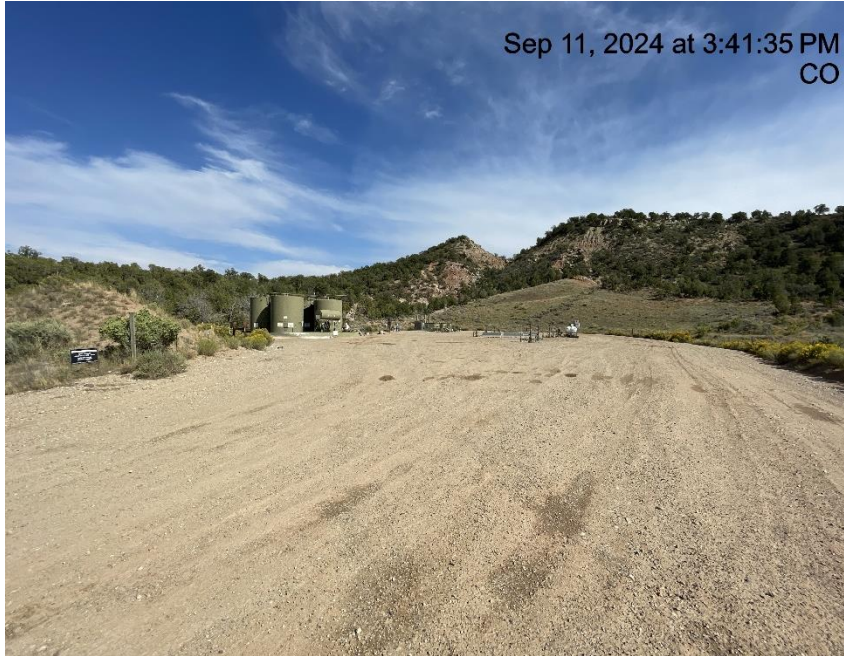
Photo # 46 From Entrance to location

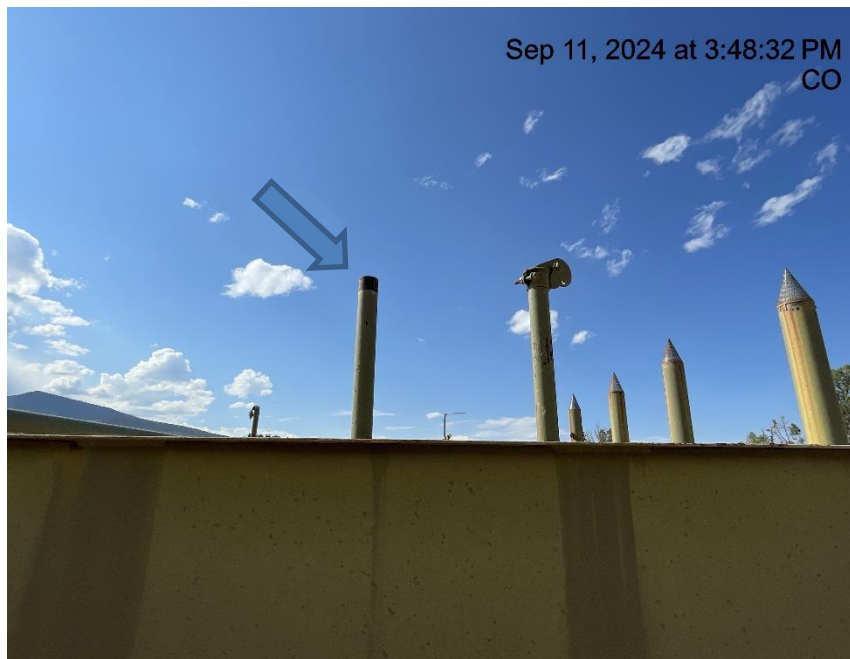
Photo # 56 Rupture disc vent line does not comply with CECMC pressure safety device rules.

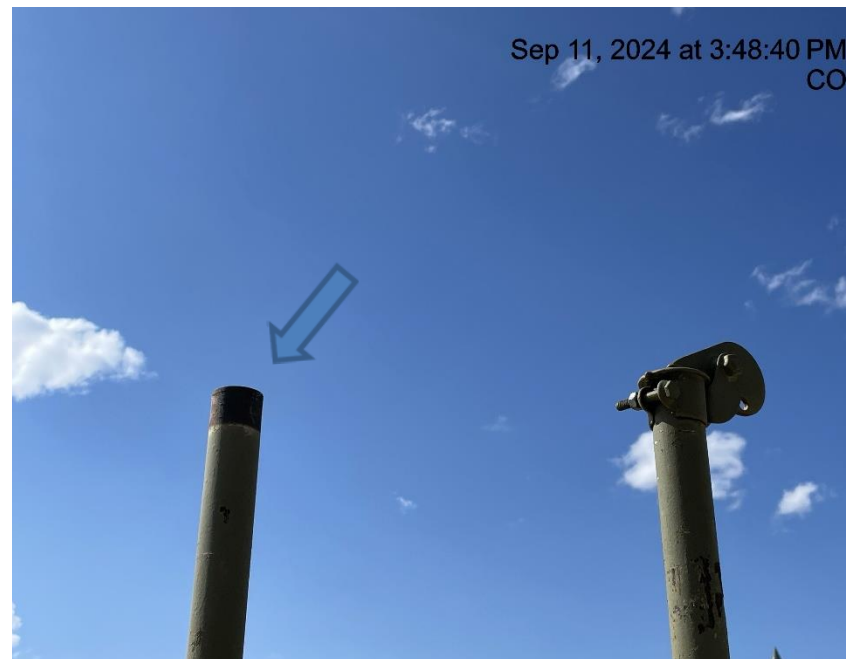
Photo # 57 Rupture disc vent line does not comply with CECMC pressure safety device rules.
