Inspection Photos

Location Name: CAERUS PICEANCE LLC Mamm Creek J6SEB Pad

Location #: 432265

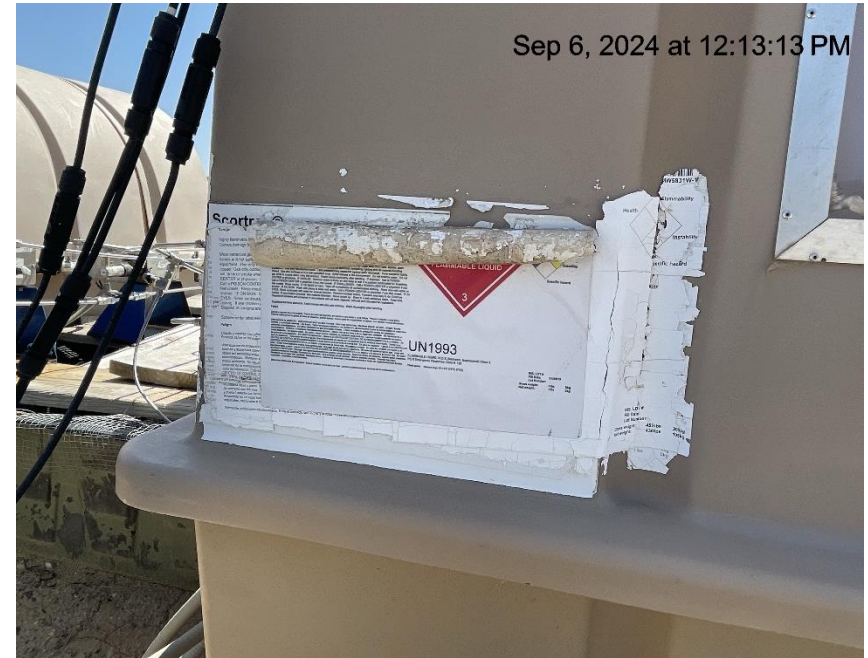
Photo # 8635 Label on chemical tank peeling & some info is illegible/does not comply with CECMC rules

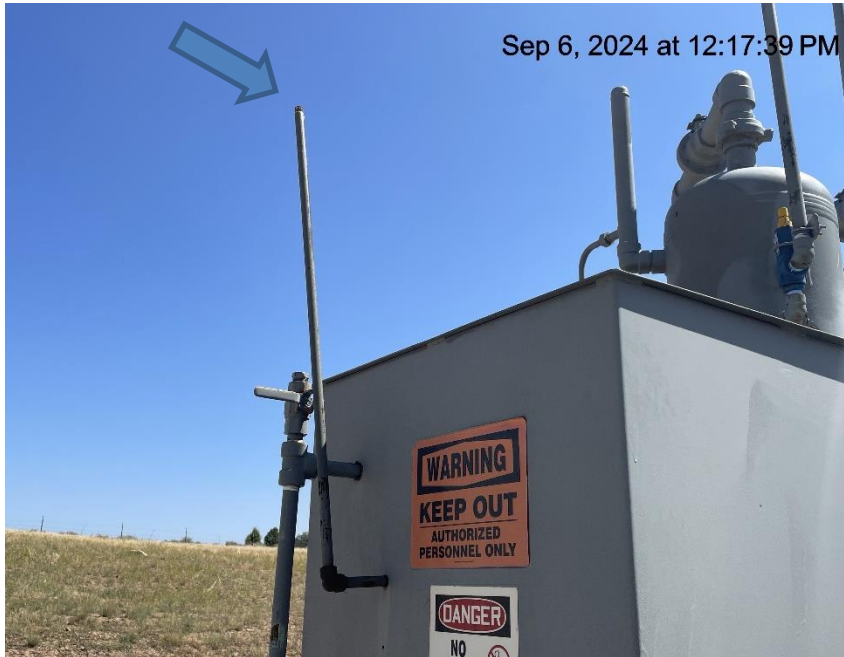
Photo # 8636 PRV vent line does not comply with CECMC pressure safety device rules

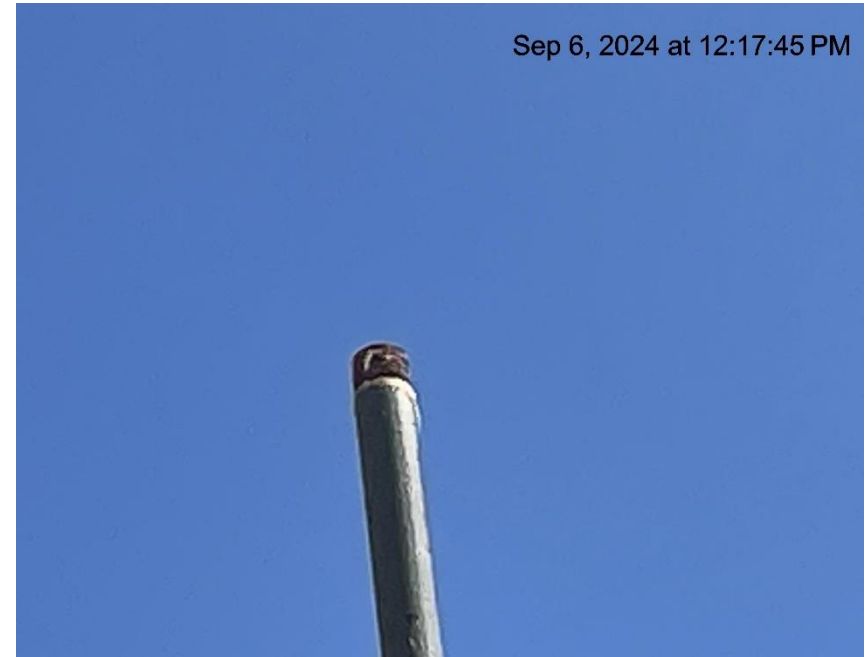
Photo # 8637 PRV vent line does not comply with CECMC pressure safety device rules
