## Inspection Photos

Location Name: MUSTANG RESOURCES LLC JUHAN FEDERAL 1-35-6S-94W Pad

Location ID: 322298

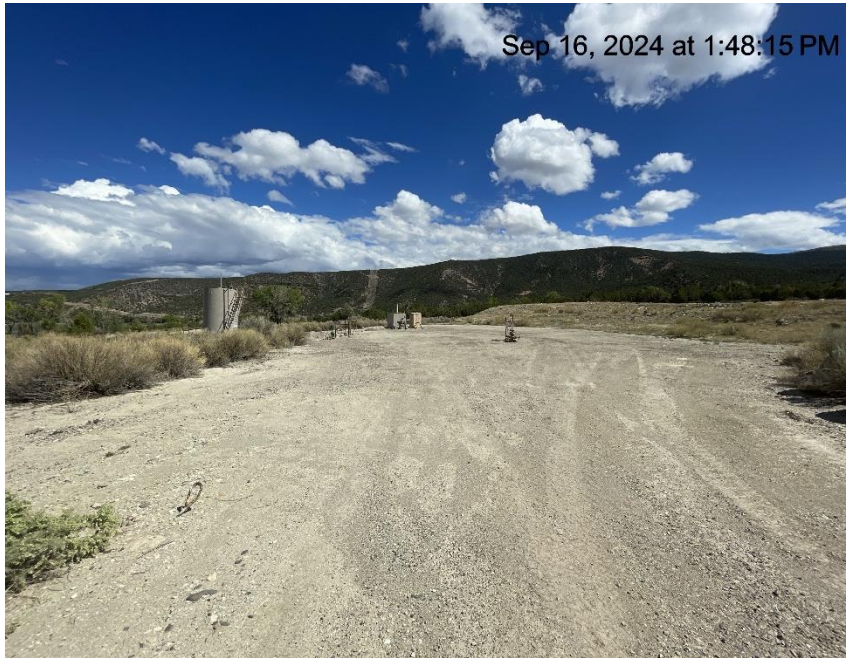
Photo # 523 From entrance to location

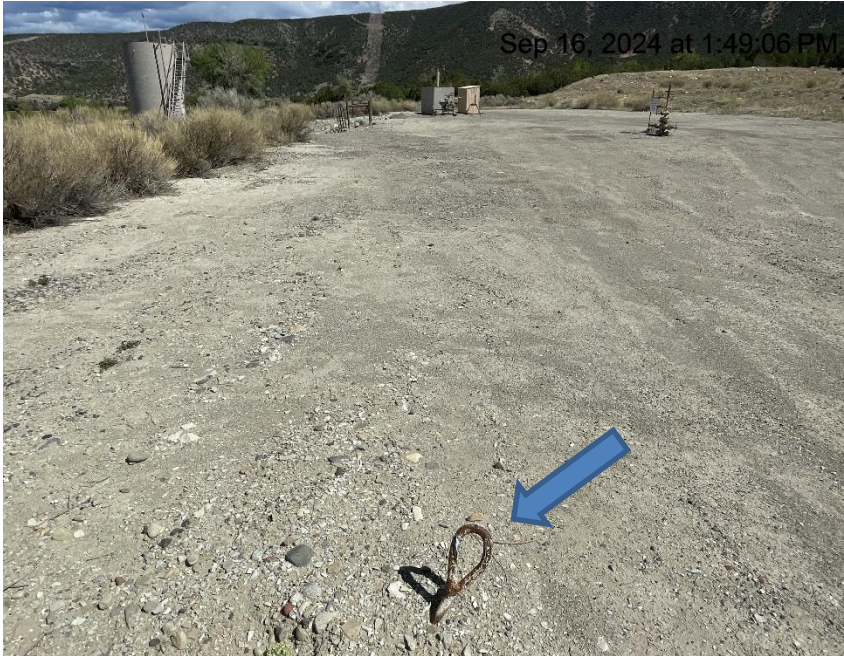
Photo # 529 Unmarked deadman

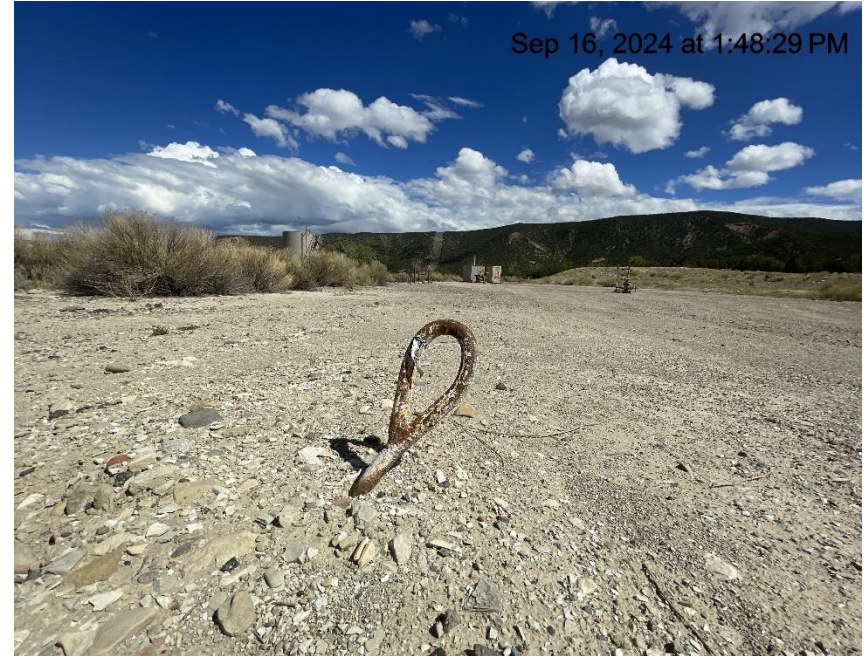
Photo # 530 Same unmarked deadman

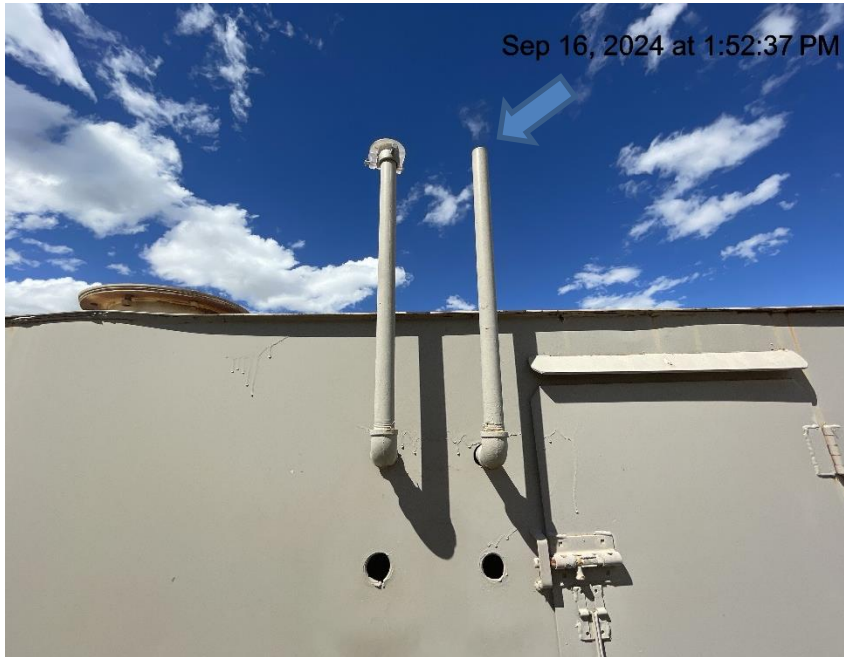
**Photo # 531 PRV vent line does not comply with CECMC pressure safety device rules**

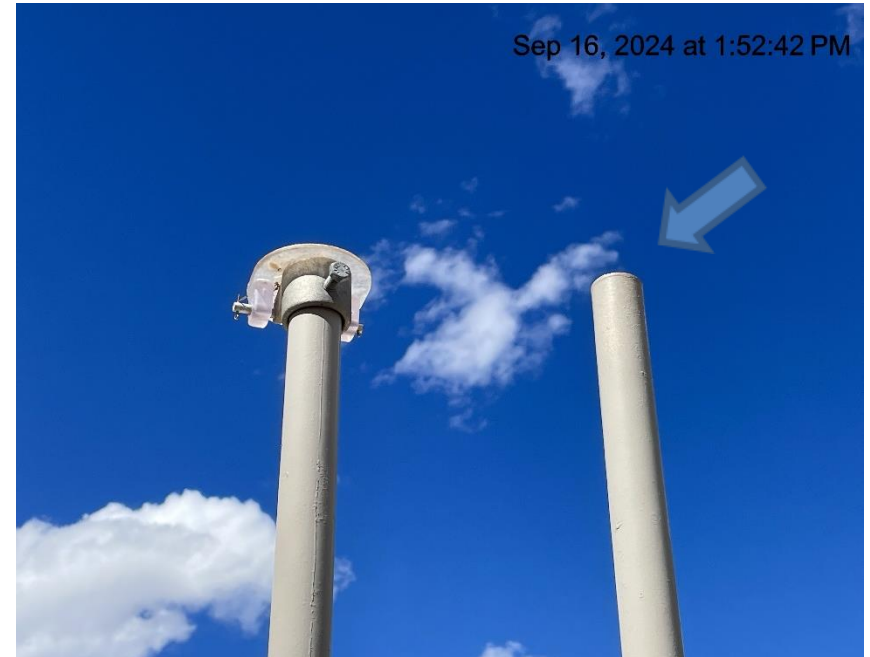
**Photo # 532 PRV vent line does not comply with CECMC pressure safety device rules**
