Inspection Photos

Location Name: TEP ROCKY MOUNTAIN LLC Clough NR 23-3 Pad

Location ID: 422211

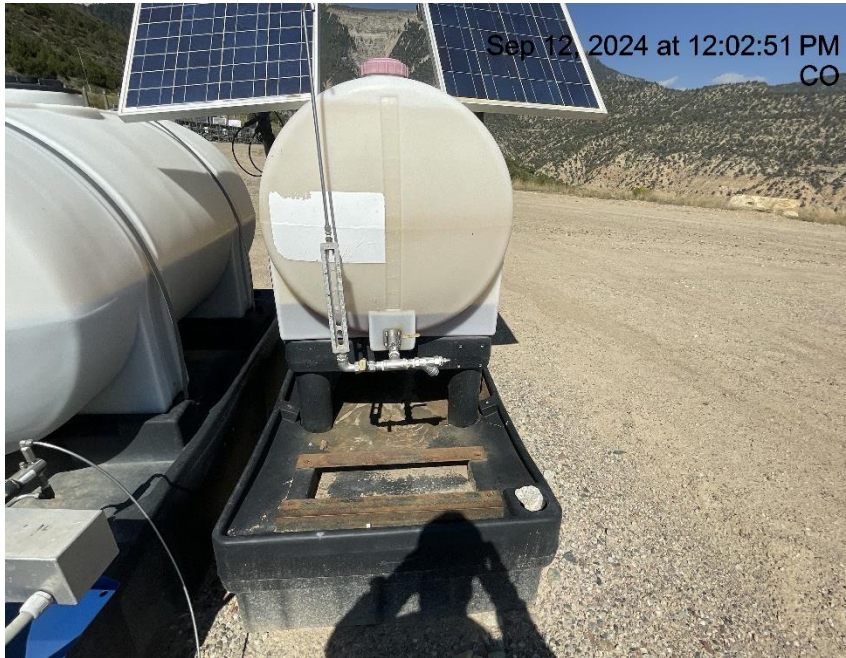
Photo # 219 Unused equipment

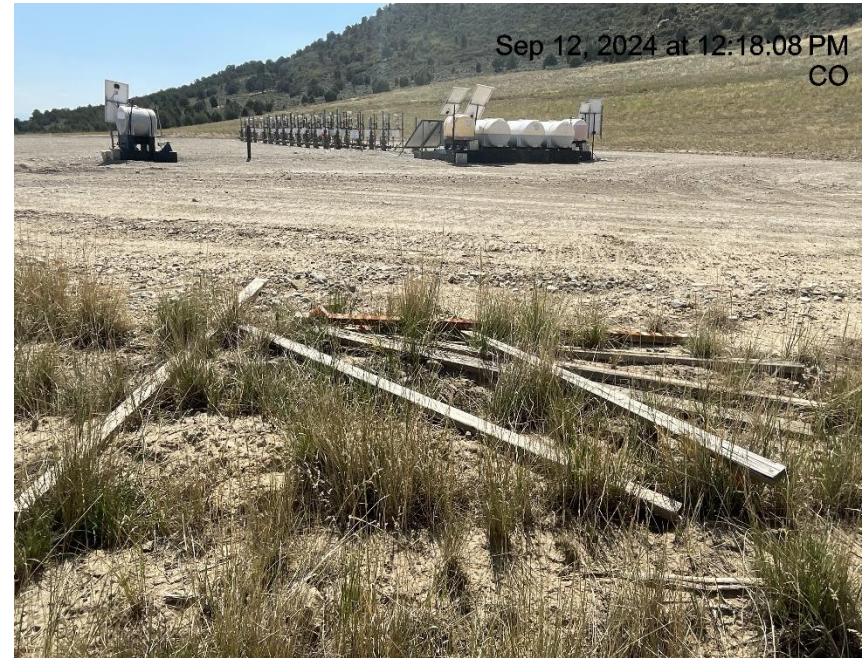
Photo # 220 Debris

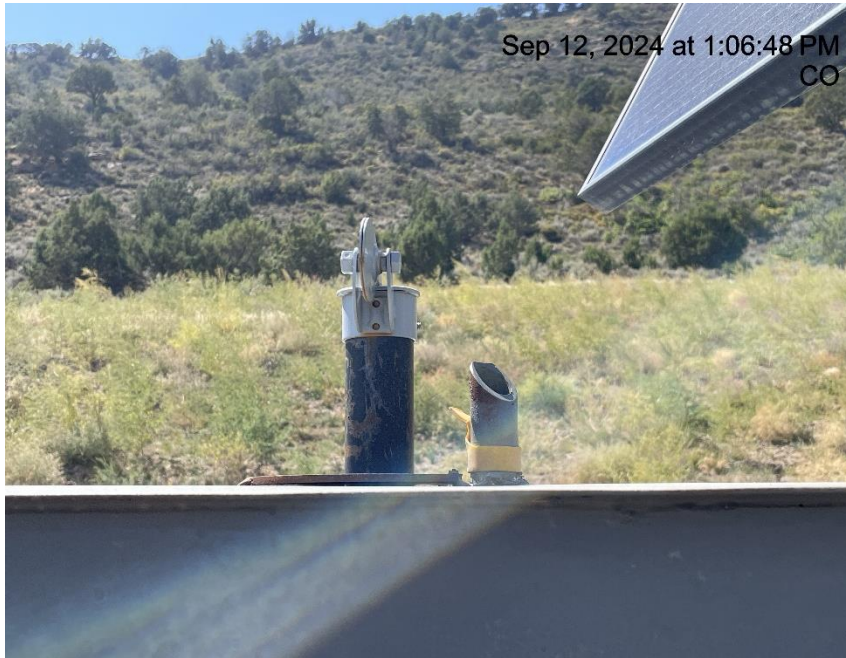
Photo # 221 Rupture disc vent line does not comply with CECMC pressure safety device rules

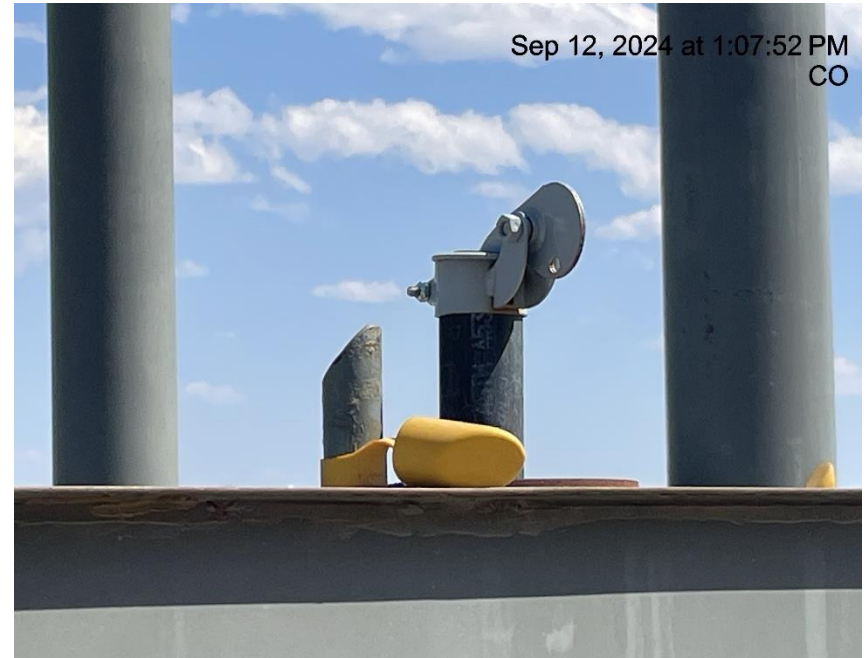
Photo # 222 Rupture disc vent line does not comply with CECMC pressure safety device rules

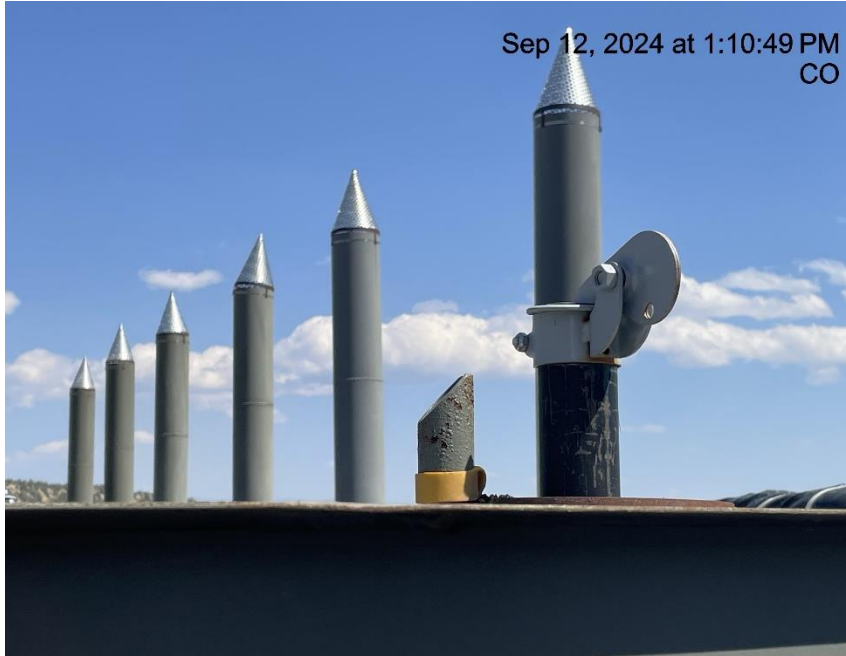
Photo # 223 Rupture disc vent line does not comply with CECMC pressure safety device rules

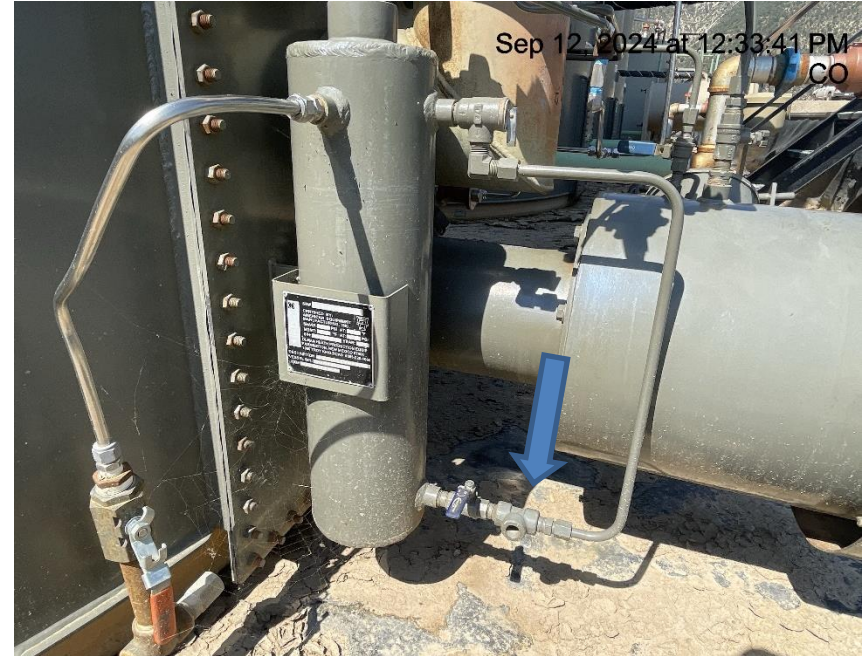
Photo # 224 PRV vent line does not comply with CECMC pressure safety device rules
