Inspection Photos
Location Name: Parmlee 3
API # 05-123-14916

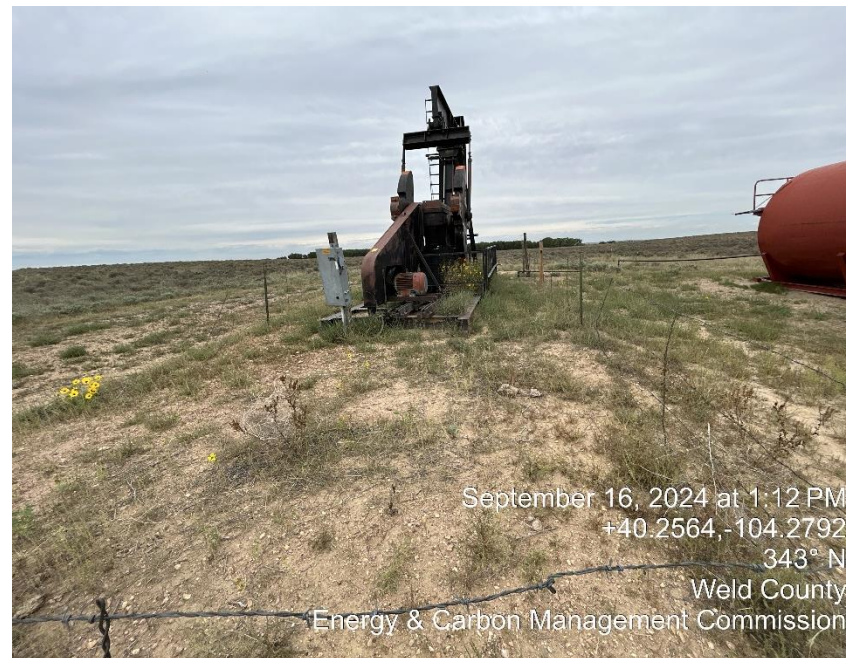
Vegetation

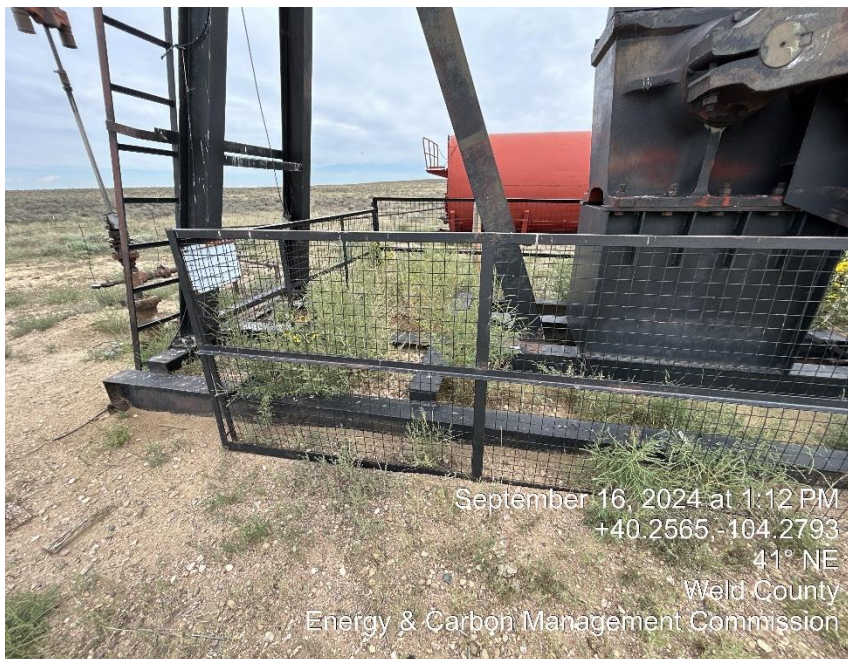
Vegetation

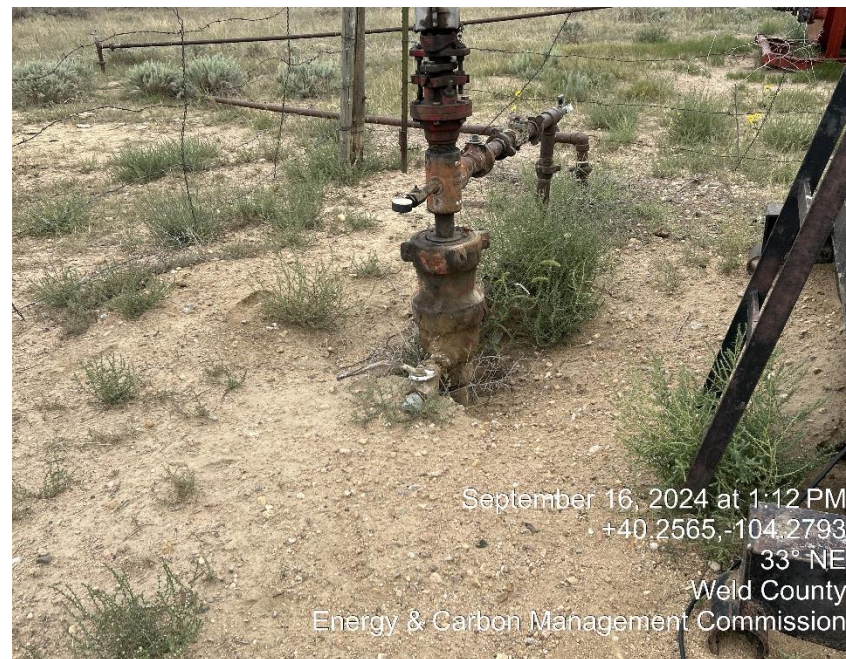
Vegetation

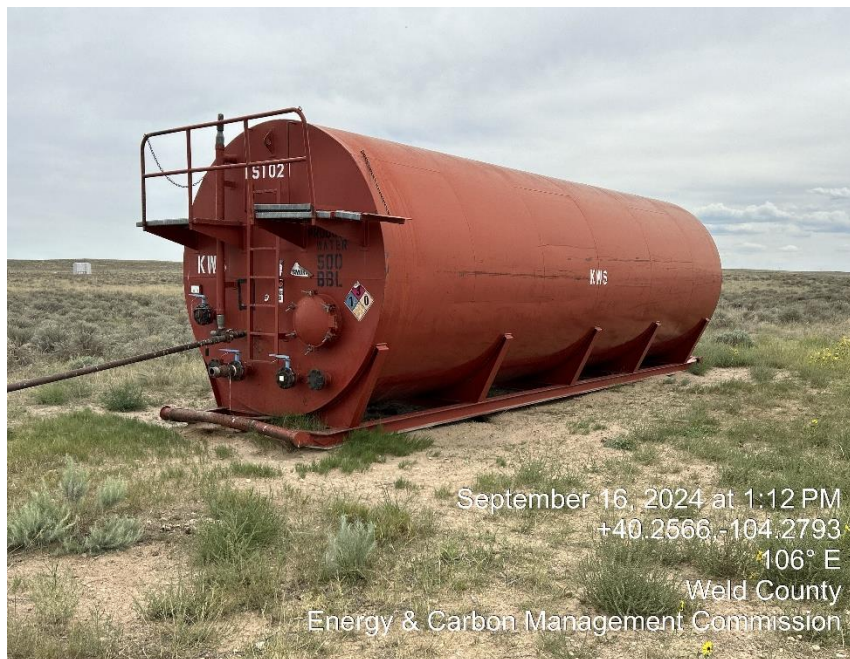
Tank needs secondary containment

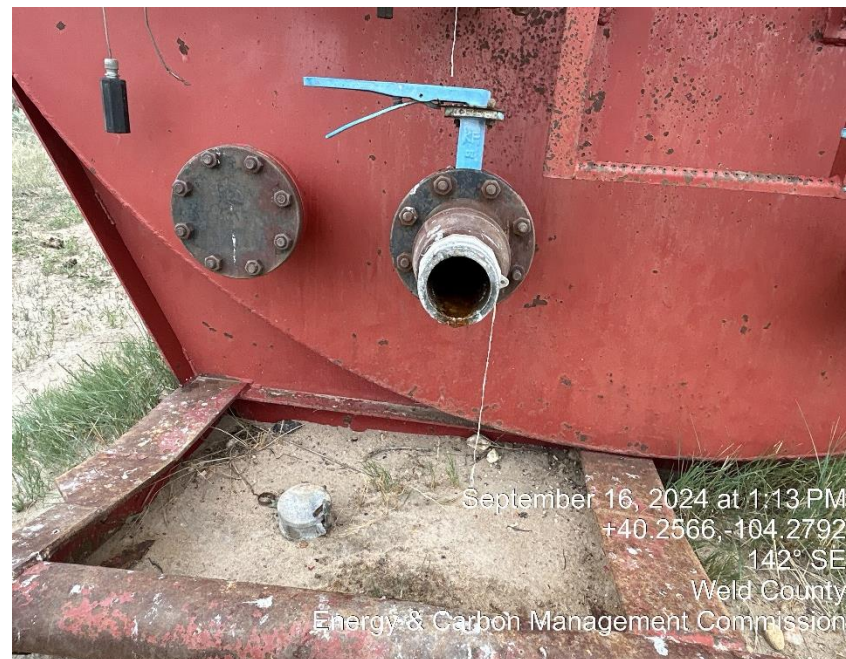
Appears to be leaking

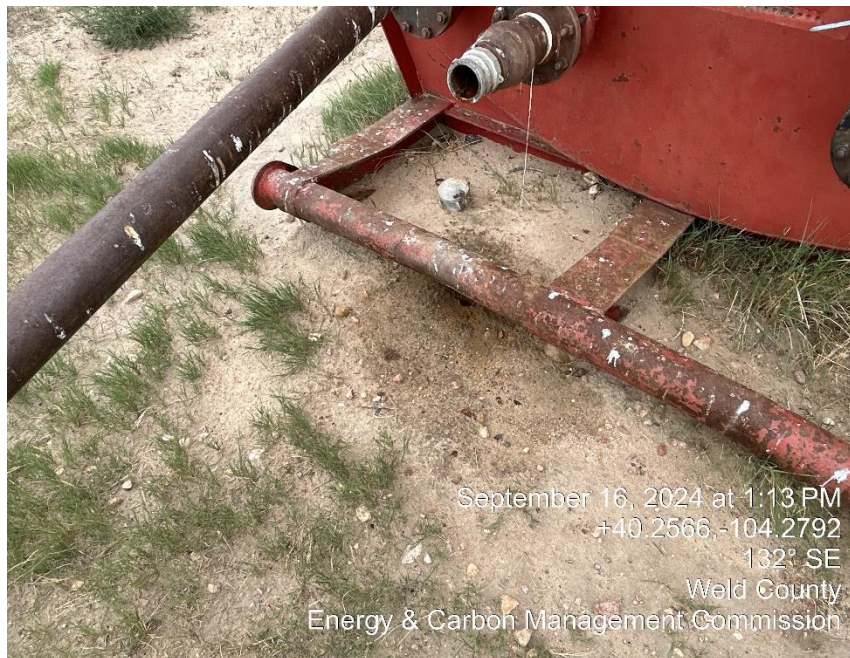
Appears to be leaking & Stained Soil

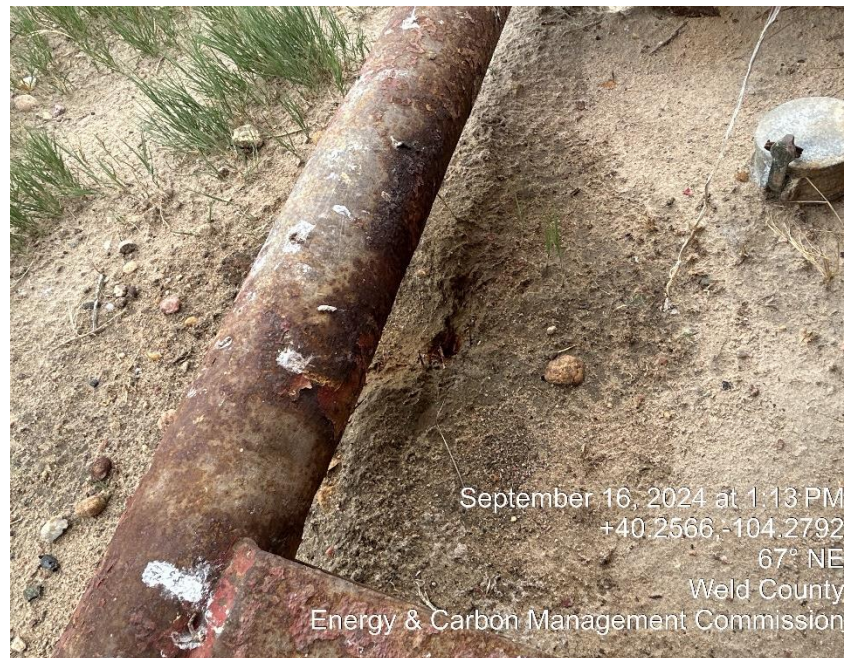
Stained Soil
