## Tank Battery Closure Checklist

Project	Occidental Petroleum
ID	292627
Survey Date	10/31/2022
User	Matt Bellia
Additional Attachments (Optional)	Partially Buried Vault Closure
Site Name & COGCC Facility Number	Berry Farms 30 31 32-8HZ O SA
Remediation Project #	25564

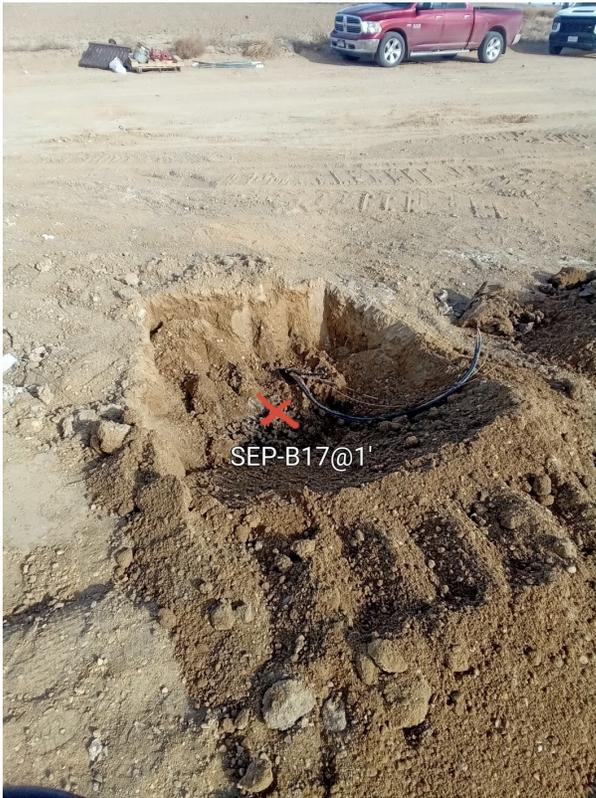
R18 - P1

R18		vertical		none observed	1.5	Yes	SEP-B17@1'
R19		horizontal		none observed	1.7	Yes	SEP-B18@1'

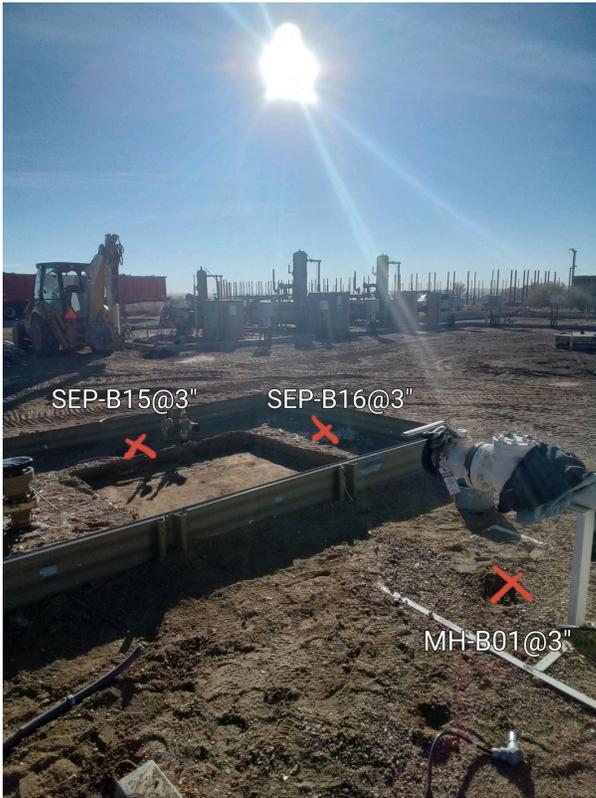
R1 - P1

Third Party Equipment							
#	Type	Age	Third Party Operator	Removal Date	Sample Taken?	Sample ID #	PID Readings
R1	Meter House			10/31/2022	Yes	MH-B01@3"	0.2
