## Inspection Photos

Location Name: TEP Rocky Mountain LLC FEDERAL PA 44-13 Pad

Location # 457469

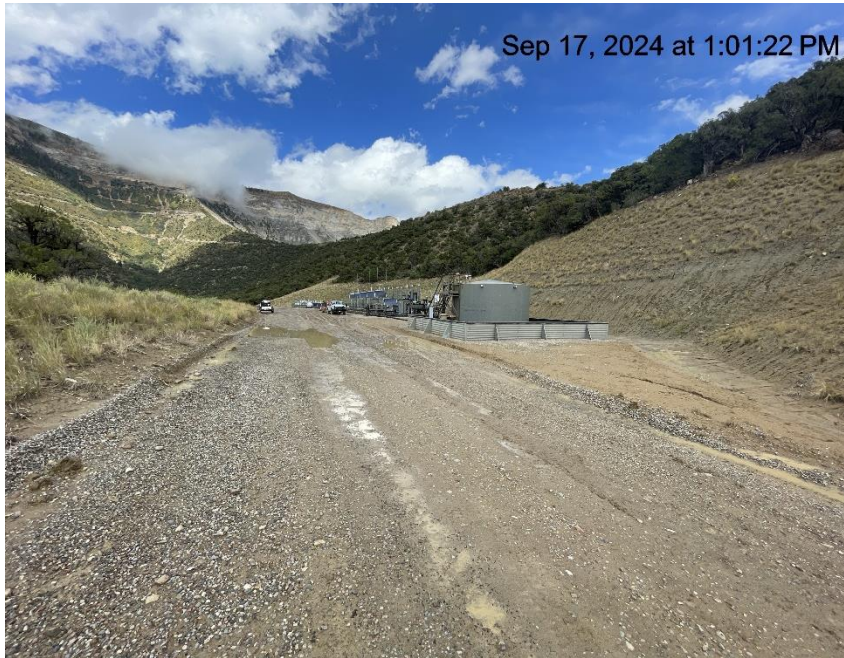
Photo # 703 From entrance to location

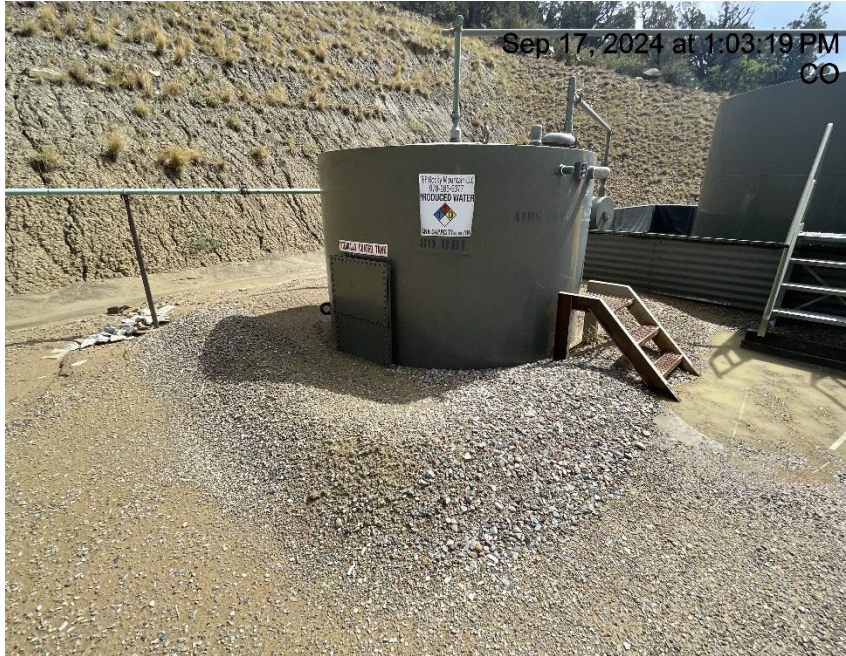
**Photo # 715 Secondary containment does not comply with CECMC secondary containment rules (additionally 80 bbl tank does not appear to be in operators Form 2A or any Form 4 Sundry as required by CECMC rules)**

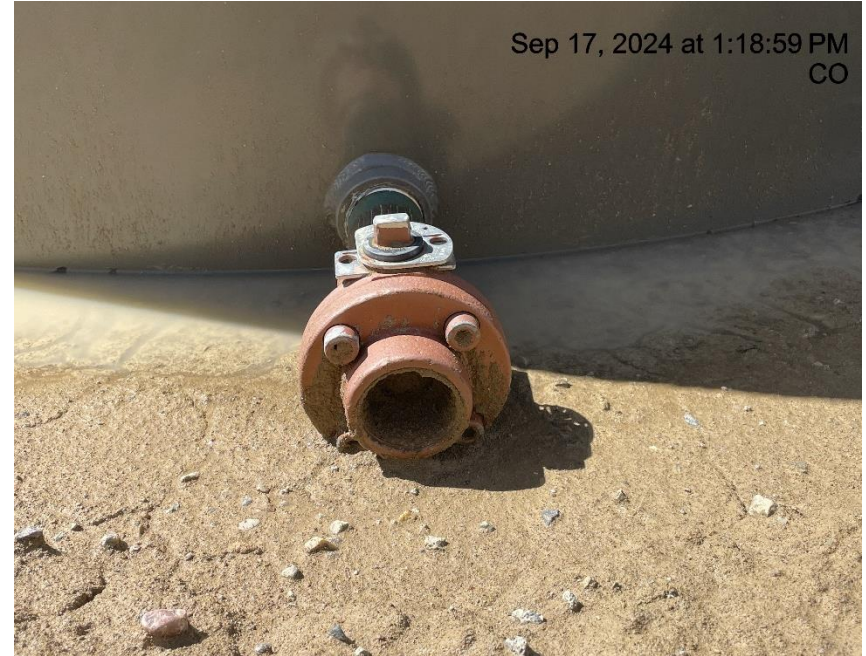
**Photo # 716 Open ended load line**

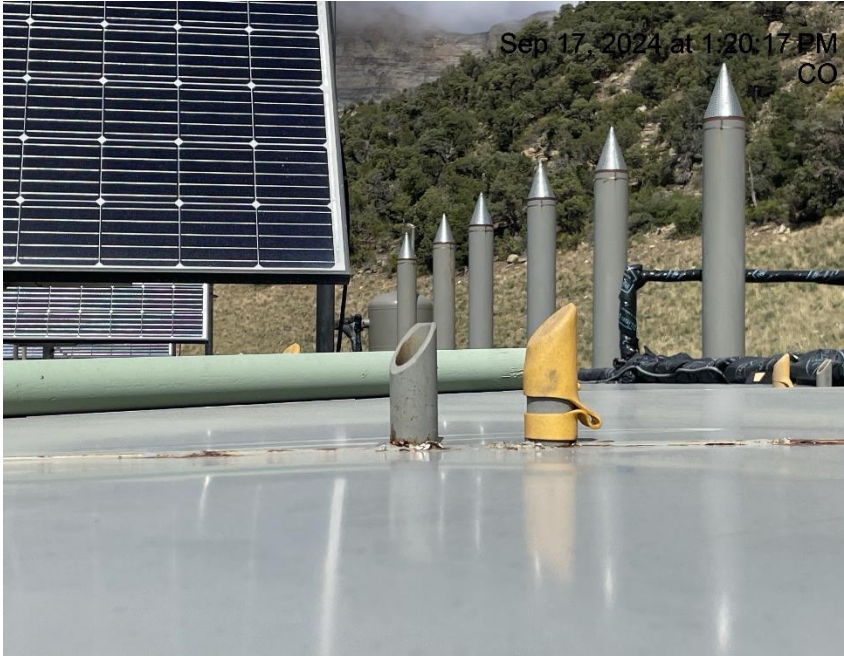
**Photo # 717 Rupture disc vent line does not comply with CECMC pressure safety device rules**

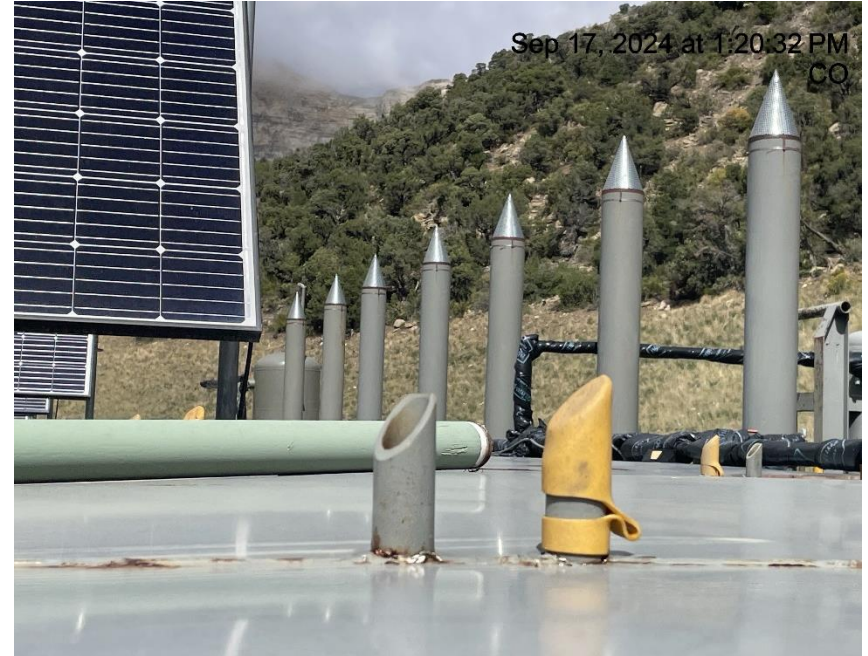
**Photo # 718 Rupture disc vent line does not comply with CECMC pressure safety device rules**

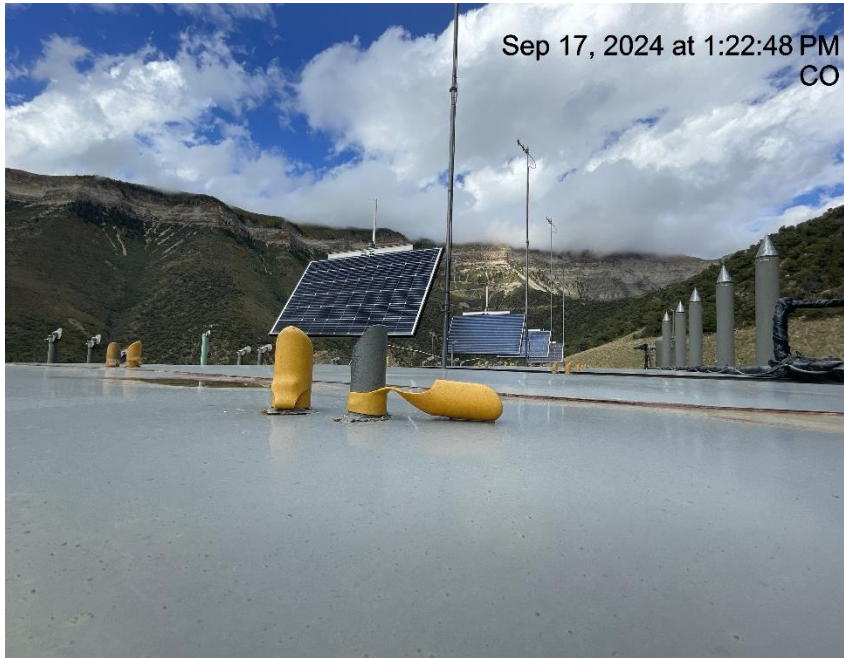
**Photo # 719 PRV vent line does not comply with CECMC pressure safety device rules**

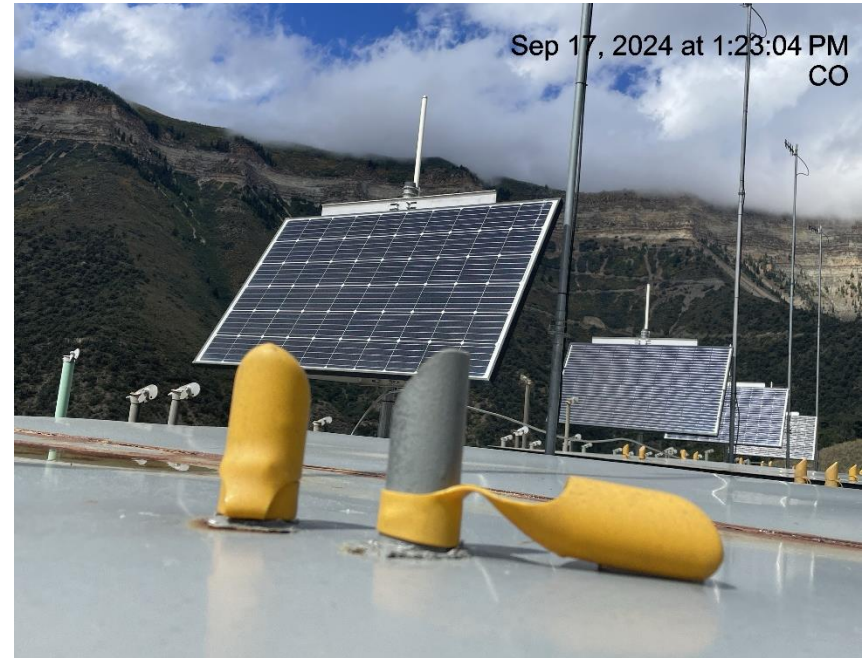
**Photo # 720 PRV vent line does not comply with CECMC pressure safety device rules**

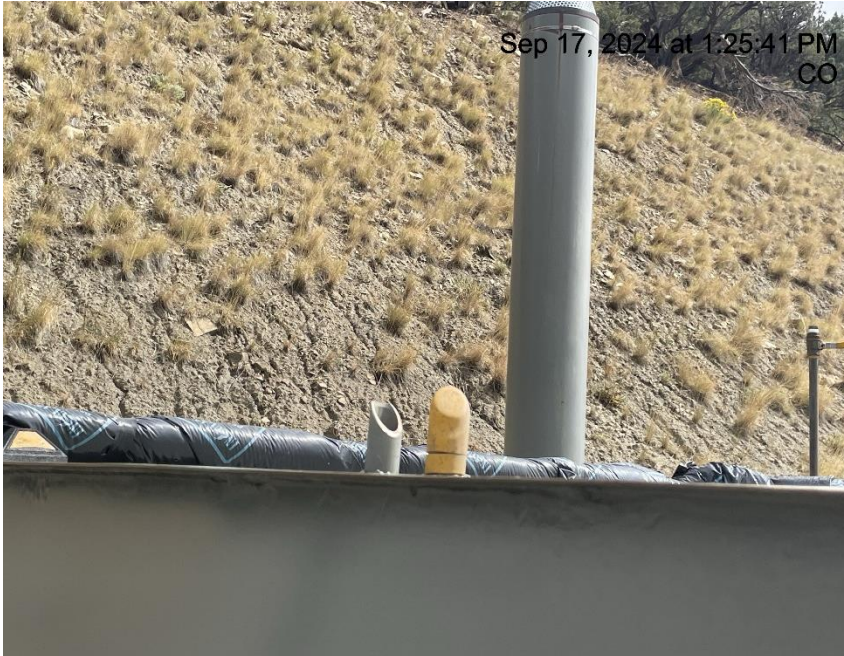
**Photo # 721 PRV vent line does not comply with CECMC pressure safety device rules**

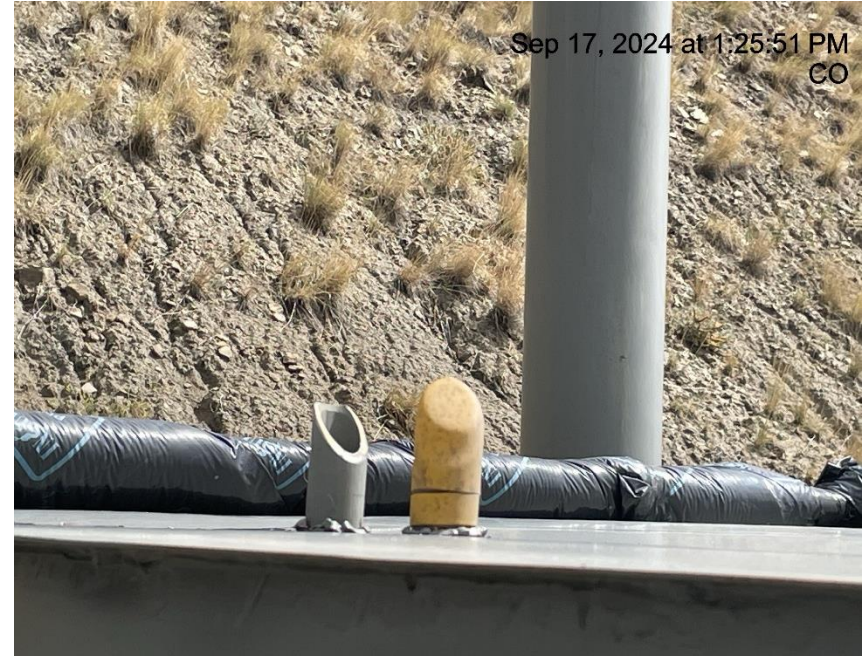
**Photo # 722 PRV vent line does not comply with CECMC pressure safety device rules**

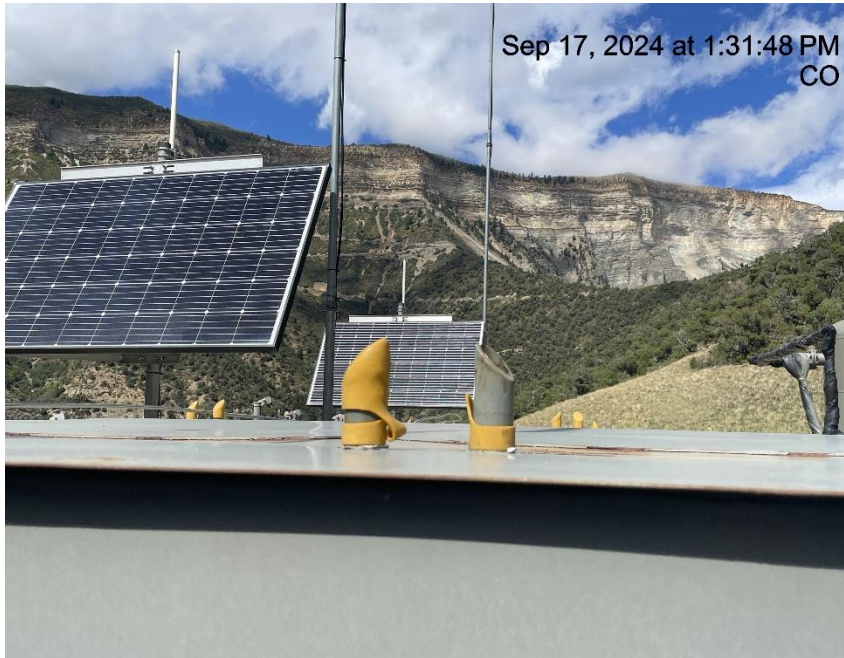
**Photo # 723 PRV vent line does not comply with CECMC pressure safety device rules**

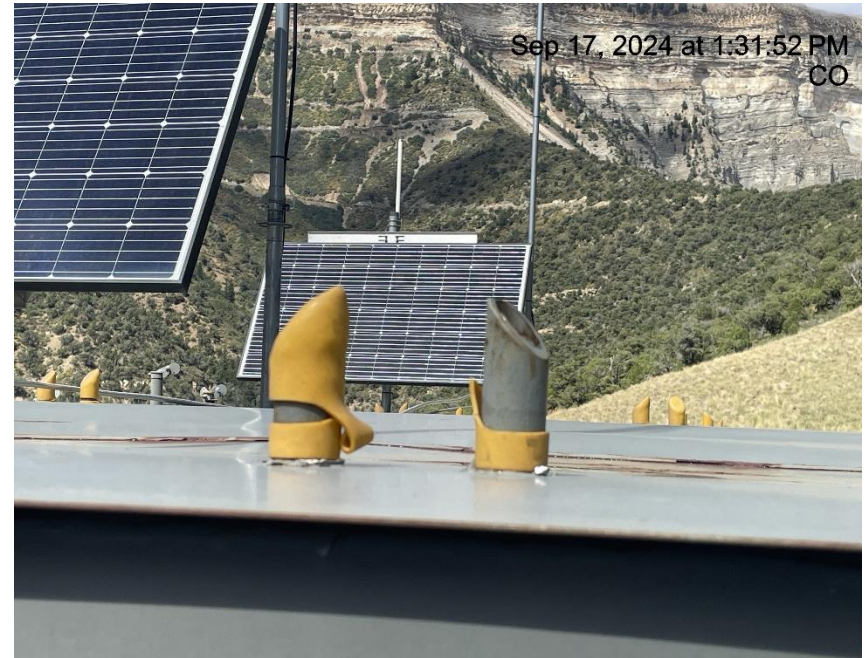
**Photo # 724 PRV vent line does not comply with CECMC pressure safety device rules**

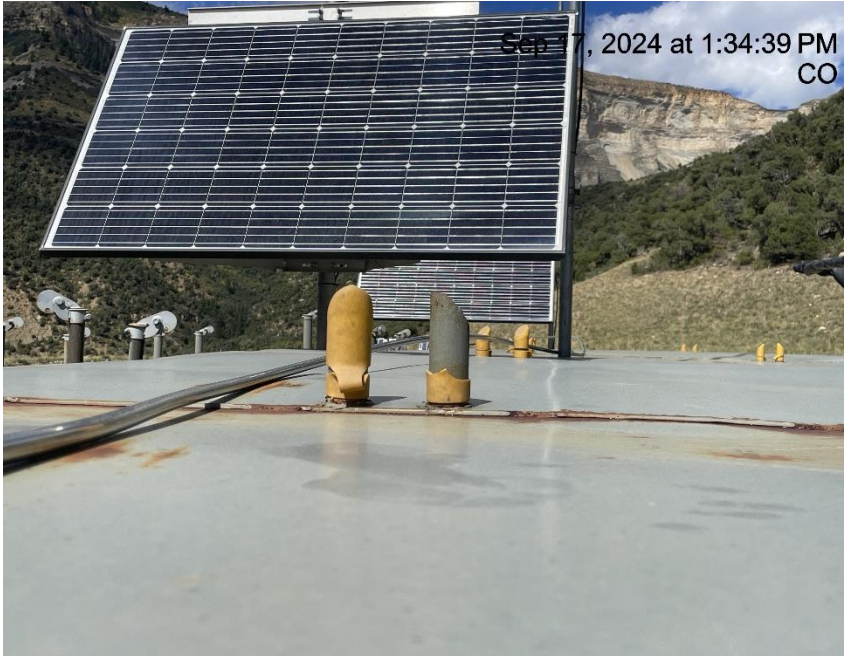
**Photo # 725 PRV vent line does not comply with CECMC pressure safety device rules**

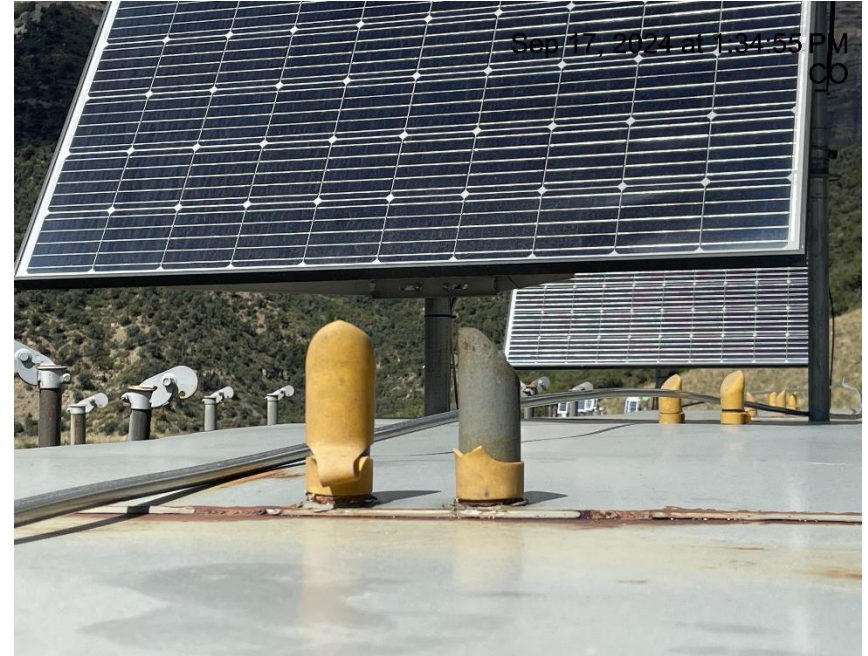
**Photo # 726 PRV vent line does not comply with CECMC pressure safety device rules**

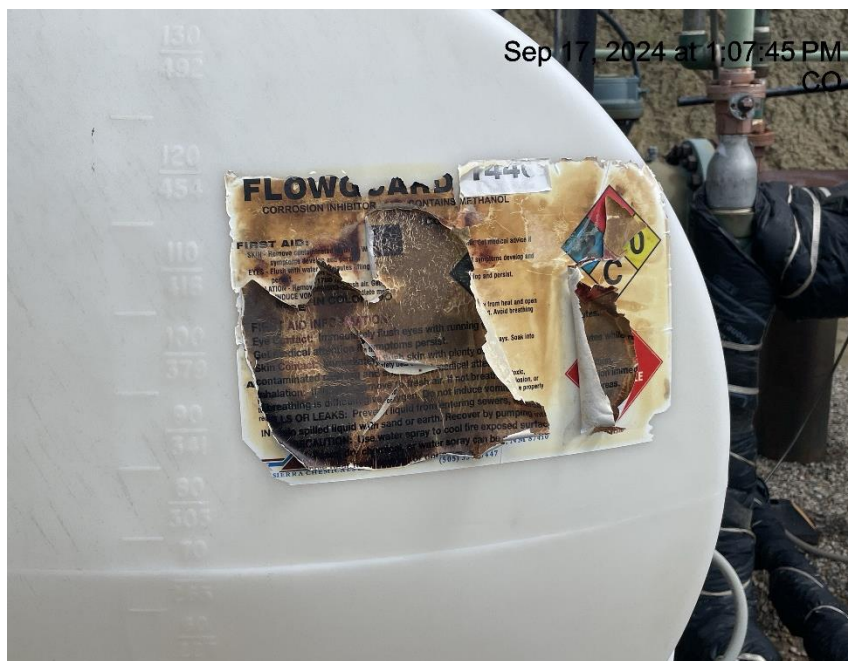
Photo # 727 Chemical tank label damaged & some required info is illegible/does not comply with CECMC rules

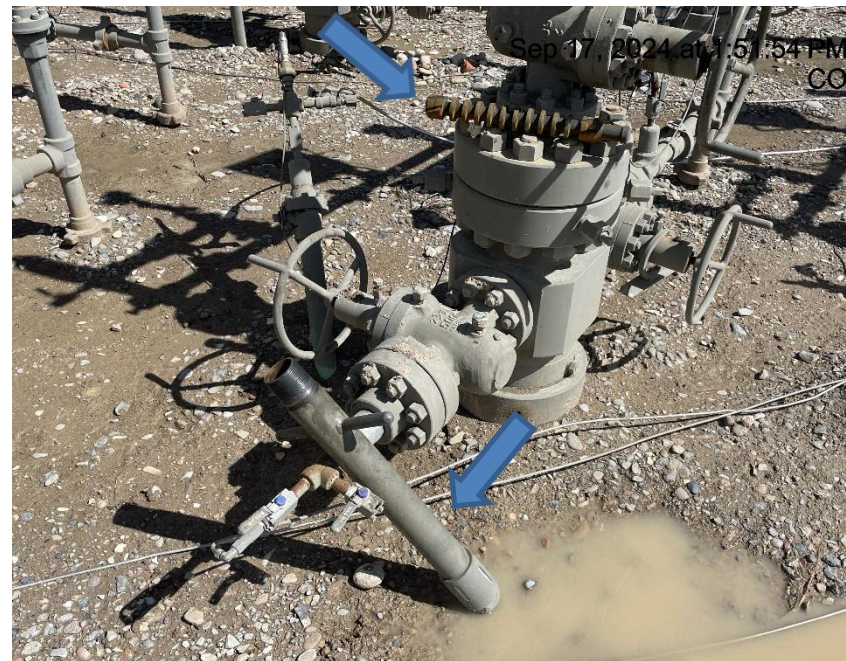
Photo # 728 Debris
