Inspection Photos

Operator: Hilcorp Energy Company - 10133

Location ID: 326146

Inspection Photos
Location Name: Huber Burkett 2-25
Location ID: 326146

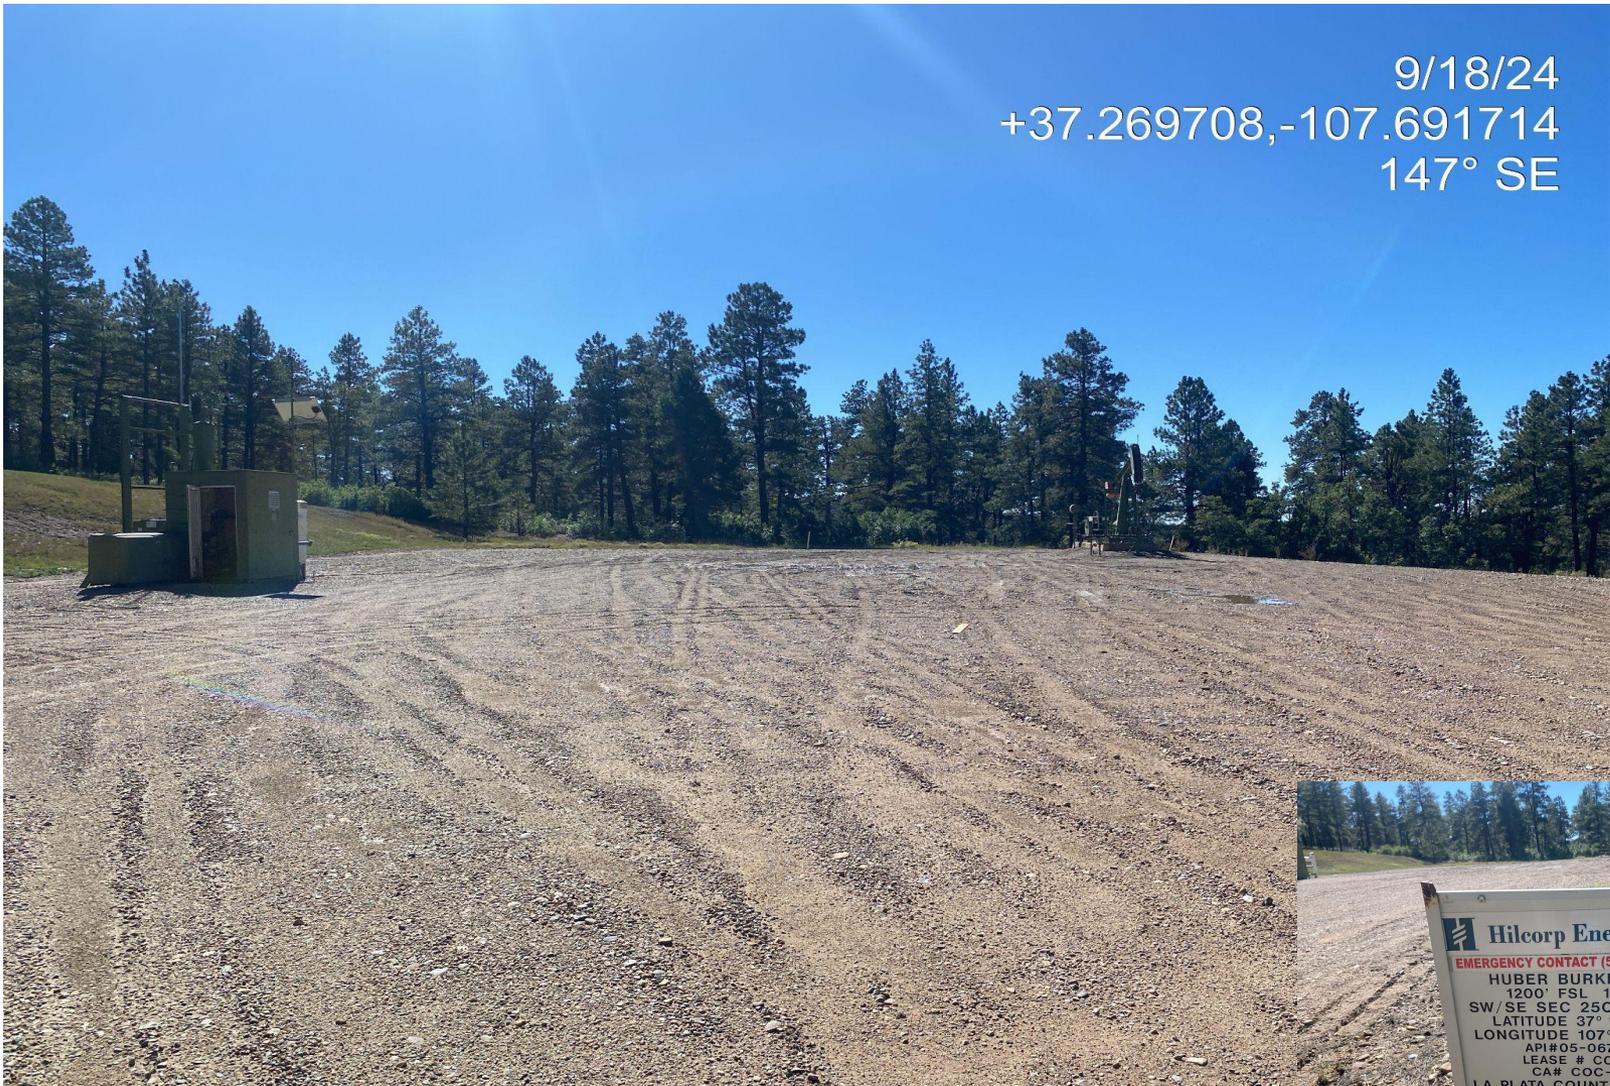
Photo 1. View of the well pad taken from the access point facing center.

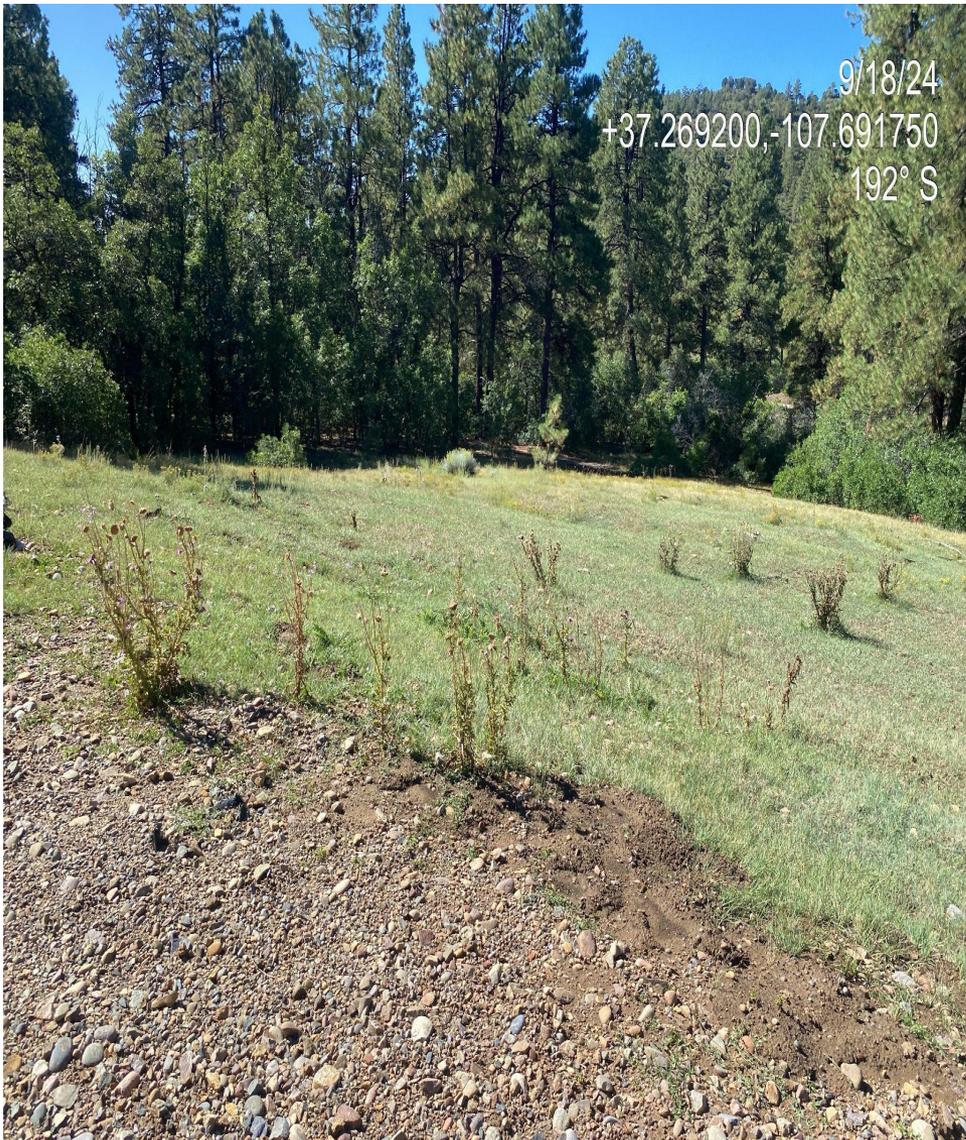
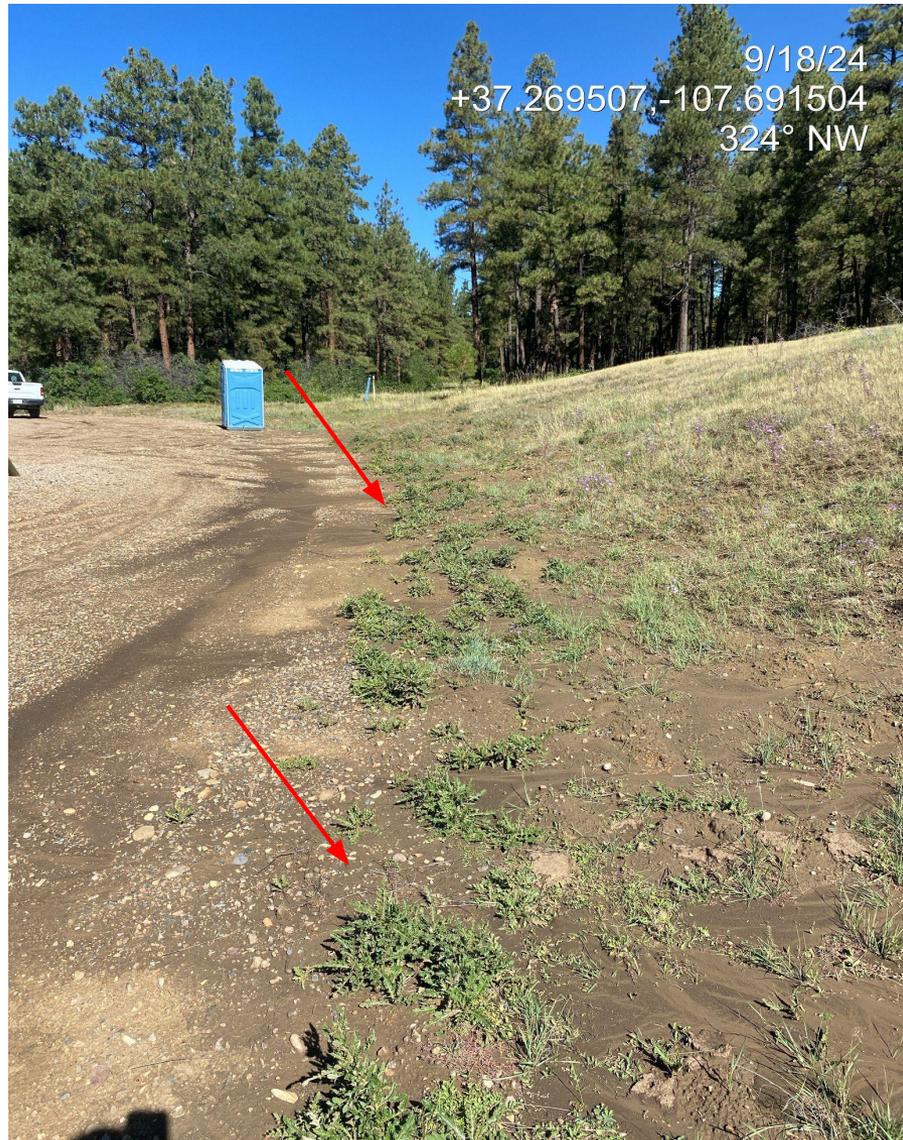
Photo 2. View of flowering Musk thistle observed in the southern interim reclamation areas (left) and Canada thistle observed along the base of the cut slope (right).

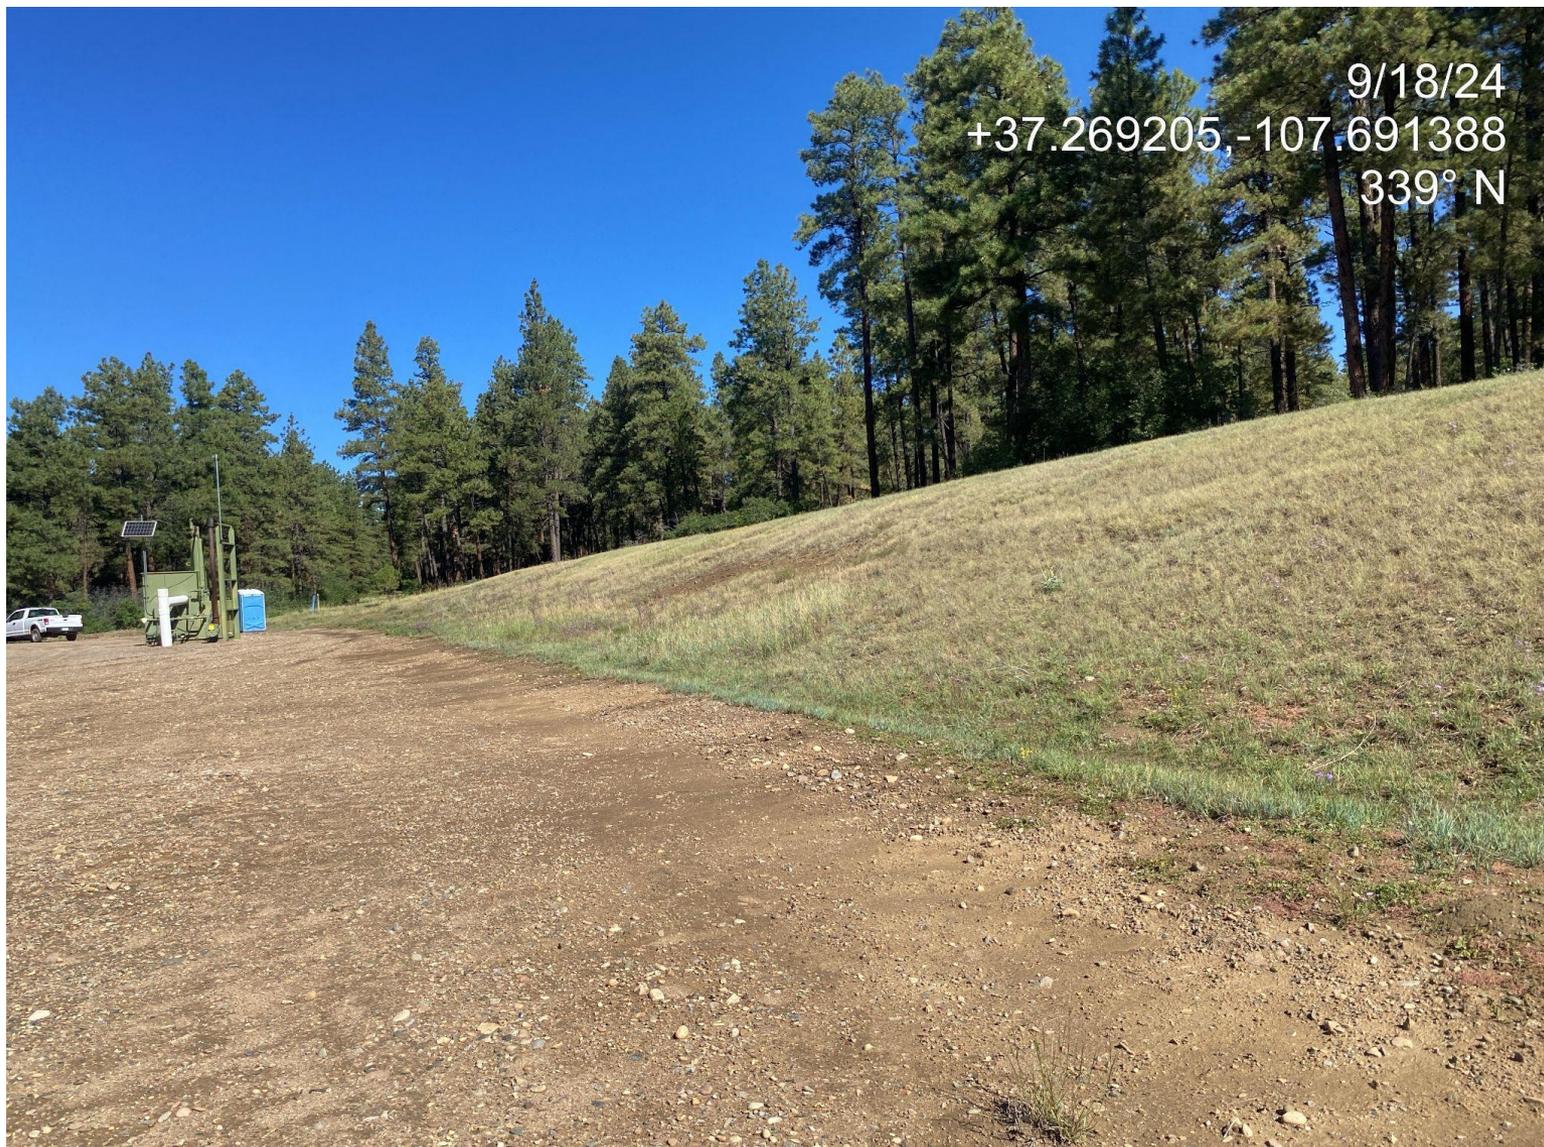
Photo 3. View of the northern interim reclamation area facing north.

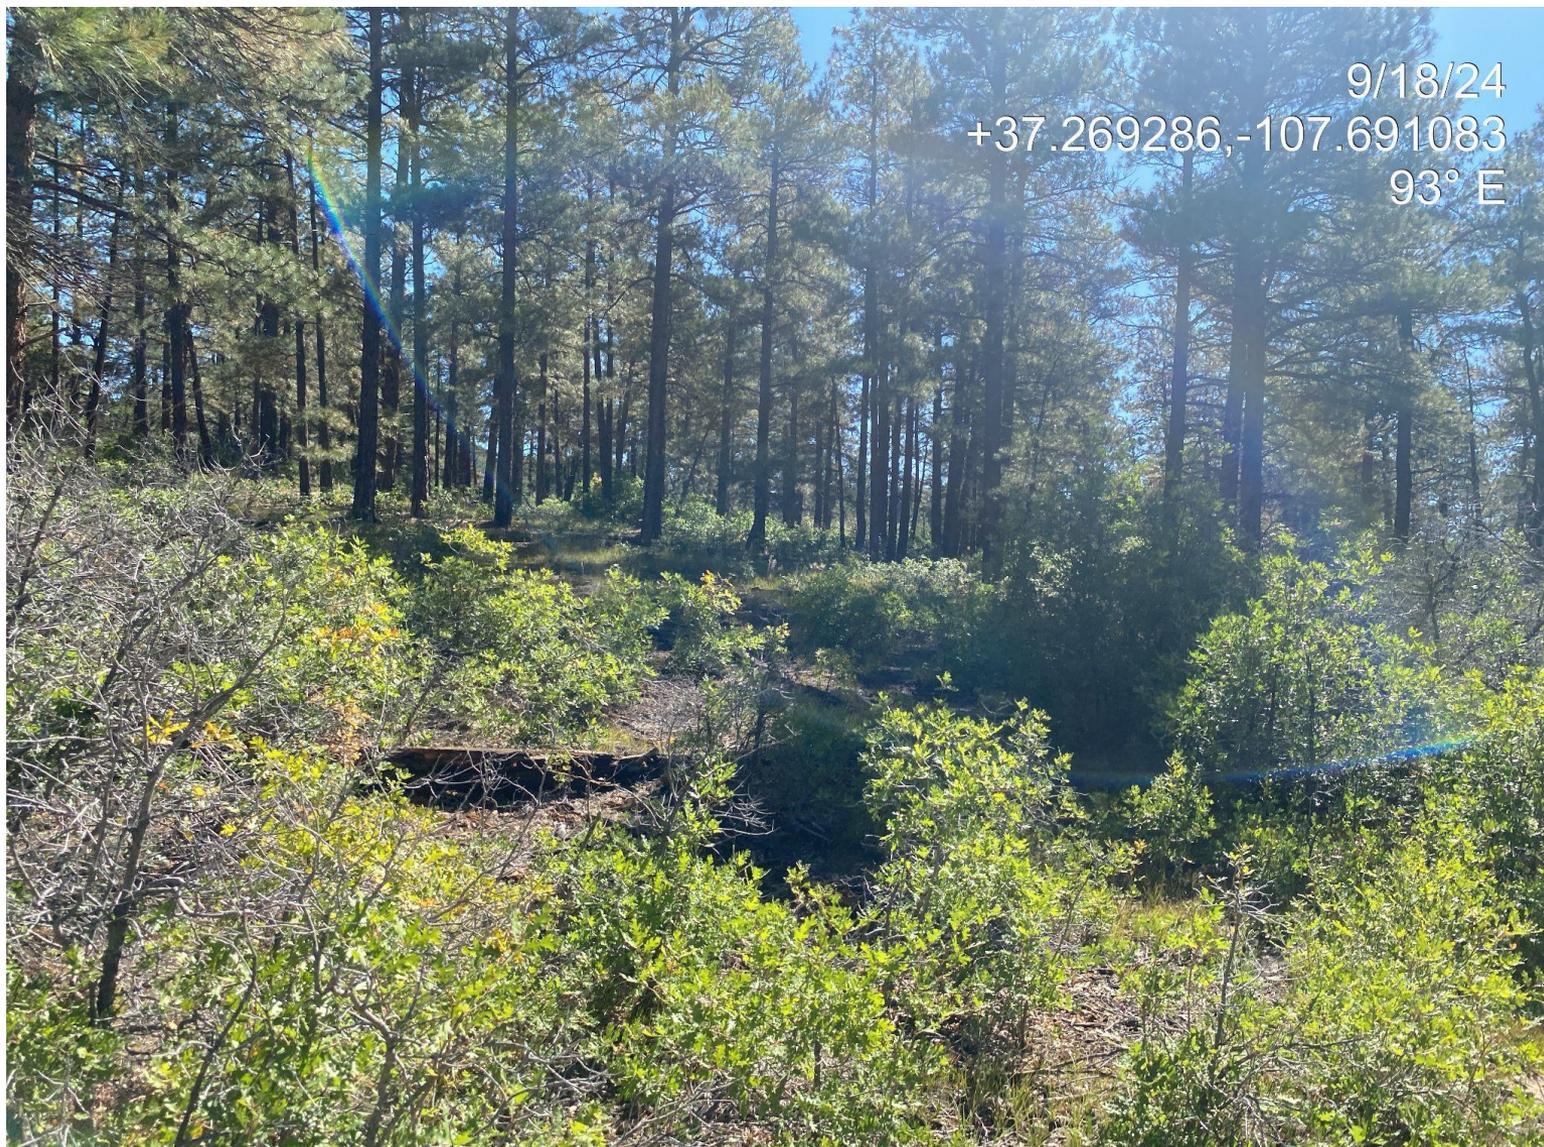
Photo 4. Reference area comprised of Gambel oak, Pine and Poa secunda.
