Inspection Photos

API: 071-06814

Operator: WAPITI OPERATING LLC

Inspection Date: 9/23/2024

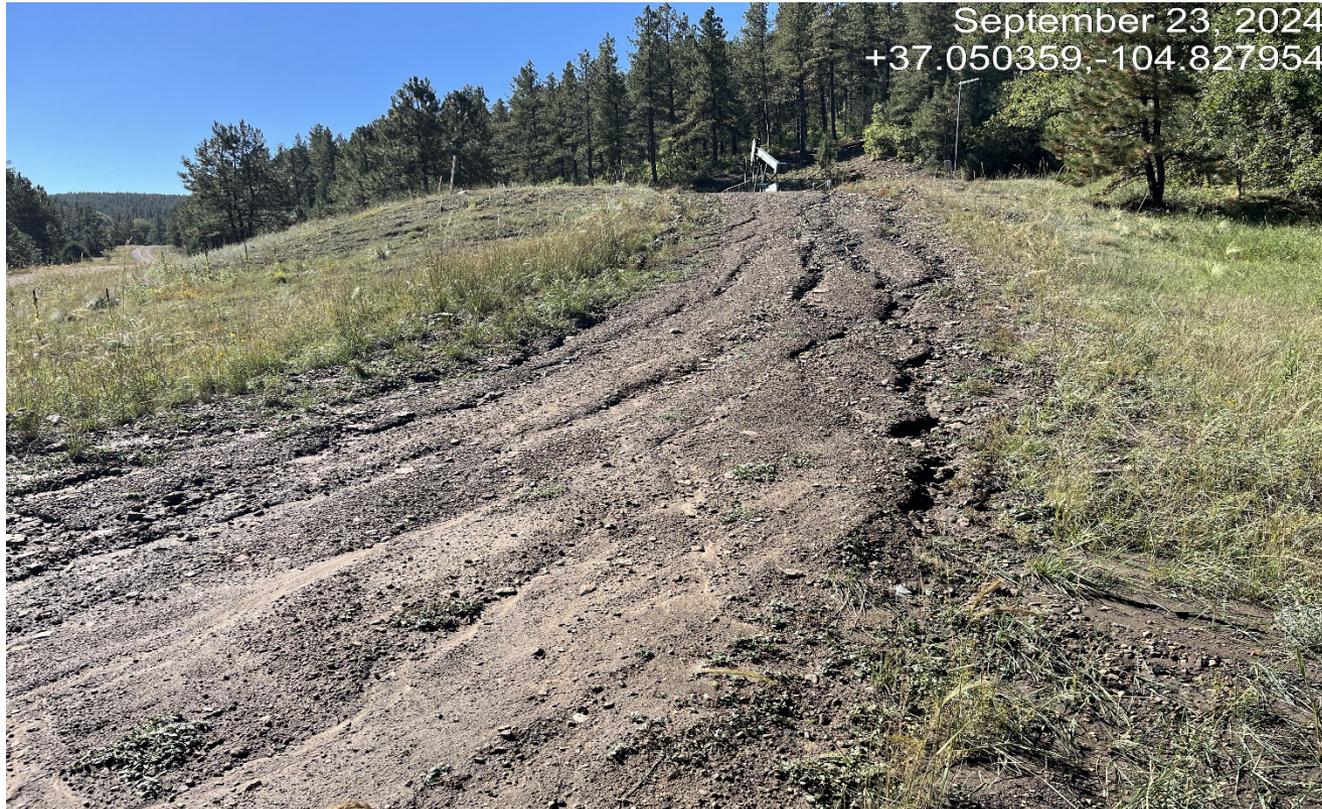
Photo 1. Facing southwest toward the access road where erosion is occurring.

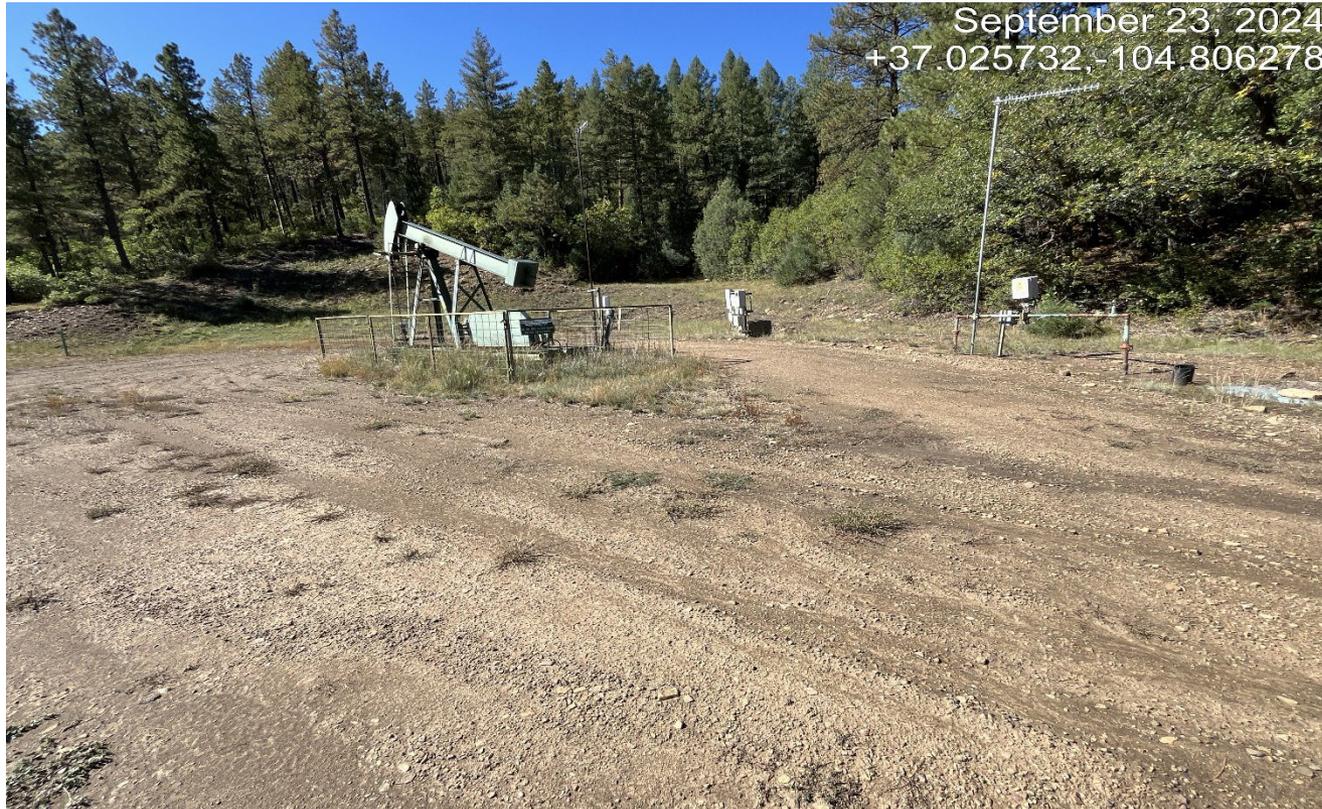
Photo 1. Facing southwest toward the wellsite.

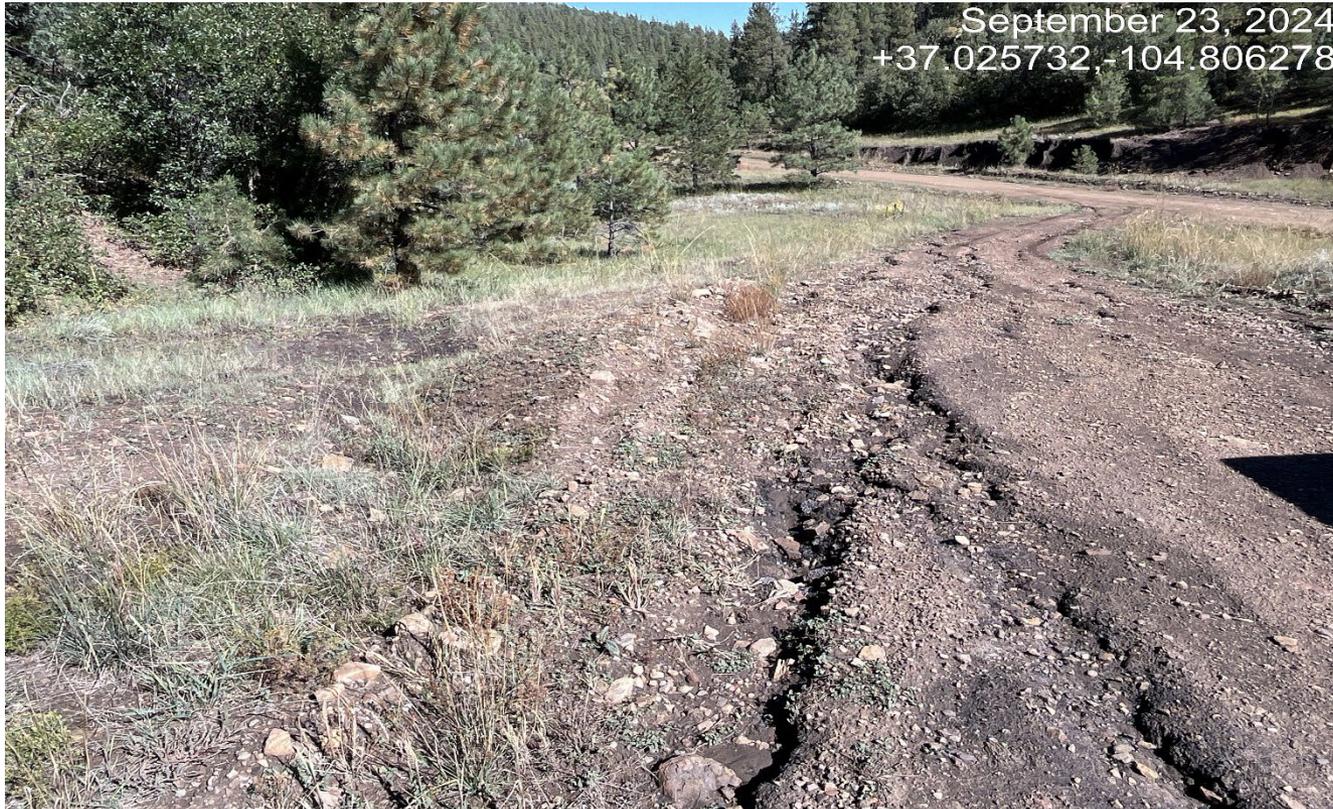
Photo 3. Facing north toward the access road. Stormwater needs to be diverted off the road.
