Inspection Photos

API: 071-06819

Operator: WAPITI OPERATING LLC

Inspection Date: 9/23/2024

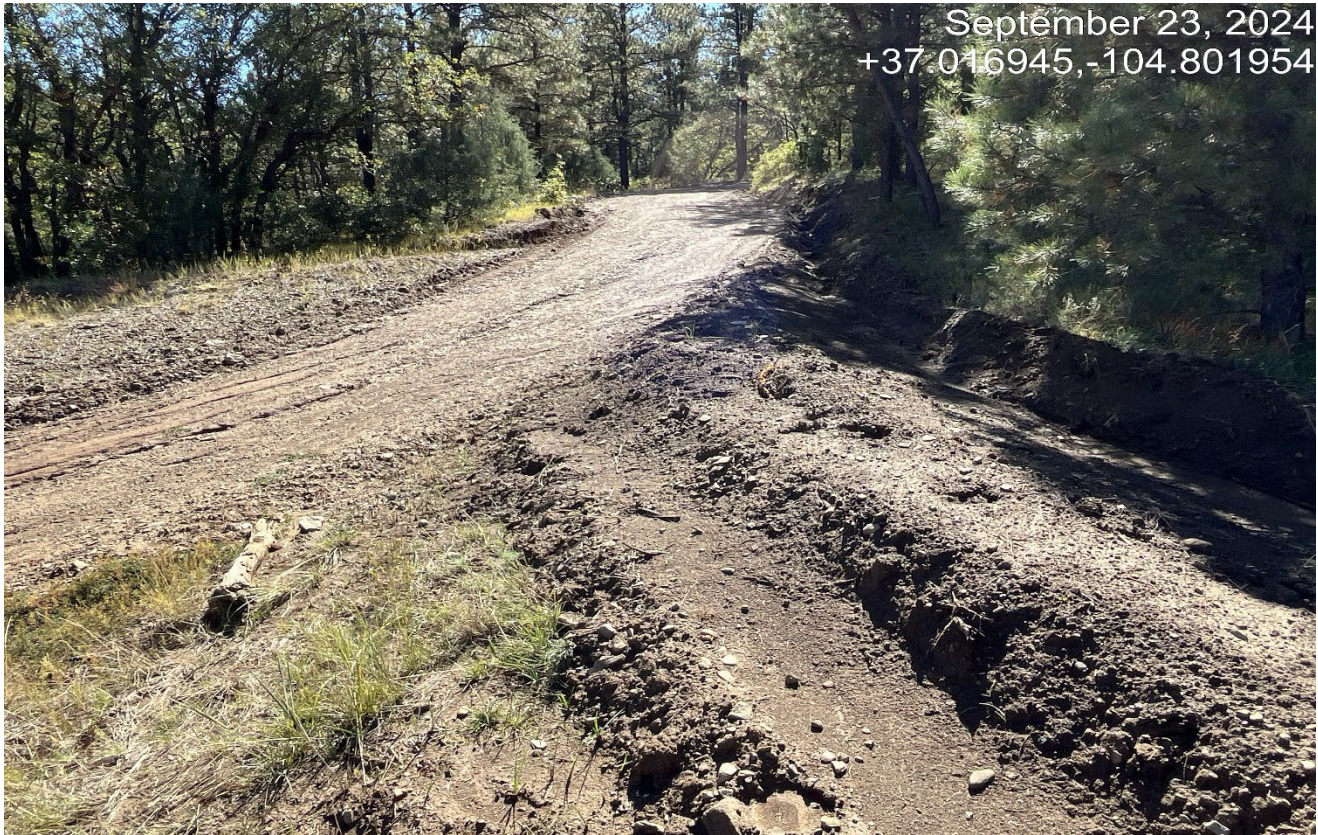
Photo 1. Facing south along the access road. This stormwater diversion was cleaned out. The disturbed soils need to be seeded for stabilization.

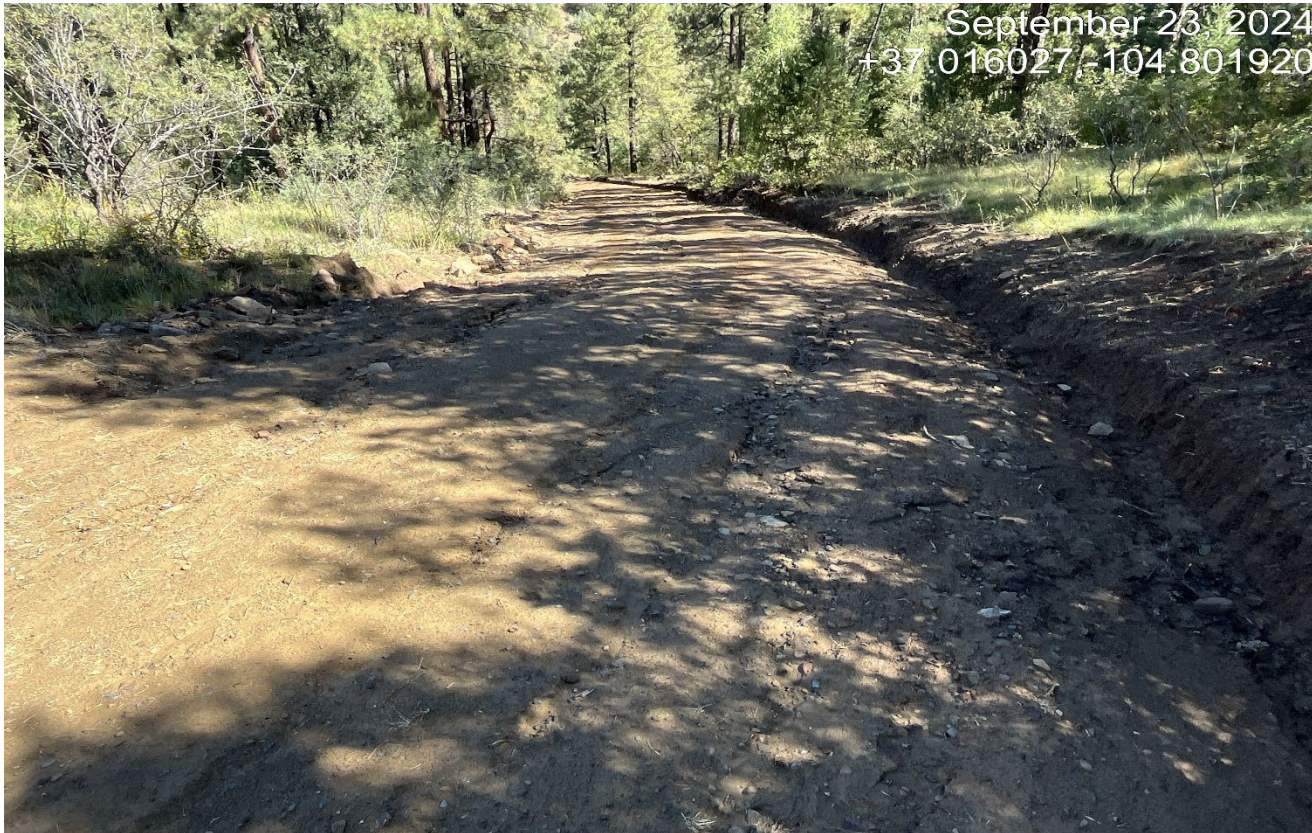
Photo 2. Facing back down the road at the wellsite. The road has been graded but no stormwater controls were installed. E.G. gravel, check dams, ect.

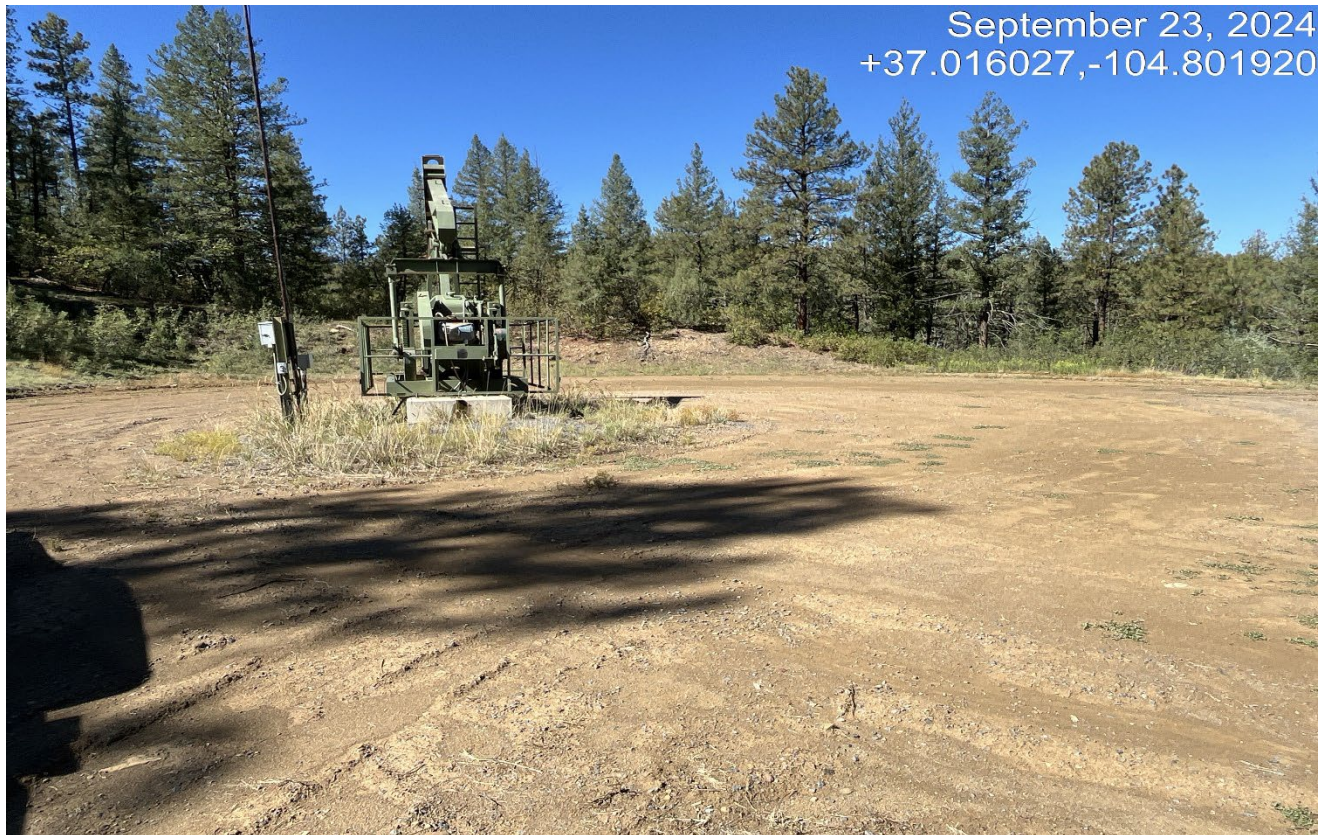
Photo 3. Facing toward the wellsite.
