Inspection Photos

API: 099-06138

Operator: OXY USA INC

Inspection Date: 9/24/2024

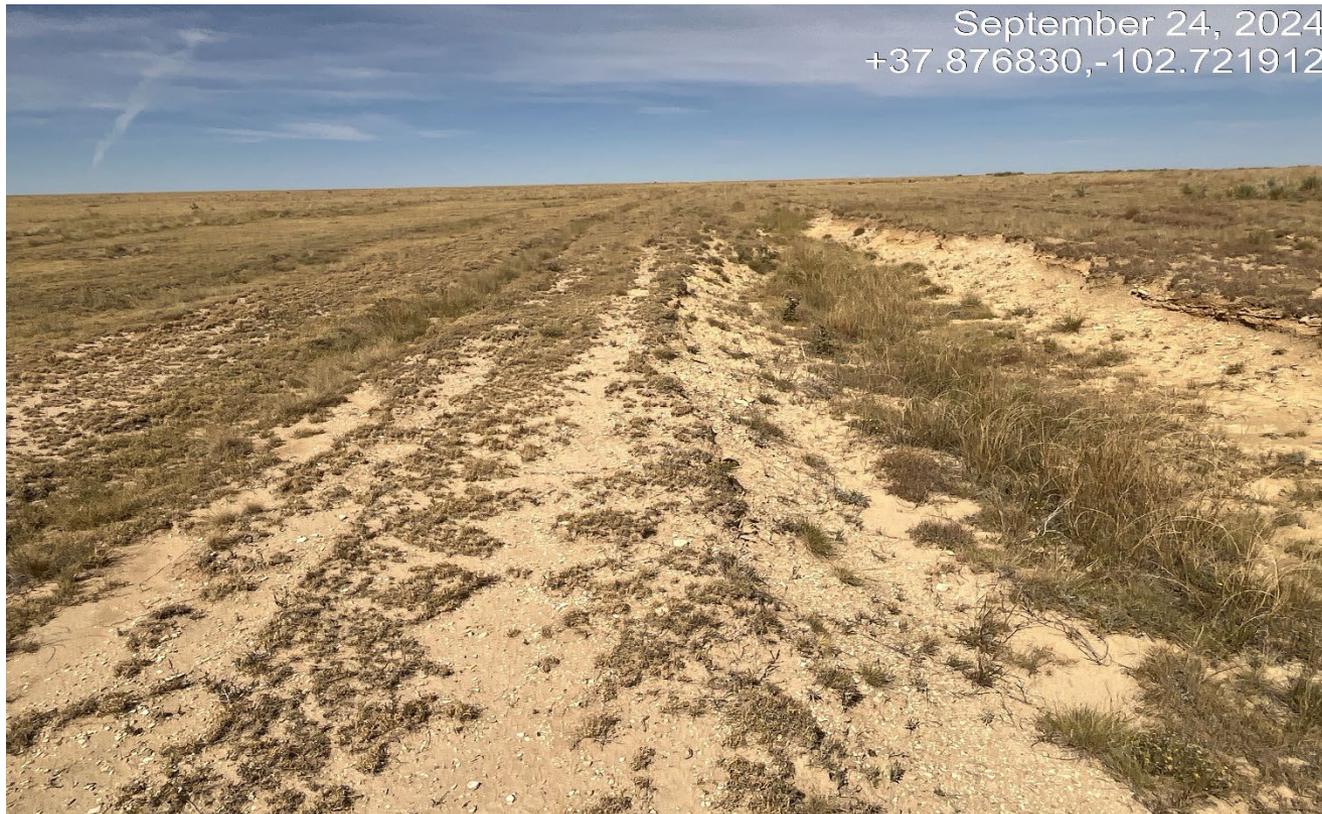
Photo 1. Facing north along the former access road at Lat/Long:37.87672,-102.72188. This area of the road has eroded and needs to be repaired and reclaimed.

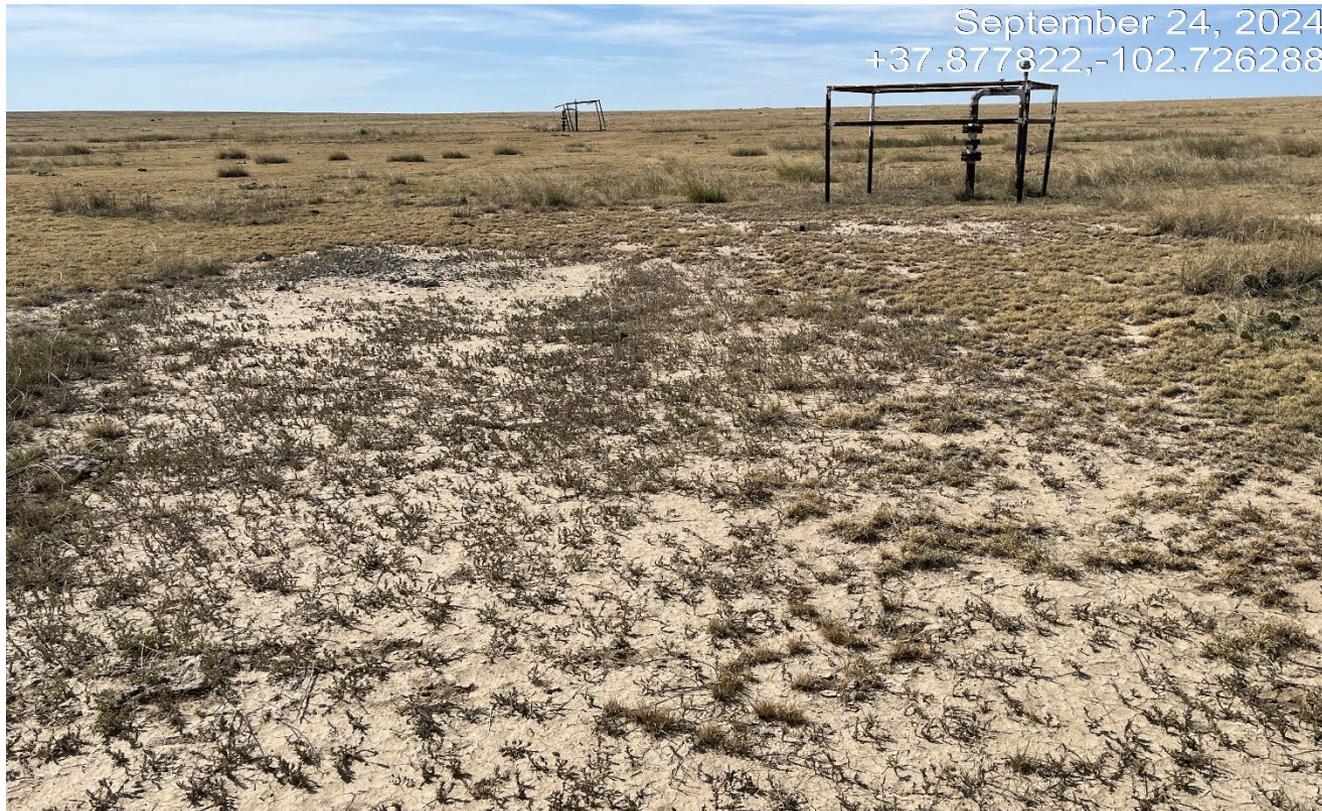
Photo 2. Facing west at the location. There are two pipe risers that remain at the location shown at red arrows. Vegetation has not re-established near the risers.

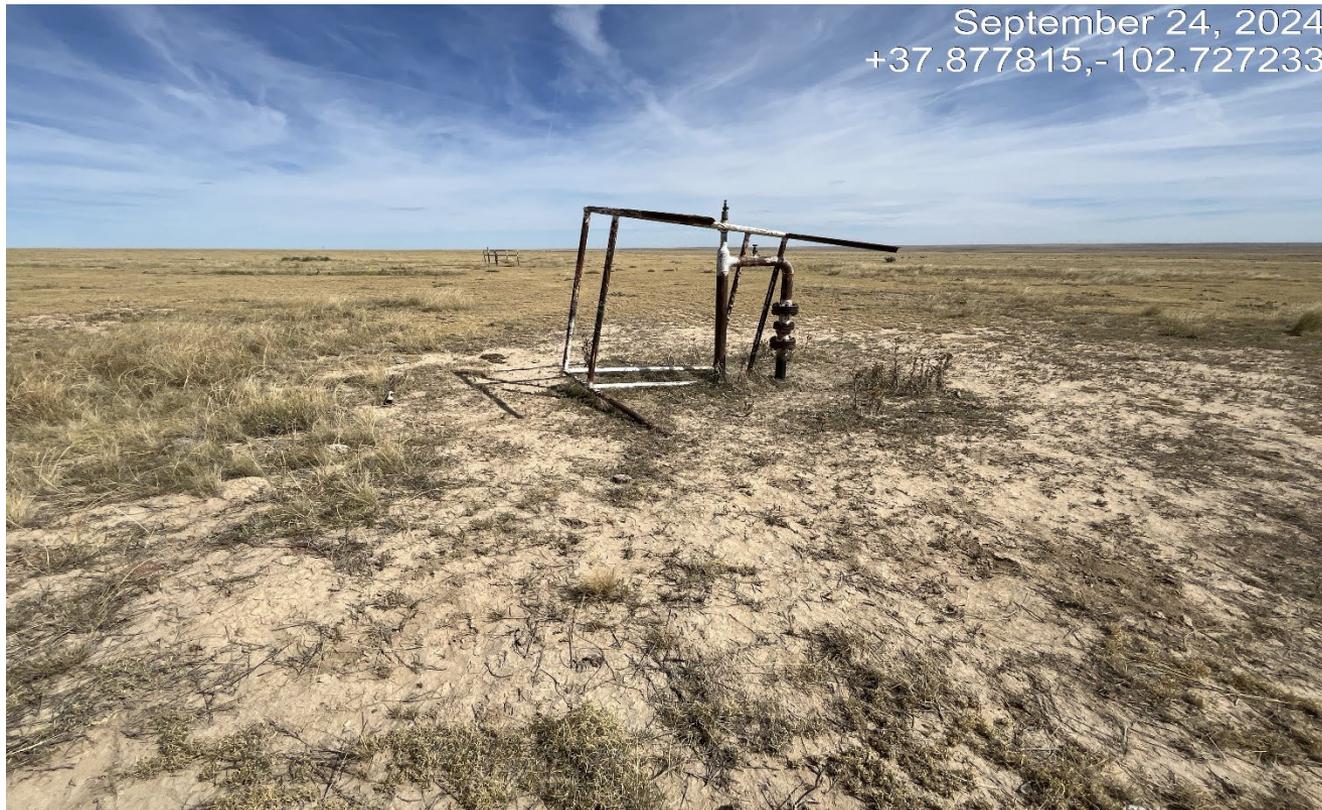
Photo 3. Facing east at the location. There are two pipe risers that remain at the location shown at red arrows. Vegetation has not re-established near the risers.

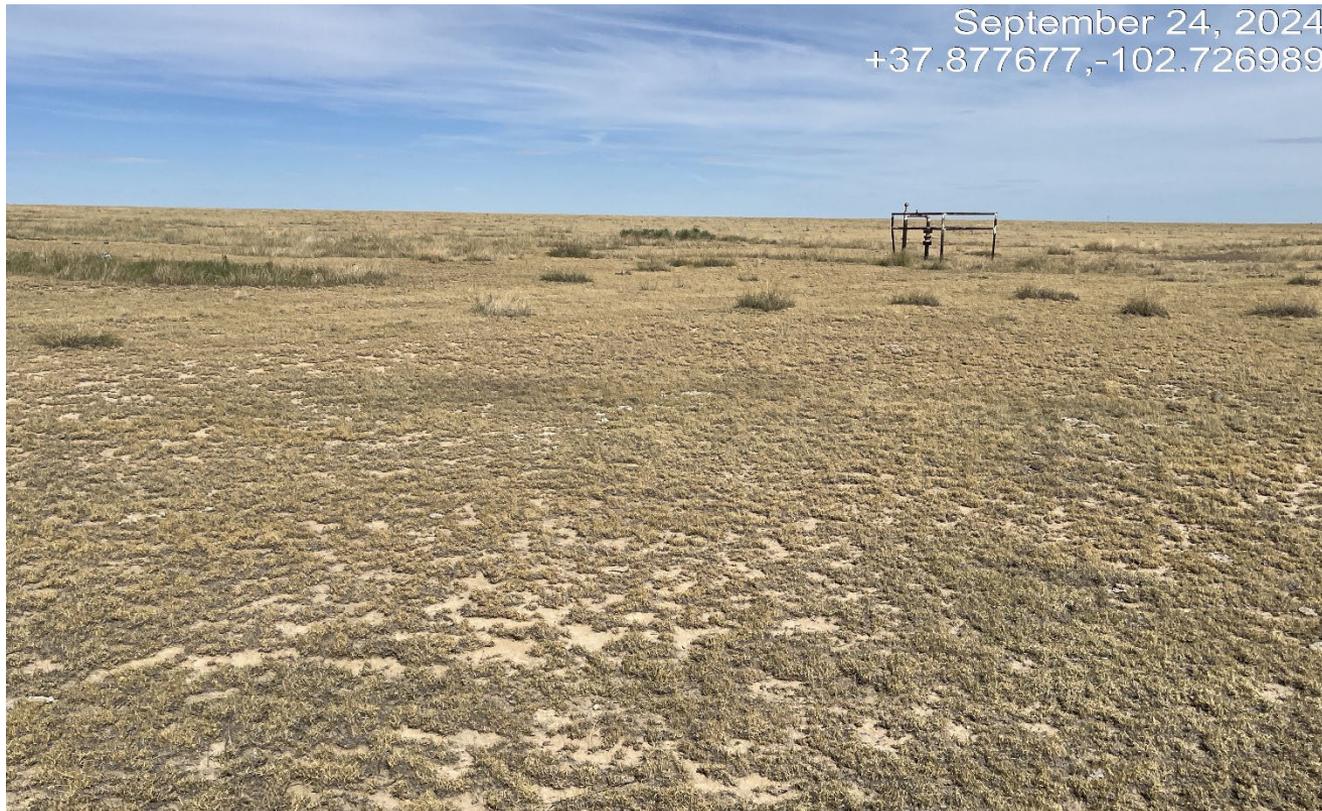
Photo 4. Facing northeast. Perennial vegetation has established throughout most of the location.

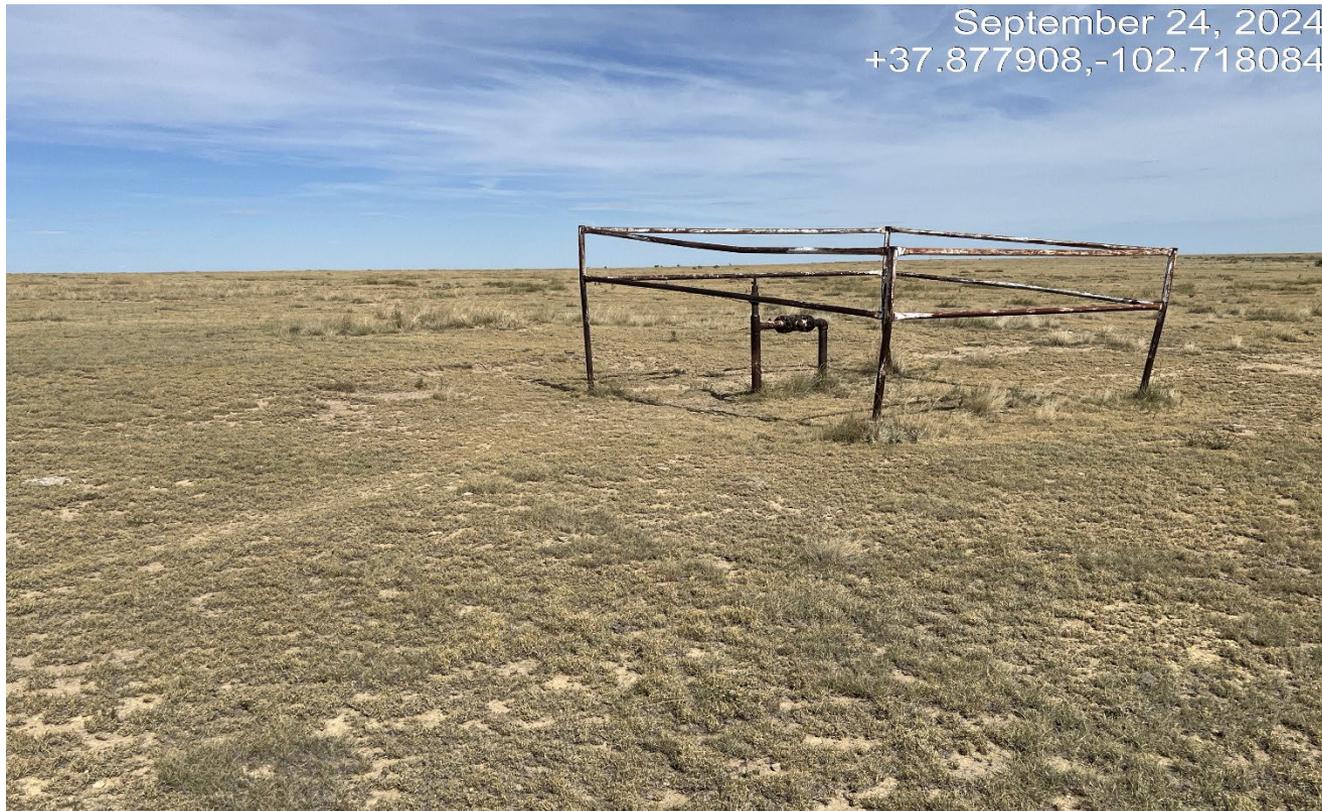
Photo 5. Another pipe riser associated with the well site was found at Lat/Long:37.87789,-102.71800. All equipment/risers need to be removed.
