Inspection Photos
Location Name: A.D. Jeffers A #1
Location ID: 323176

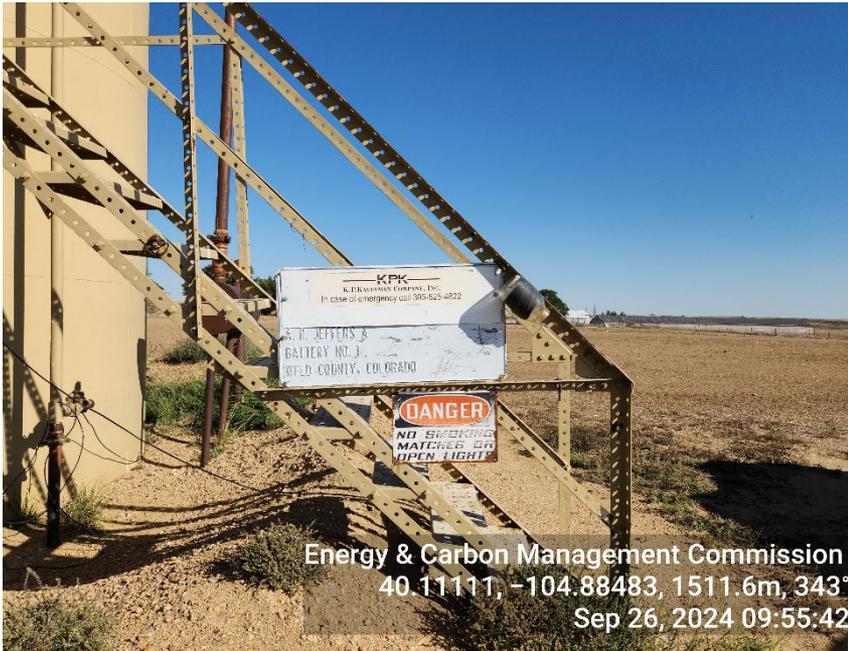
Photo 1: Tank Battery Sign

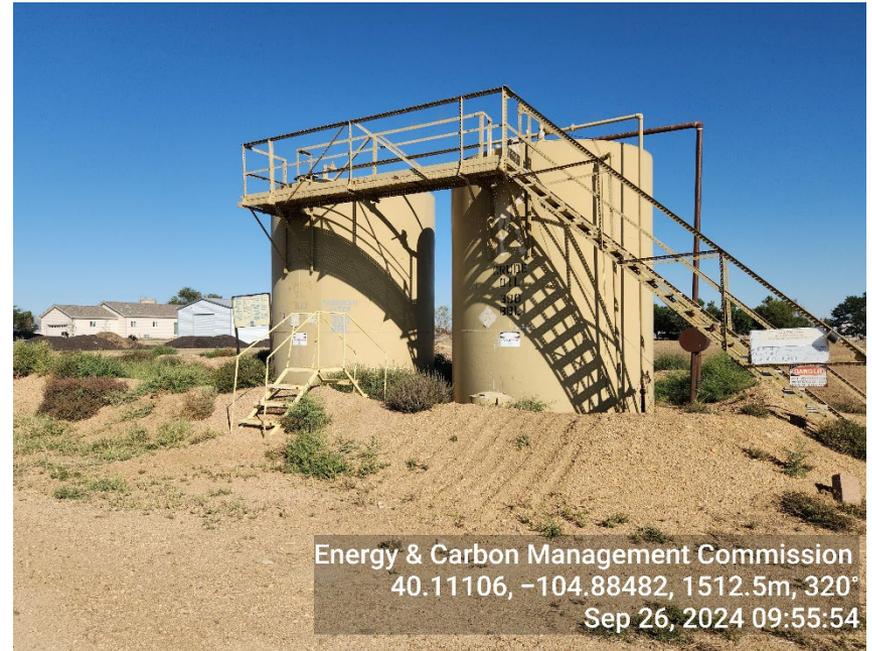
Photo 2: Tank Battery

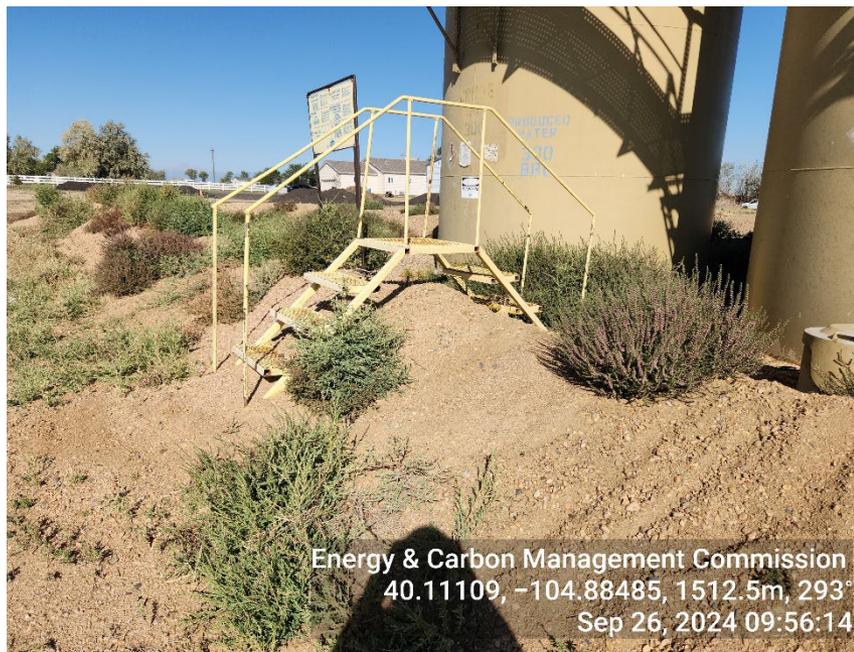
Photo 3: Overgrown vegetation

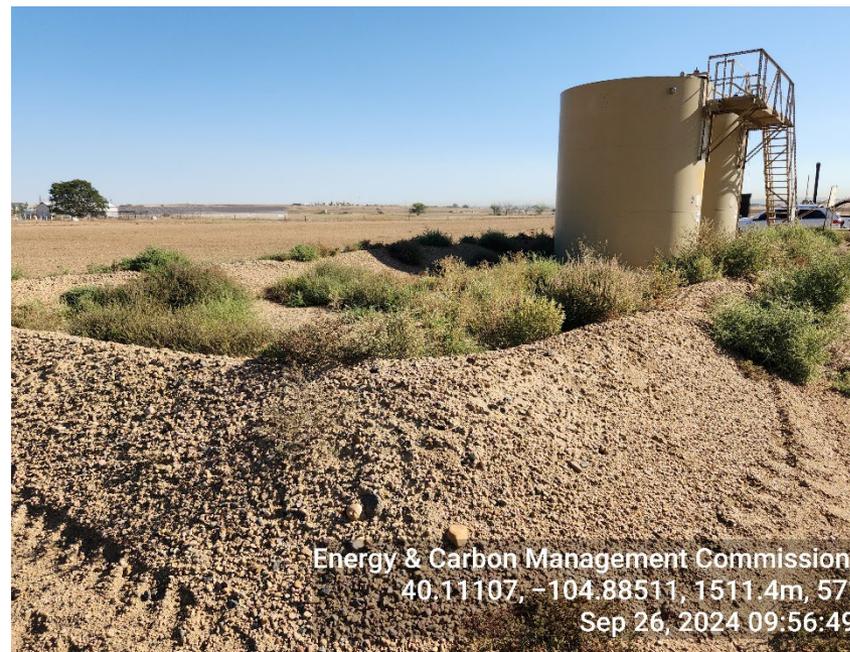
Photo 4: Overgrown vegetation

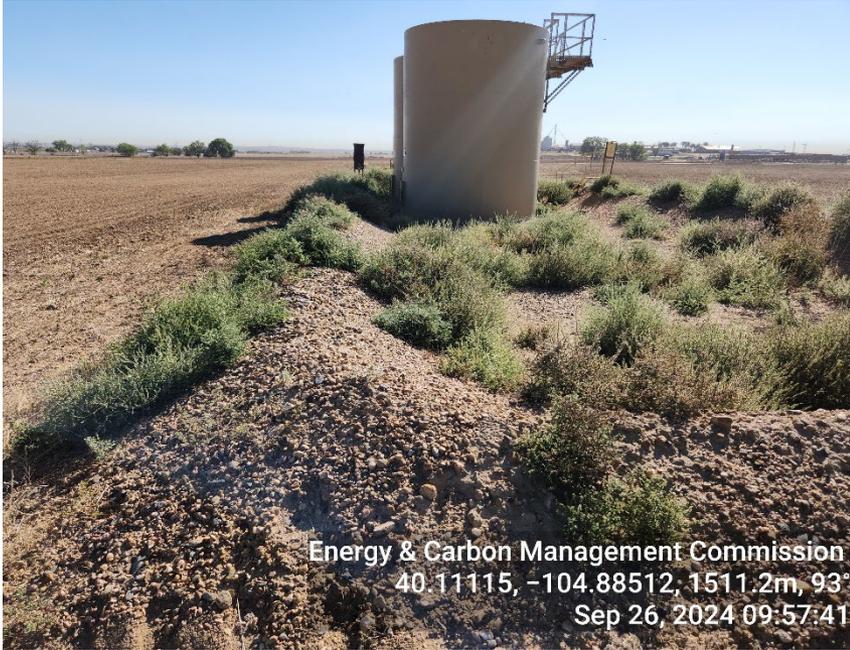
Photo 5: Overgrown vegetation

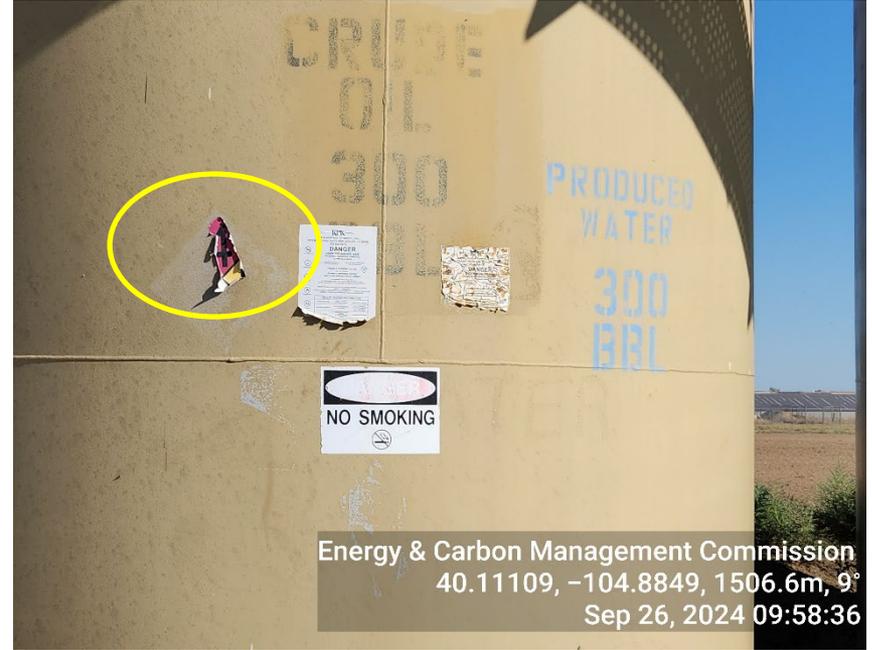
Photo 6: No NFPA placard

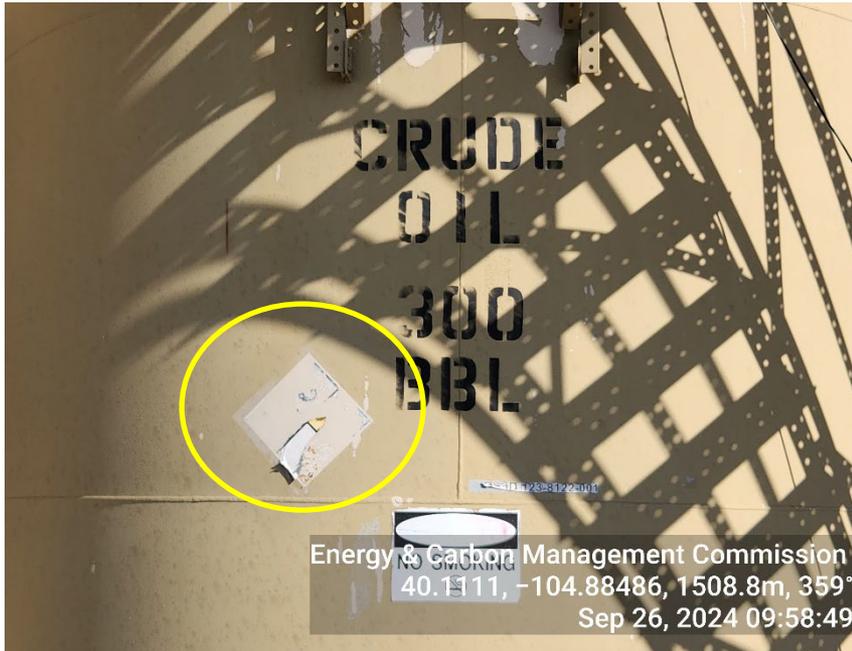
Photo 7: No NFPA placard

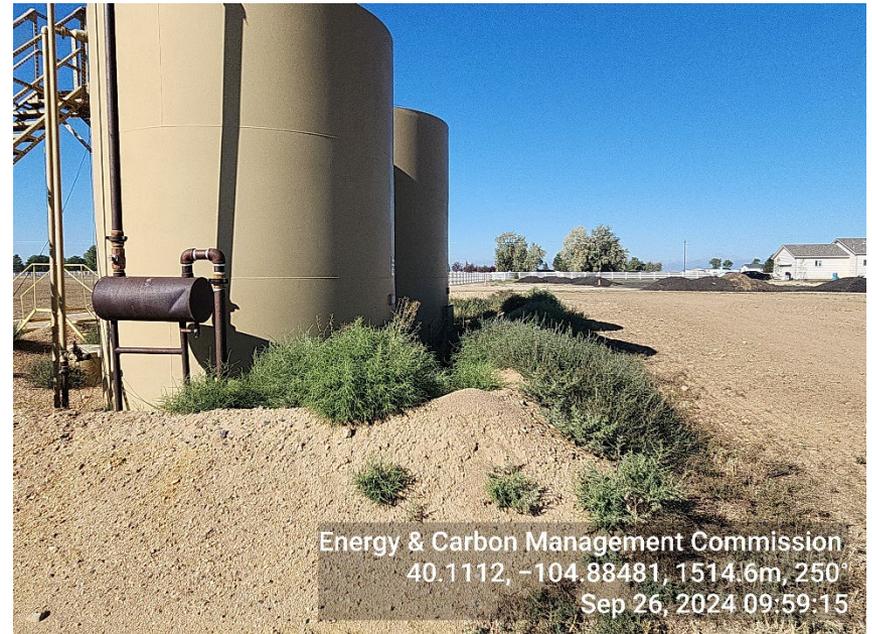
Photo 8: Overgrown vegetation

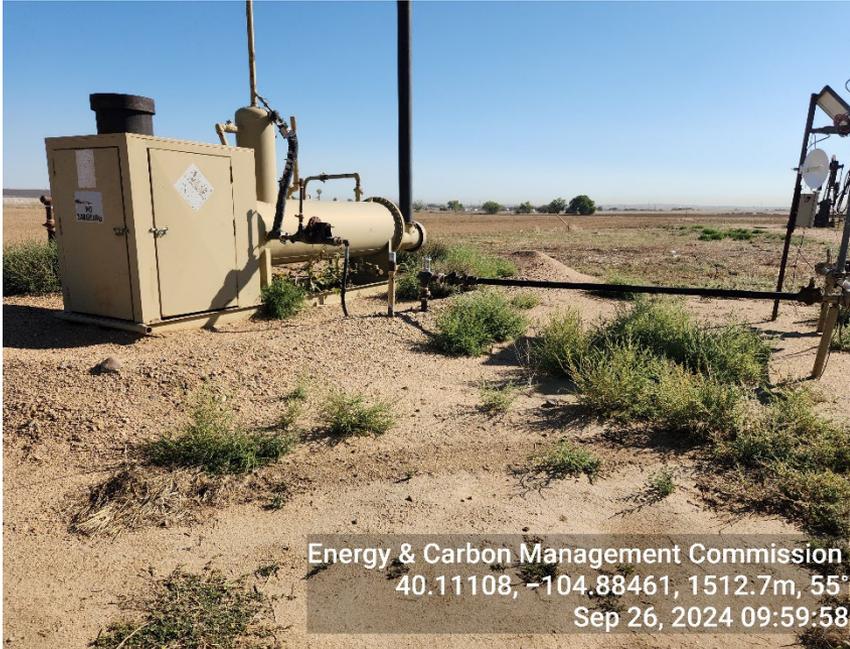
Photo 9: Overgrown vegetation

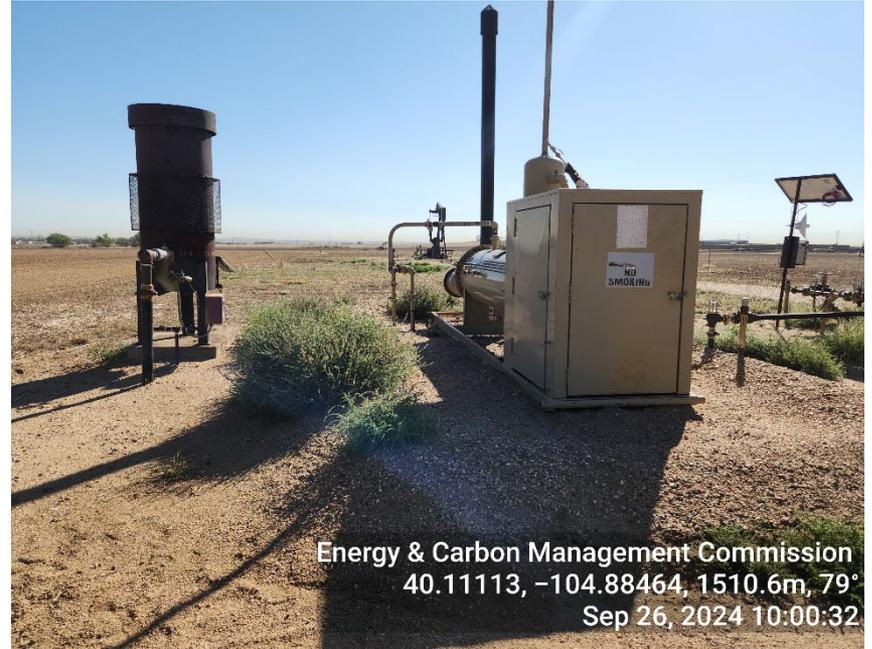
Photo 10: Overgrown vegetation

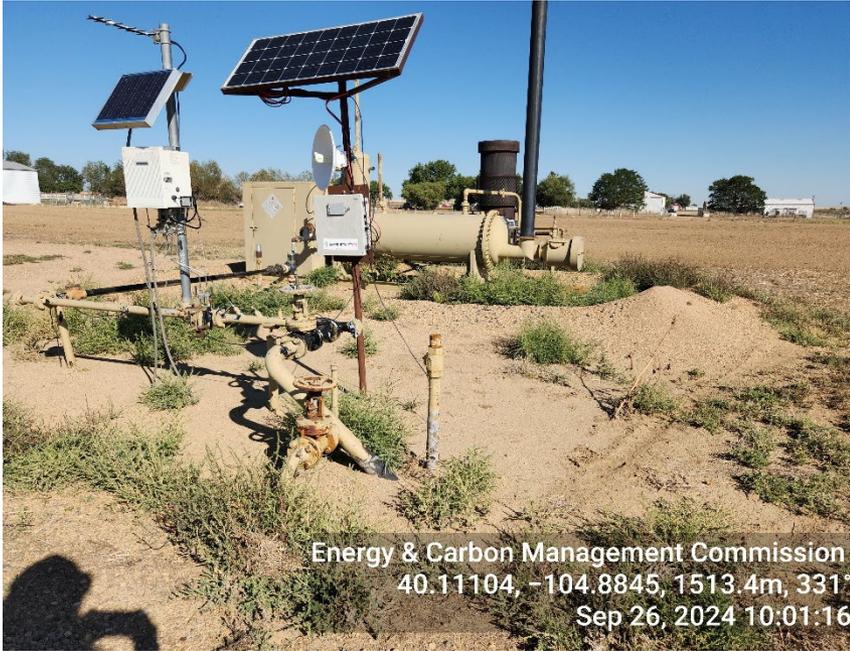
Photo 11: Overgrown vegetation

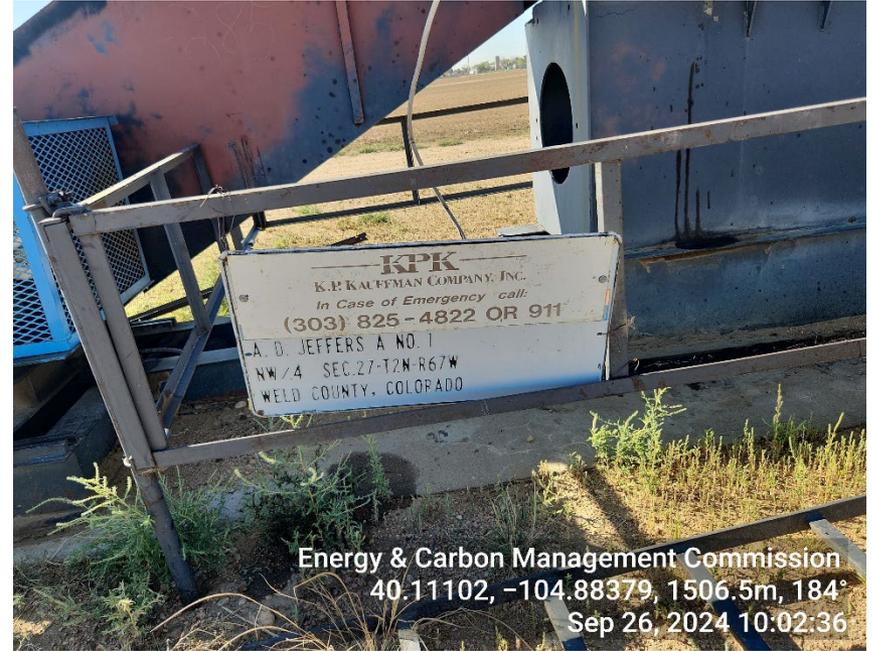
Photo 12: Wellhead Sign

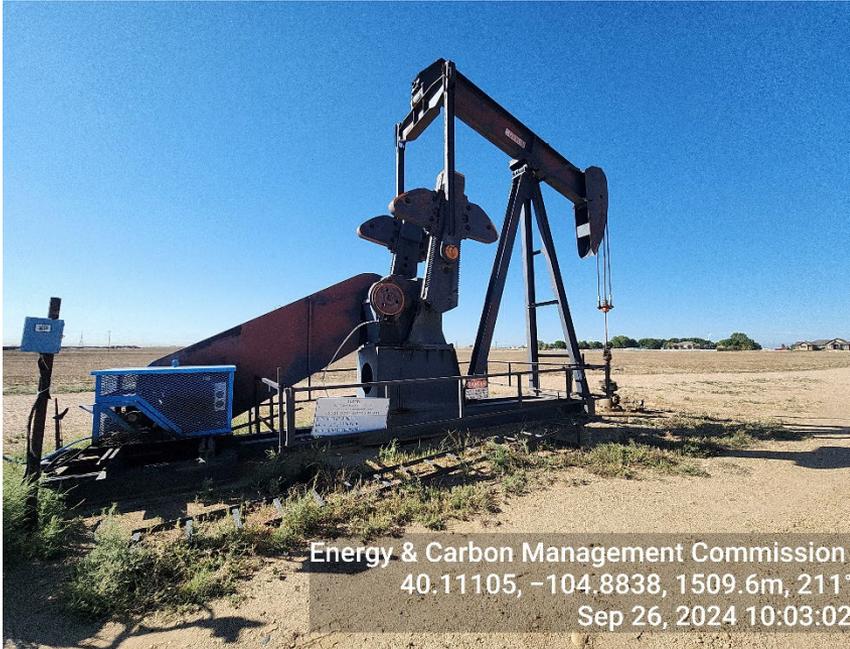
Photo 13: Pumpjack

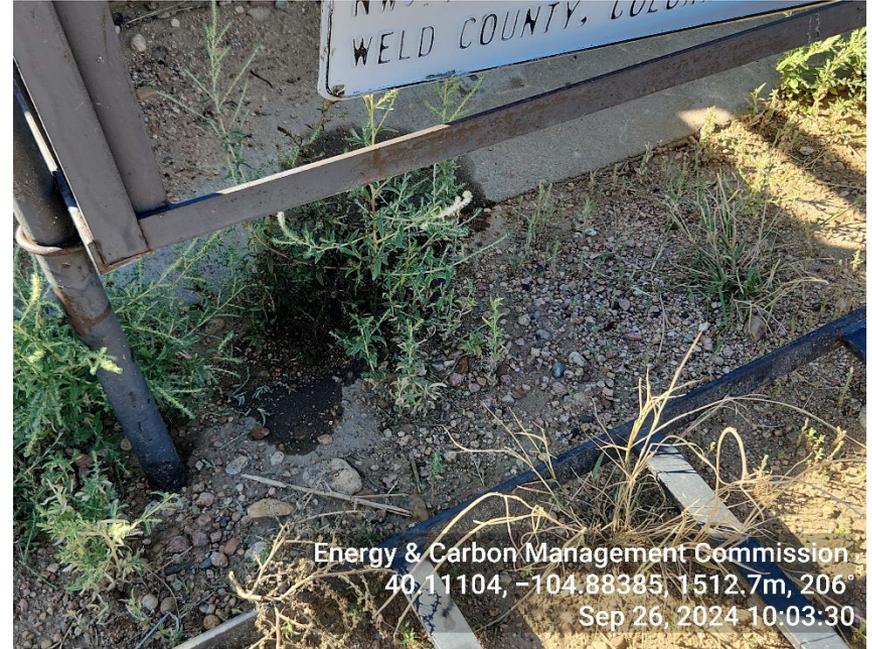
Photo 14: Stained soil

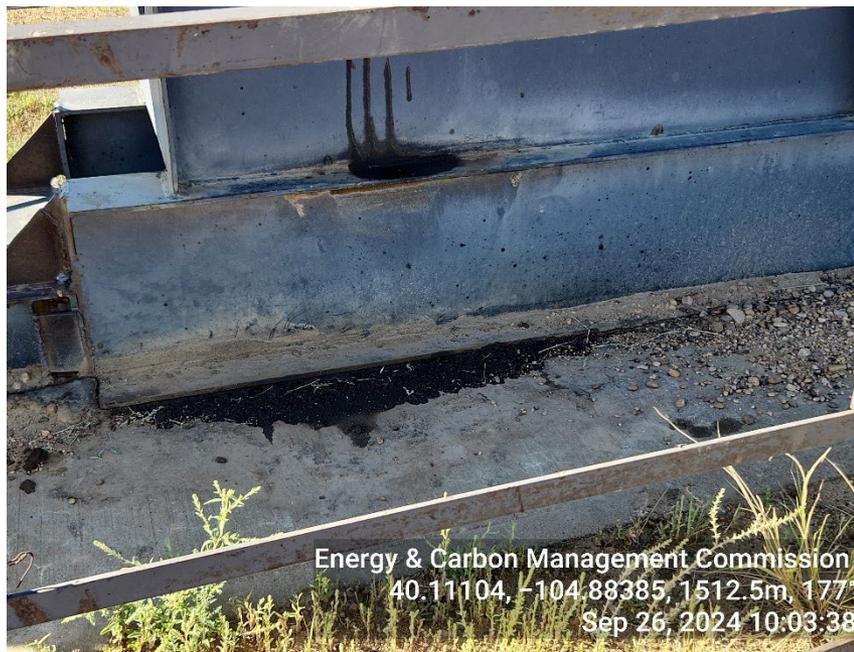
Photo 15: Stained soil

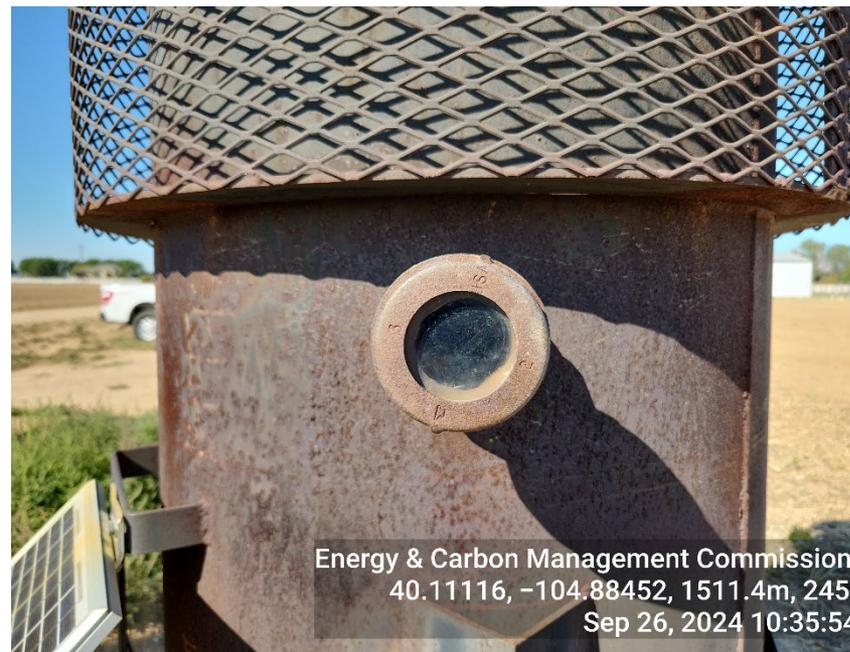
Photo 16: Pilot does not appear to be on
