Inspection Photos
Operator: Dover Atwood/Envex Baca
Location Name: Gibson, Leslie 2-19 API: 009-06072

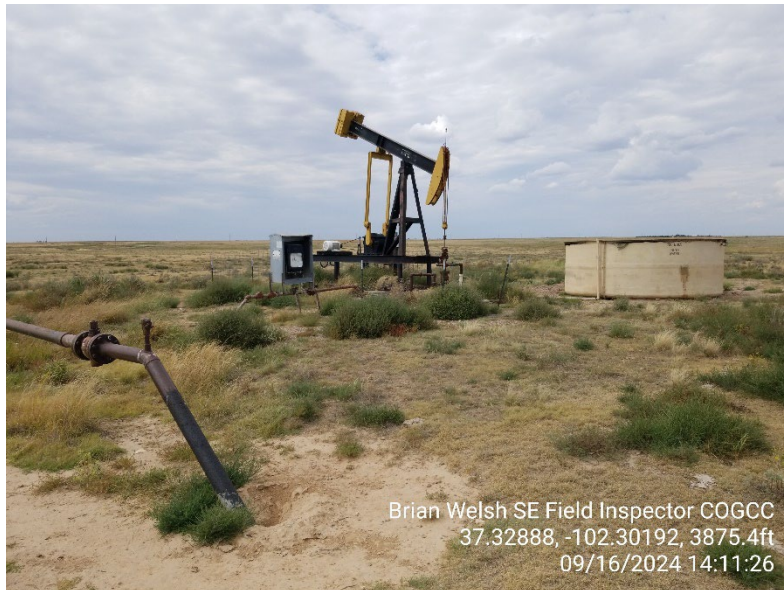
1. Pumping unit and water tank on north side of wellhead

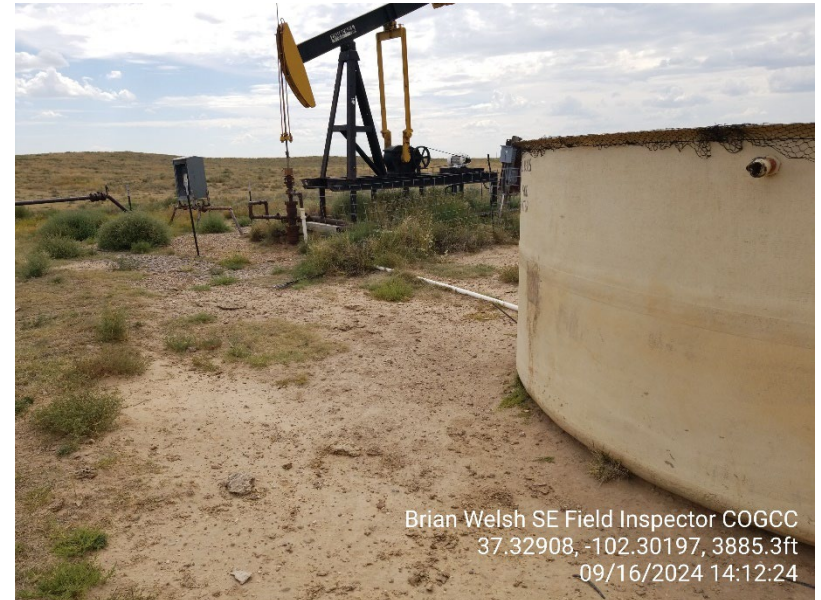
2. Water tank has no berms. Meter run on south side of wellhead

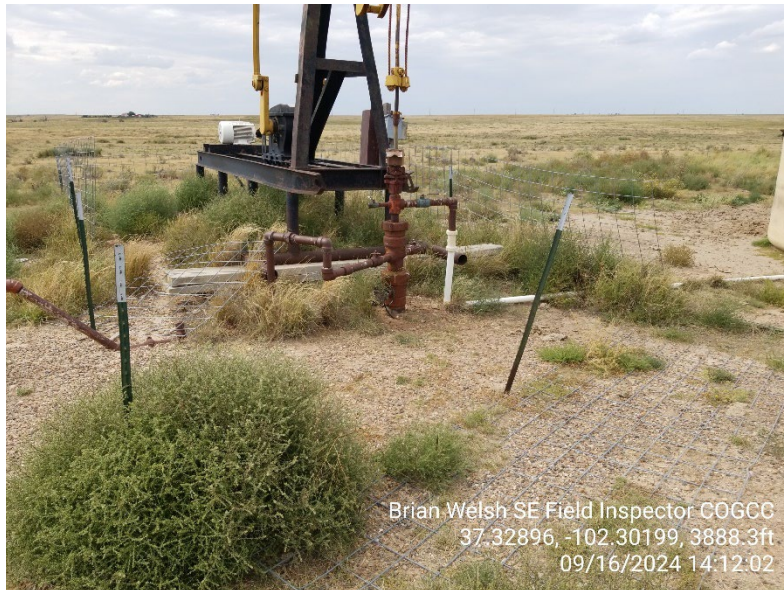
3. Wellhead and water leg. Fencing laying on the ground

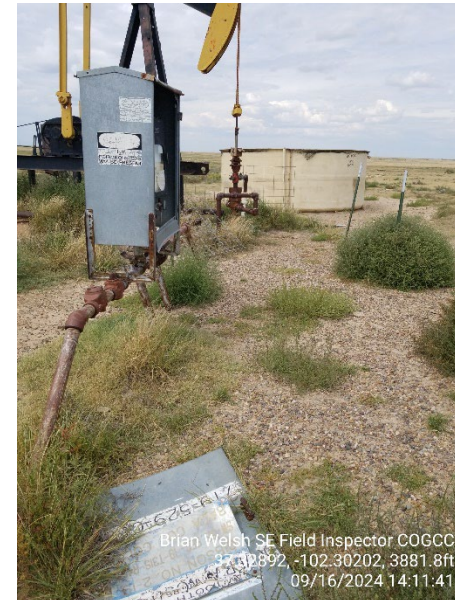
4. Meter run door laying on the ground. Lease sign isn't legible
