# Interim Reclamation and Stormwater Inspection

Date: 10/01/24

Operator: Confluence DJ LLC - 10518

Location ID: 458676

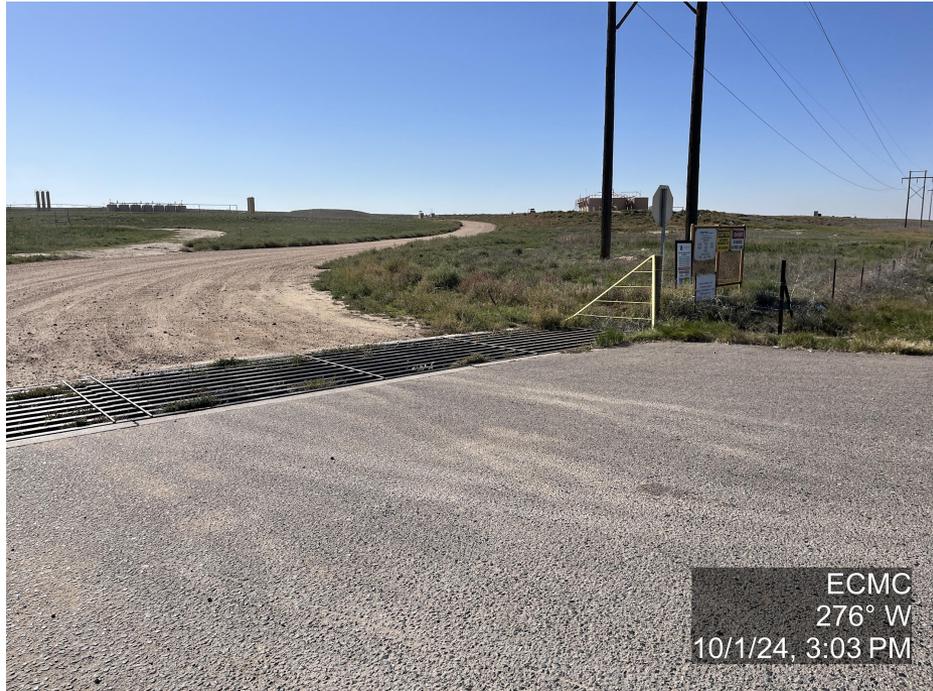
**Photo 1.** The photo was taken at the entrance to the well location facing West. The photo illustrates the Operator location sign and cattle guard.

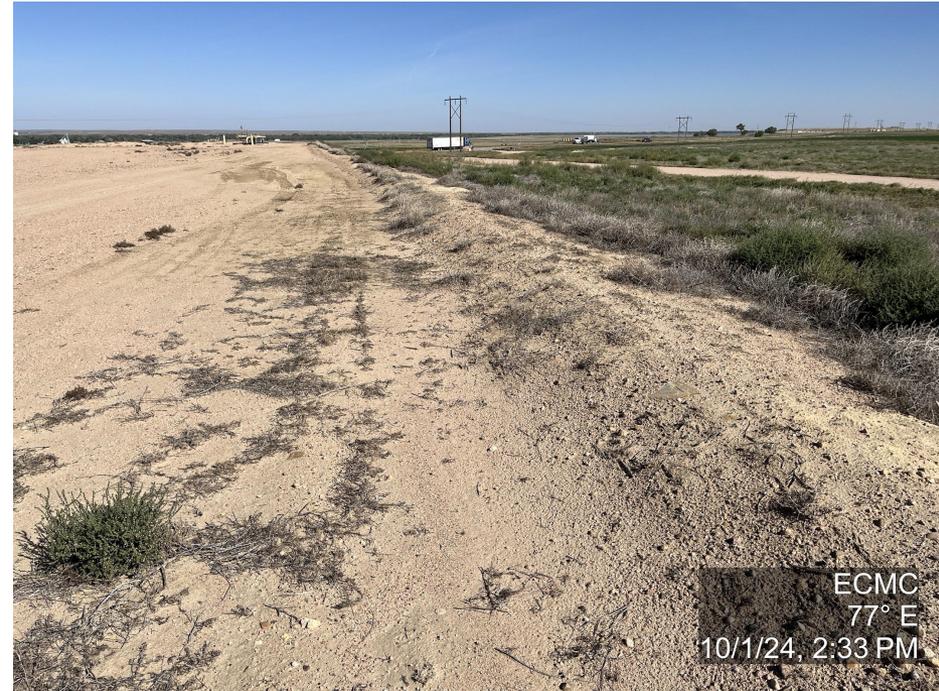
**Photo 2.** The photo was taken at the well location facing East. The photo illustrates the Russian thistle in interim areas not being managed with both old growth and new growth.

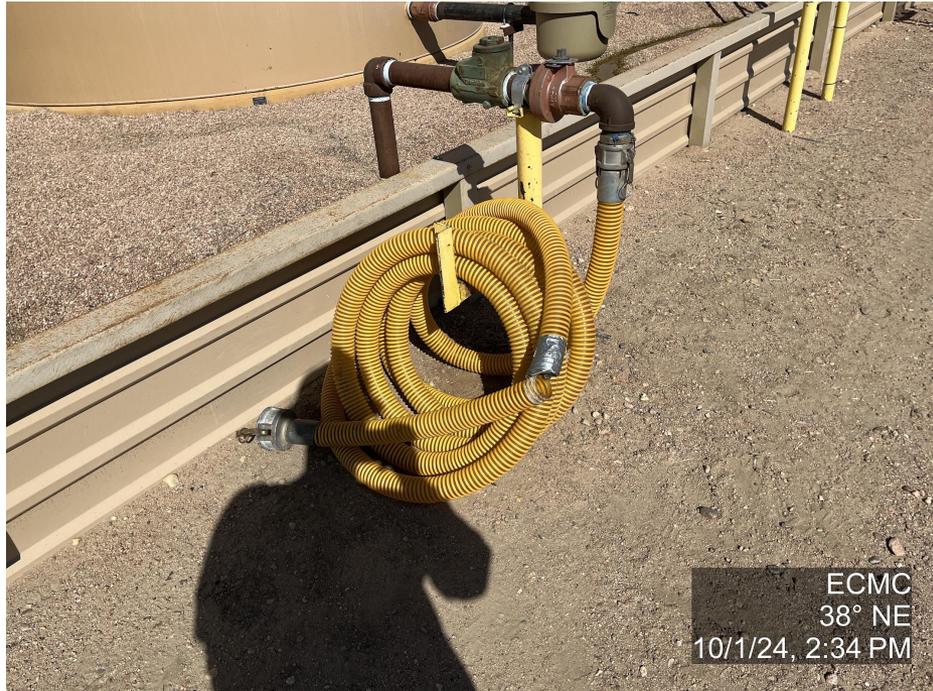
**Photo 3.** The photo was taken at the well location facing Northeast. The photo illustrates a broken hose continuing to in use that should be replaced.

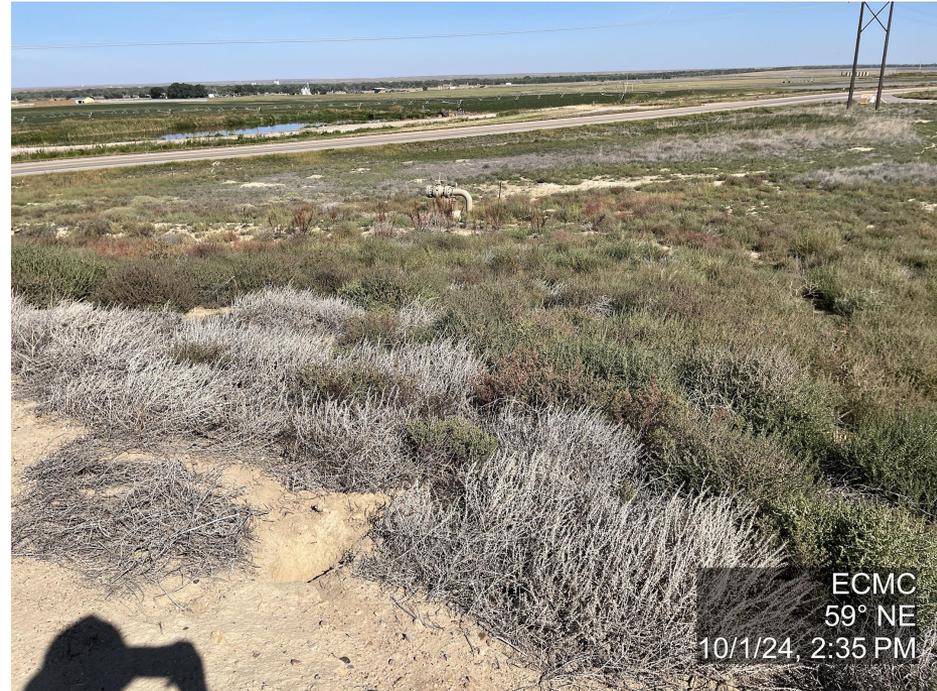
**Photo 4.** The photo was taken at the well location facing Northeast. Refer to the comment for photo 2.

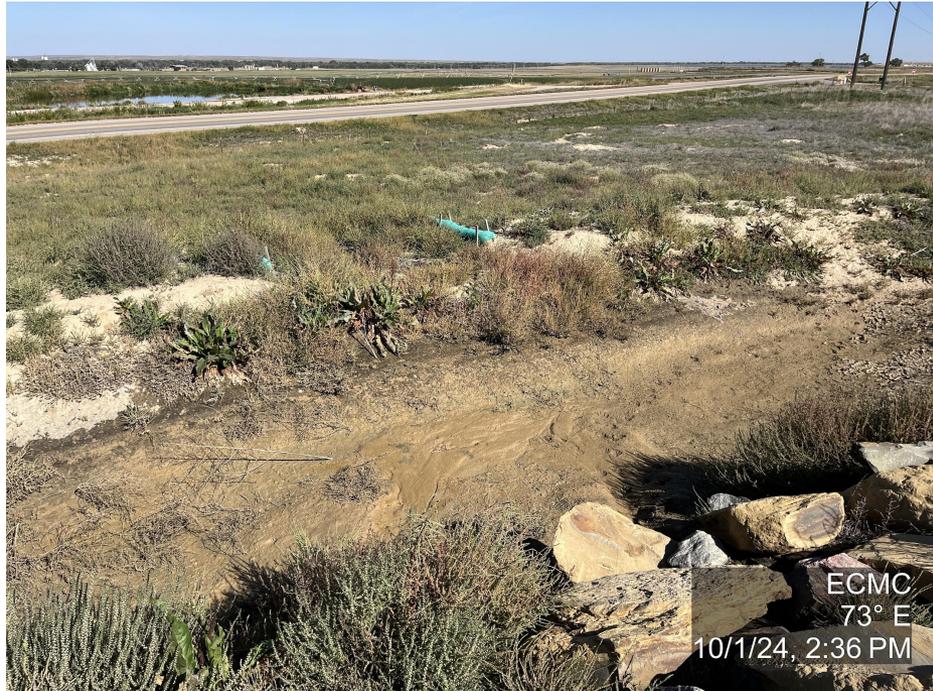
**Photo 5.** The photo was taken at the well location facing East. Refer to the comment for photo 2.

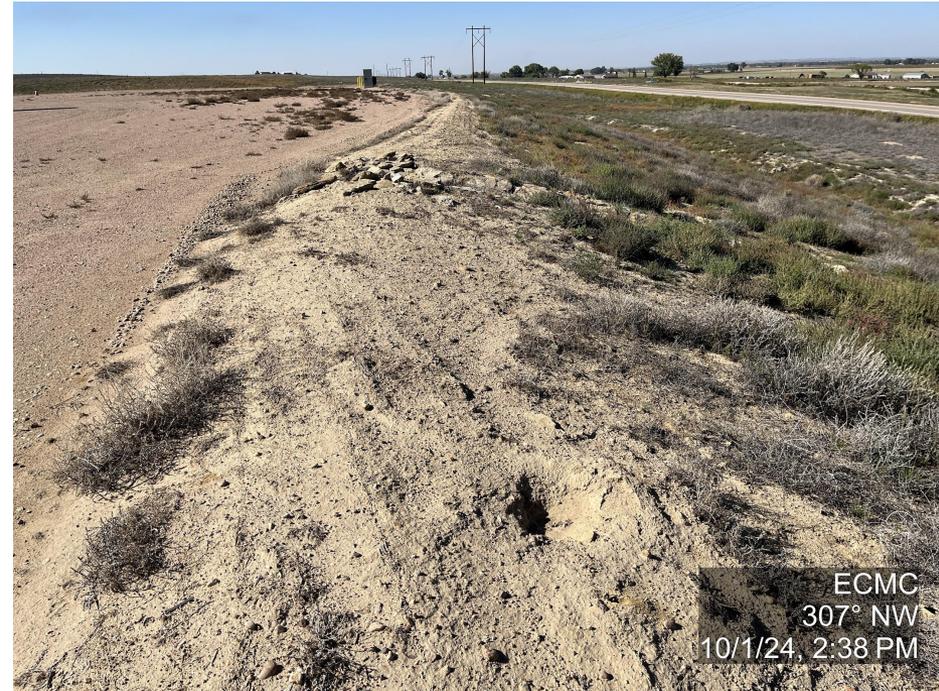
**Photo 6.** The photo was taken at the well location facing Northwest. Refer to the comment for photo 2.

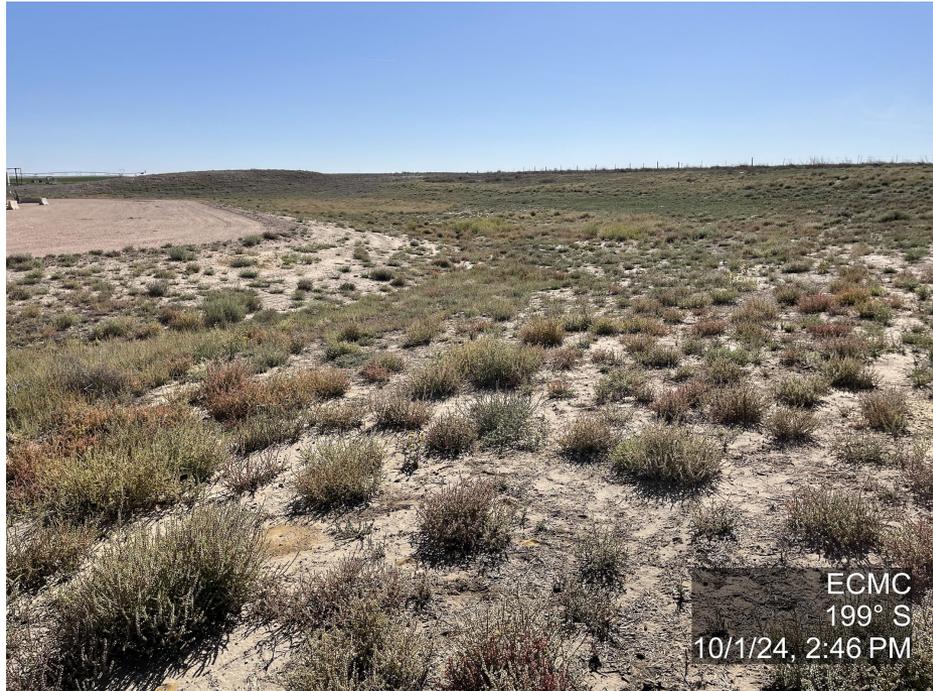
**Photo 7.** The photo was taken at the well location facing South. Refer to the comment for photo 2.

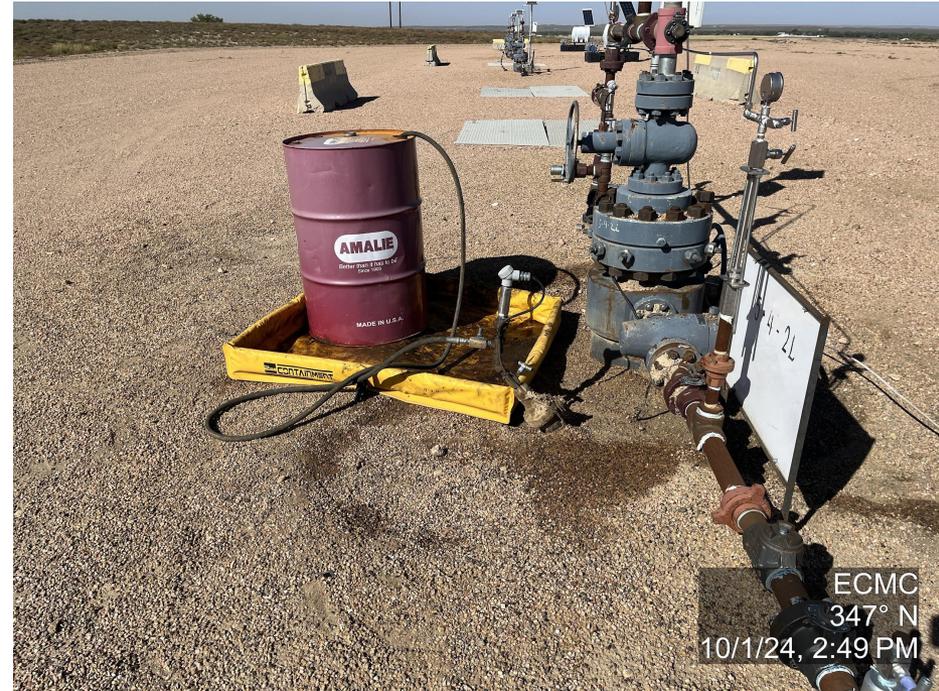
**Photo 8.** The photo was taken at the well location facing North. The photo illustrates stained soil around the Silverton 5-4-2L wellhead.

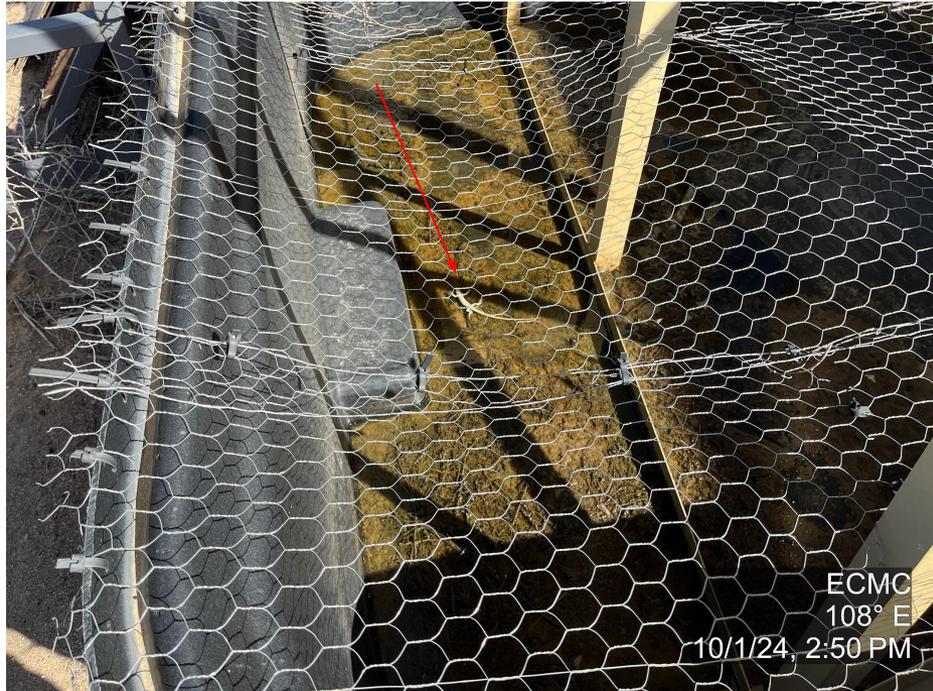
**Photo 9.** The photo was taken at the well location facing East. The photo illustrates a dead lizard with secondary containment.

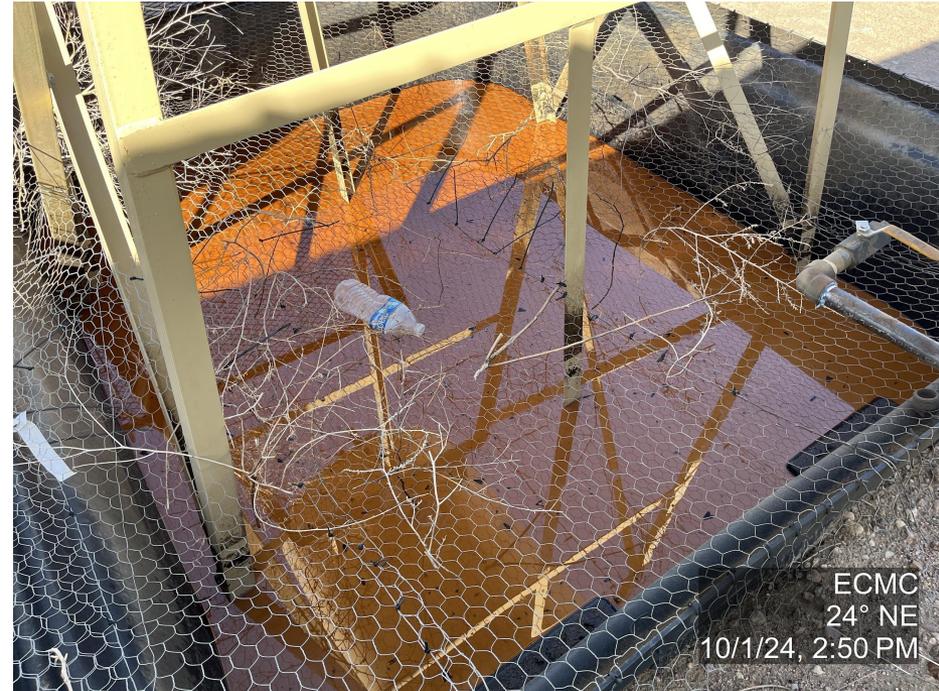
**Photo 10.** The photo was taken at the well location facing Northeast. The photo illustrates another secondary containment with standing orange liquid within it.

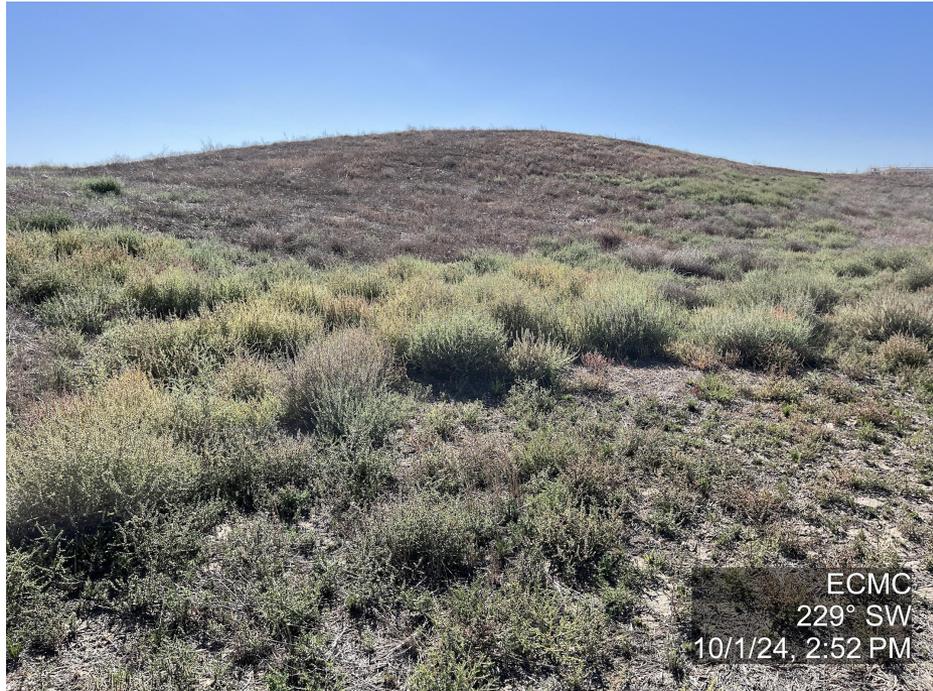
**Photo 11.** The photo was taken at the well location facing Southwest. The photo illustrates the topsoil stockpile is dominated by russian thistle and other tumbleweeds and has very little to no germination of desirable vegetation.

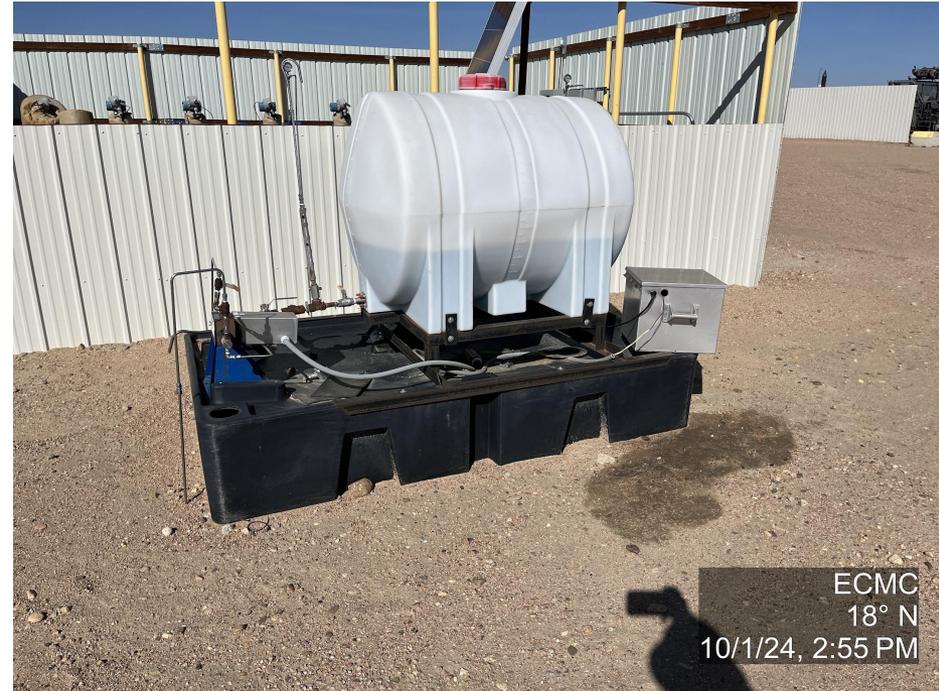
**Photo 12.** The photo was taken at the well location facing North. The photo illustrates stained soil on the production pad.

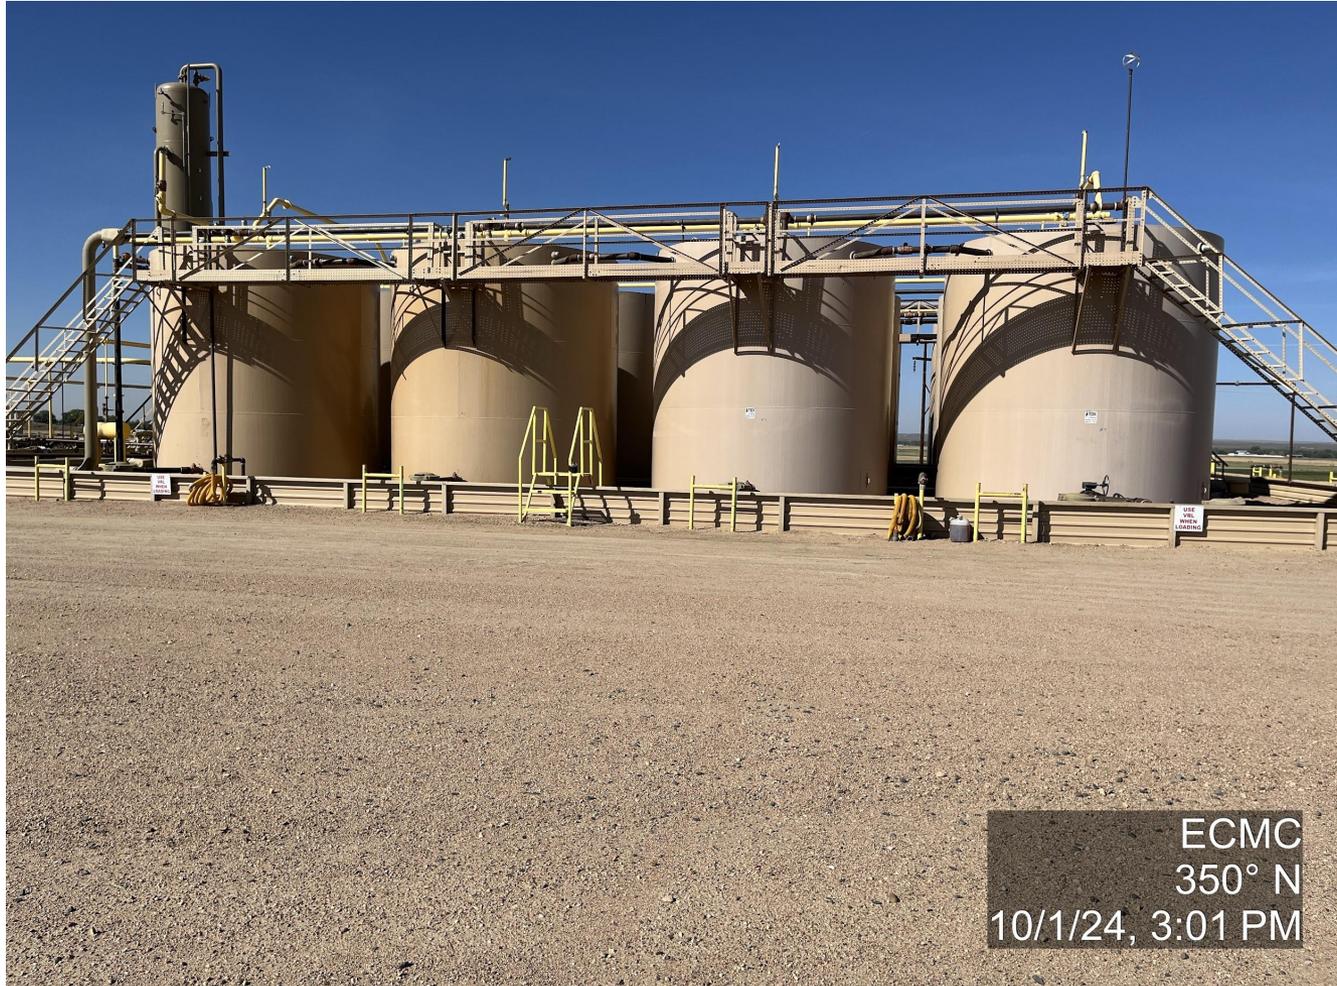
**Photo 13.** The photo was taken at the well location facing North. The photo illustrates the tanks are missing any identifying placards or labels.
