Inspection Photos

Location Name: TEP ROCKY MOUNTAIN LLC, GM/34-4

Location ID: 334896

Date: 10/3/2024

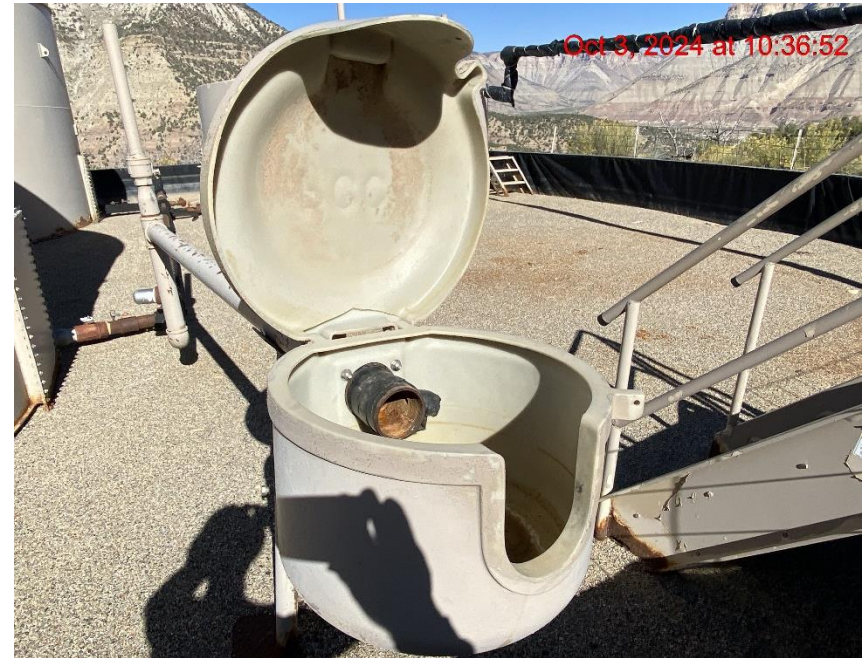
Open-Ended Load Line – Photo #03867

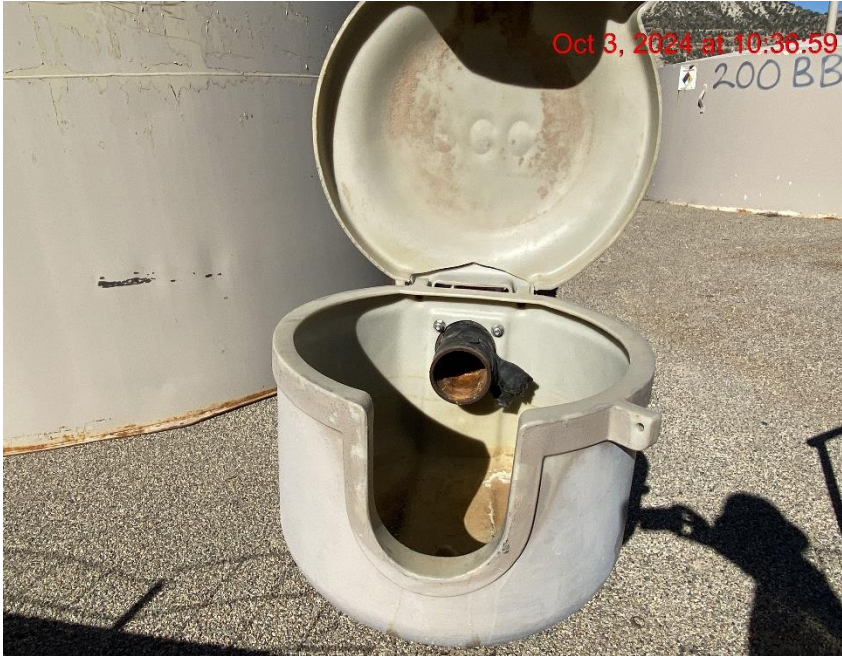
Open-Ended Load Line – Photo #03868

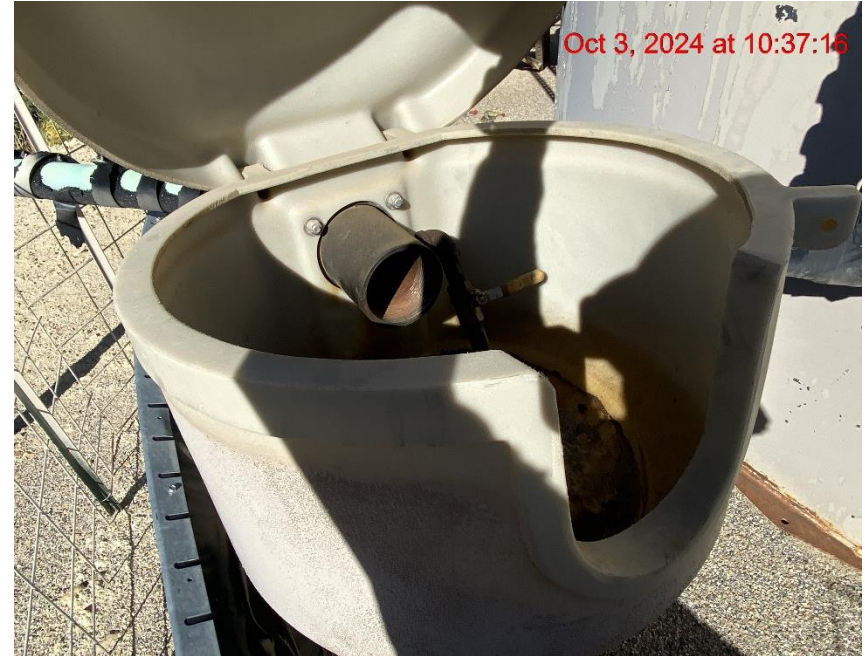
Open-Ended Load Line – Photo #03869

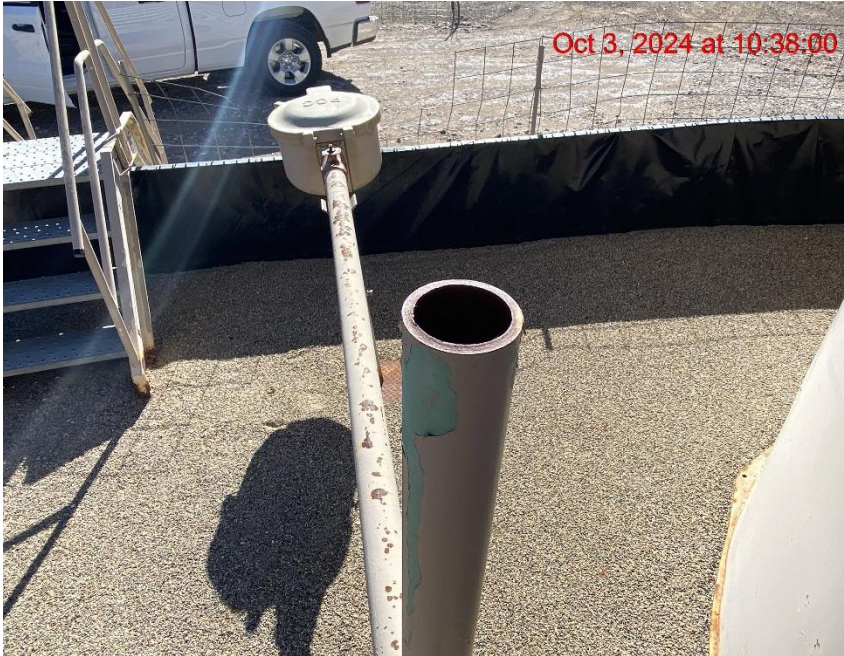
Open-Ended Vent Line – Photo #03870

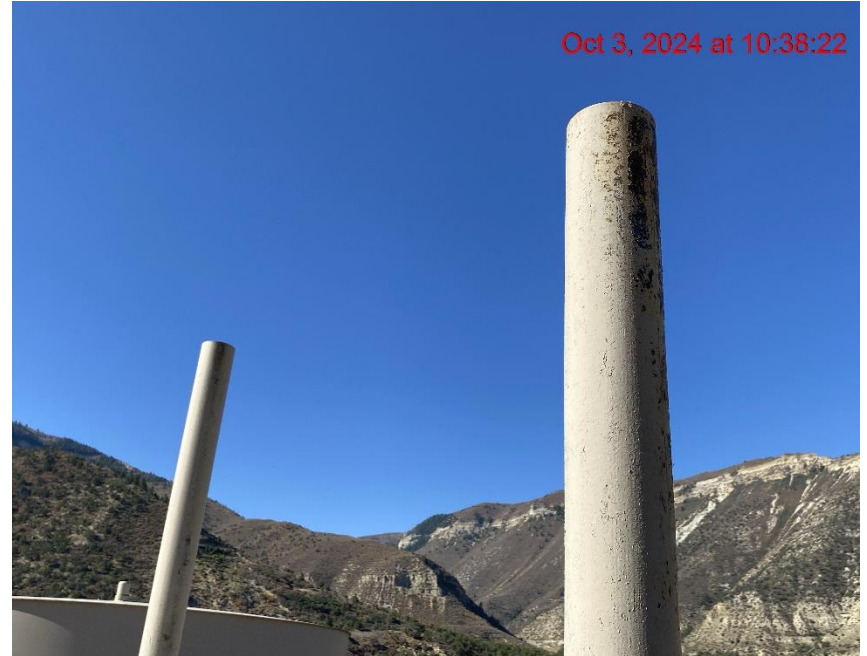
Open-Ended Vent Lines – Photo #03871

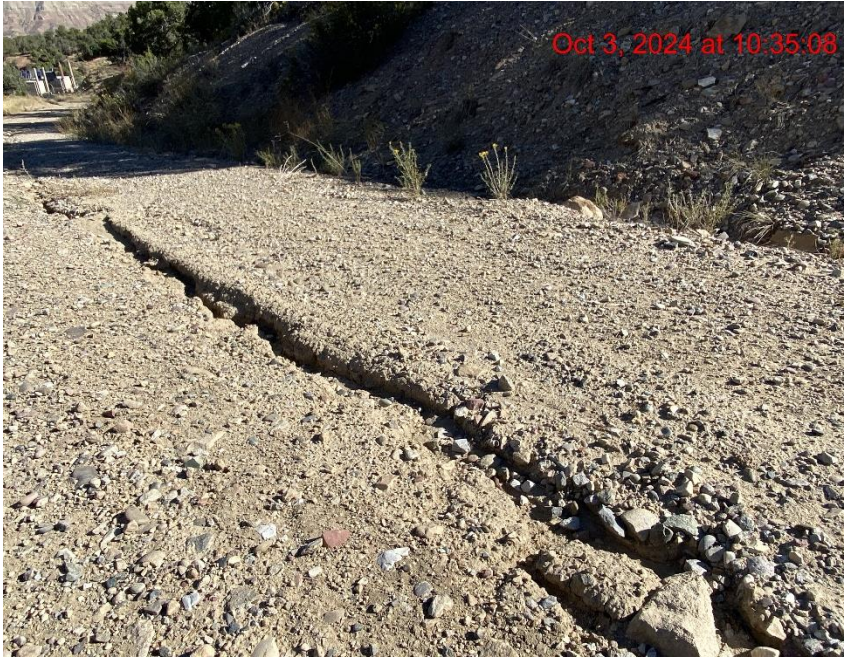
Rill Erosion on Access Road into Location – Photo #03865

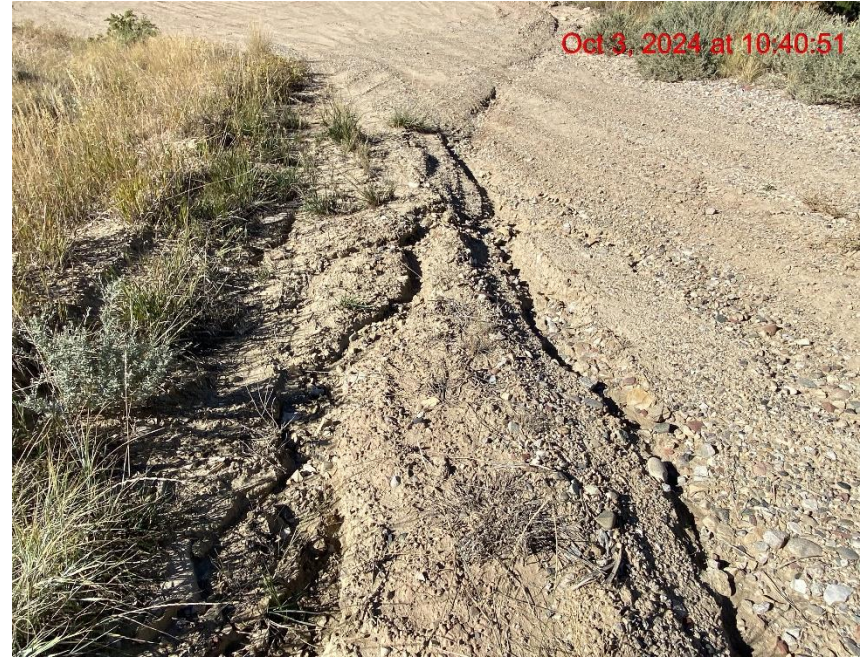
Rill Erosion on Access Road to Wellheads – Photo #03878

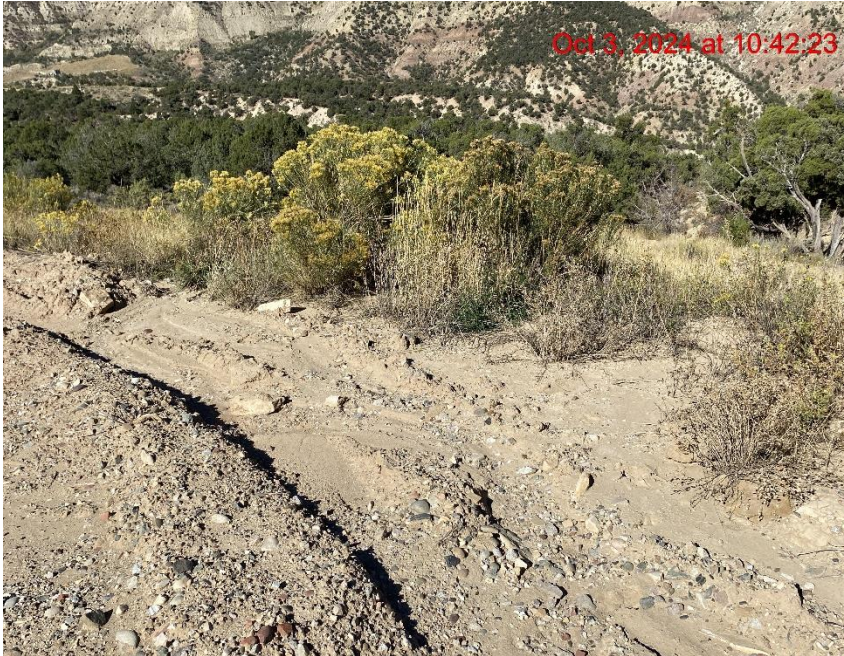
**Rill Erosion from Access Road Transporting Sediment Offsite
– Photo #03879**
