Inspection Photos

API: 061-06403

Operator: STRACHAN EXPLORATION INC

Inspection Date: 10/3/2024

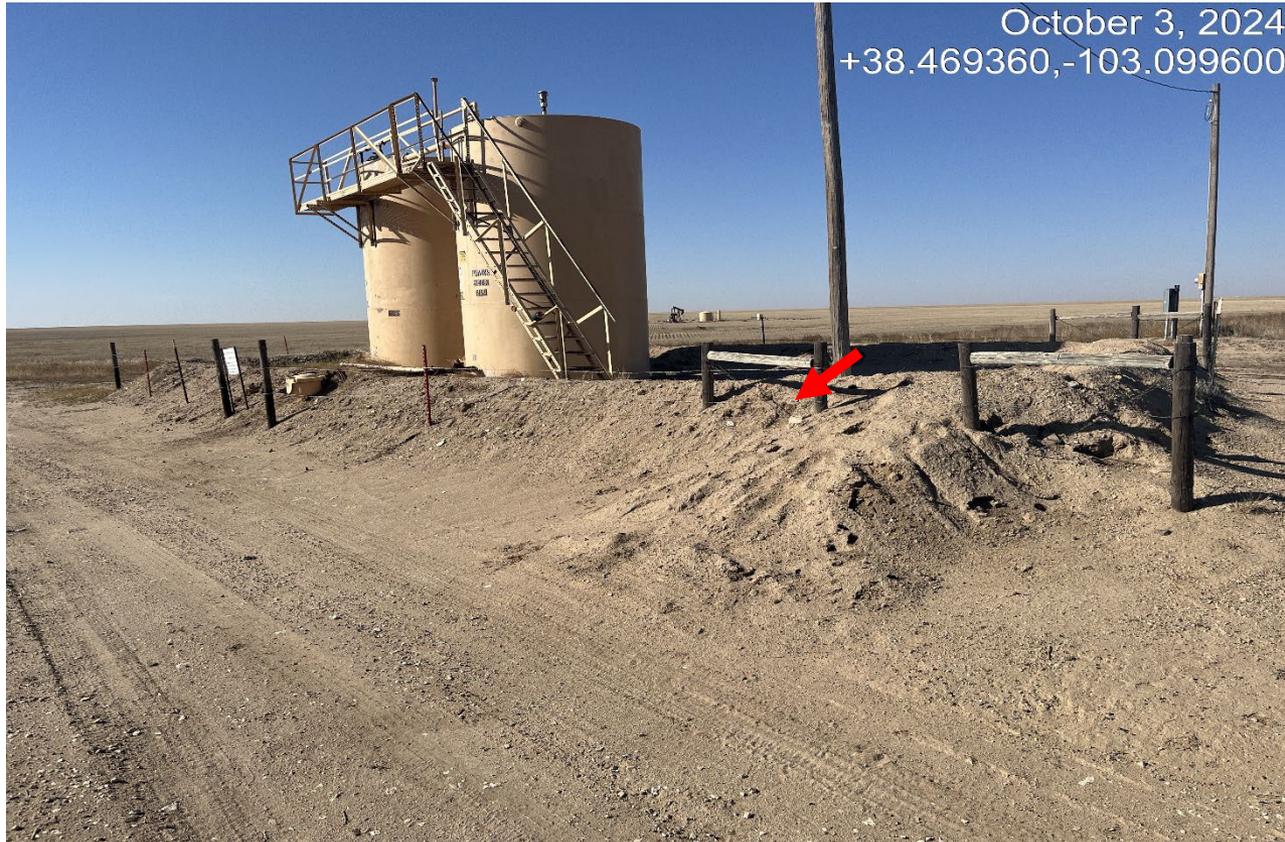
Photo 1. Facing toward the offsite tank battery location. The fence is not adequate to prevent livestock entry and there is no gate at the red arrow.

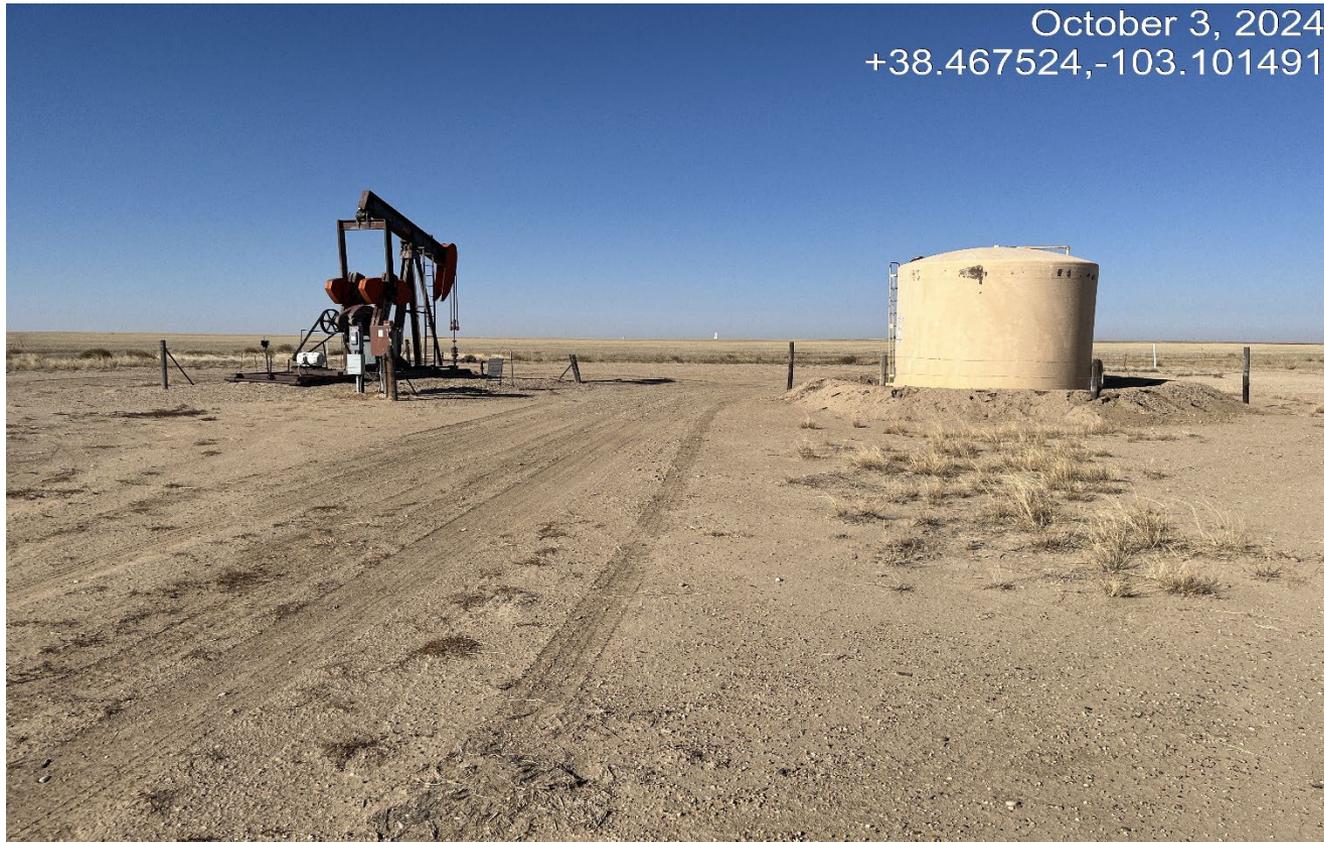
Photo 2. Facing southwest at the wellsite.

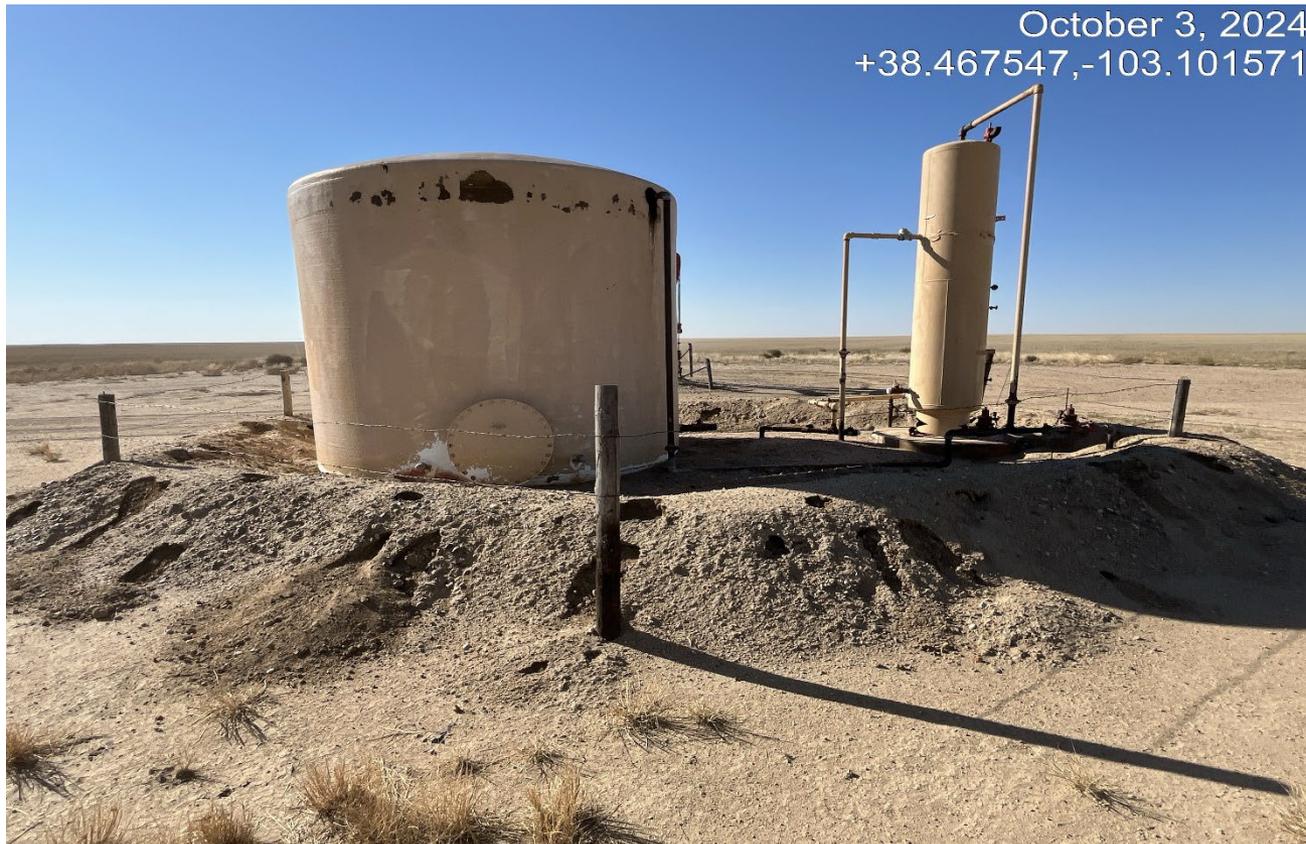
Photo 3. Facing toward the tank. The berm around the tank has been rebuilt. The sides of the berm are not compacted.

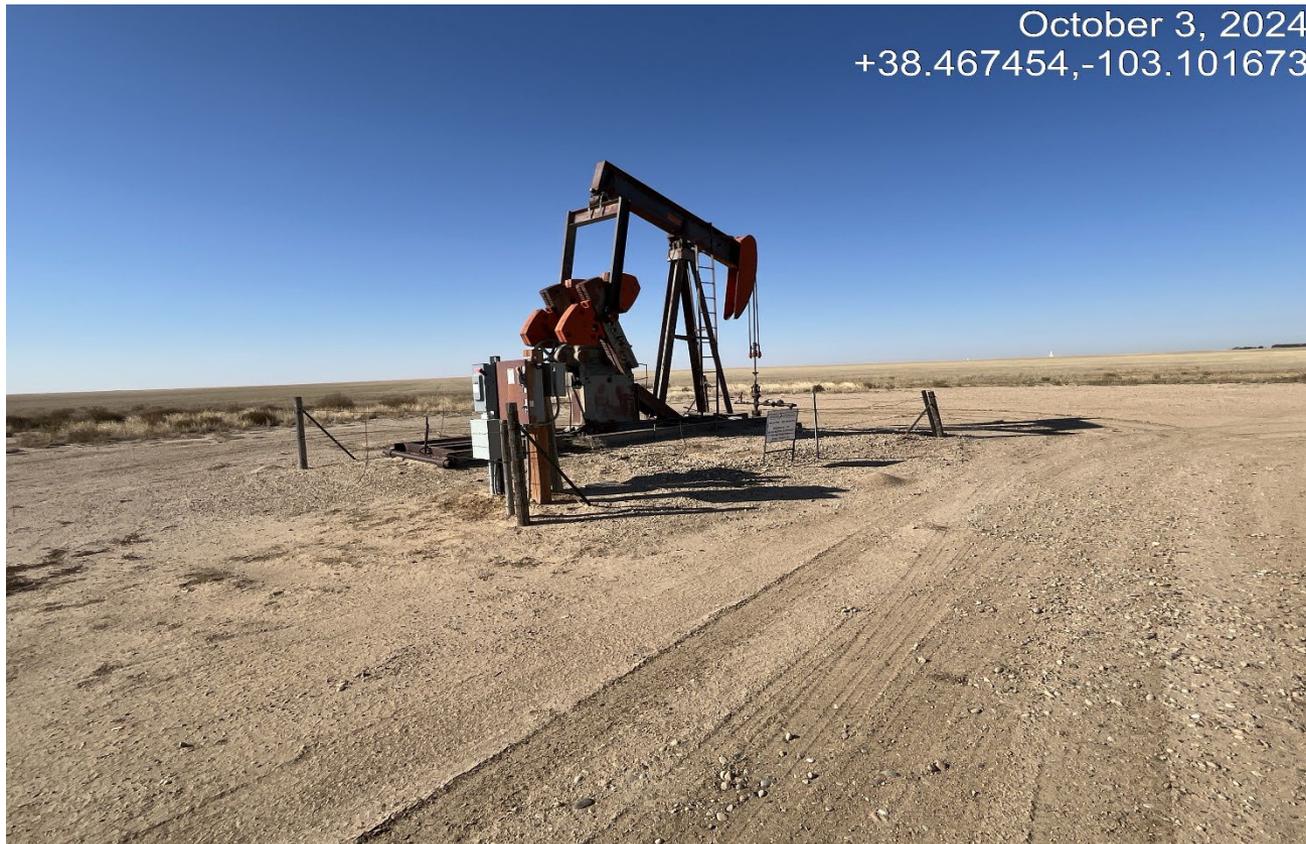
Photo 4. A new well sign was installed at the wellhead.
