Inspection Photos
Location: Manway 13-32, Manway 13-32 TR
Location ID: 307392
API # 05-071-06371, TR 05-071-06773

COLORADO

Energy & Carbon Management
Commission

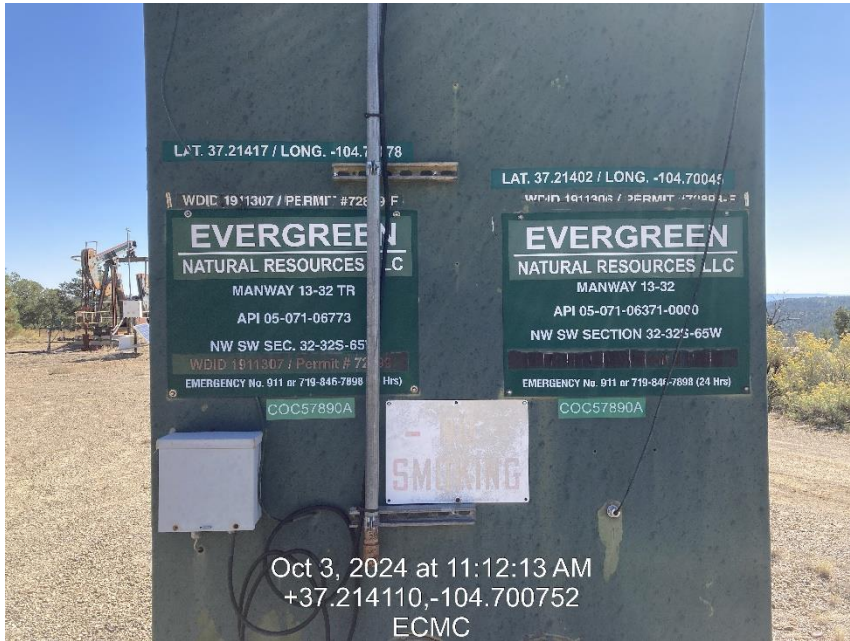
Photo 1 – Well placard on meter house, WDID stickers illegible

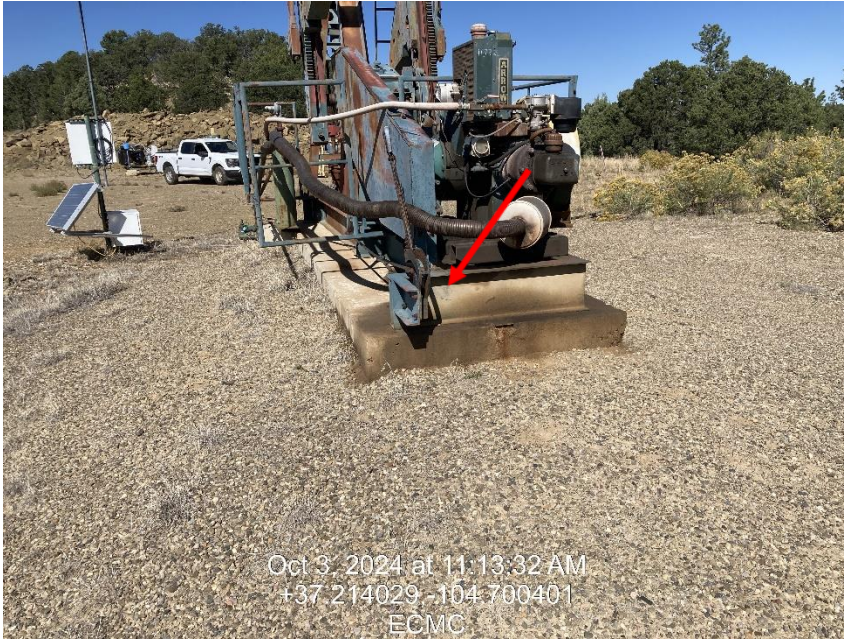
Photo 3 – Stained soils

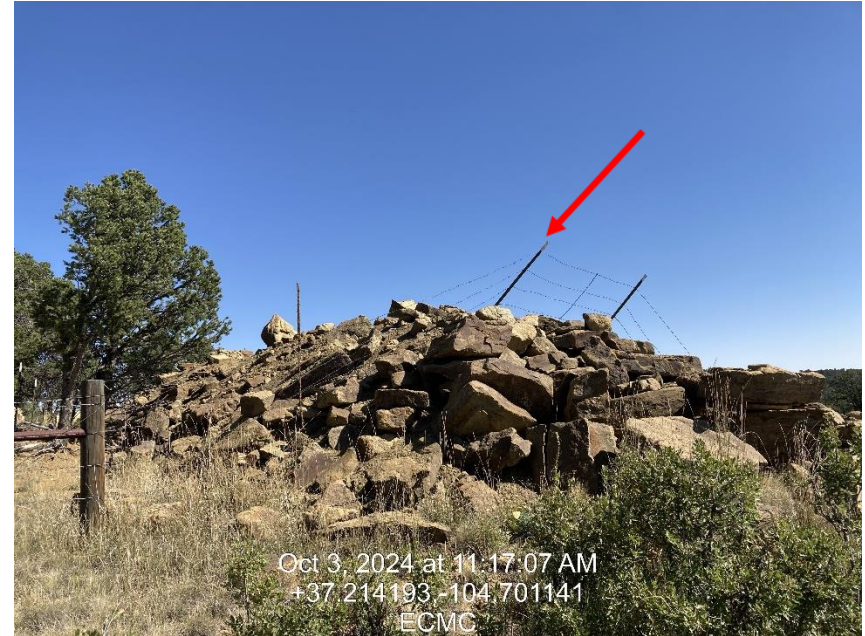
Photo 8 – Pit Fencing Inadequate
