# Interim Reclamation and Stormwater Inspection

Operator: WESTERN OPERATING COMPANY - 95620

Location ID: 312229

Inspection Document #: 708201670

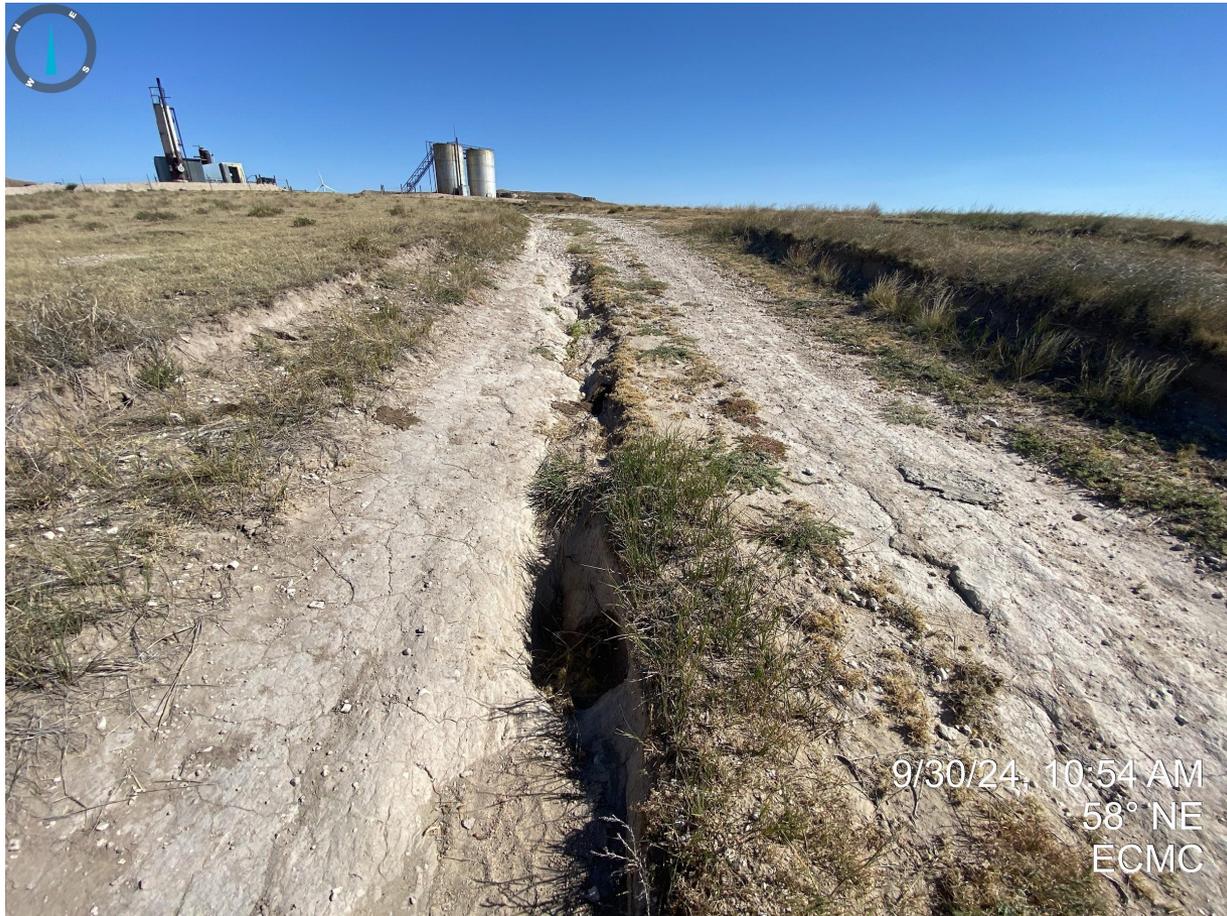
**Photo 1.** Erosion degradation south of the production facilities.

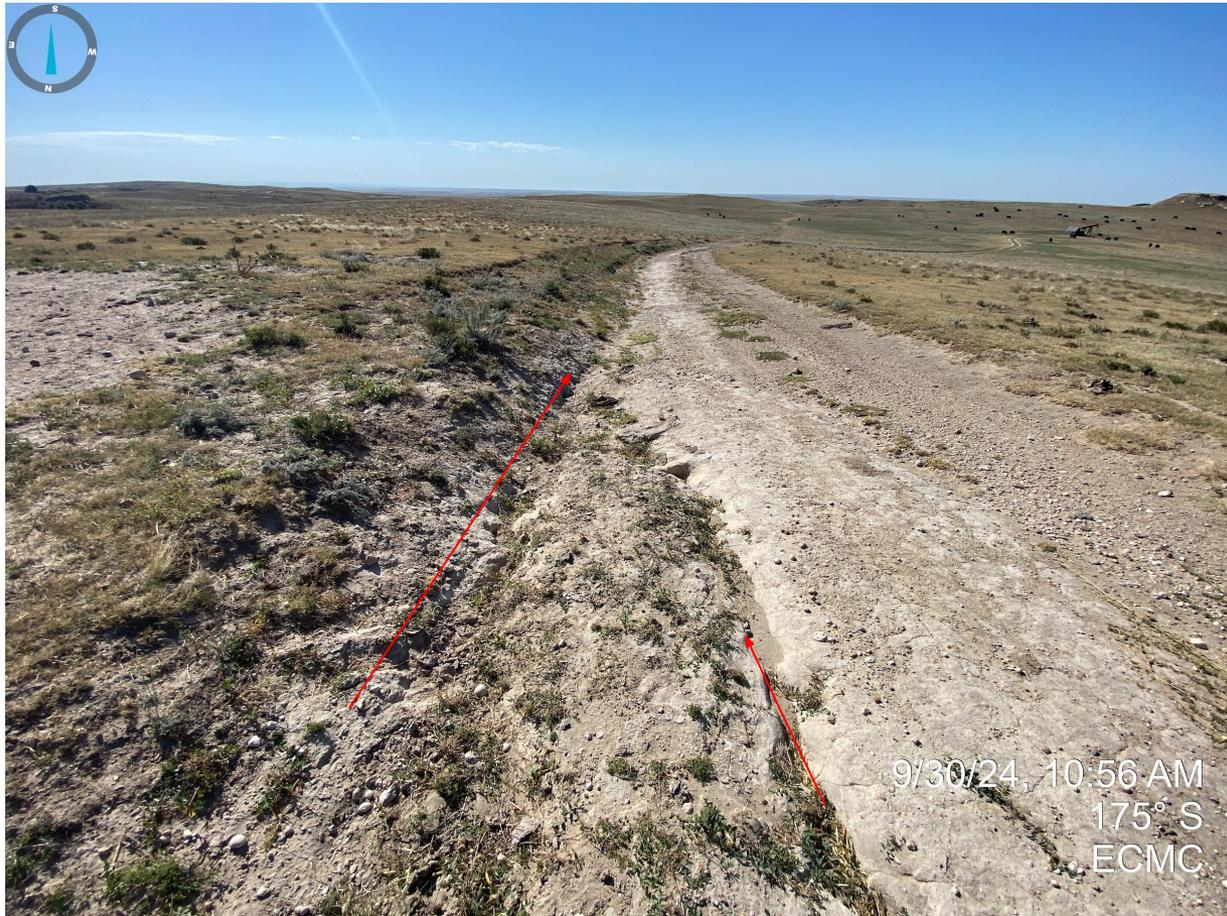
**Photo 2.** Erosion degradation south of the production facilities.

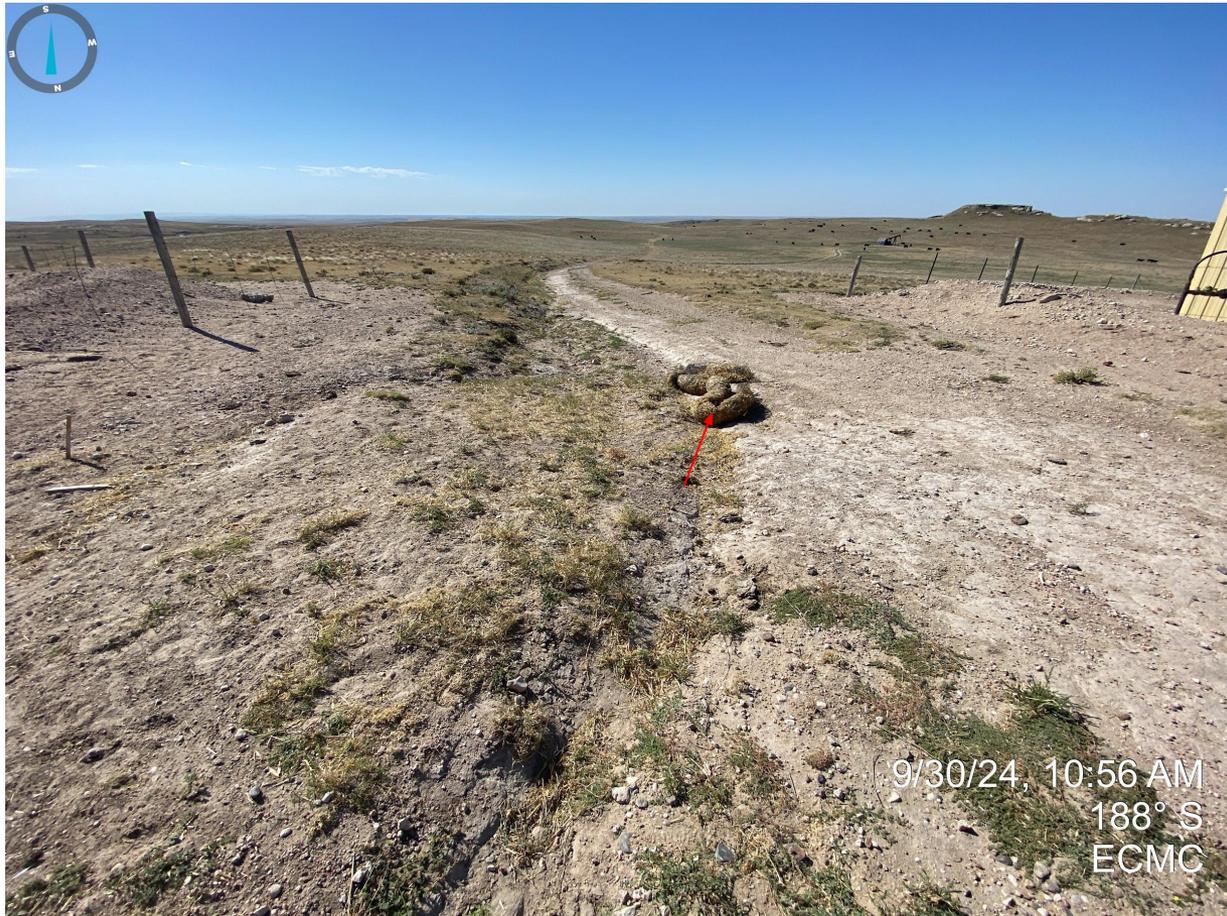
**Photo 3.** Erosion degradation along the access near production facilities. Straw wattles is now considered debris and needs to be removed.

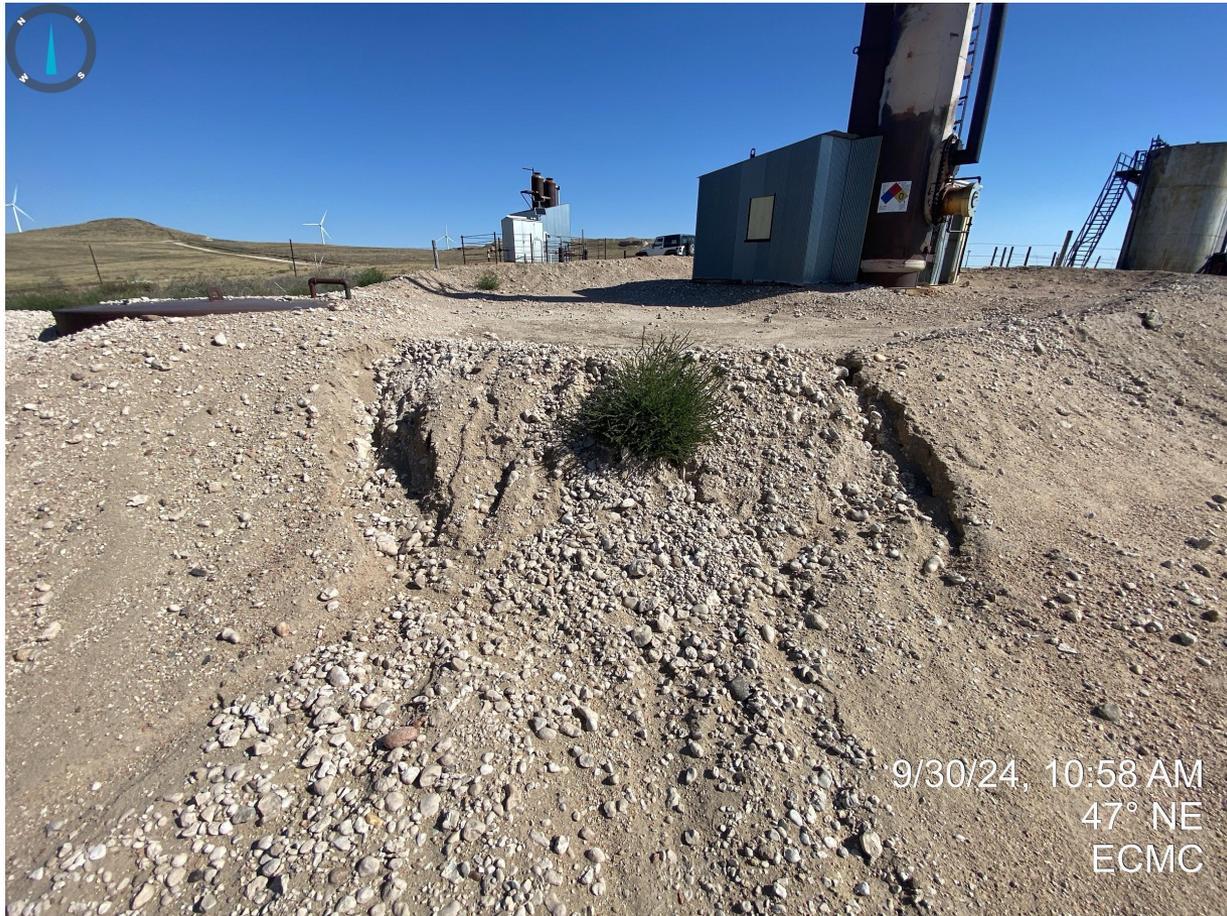
**Photo 4.** Undesirable vegetation and erosion degradation observed within the pit berm area.

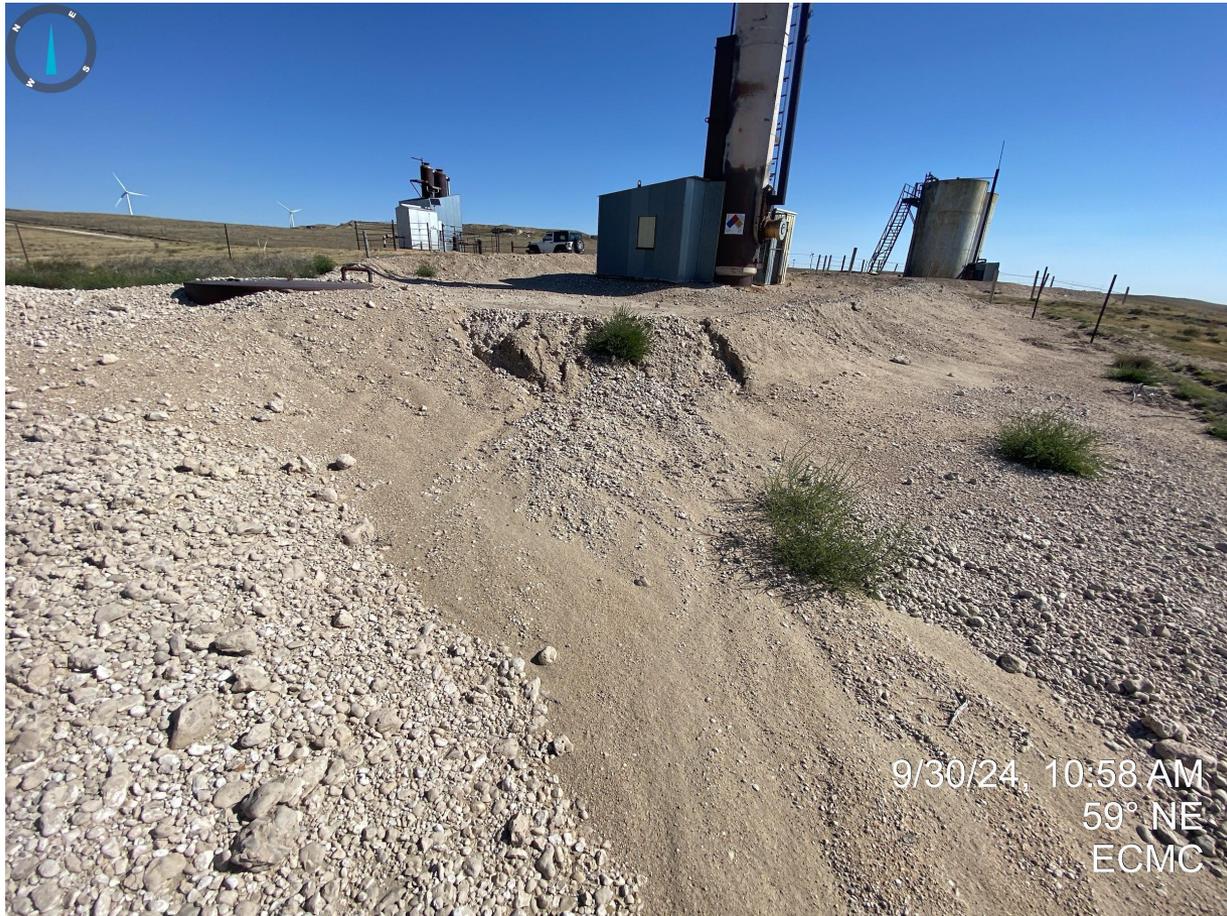
**Photo 5.** Continued from Photo 4; photo illustrates sediment transport.

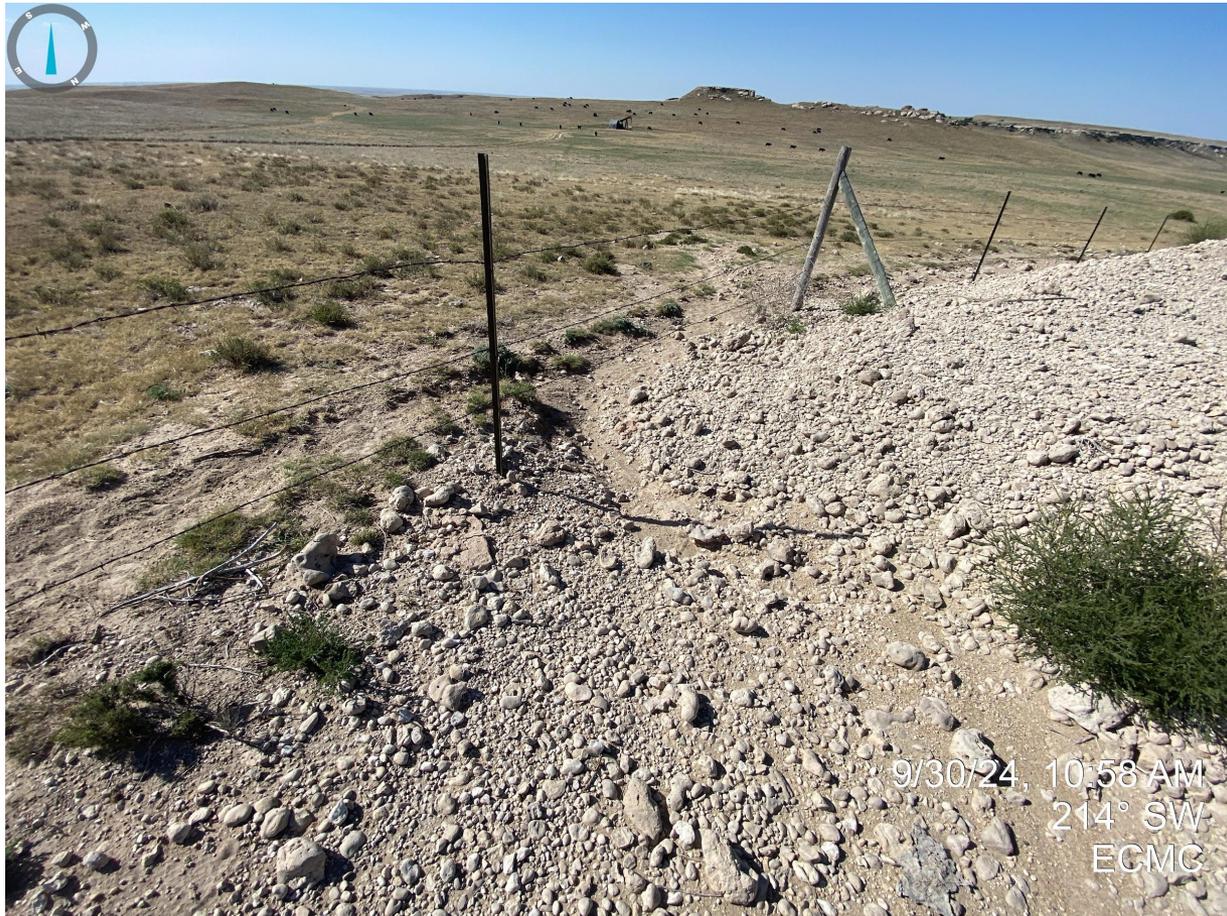
**Photo 6.** Continued from Photo 5; photo illustrates erosion degradation and sediment transport.

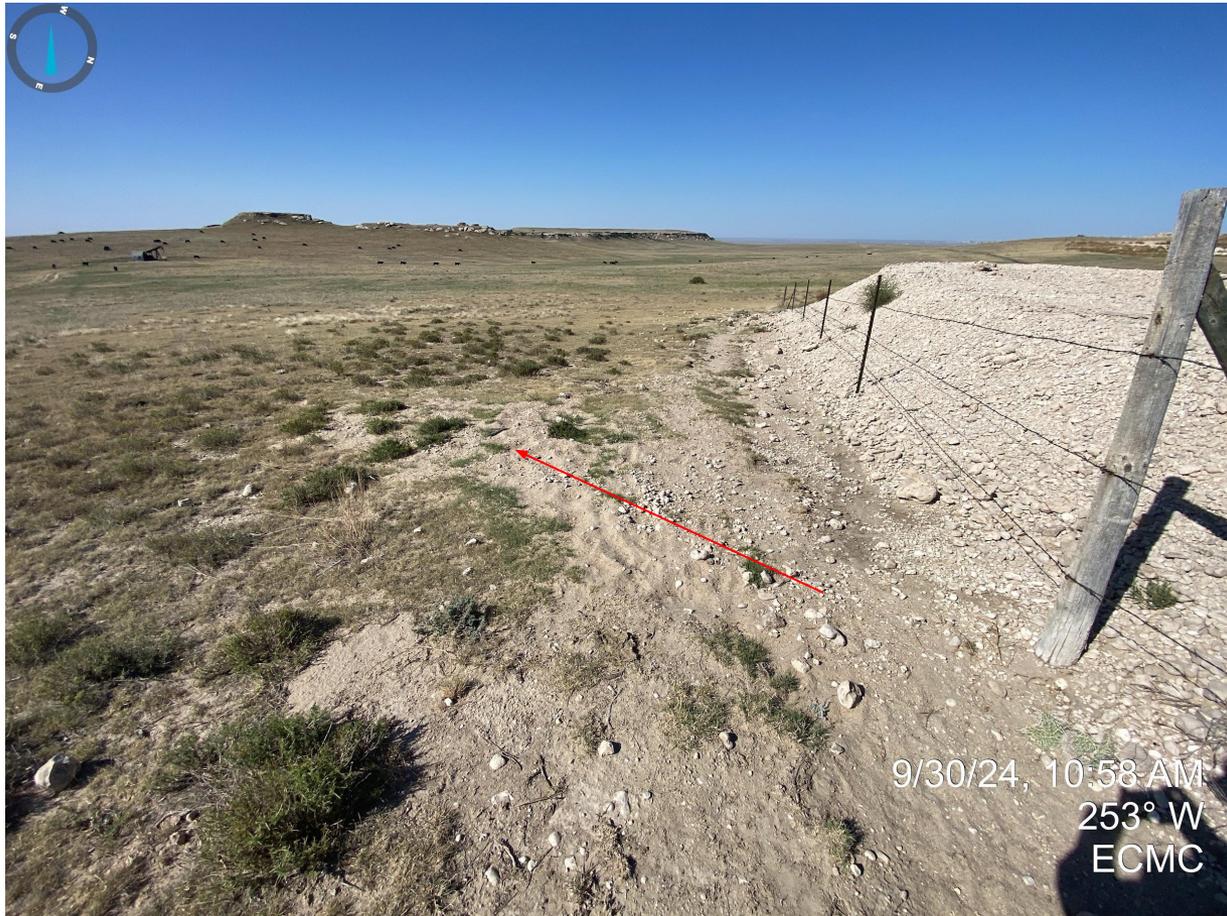
**Photo 7.** Continued from Photo 6; photo illustrates erosion degradation and sediment transport.

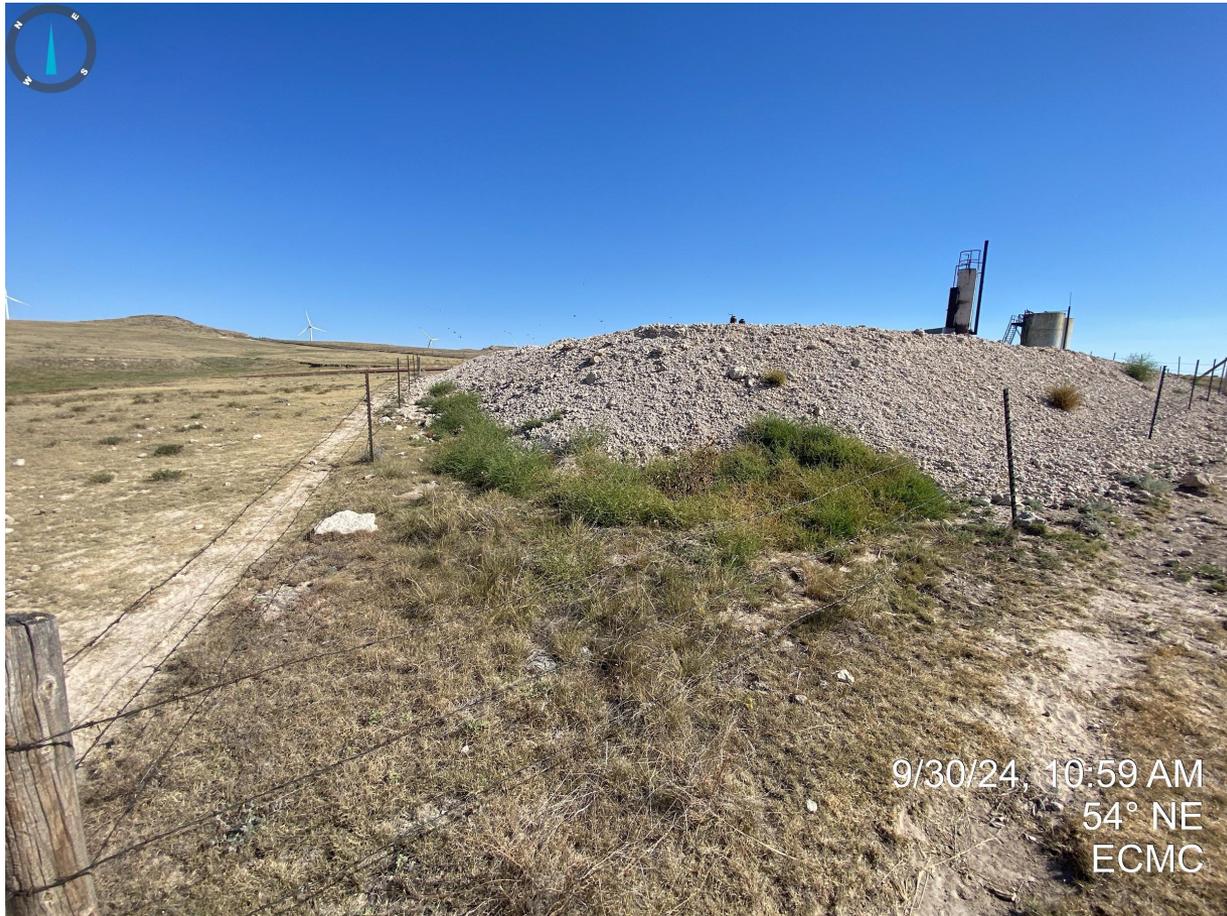
**Photo 8.** Undesirable vegetation observed around pit.

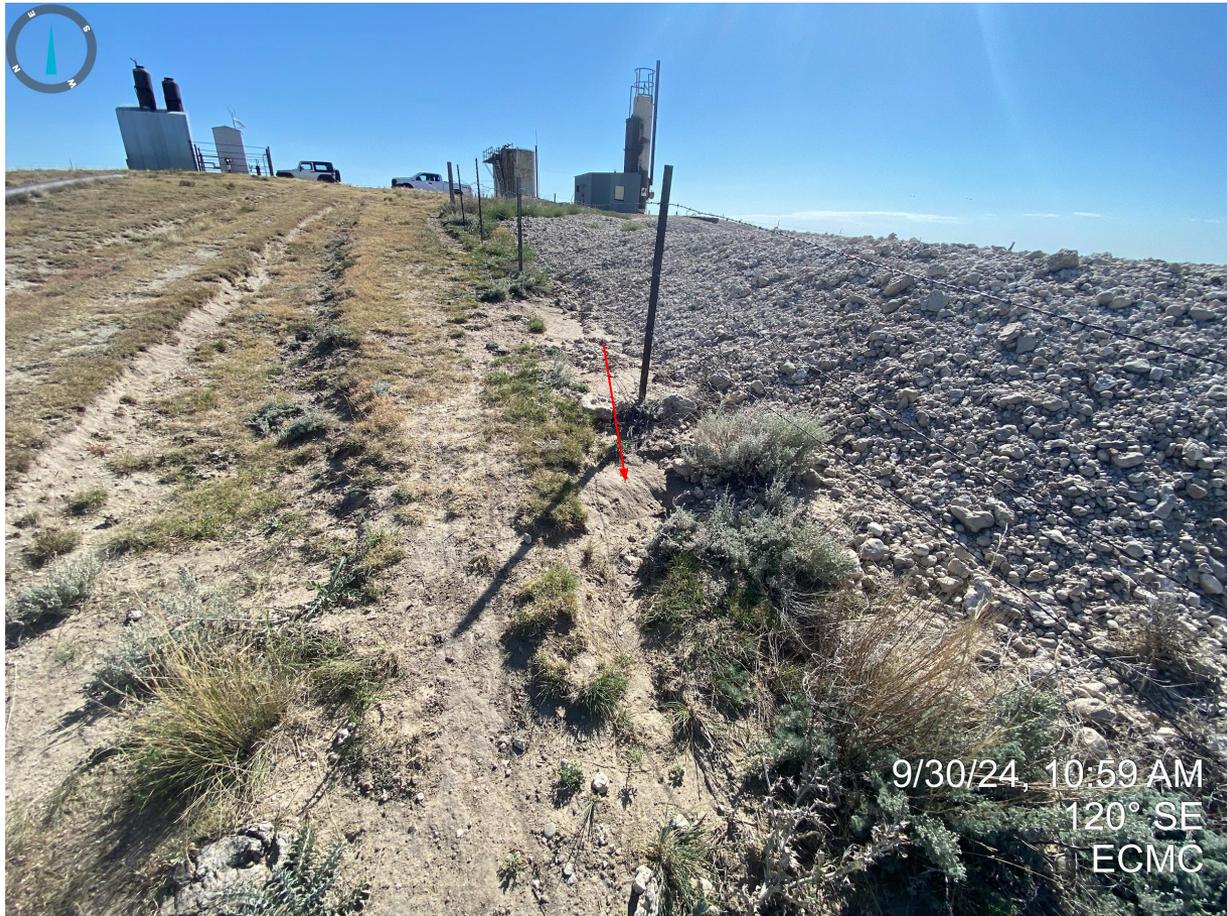
**Photo 9.** Erosion degradation on north side of pit.

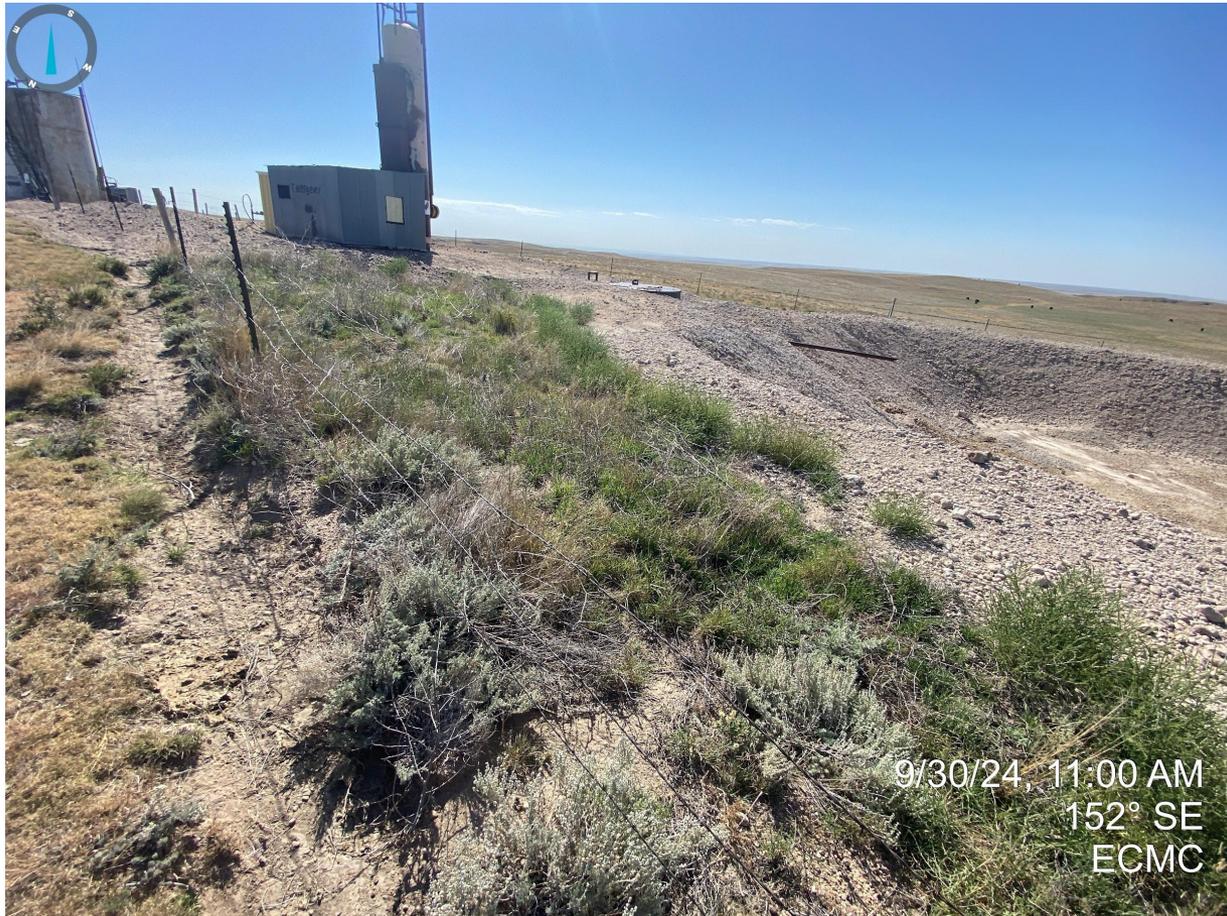
**Photo 10.** Undesirable vegetation observed on north side of pit area.

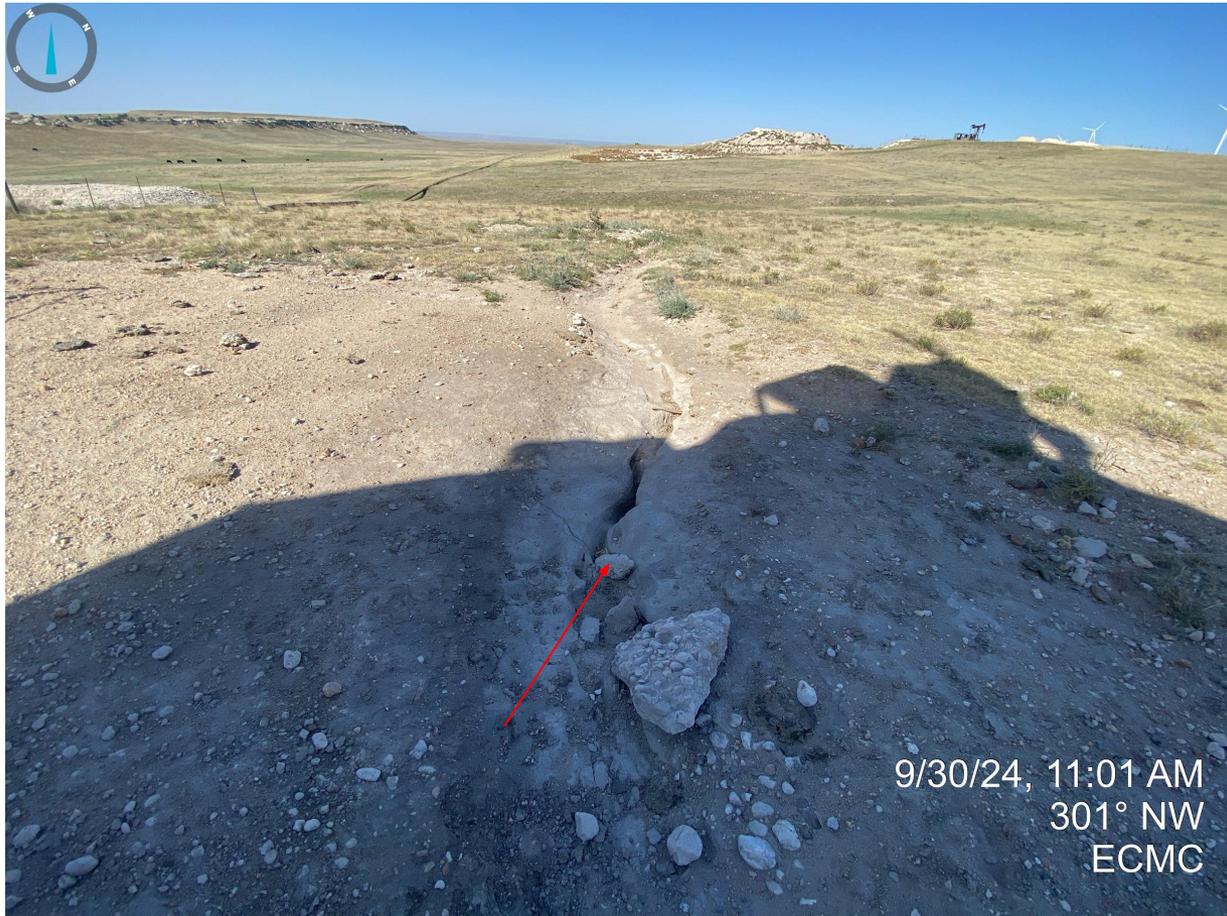
**Photo 11.** Erosion degradation observed on northside of meter shed.

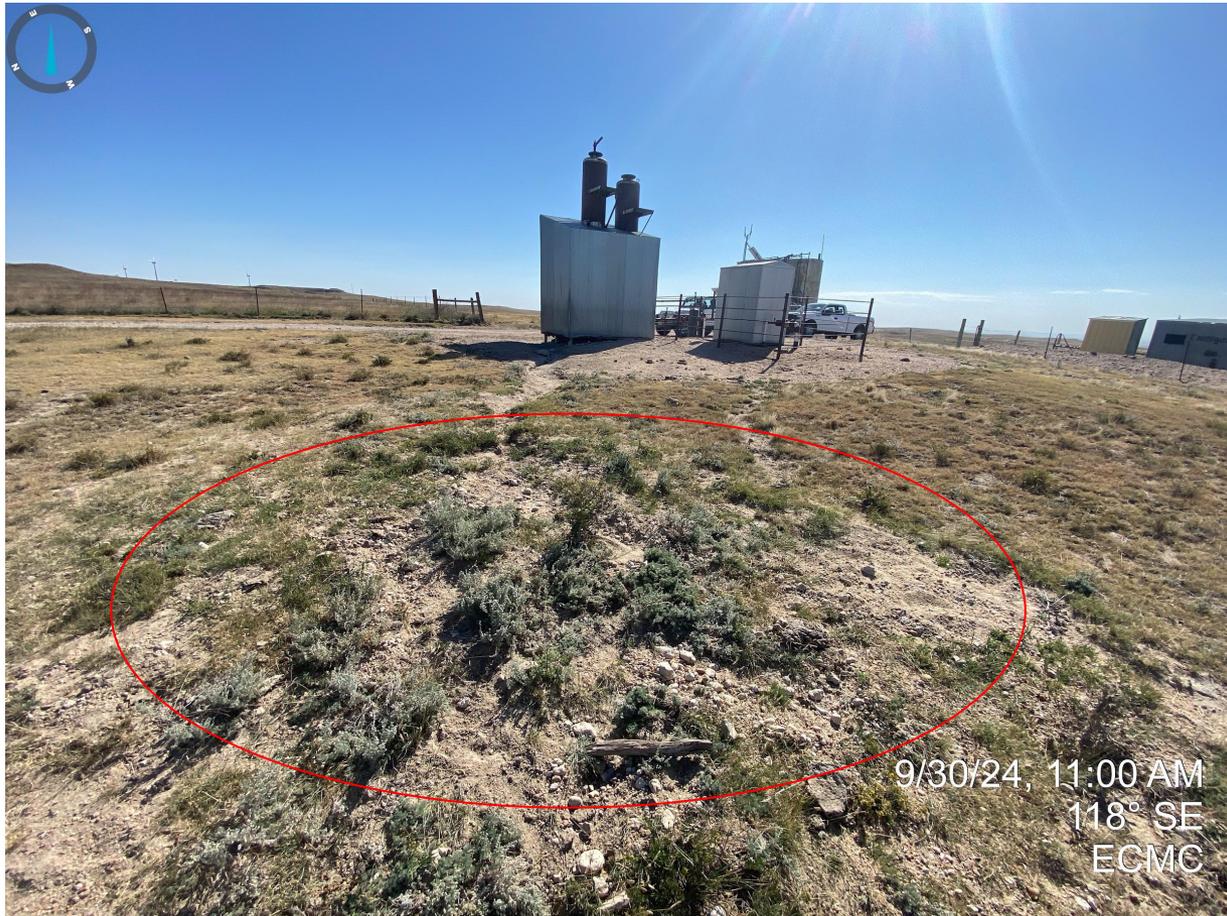
**Photo 13.** Continued from Photo 12; sediment deposition observed.

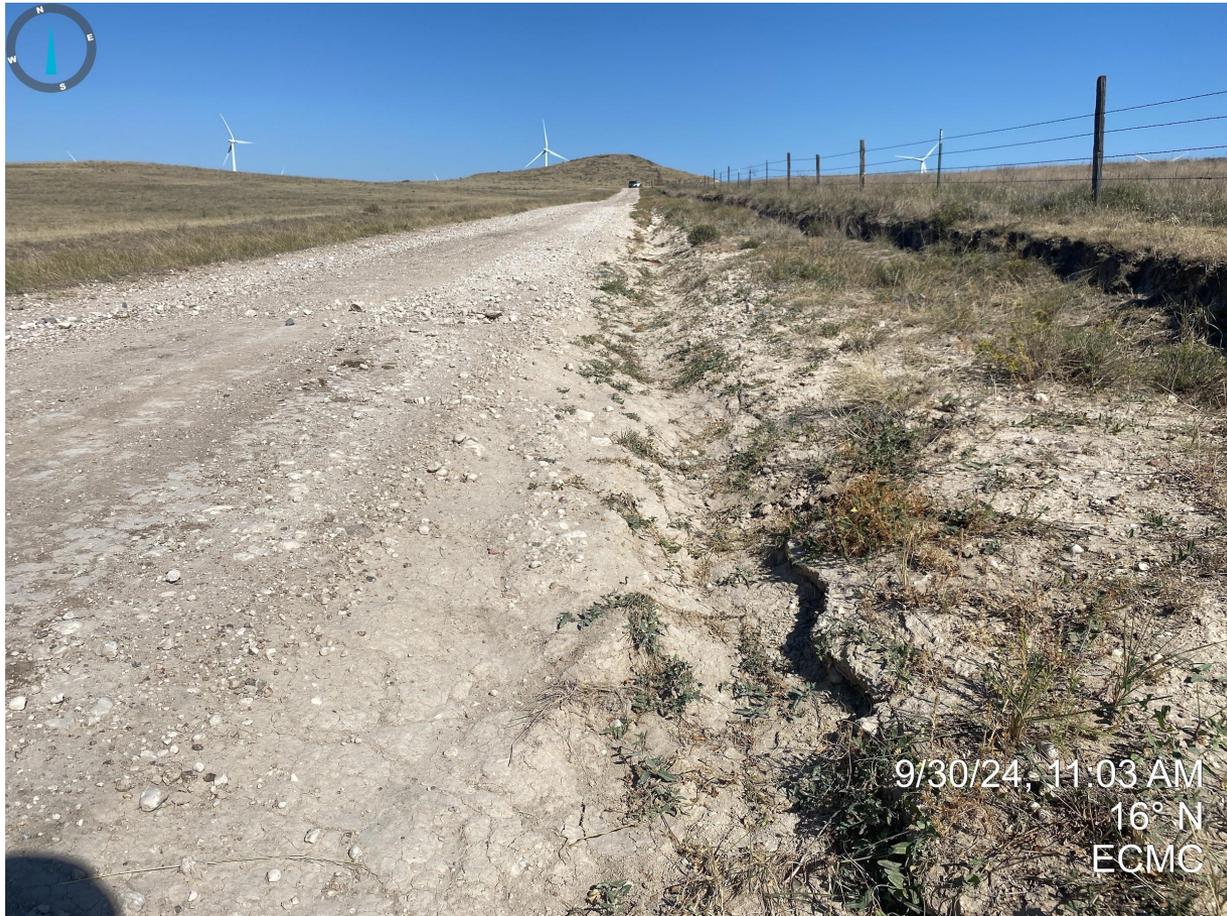
**Photo 14.** Erosion degradation observed along the access road, north of the production facilities.
