## Wellhead Closure Checklist 2

Additional Attachments (Optional)	Flowline Closure
Site Name	HSR-Lillevand 10-3
Remediation Project #	30124
<b>Wellhead Information</b>	
Weather	50, sunny
Client	Oxy
Location	
Latitude	40.25163
Longitude	-104.76168
General Condition of Site	Good
USCS Soil Type	<i>Sandy Loam / Sandy Loam</i>
Estimated Depth to Groundwater	<20'
Hydrocarbon Impacted Soils / Spills	None observed
Salt Crusted Soils or Impacted Vegetation	None observed

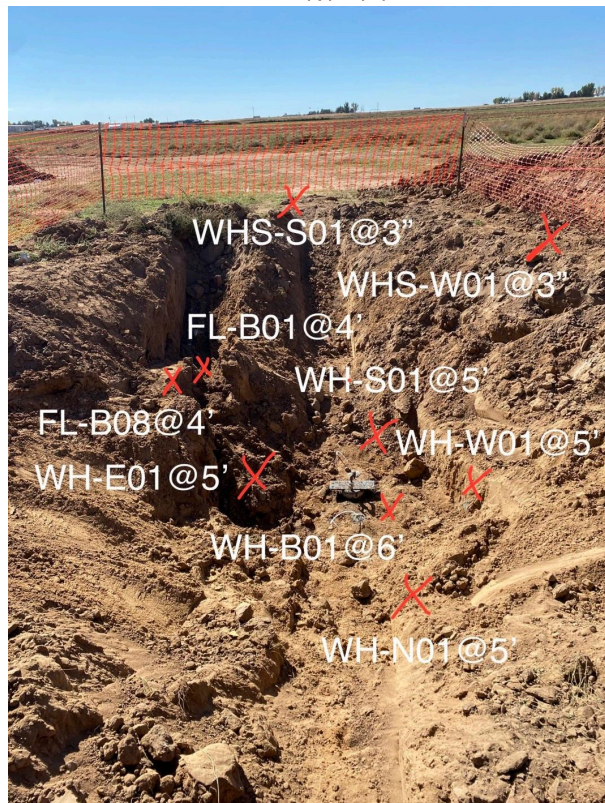
R1 - P1

Looking south

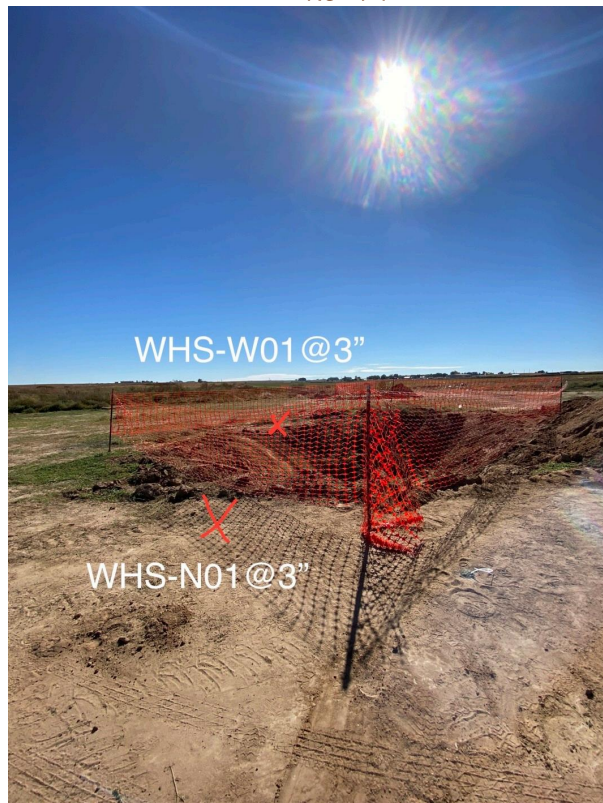
R6 - P1

Looking west

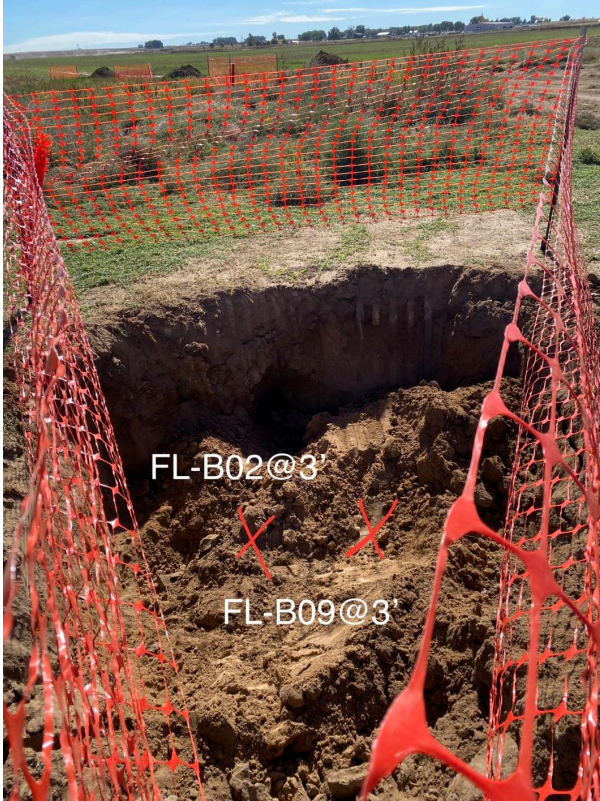
R11 - P1

Looking east

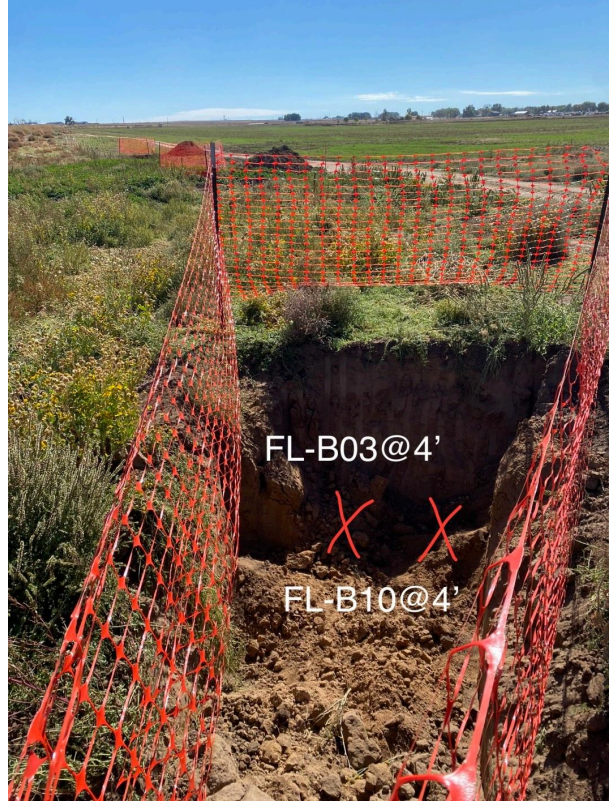
R12 - P1

Looking east

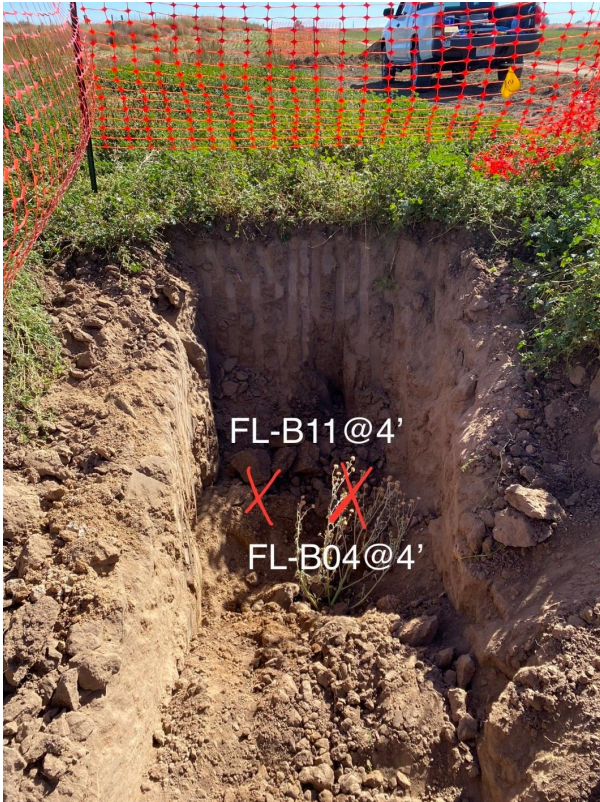
R13 - P1

Looking east

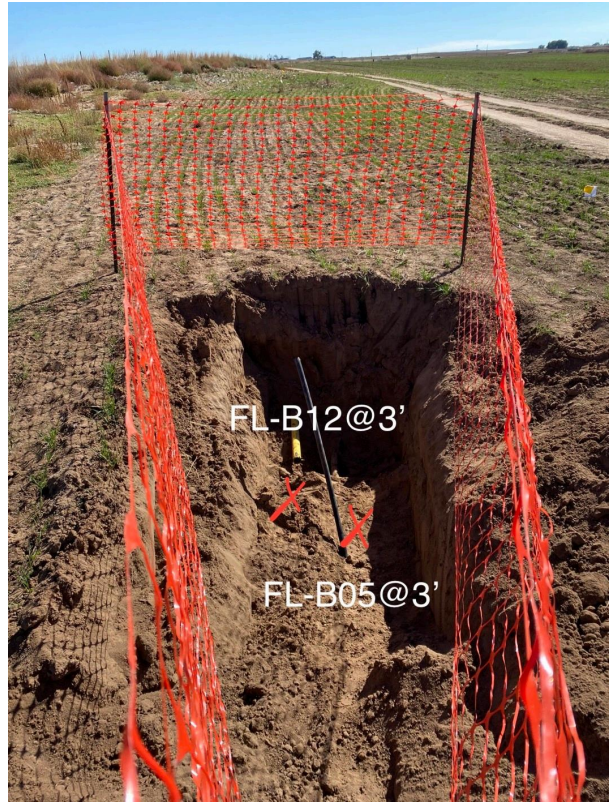
R14 - P1

Looking east

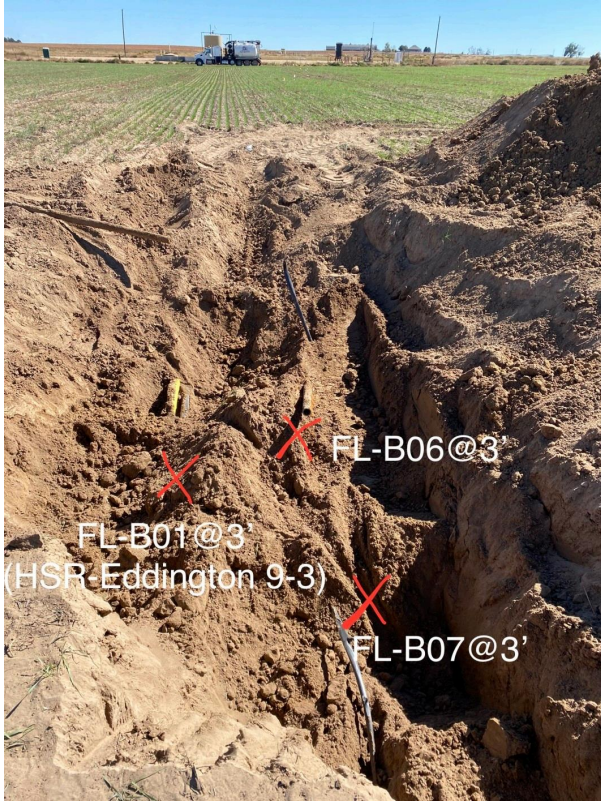
R15 - P1

Looking east

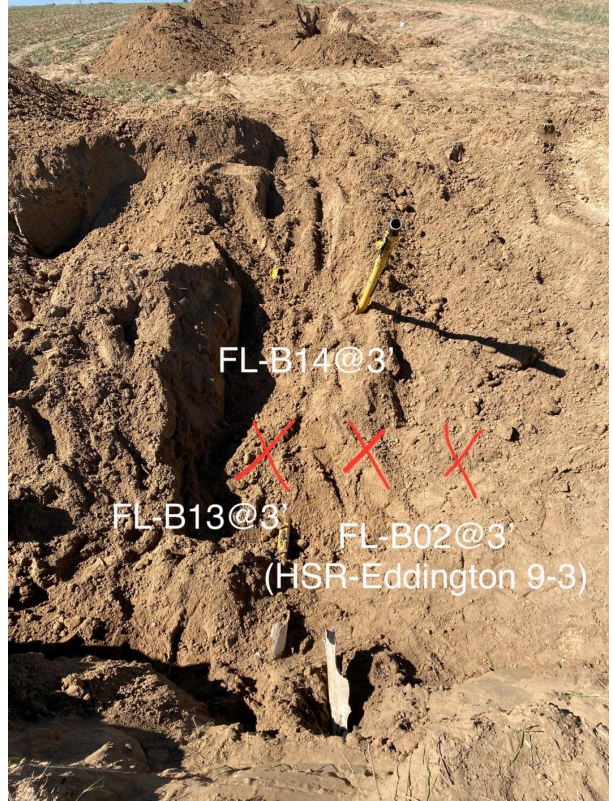
R17 - P1

Looking west

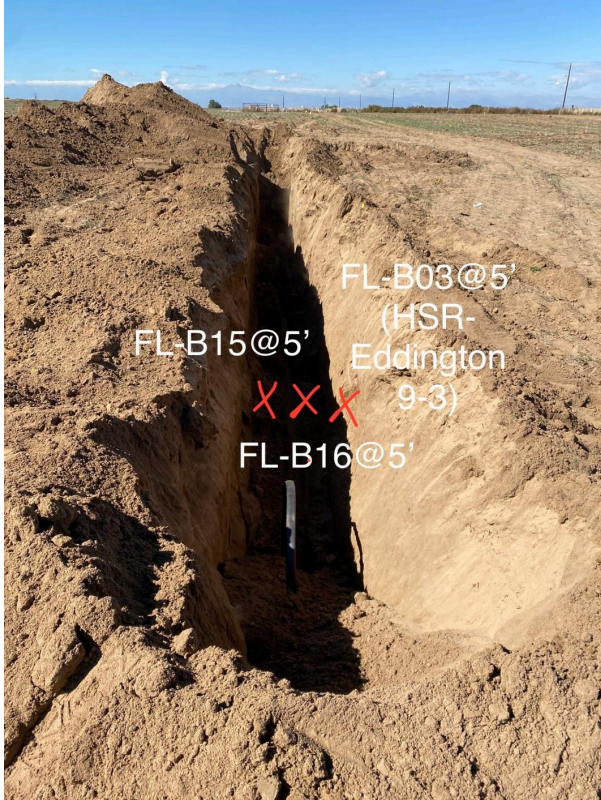
R19 - P1

Looking west

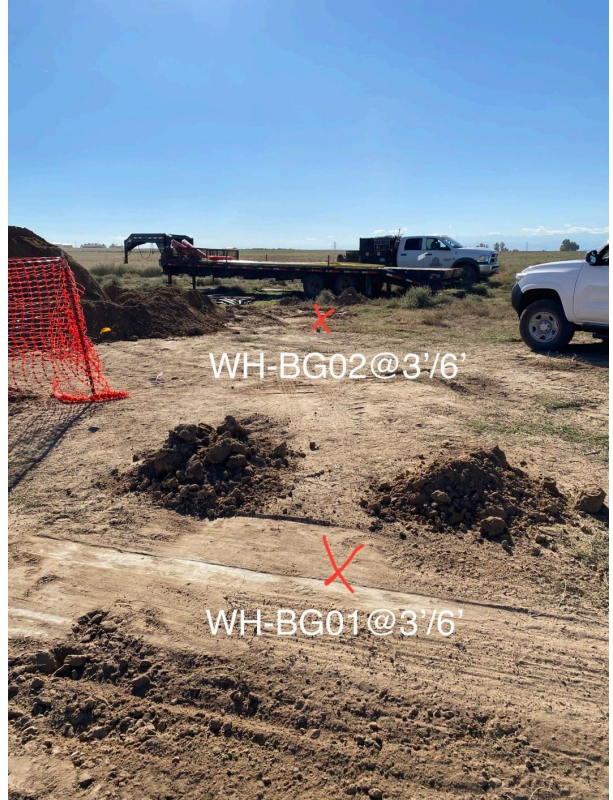
R26 - P1

Looking south

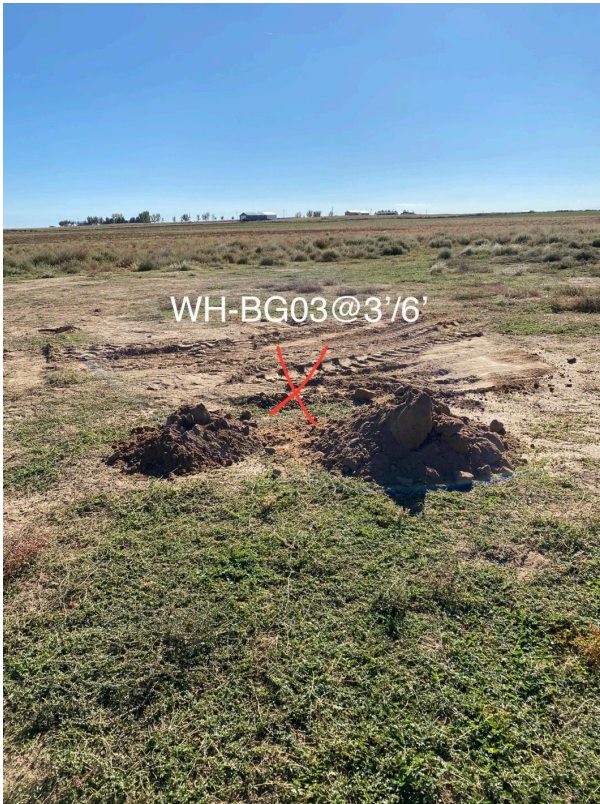
R29 - P1

Looking south

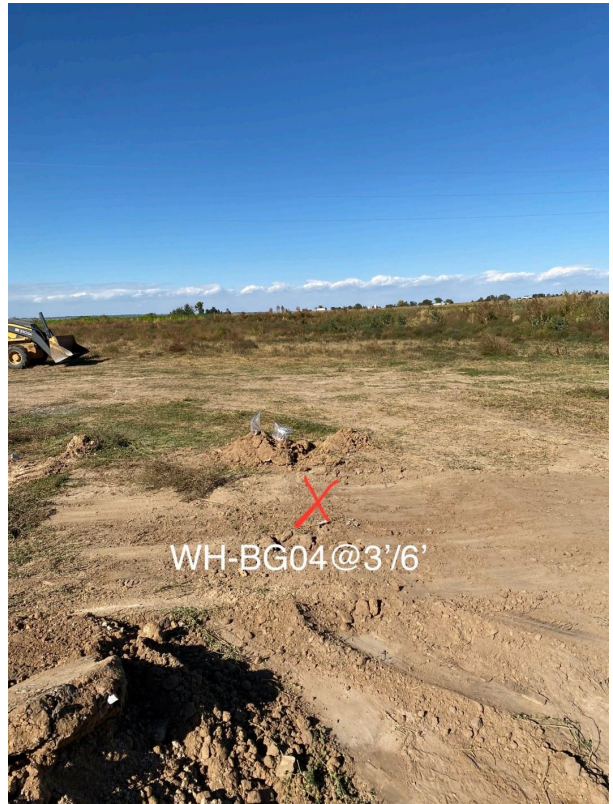
R31 - P1

Looking north

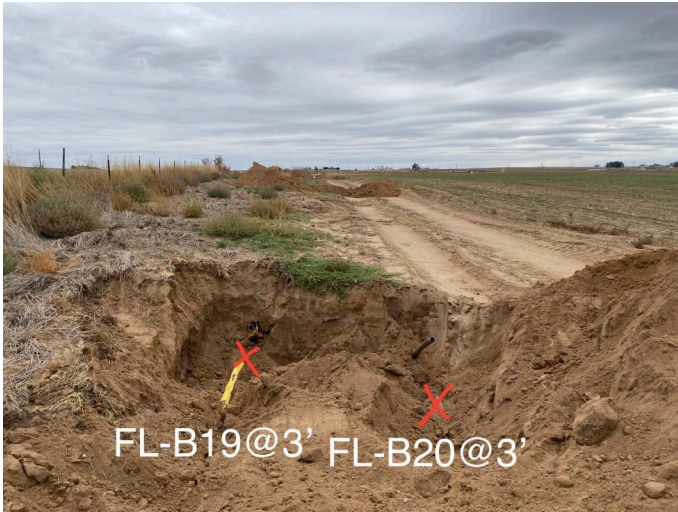
R36 - P1

Looking east

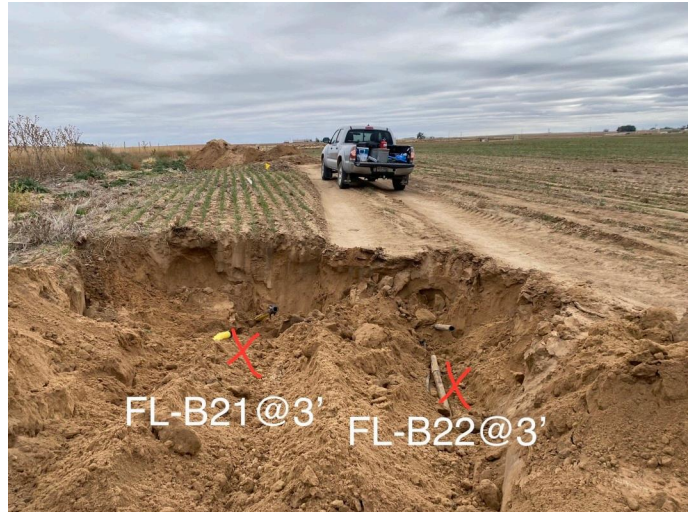
R38 - P1

Looking east

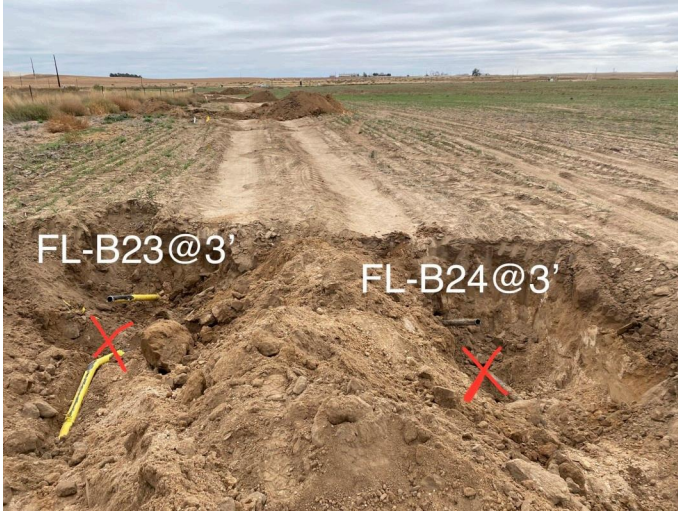
R40 - P1

Looking east

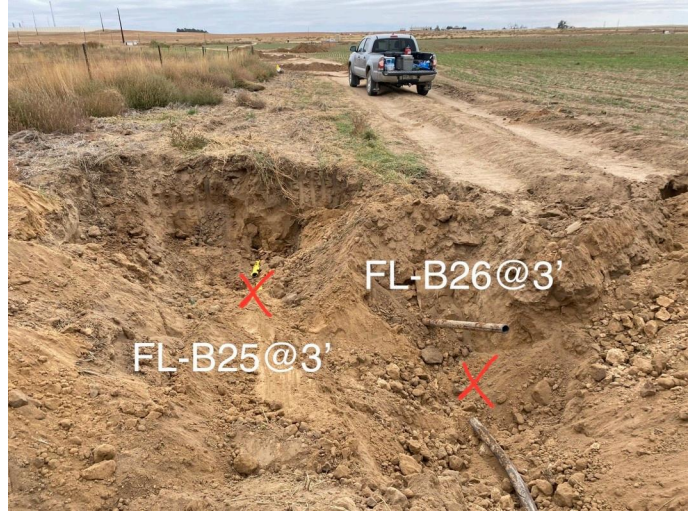
R42 - P1

Looking east

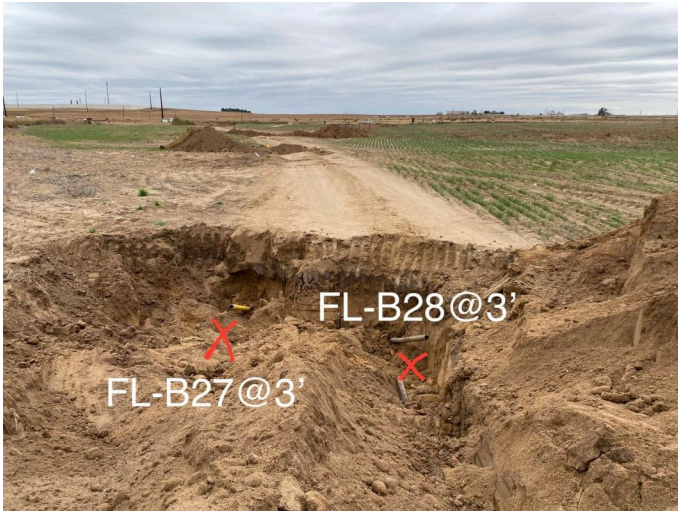
R44 - P1

Looking east

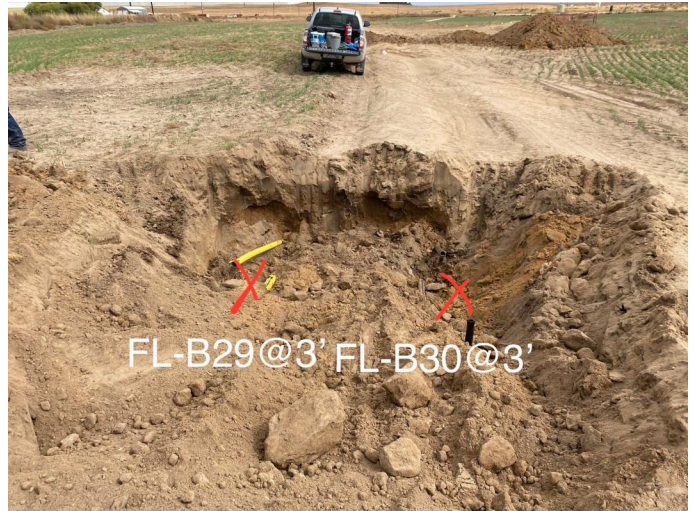
R46 - P1

Looking east

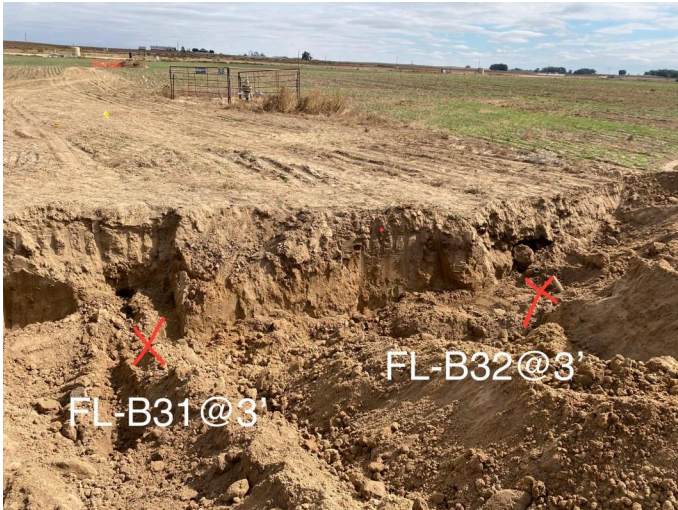
R48 - P1

Looking east

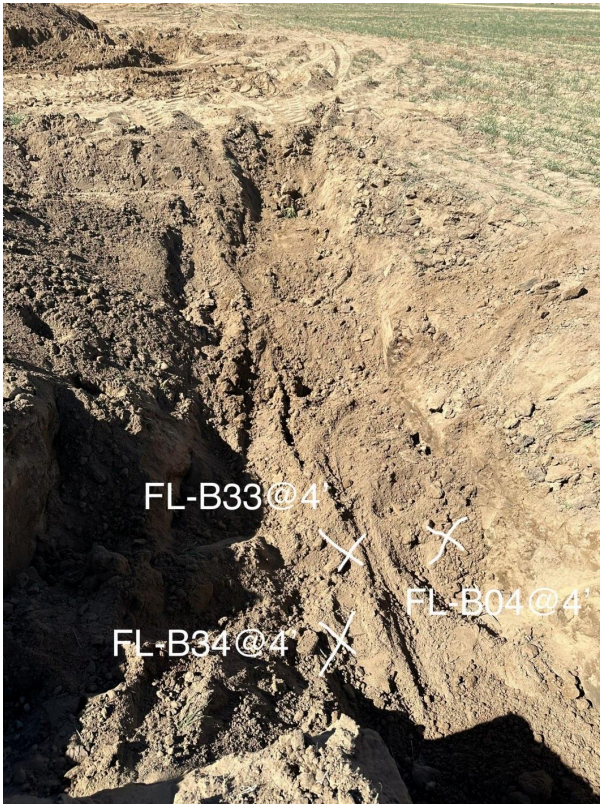
R49 - P1

Facing West

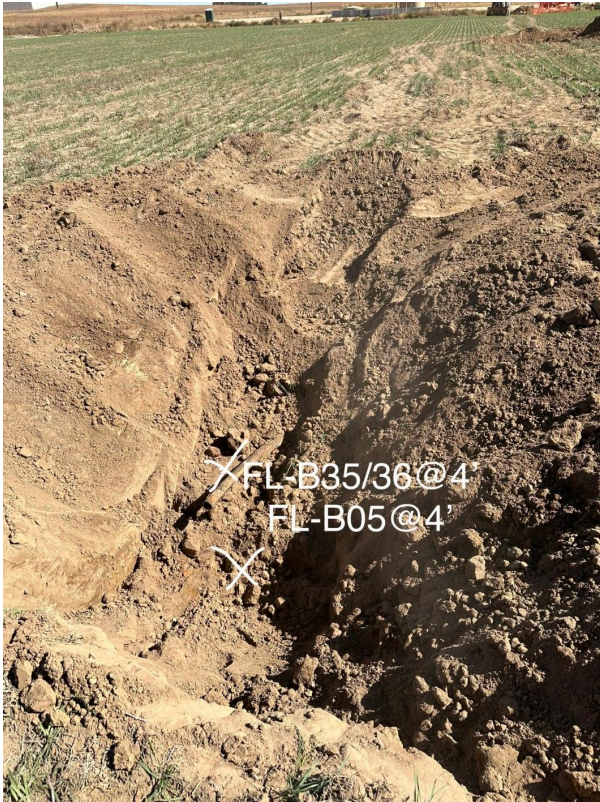
R51 - P1

Facing East

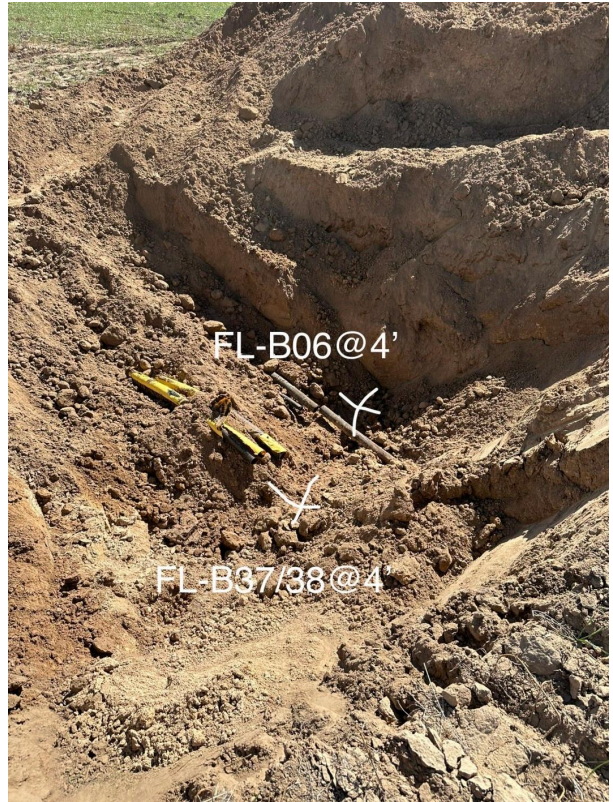
R53 - P1

Facing East

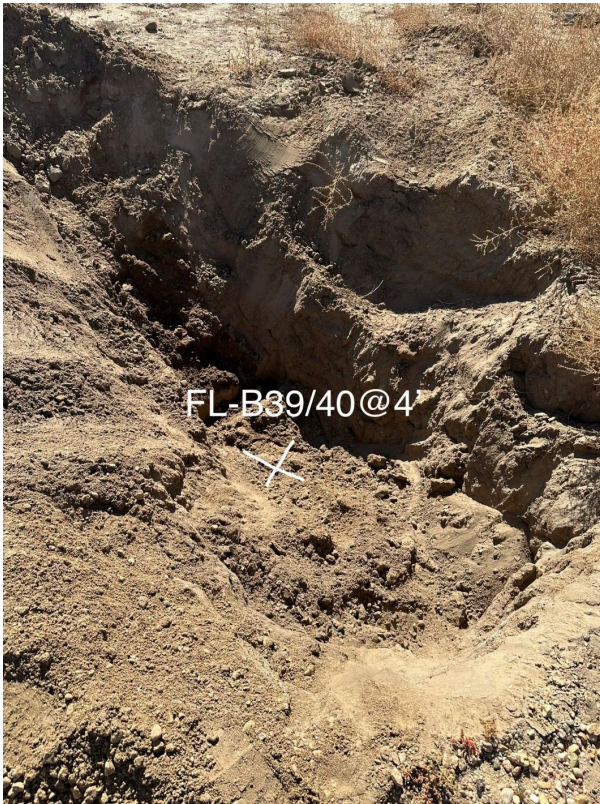
R55 - P1

Facing East

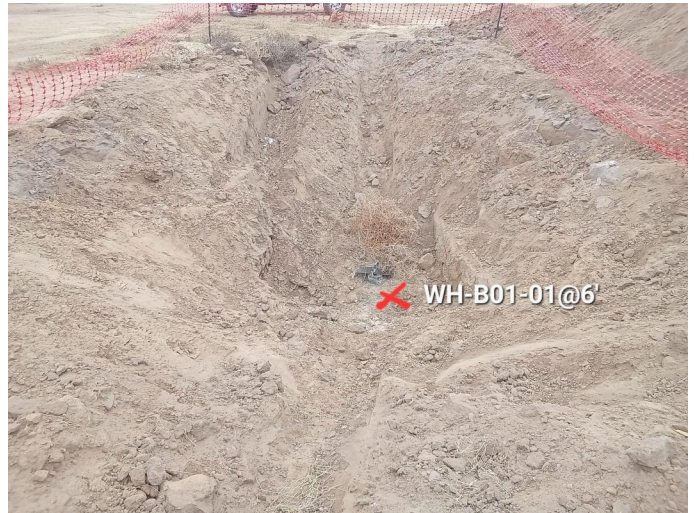
R57 - P1

Looking south

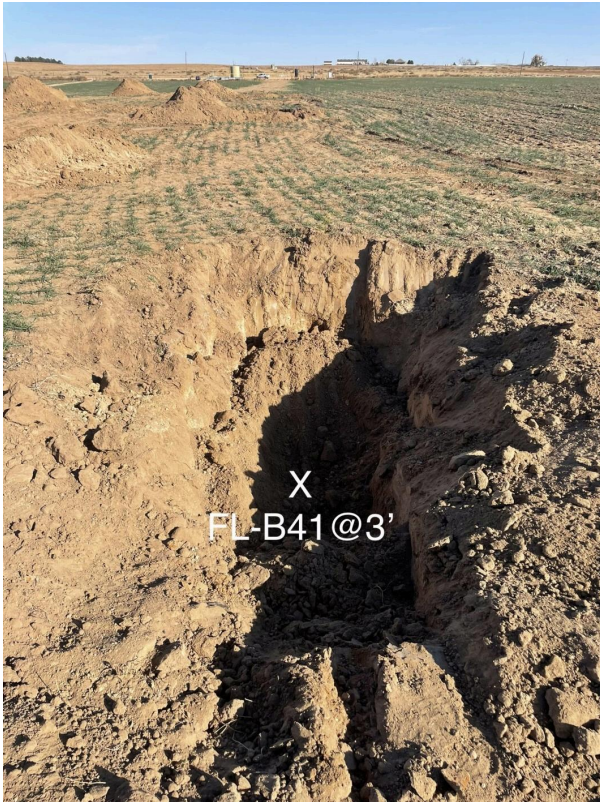
R58 - P1

Facing East

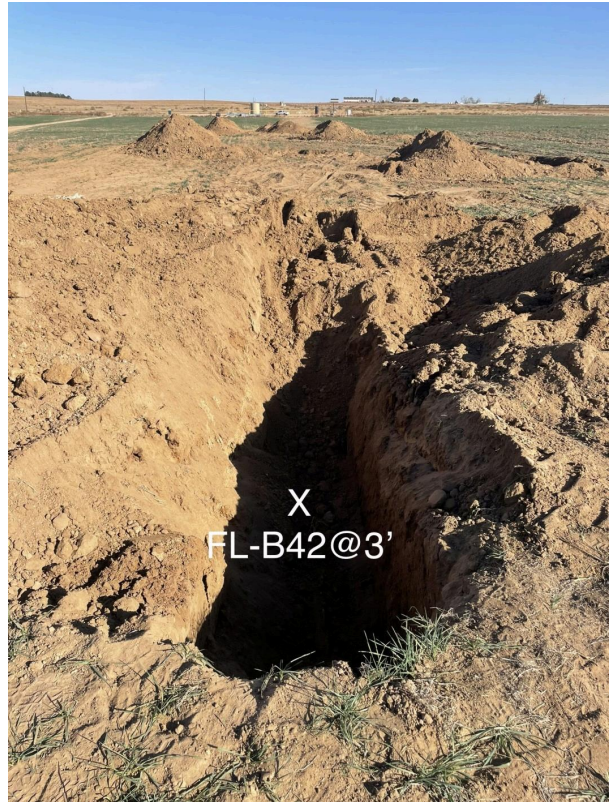
R59 - P1

Facing East

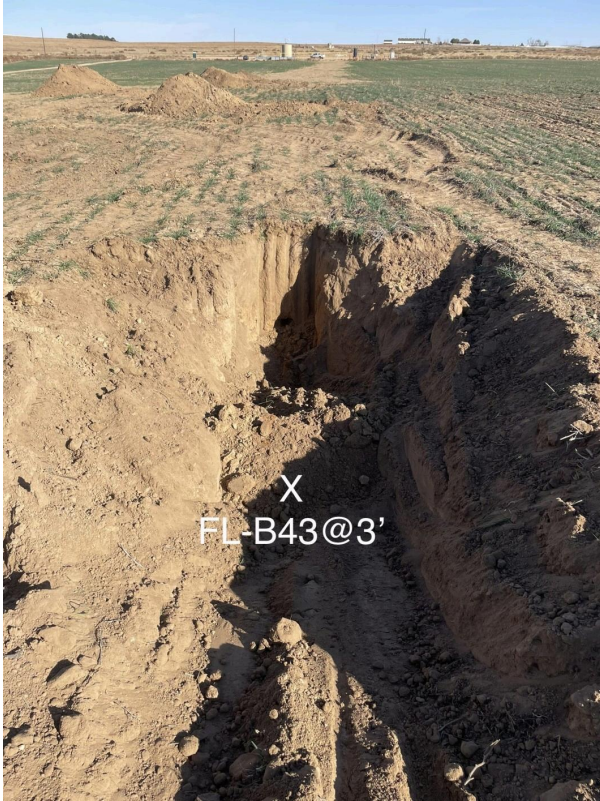
R60 - P1

Facing East

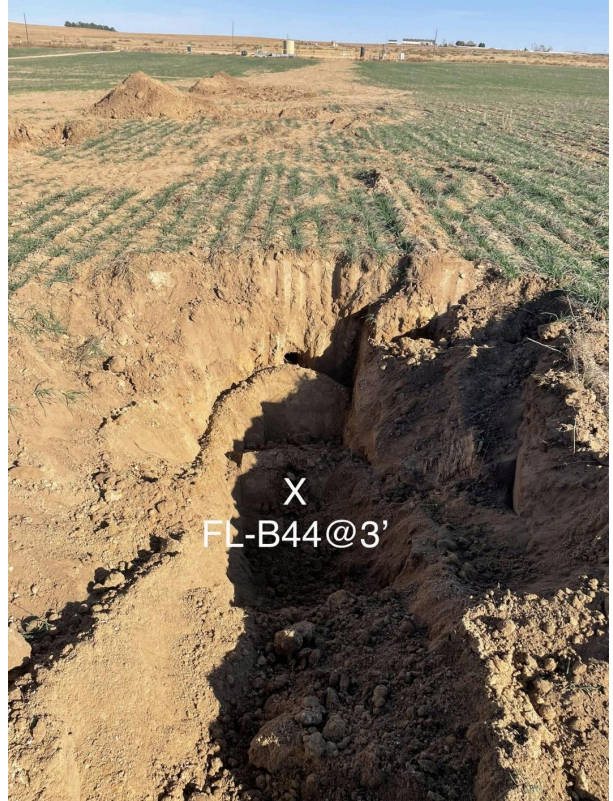
R61 - P1

Facing East

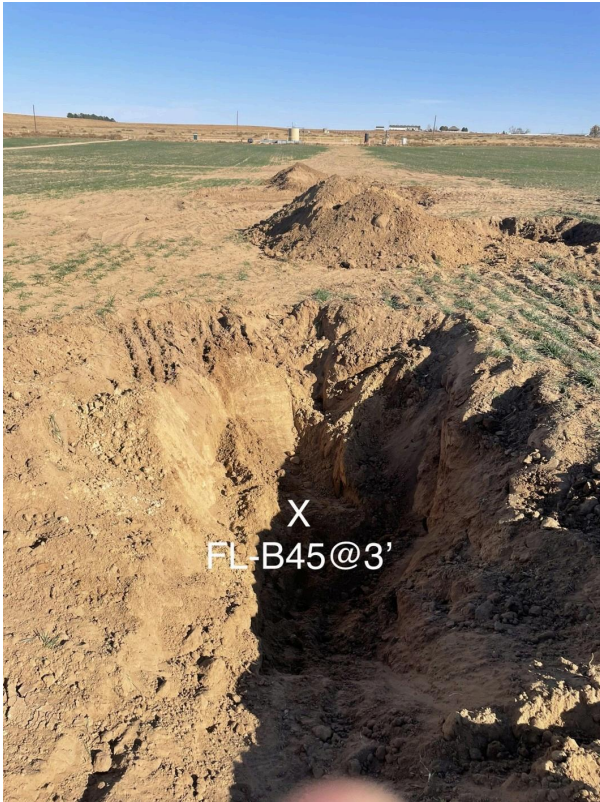
R62 - P1

Facing East

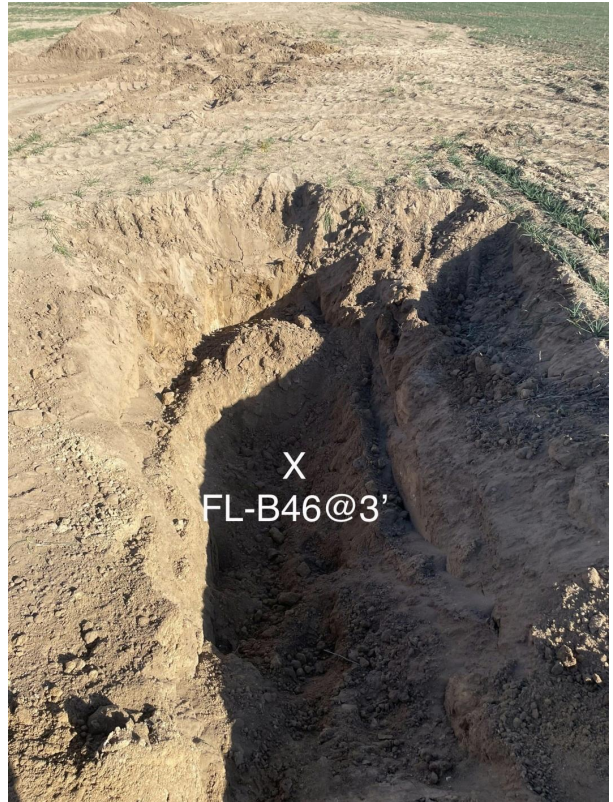
R63 - P1

Facing East

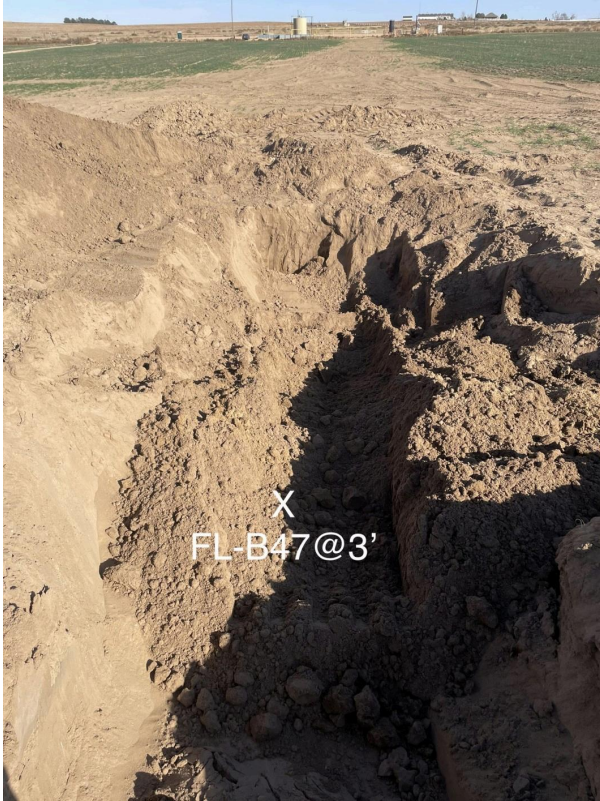
R64 - P1

Facing East

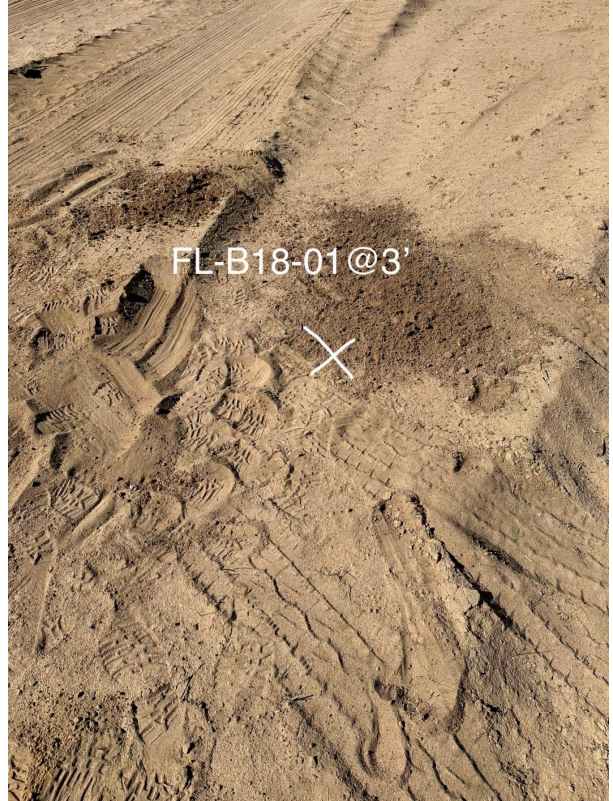
R66 - P1

Facing west

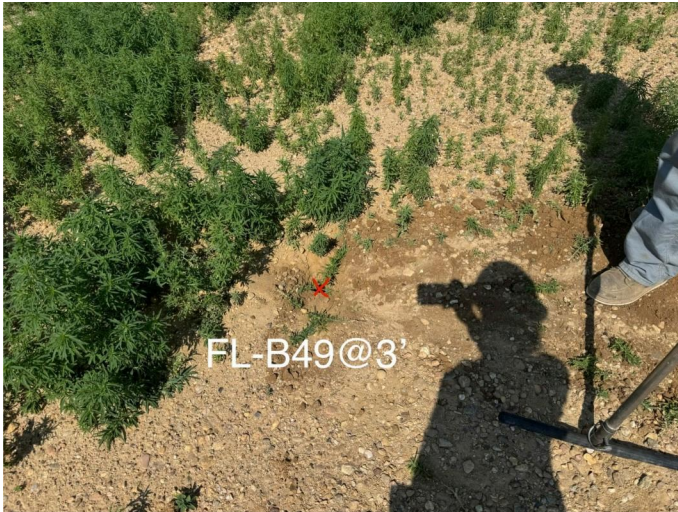
R67 - P1

facing west

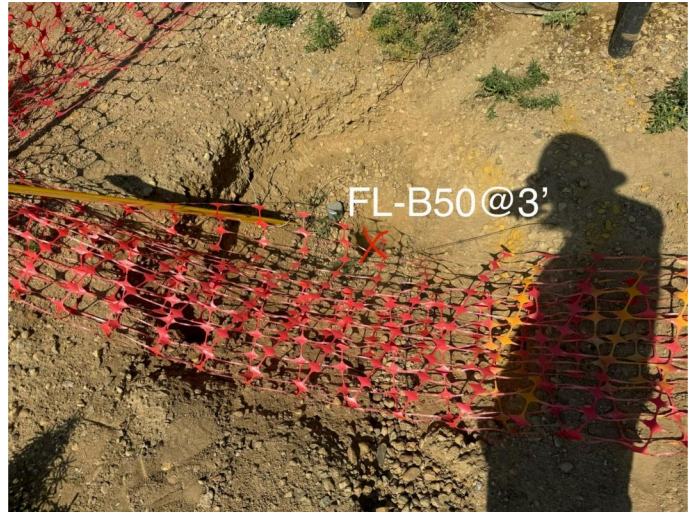
R68 - P1

facing west

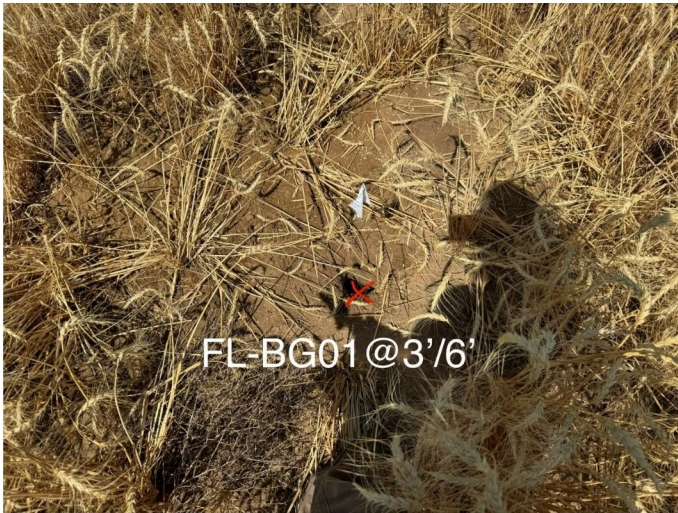
R69 - P1

facing west

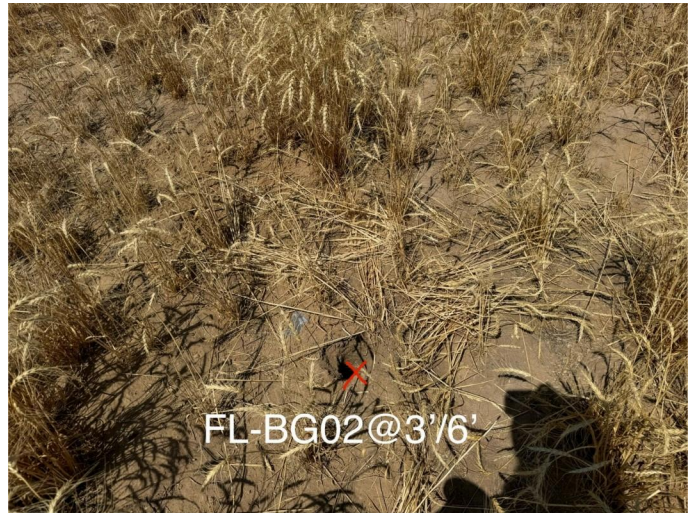
R71 - P1

facing west

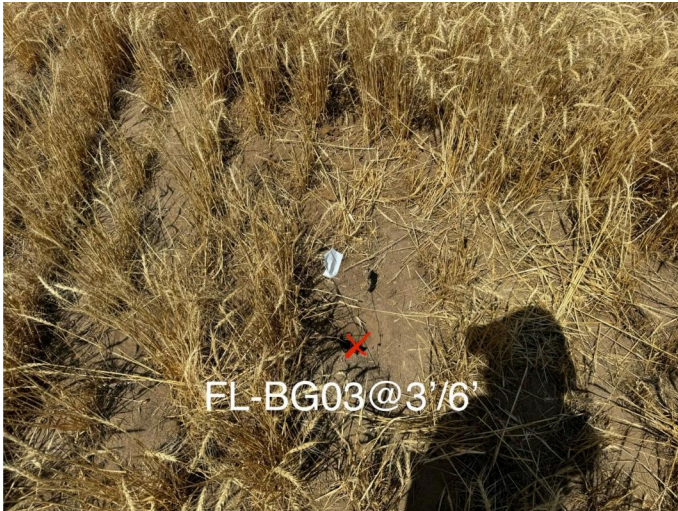
R73 - P1

facing west

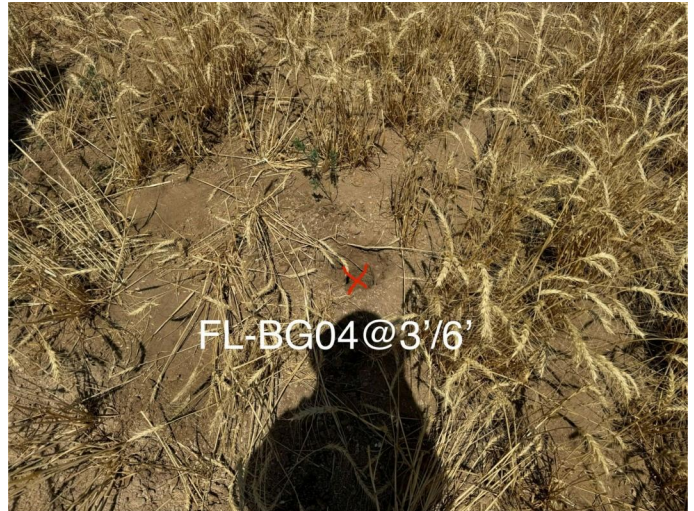
R75 - P1

facing west

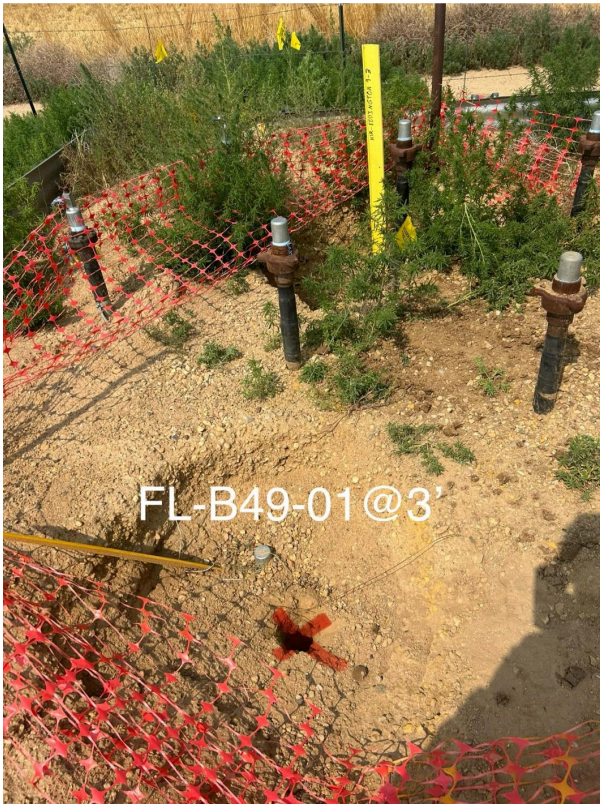
R77 - P1

FL-B49-01 @3'

Facing west
