Site Specific Final Reclamation Completion Notice – Cropland Drone Imagery

Permit Closure Report – Cropland

Location ID: 322962

Location Name: DR-65N64W/10SWSW

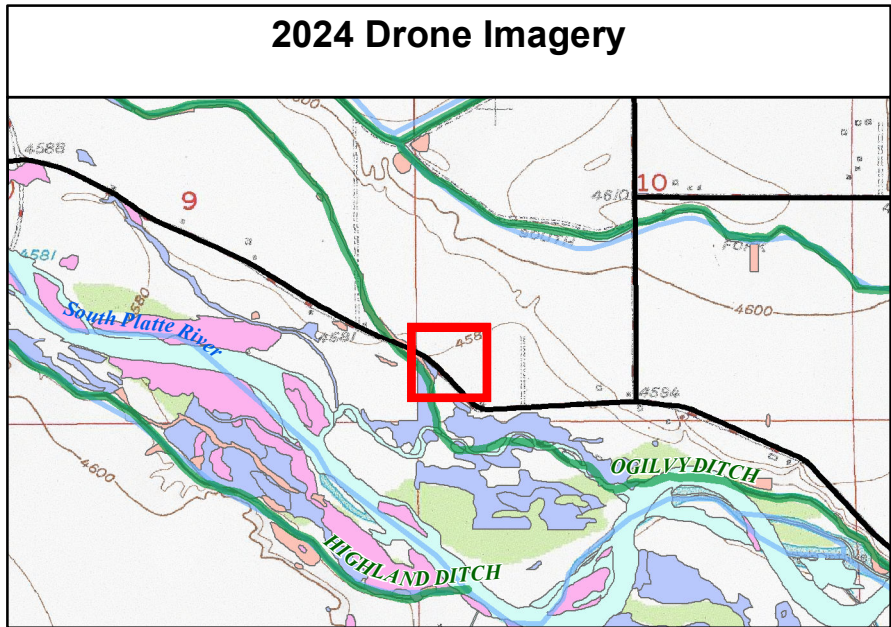
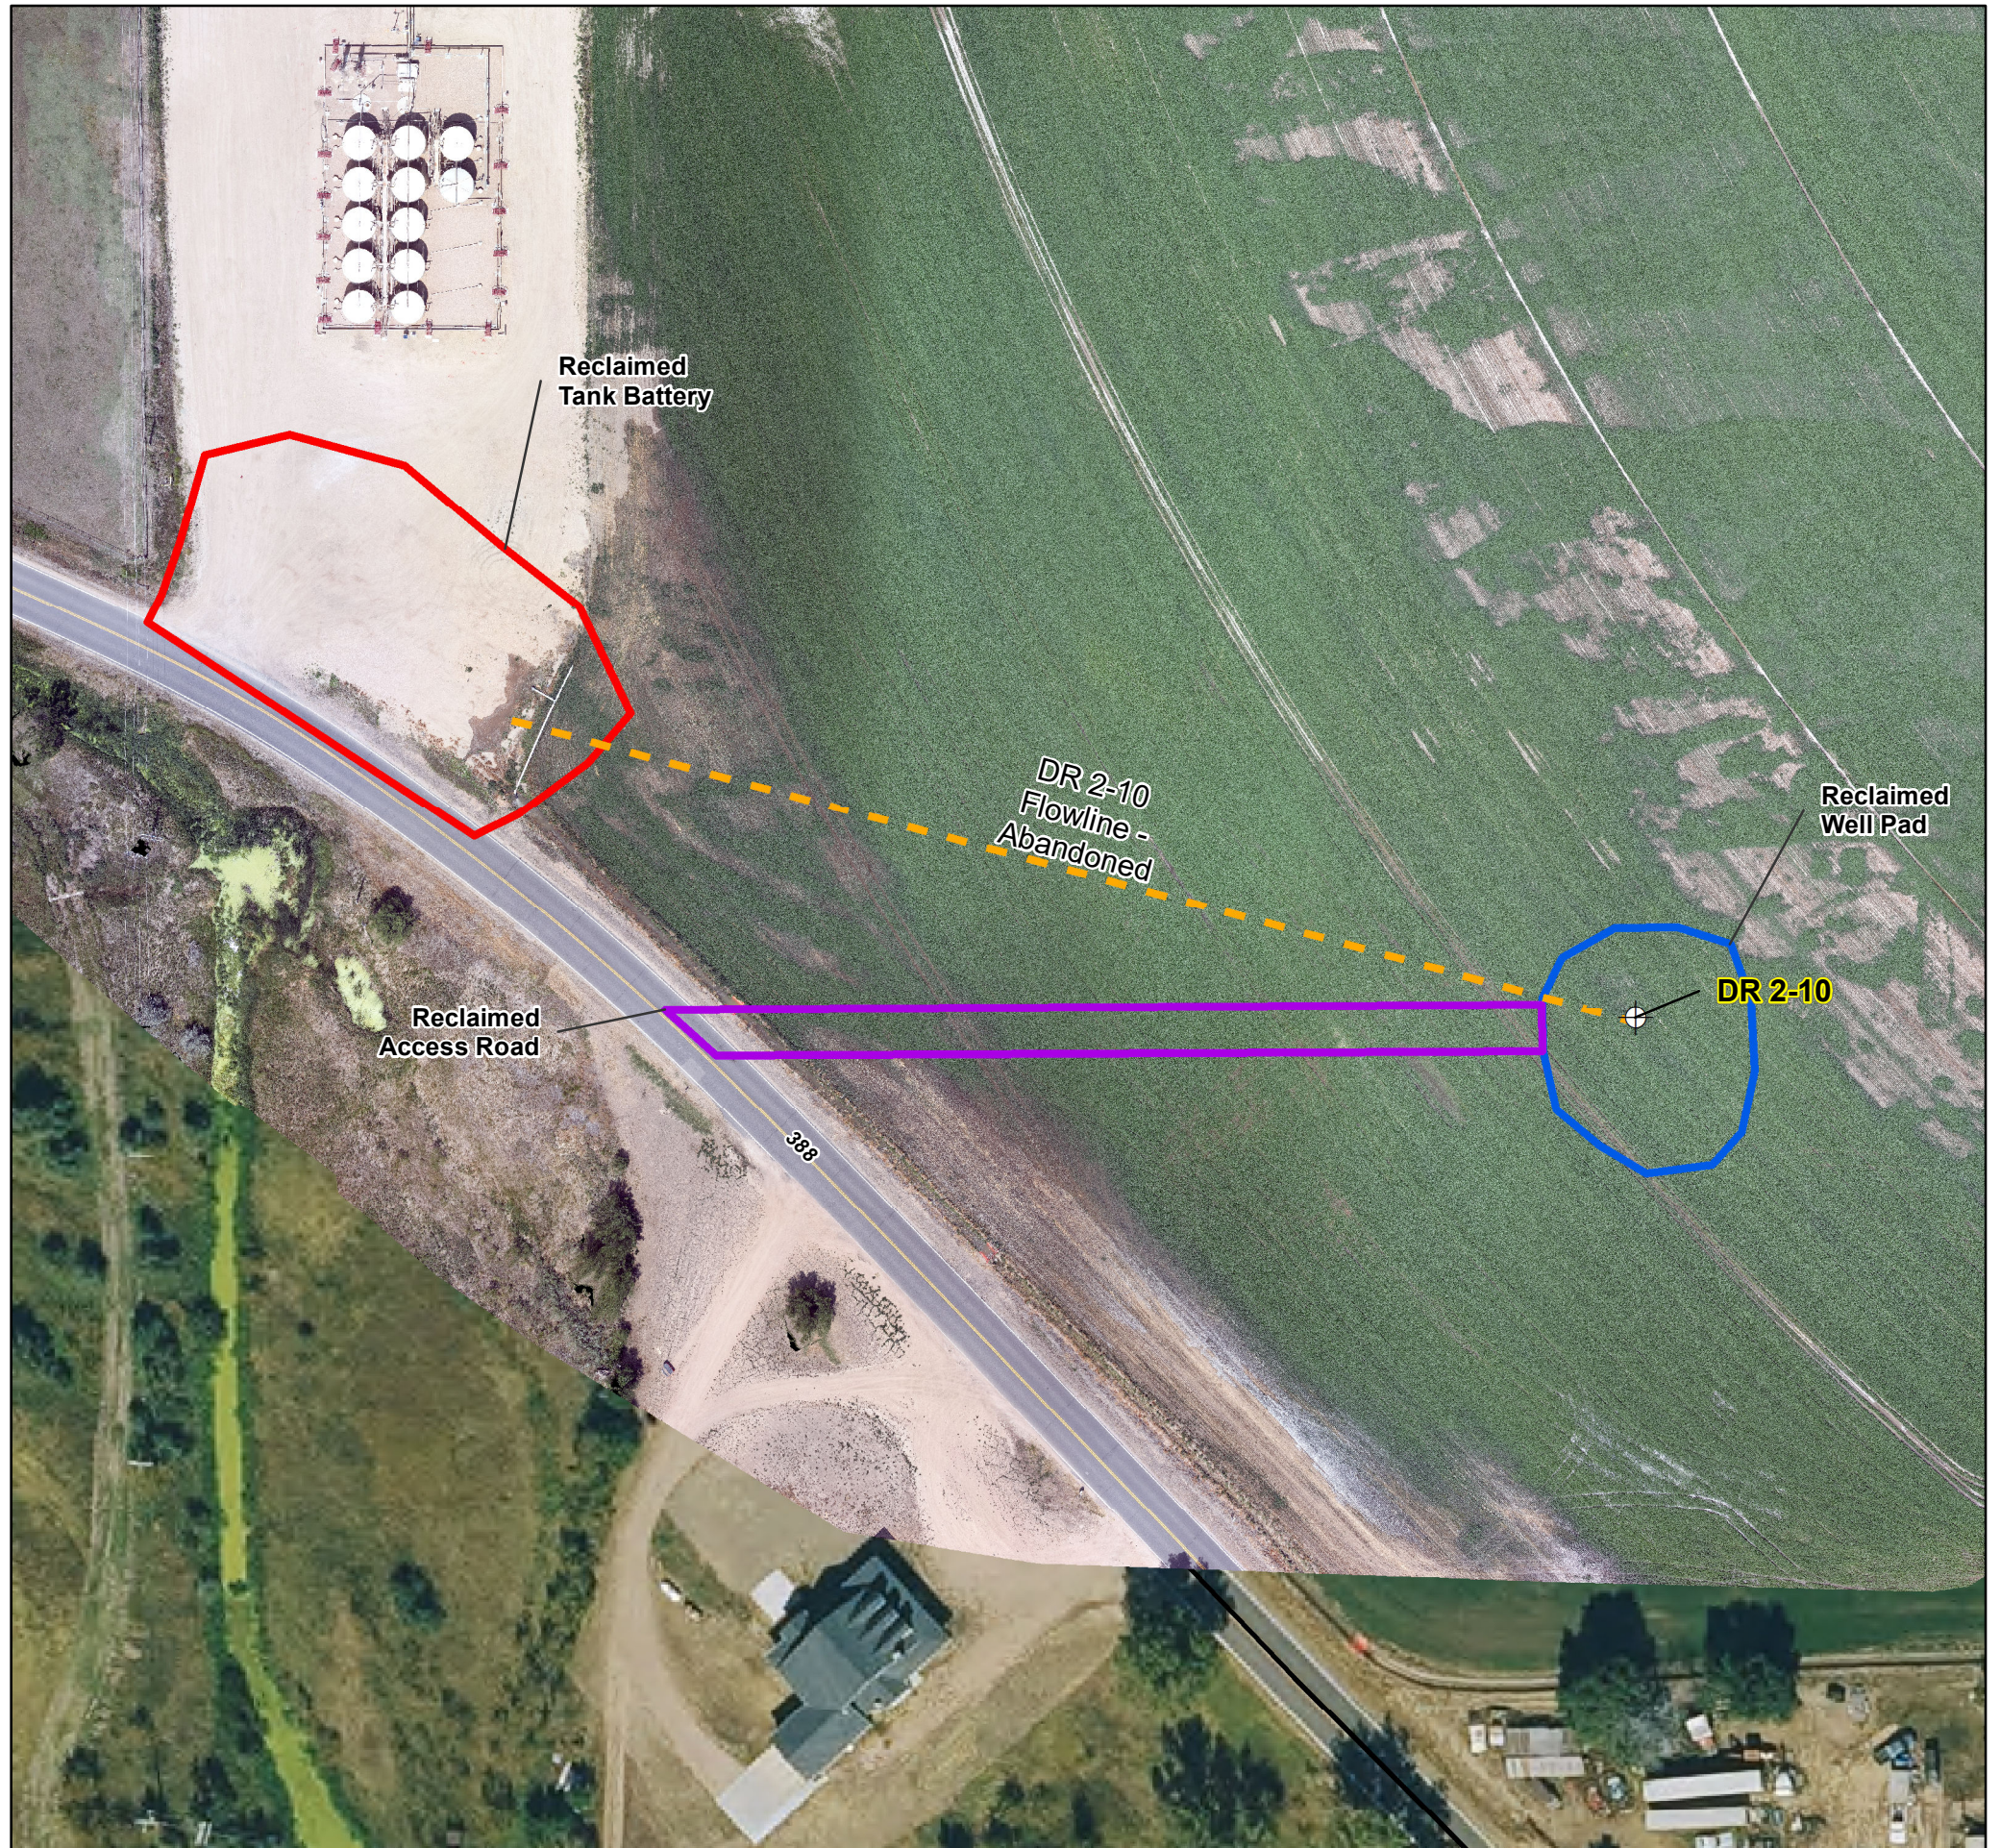
PDC Form 4 Final Reclamation - Post Plugging Overview

Drone imagery confirms that no equipment was left on site at this location after reclamation activities occurred.
