Inspection Photos

Operator: TEP ROCKY MOUNTAIN LLC #96850

Location ID: 335426

Inspection Doc: 696206363

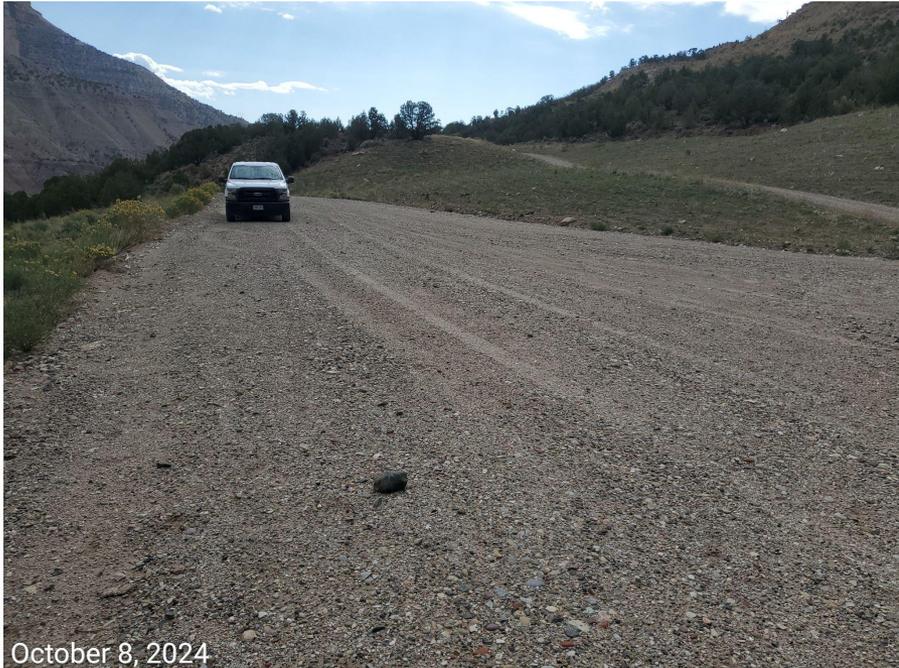
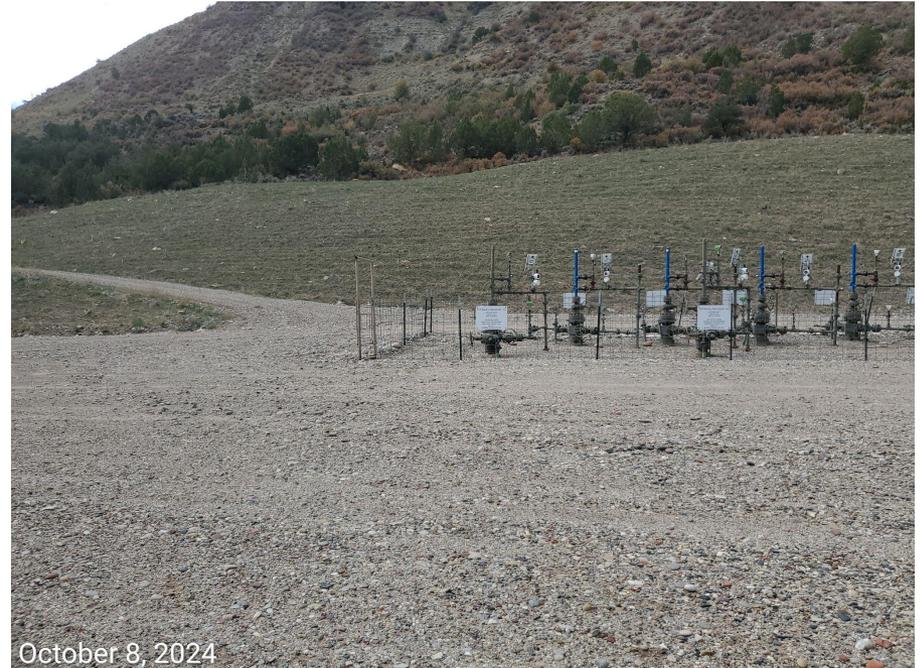
Photo 1: Photos 1-2 taken from the north end of the Location. Photos provide an overview from east, southeast, southwest to west.

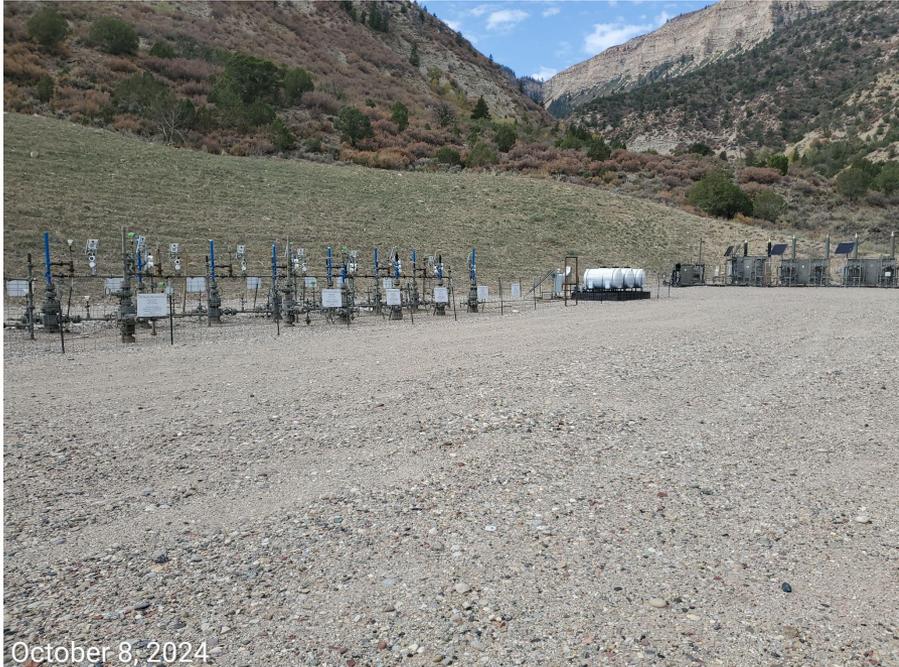
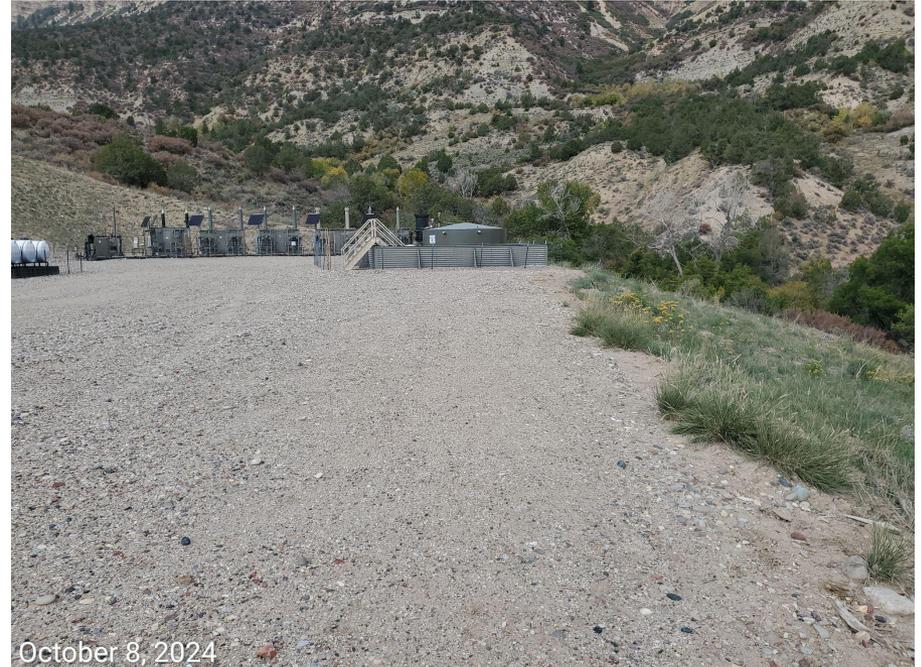
Photo 2: See comments under photo 1.

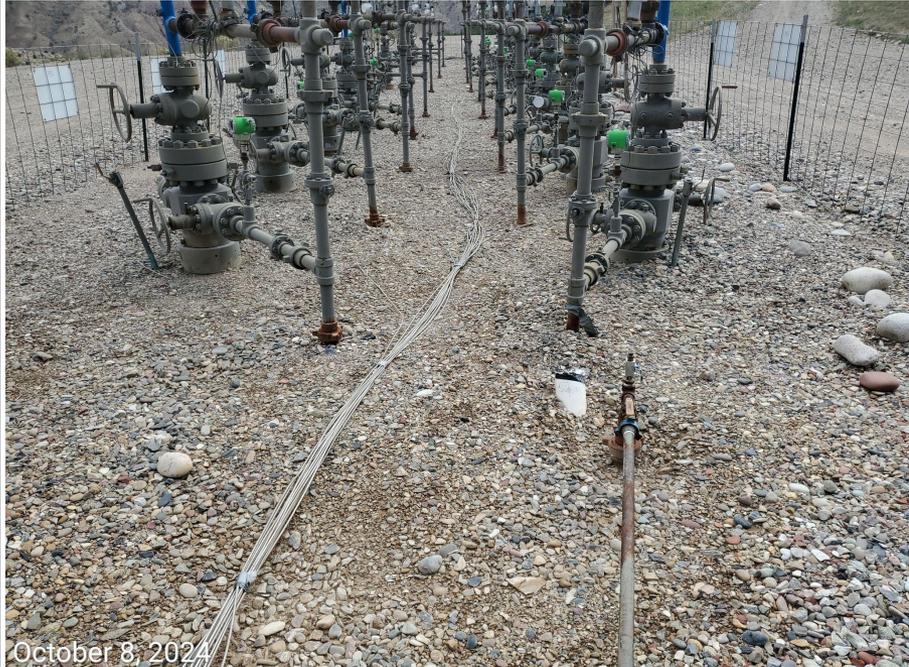
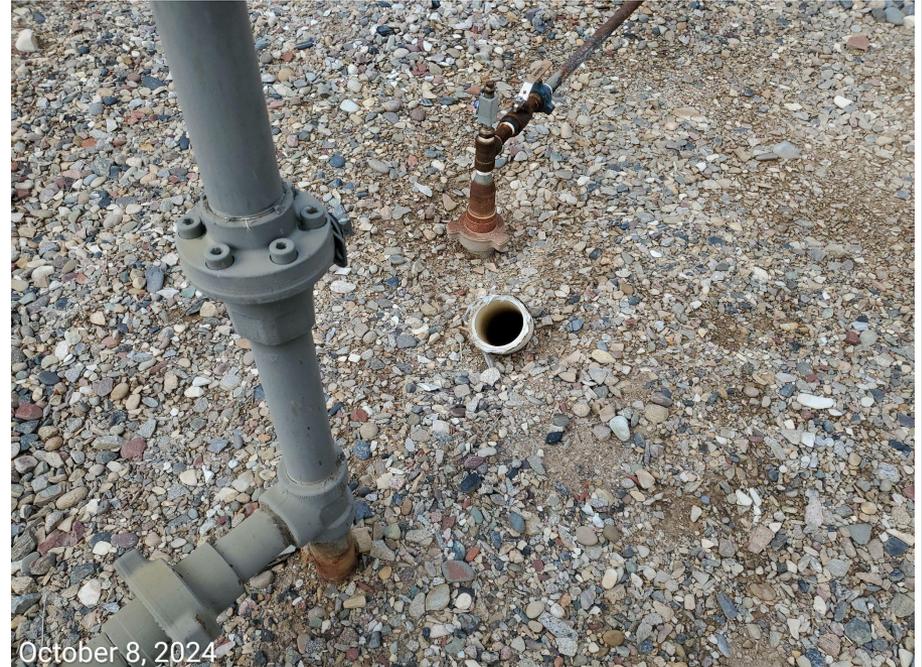
Photo 3: PVC pipe at wells open at end. Pipe requires covering to prevent wildlife access.

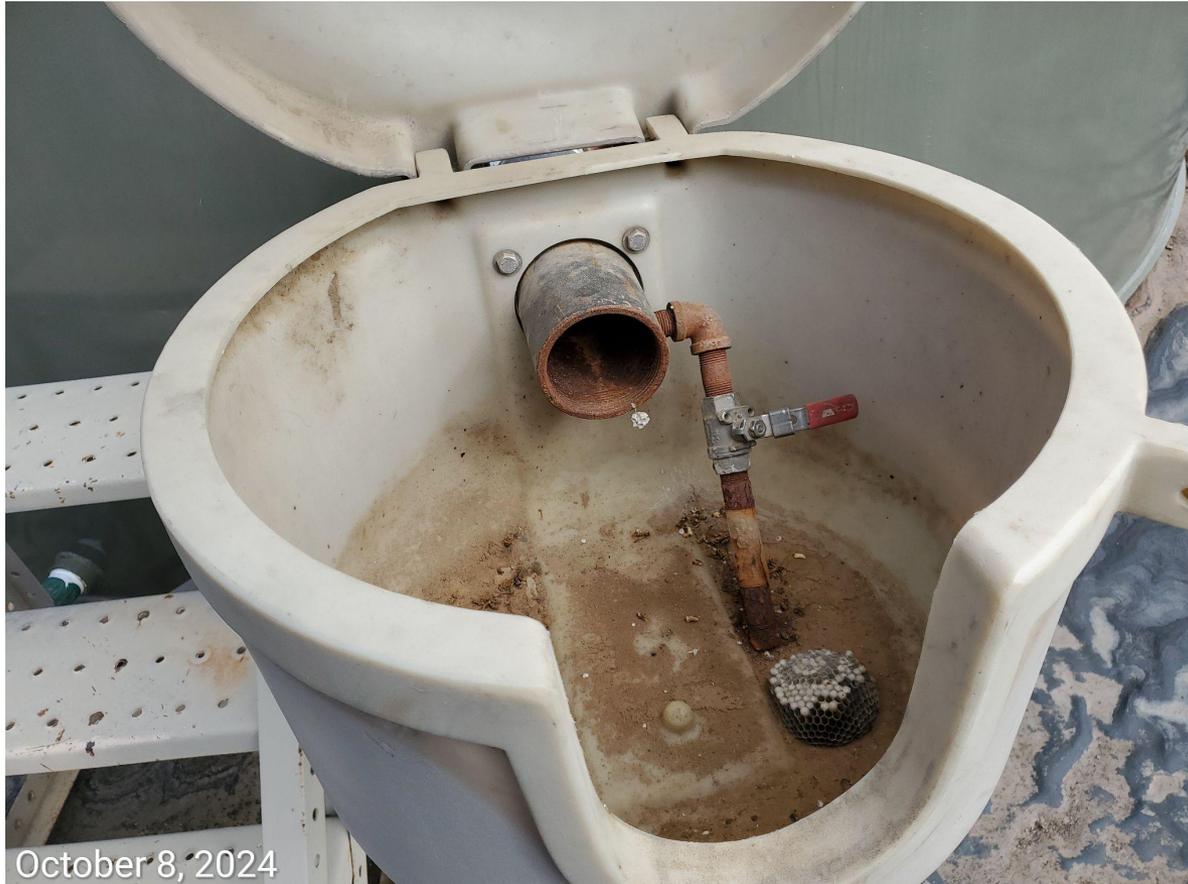
Photo 4: Line at tank missing cap/plug.

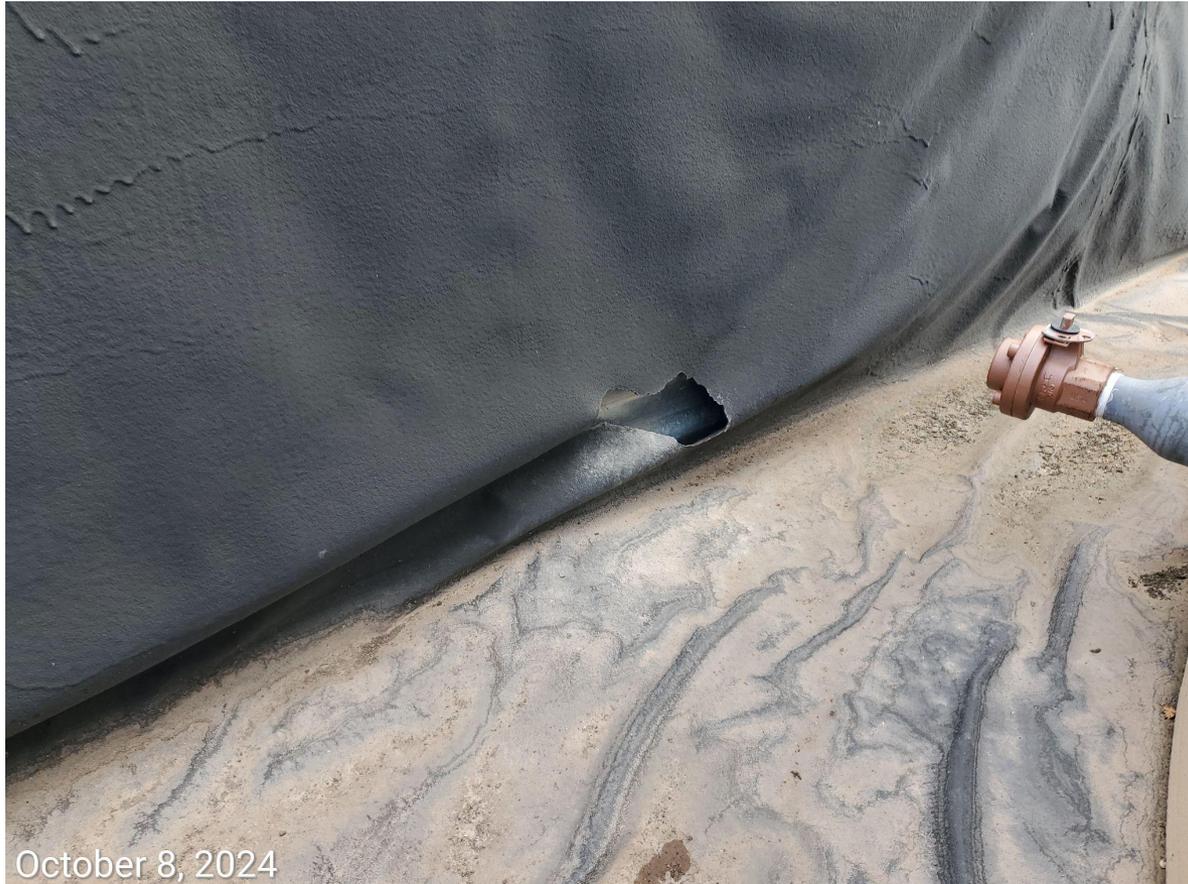
Photo 5: Photo taken from the tank battery facility's secondary containment BMP- BMP no longer sufficiently impervious to contain a spill or release.

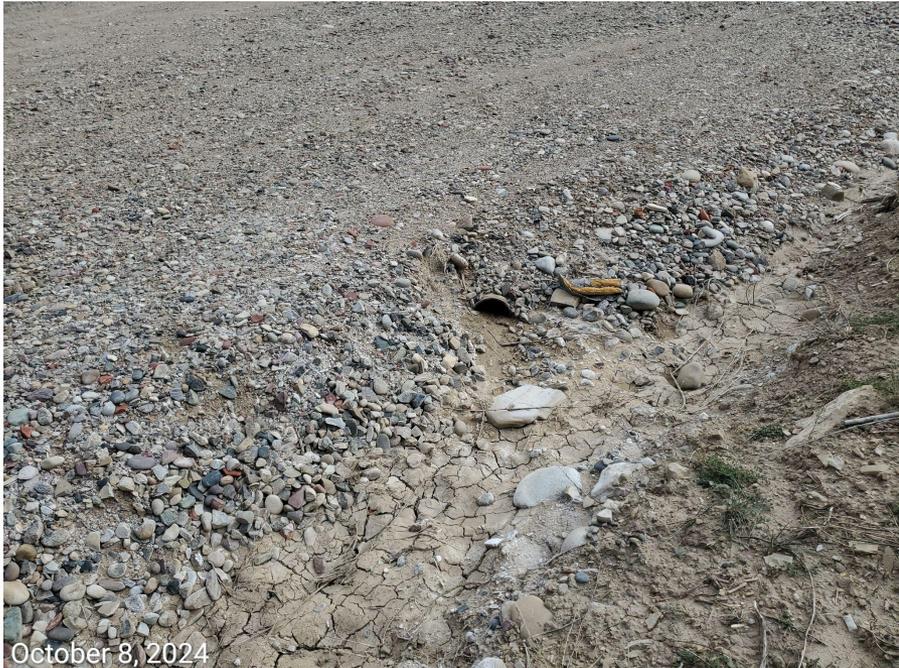
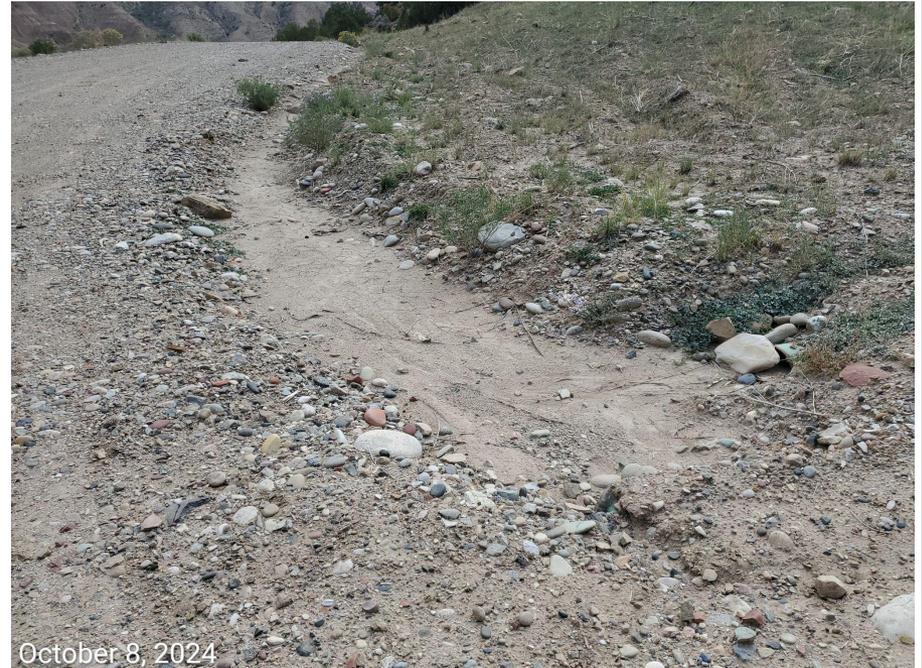
Photo 6: Culverts on the Location are filling with sediment. Maintenance advised prior to failure.

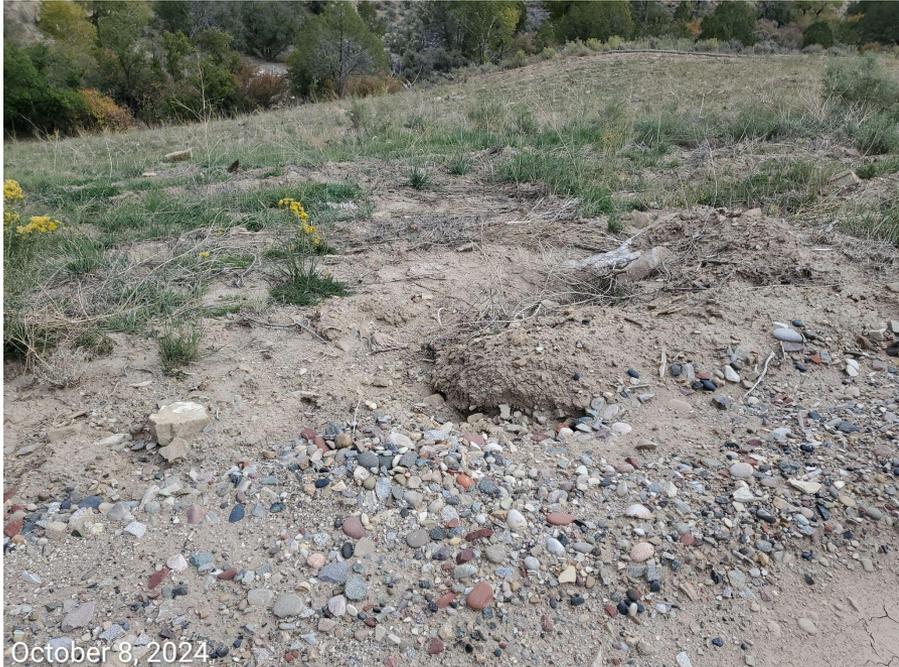
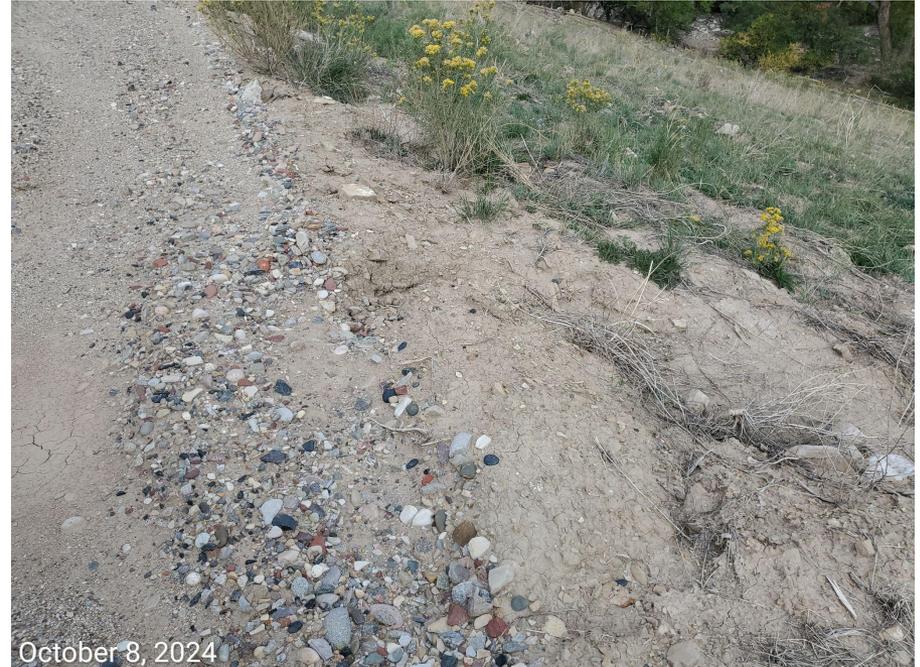
Photo 7: Photos 7-8 taken from along the northern perimeter of the working pad surface. BMPs to manage runoff from these areas have not been implemented. Photos examples showing areas where concentrated stormwater runoff is discharging from the pad onto the fill slopes, and where degradation is becoming evident; continued discharge from these points without proper BMPs will likely result in gully erosion, sediment transport with sediment deposition impacting vegetation establishing on the interim areas.

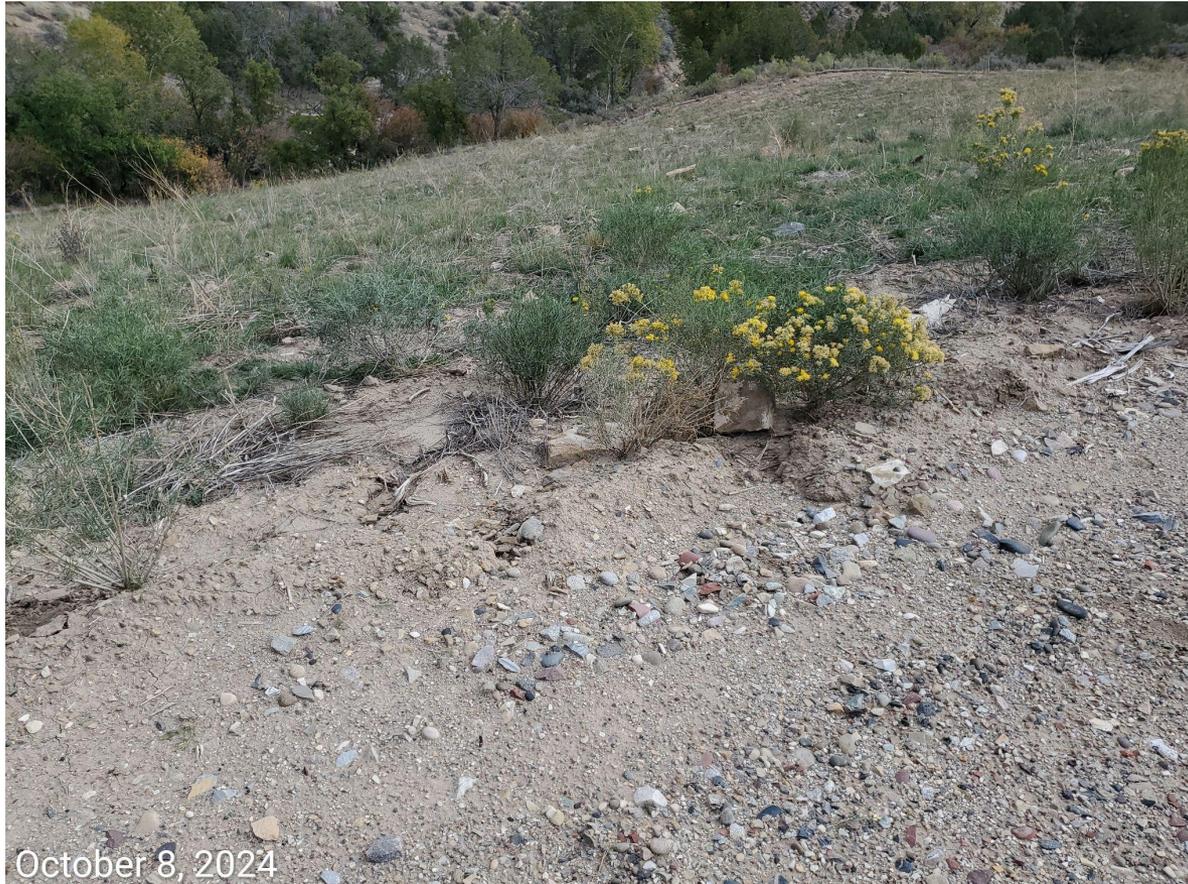
Photo 8: See comments under photo 7.
