Inspection Photos

10/08/2024

Operator: TEP ROCKY MOUNTAIN LLC #96850

Location ID: 335654

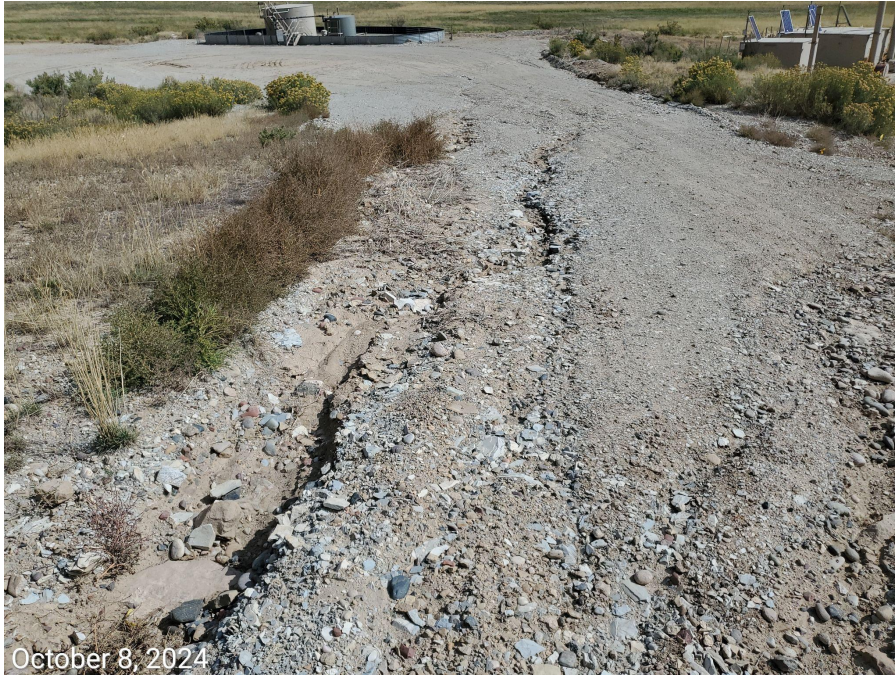
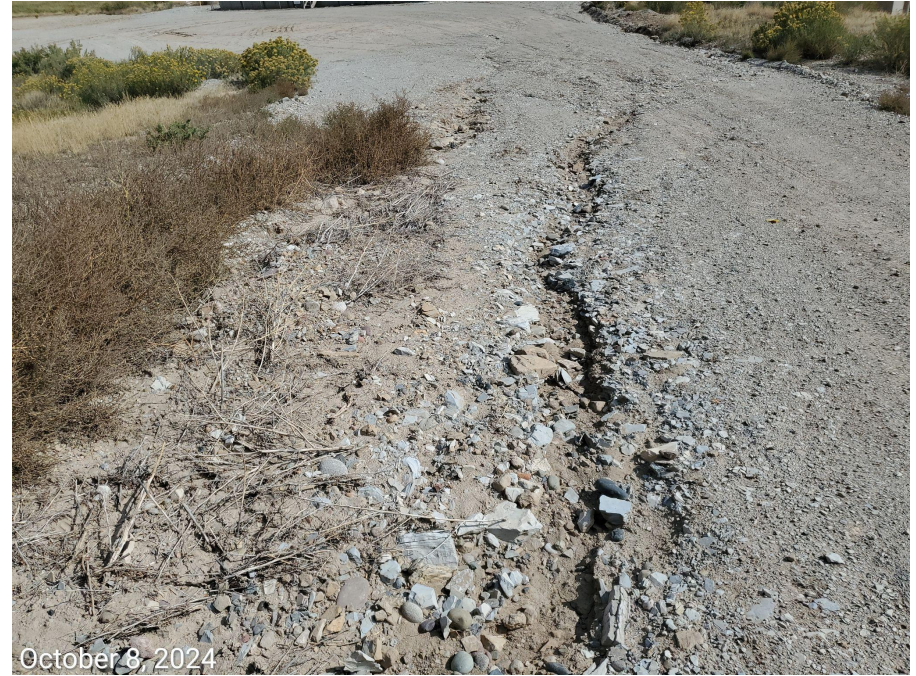
Photo 1: Photos taken from the access road/Location entrance. Stormwater diversion ditches have not been maintained in proper functioning condition resulting in runoff onto the road and Location and persisting degradation.

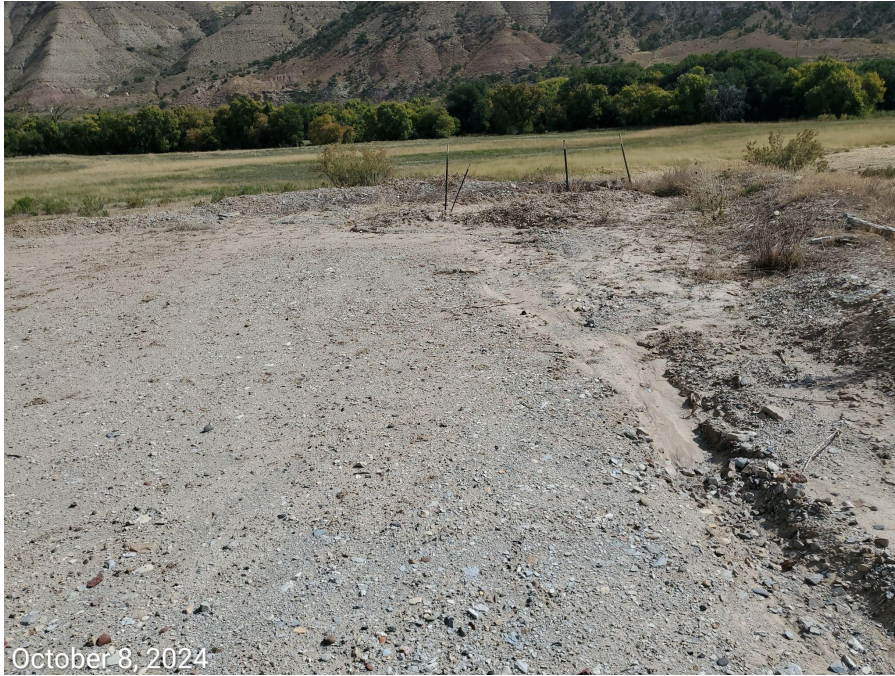
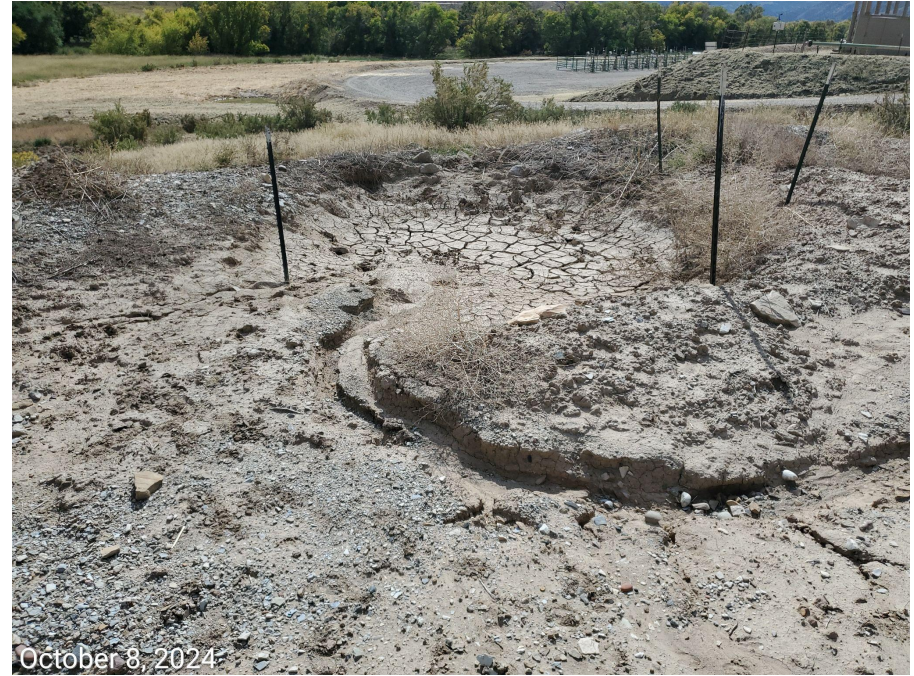
Photo 2: Photos taken from the sediment trap on the southeast end of the pad. Photos show the inlet/outlet have not been installed or maintained with a properly engineered inlet/outlet. Degradation to the control has persisted.

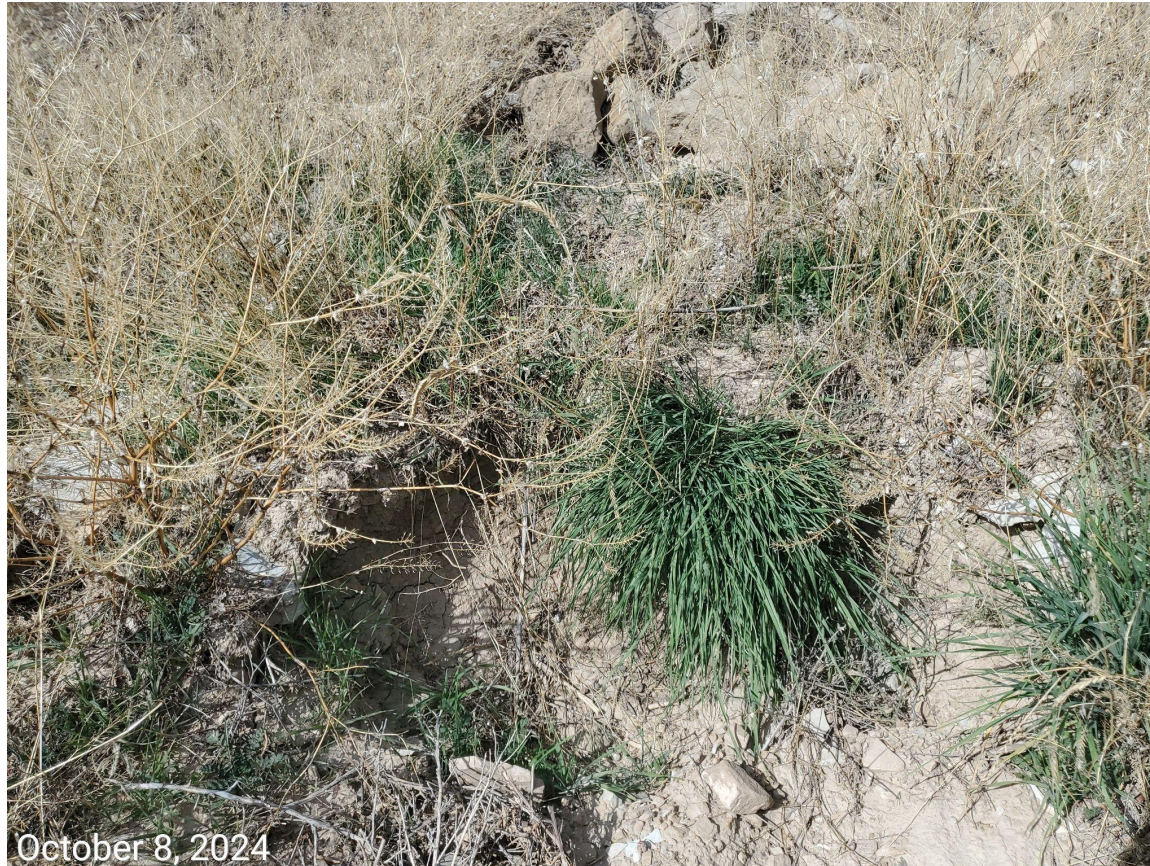
Photo 3: Photo taken from the sediment trap on the southeastern end of the Location. Photo shows BMP remains in disrepair; control has not been constructed with an engineered outlet resulting in gully erosion and degradation.

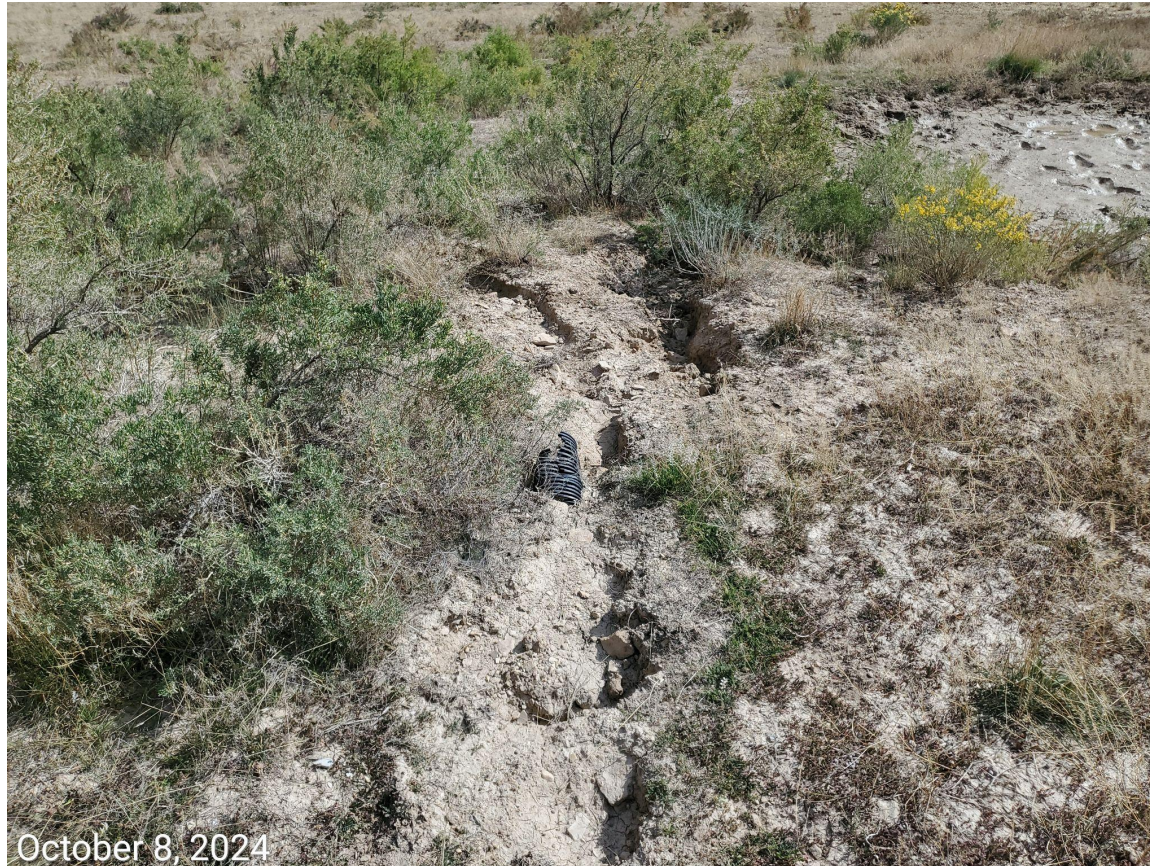
Photo 4: Photo taken from the sediment trap on the southeastern interim areas of the Location. Photo shows BMP remains in disrepair; control has not been constructed with an engineered inlet resulting in gully erosion and degradation.

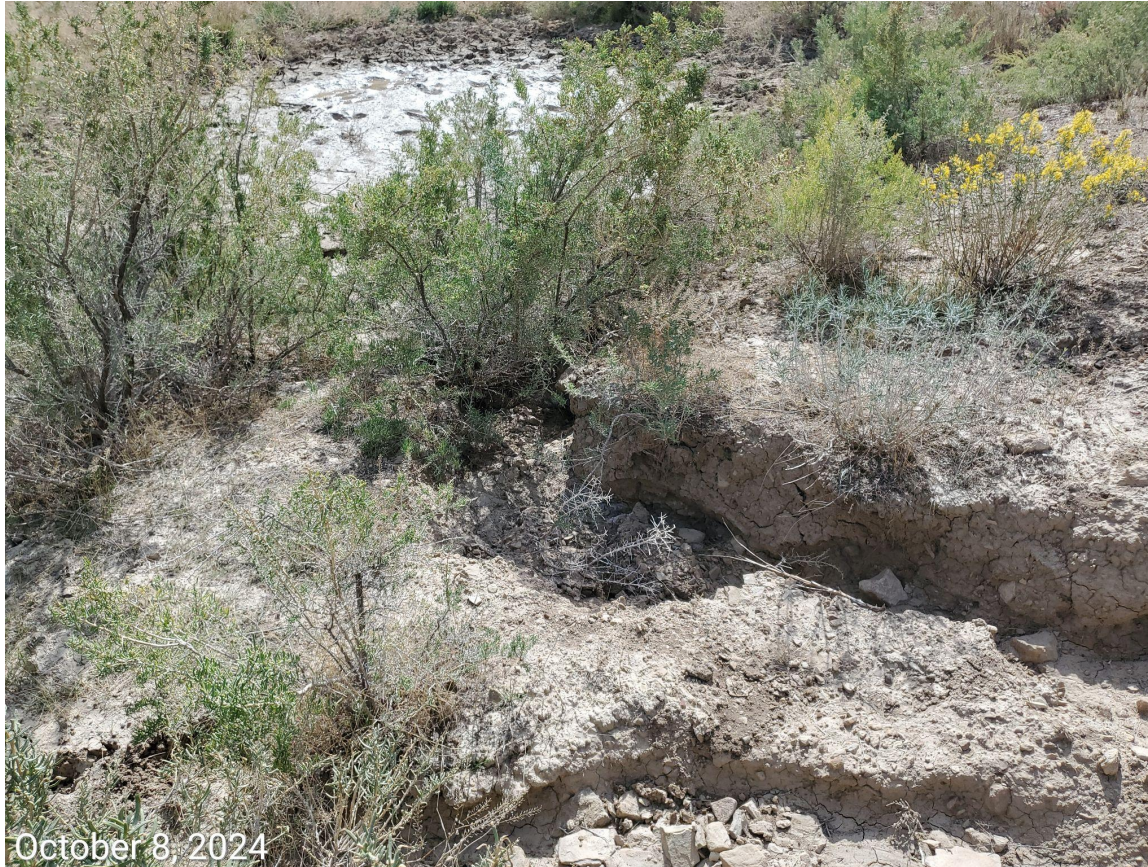
Photo 5: Photo taken from the sediment trap on the southeastern interim areas of the Location. Photo shows BMP remains in disrepair; control has not been constructed with an engineered inlet resulting in gully erosion and degradation.

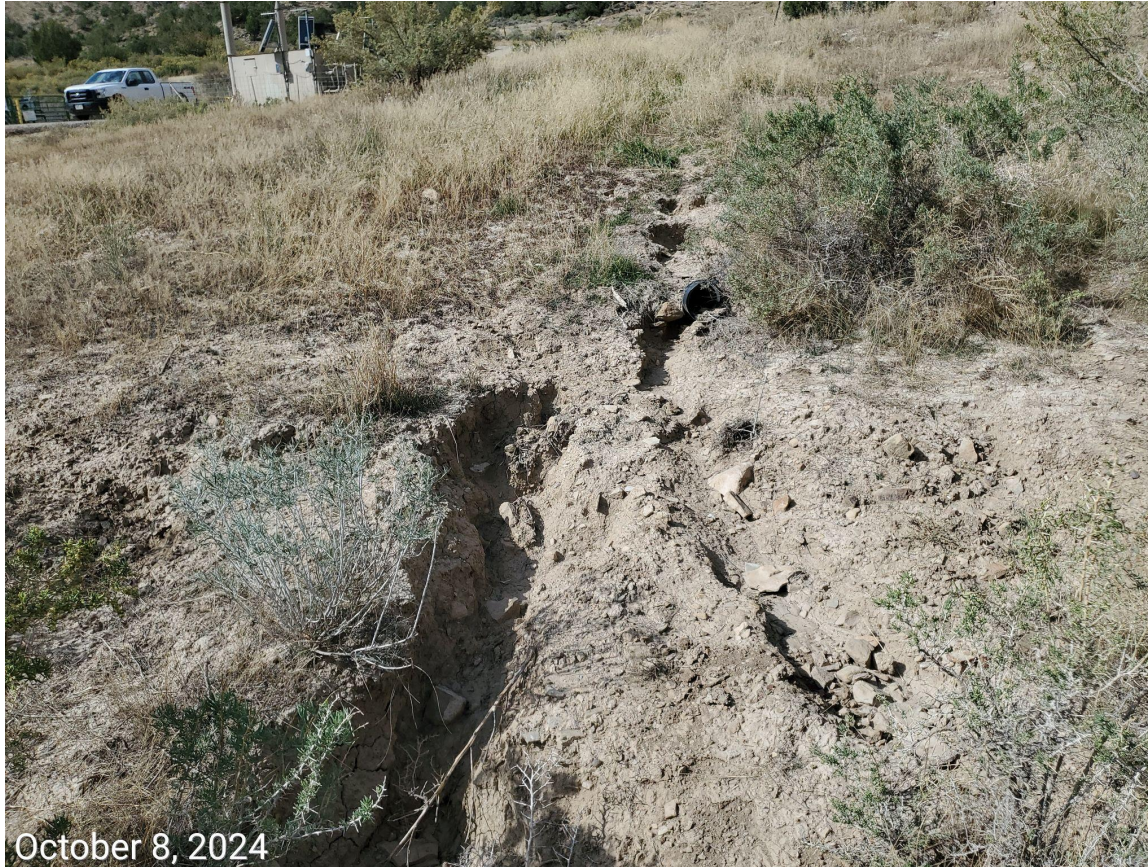
Photo 6: Photo taken from the sediment trap on the southeastern interim areas of the Location. Photo shows BMP remains in disrepair; control has not been constructed with an engineered inlet resulting in gully erosion and degradation.

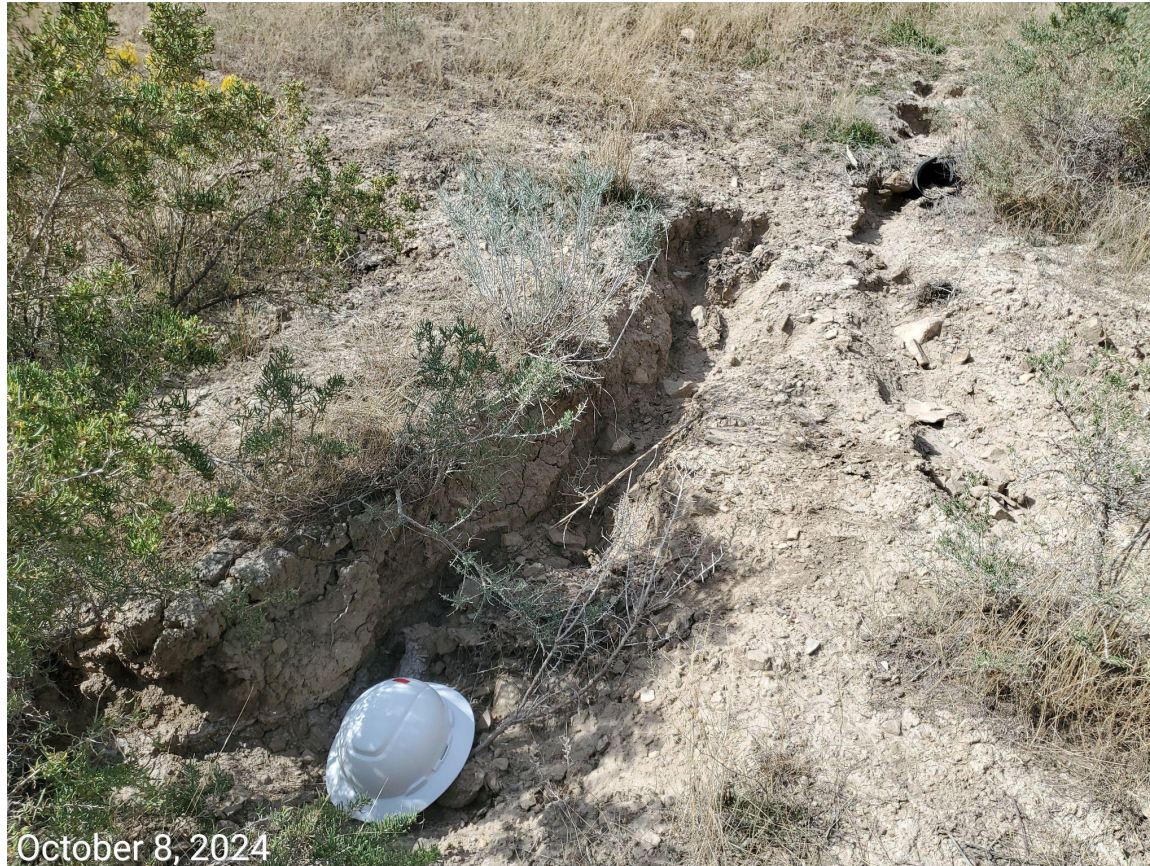
Photo 7: Continued from photo 6. Hard hat in photo used for reference.

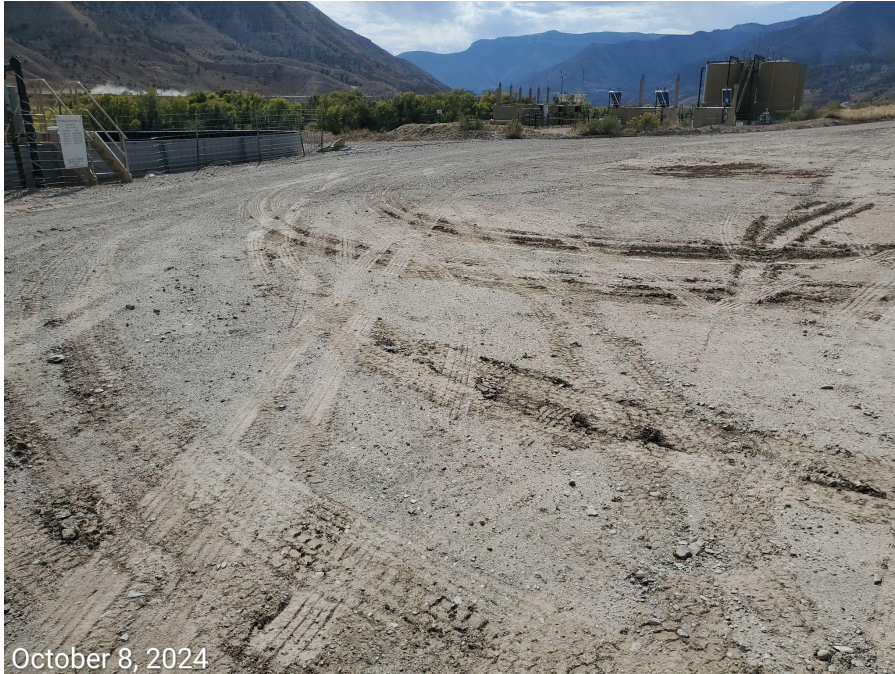
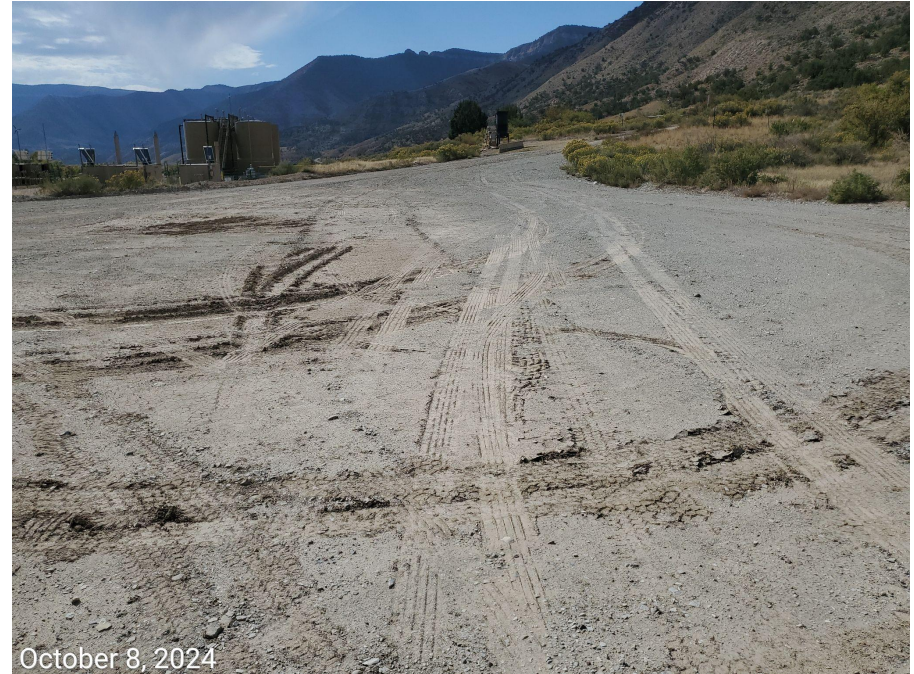
Photo 8: BMPs to stabilize the working pad surface have not been installed or maintained. Degradation/tracking has persisted.

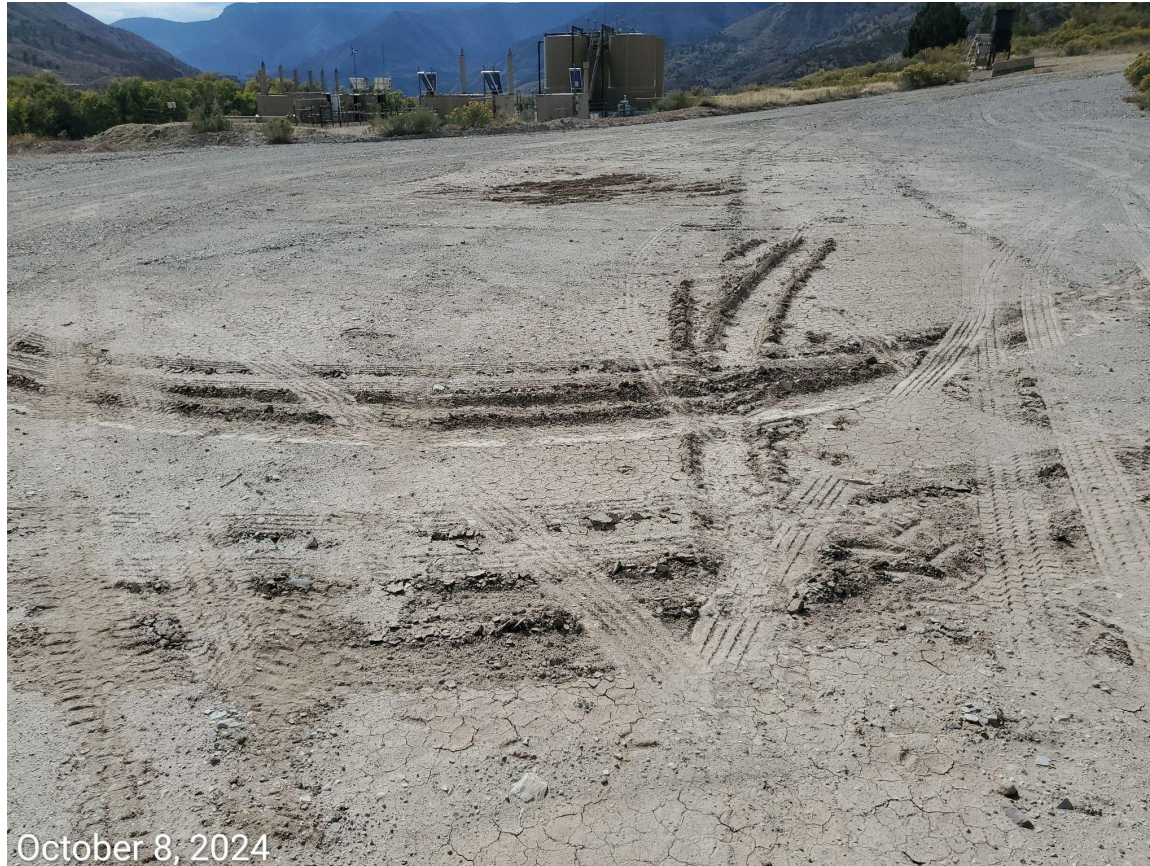
Photo 9: Continued from photo 8.

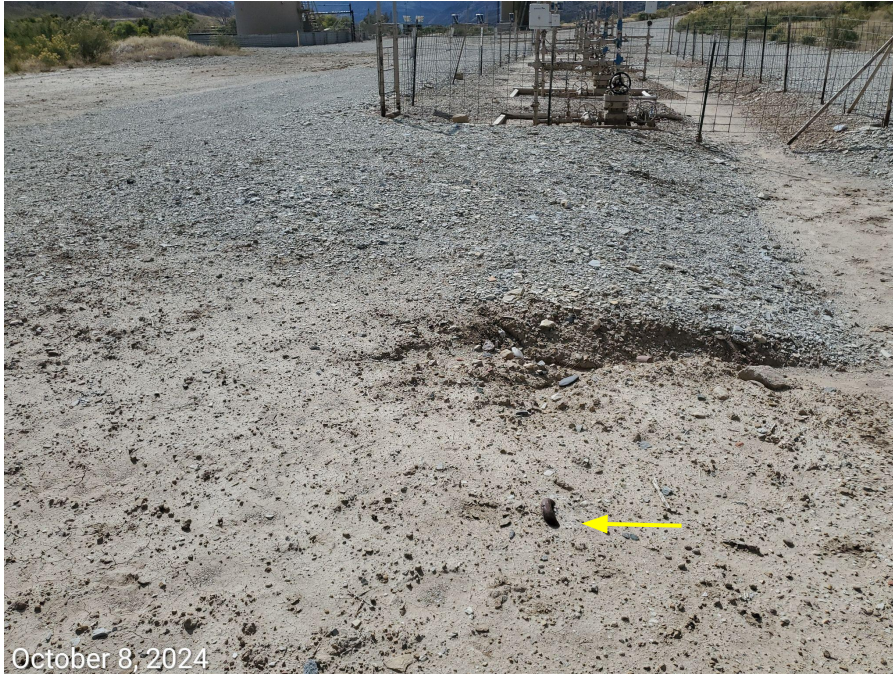
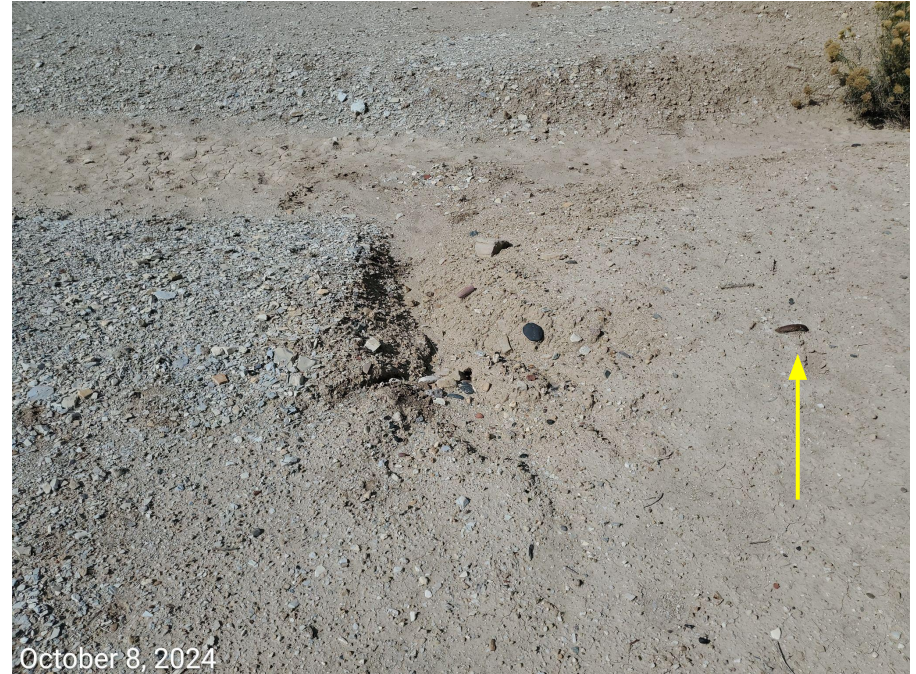
Photo 10: Photos examples of erosion degradation and anchors missing required marking.
