# Interim Reclamation and Stormwater Inspection

September 10, 2024

Operator: FULCRUM ENERGY OPERATING # 10805

Location ID: 445005

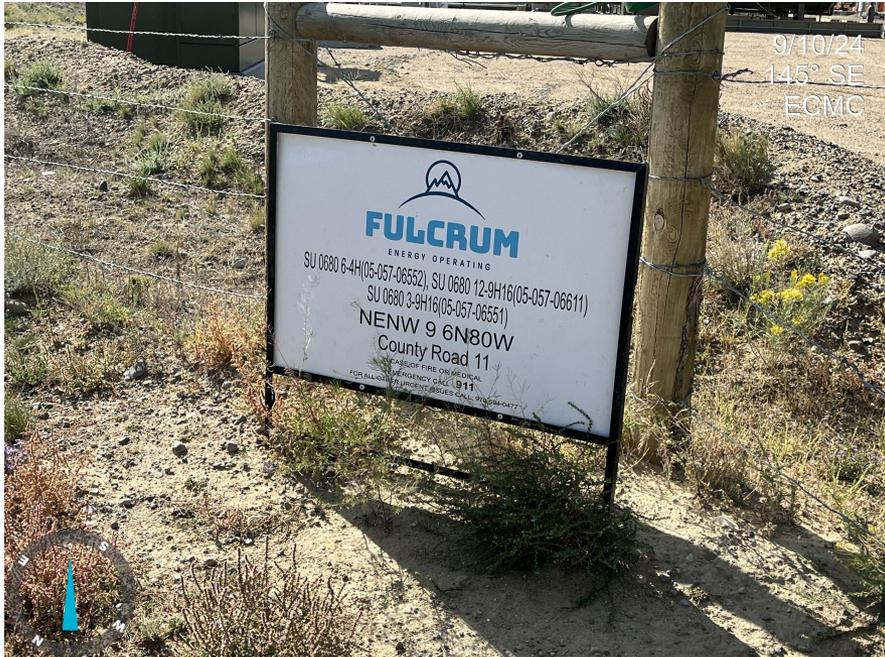
**Photo 1.** Photo taken from the entrance of Location, illustrating Operator's sign.

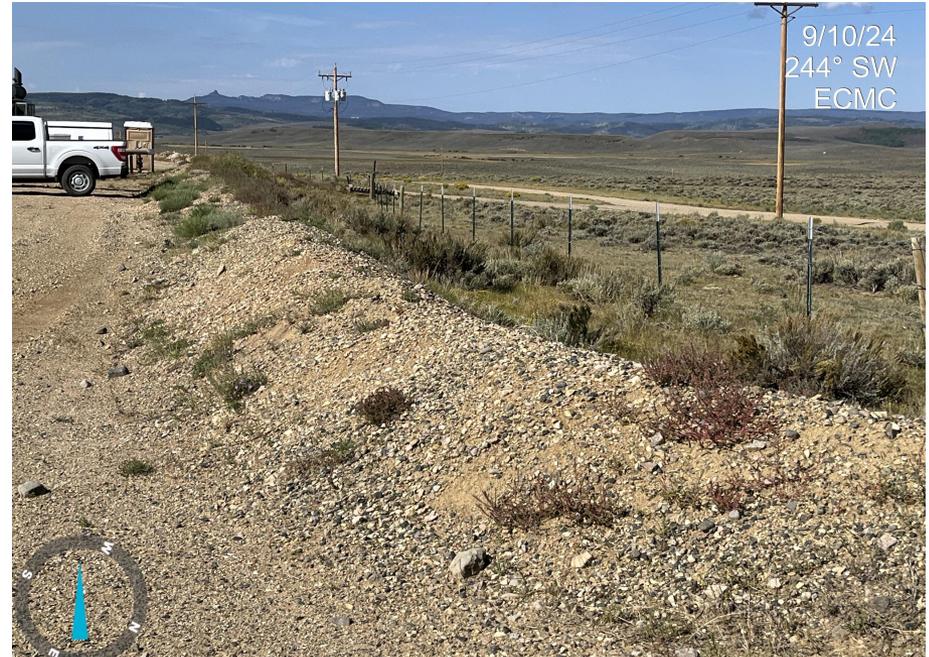
**Photo 2.** Photo taken the entrance of the Location, facing SW. Weeds observed growing on the berms and on other portions of the perimeter.

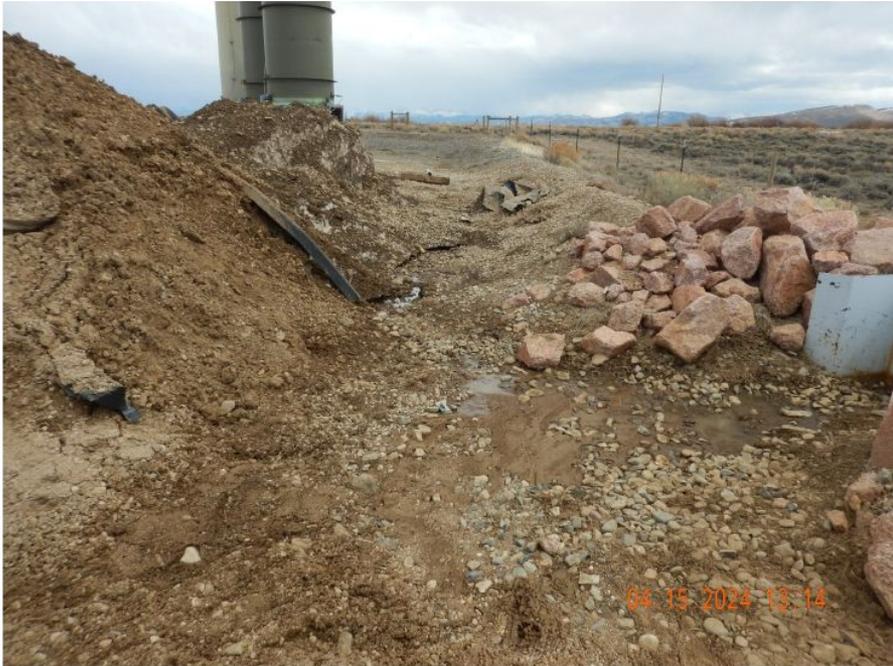
**Photo 3.** Photo taken 4/15/2024 from the southeastern working pad surface, facing East. Photo illustrates a snow plow pile with random debris.

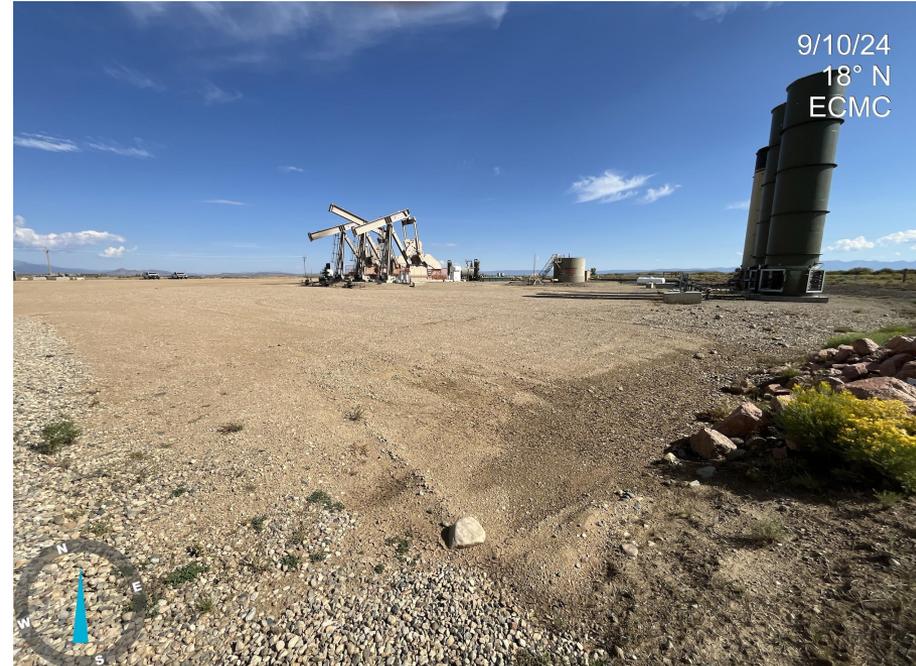
**Photo 4.** Photo taken from the southeastern working pad, facing North. Photo illustrates that Operator removed snow plow pile with random debris.

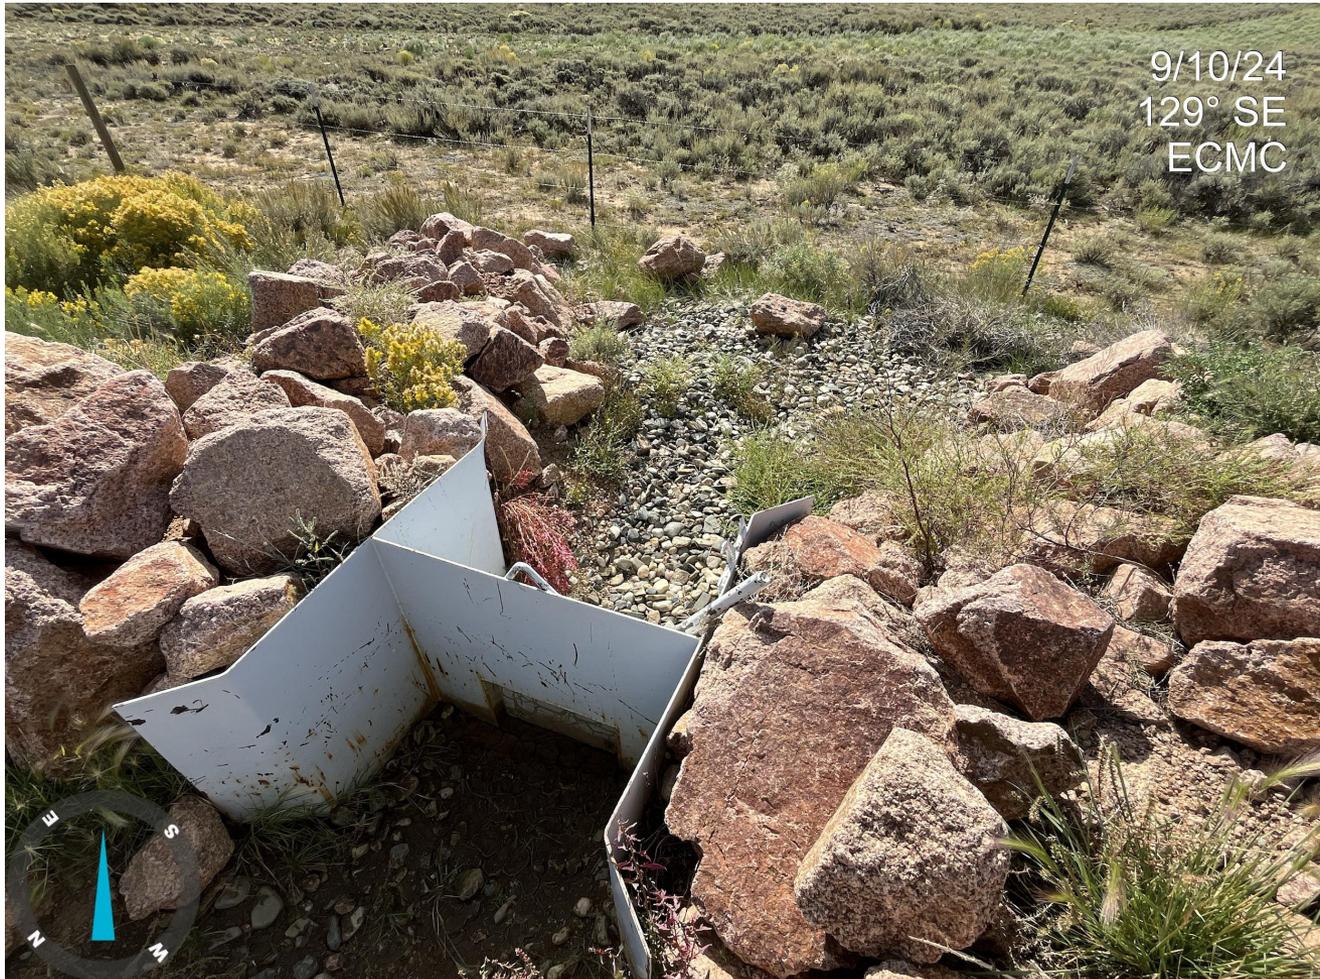
**Photo 5.** Photo taken from the southern working pad surface, facing SE. Photo illustrates the stabilized outlet. At the time of this inspection, there was no sediment discharge off of the Location.

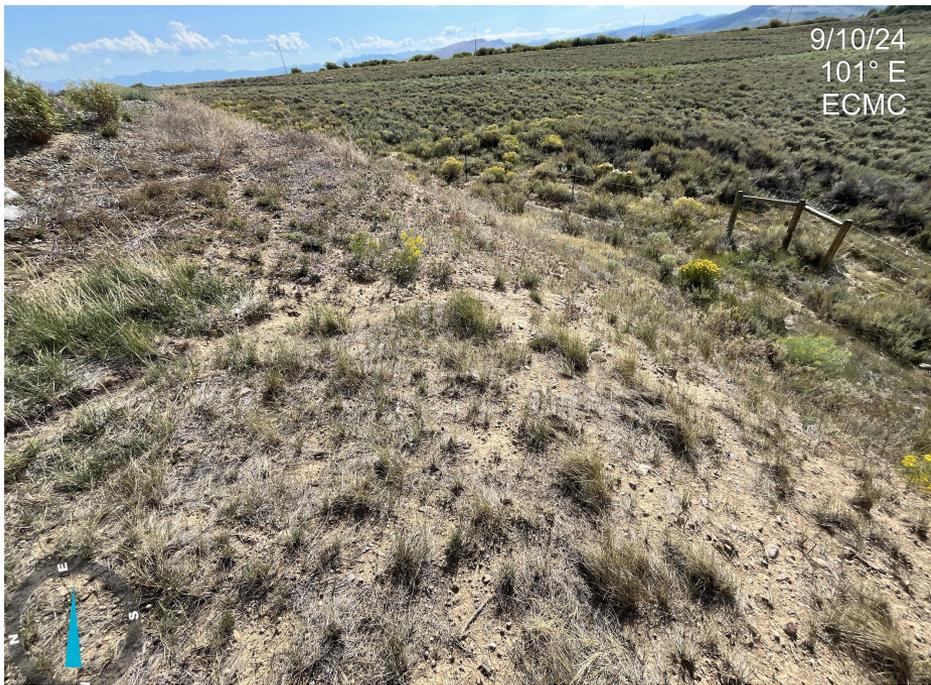
**Photo 6.** Photo taken from the eastern working pad surface, facing East. Photo illustrates revegetation of the fill slopes are in process. Operator shall continue to monitor and manage until Location reaches 1003 standards.

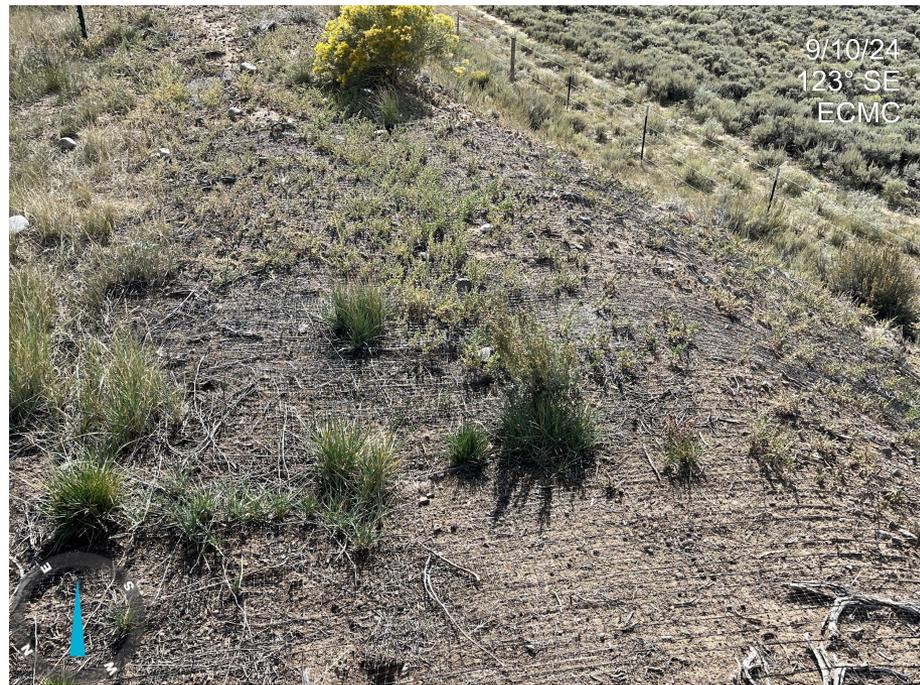
**Photo 7.** Photo taken from the eastern working pad, facing SE. Photo illustrates a portion of the topsoil stockpile with temporary BMPs (erosion control netting). Operator shall continue to monitor and manage until Location reaches 1002 standards.

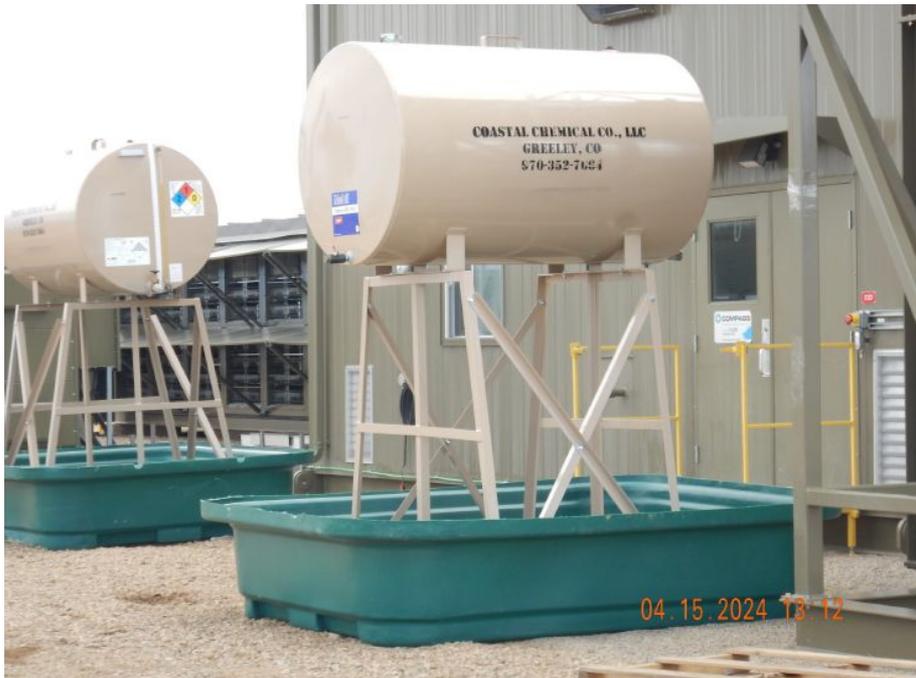
**Photo 8.** Photo taken 4/15/2024 from the southern working pad surface, facing Southeast. Photo illustrates the equipment and secondary containment lacks wildlife protection.

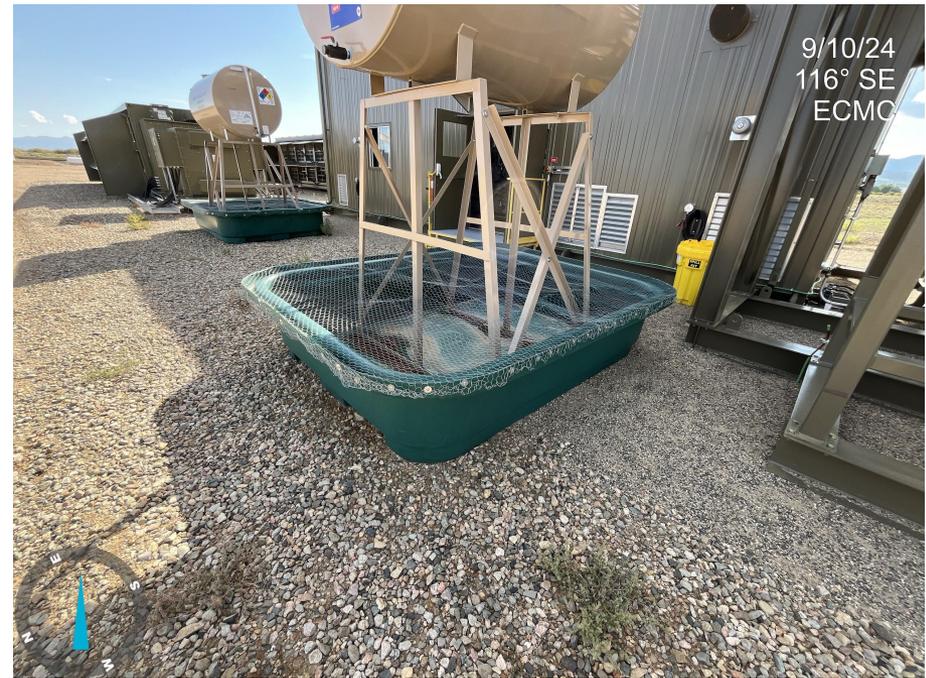
**Photo 9.** Photo taken from the southern working pad, facing SE. Photo illustrates that wildlife BMPs were implemented on secondary containment.
