# New Construction and Stormwater Inspection

September 10, 2024

Location ID: 487288

Inspection Document #: 712300072

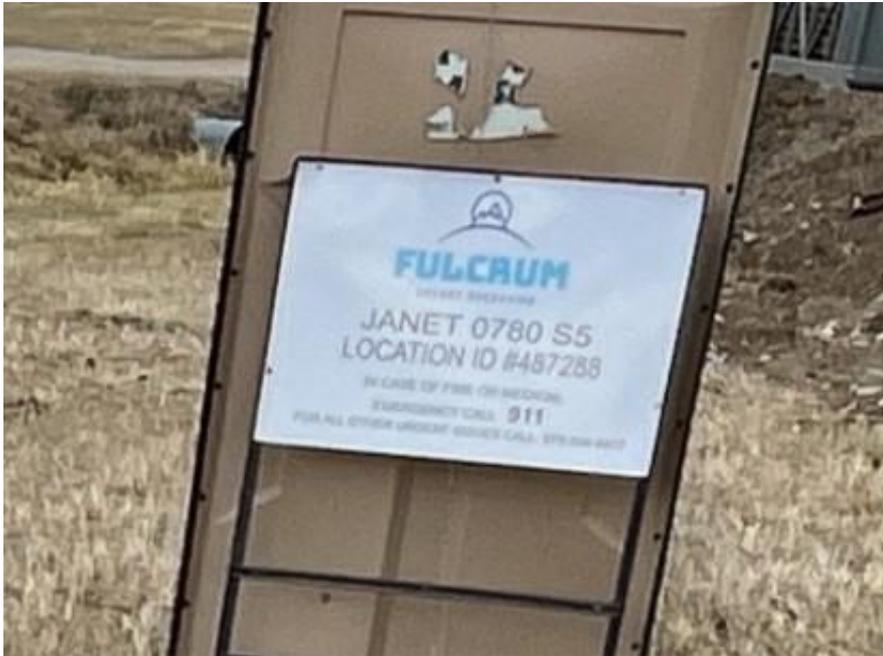
**Photo 1.** Photo taken from the entrance of Location. Photo illustrates the Location's Operator sign.

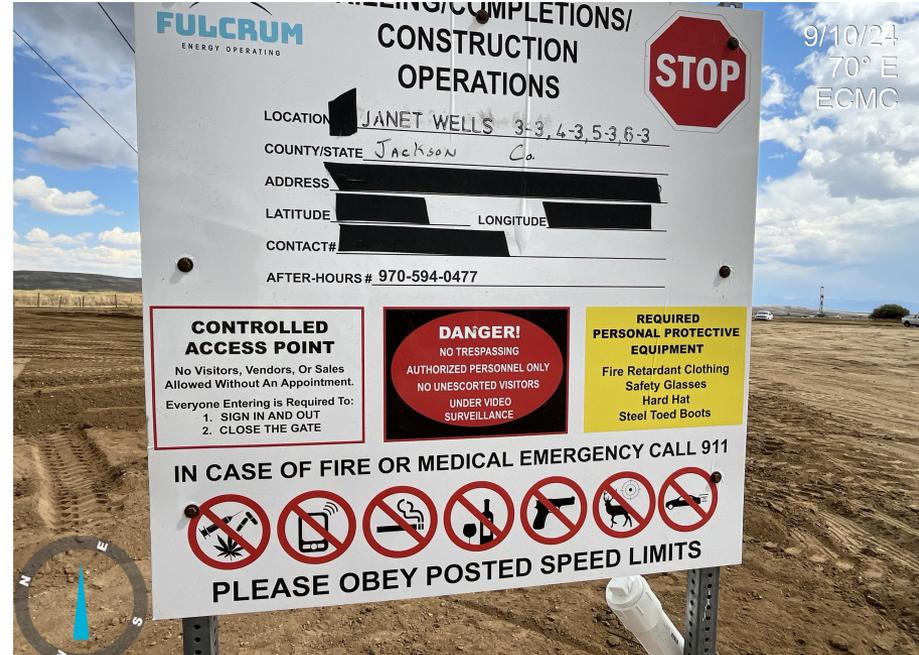
**Photo 2.** Photo taken from the access road entrance near the Ray Ranch North Location. Operator shall comply with Rule 605.

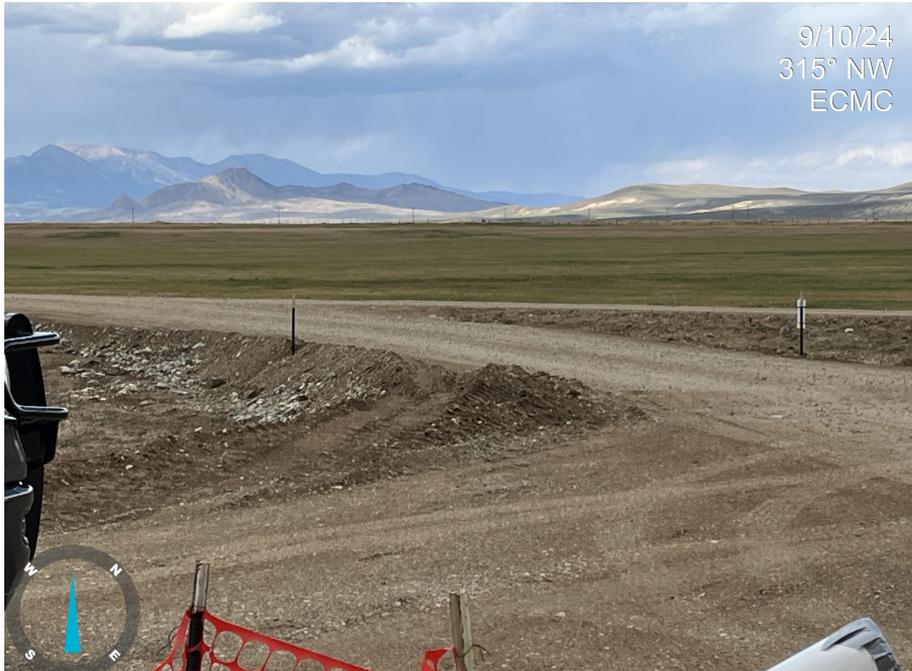
**Photo 3.** Photo taken from the Location entrance facing northwest towards the access road.

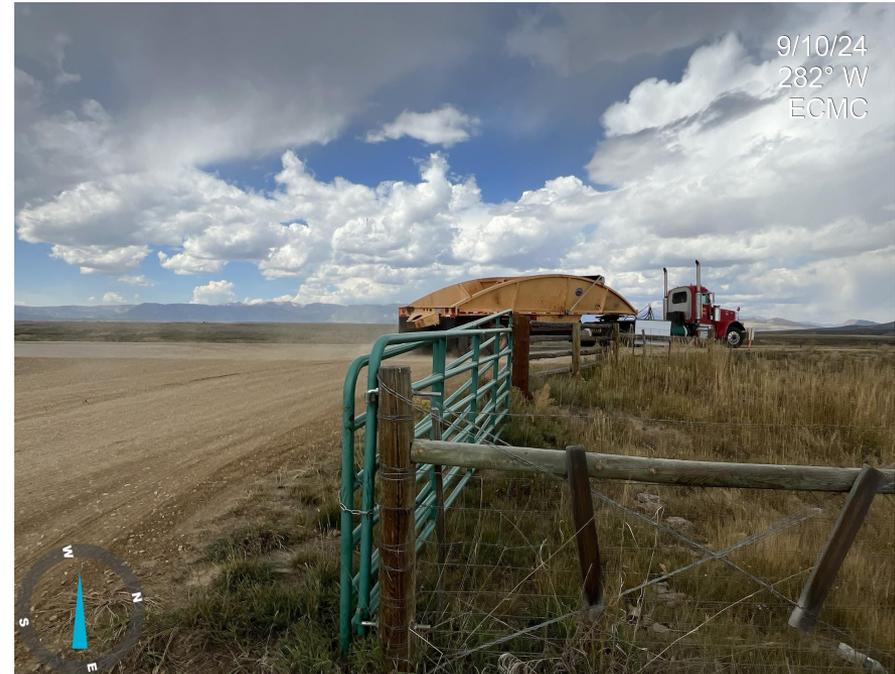
**Photo 4.** Photo taken from the entrance of access road Location facing Highway 14. Tracking pad not installed to prevent track of material off site. Discussion with Operator that street sweeper was employed to clean sediment tracked off-site.

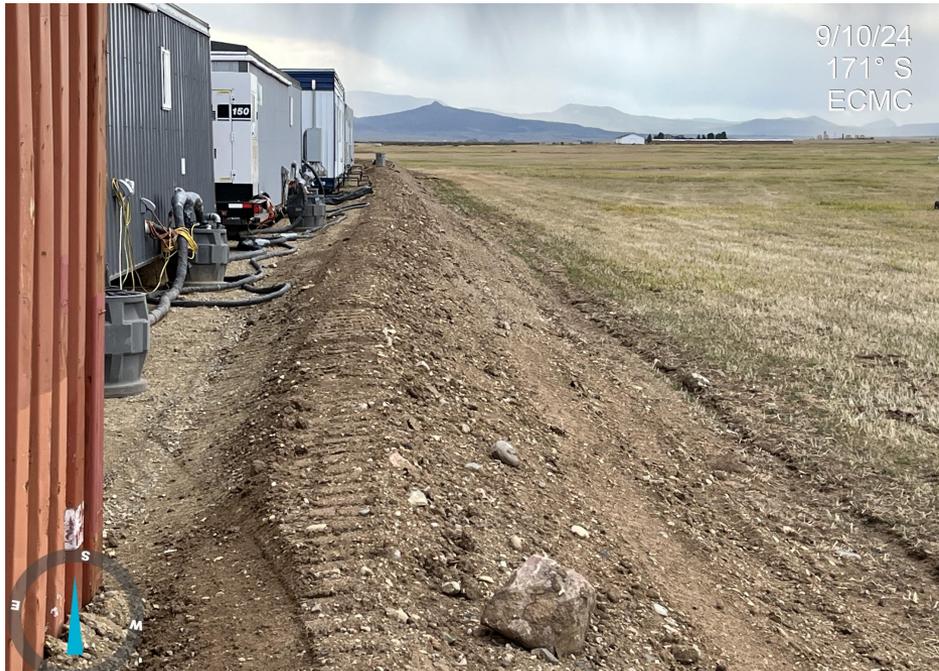
**Photo 5.** Photo taken from the northwestern edge of Location, facing south. Photo illustrates perimeter stormwater BMPs.

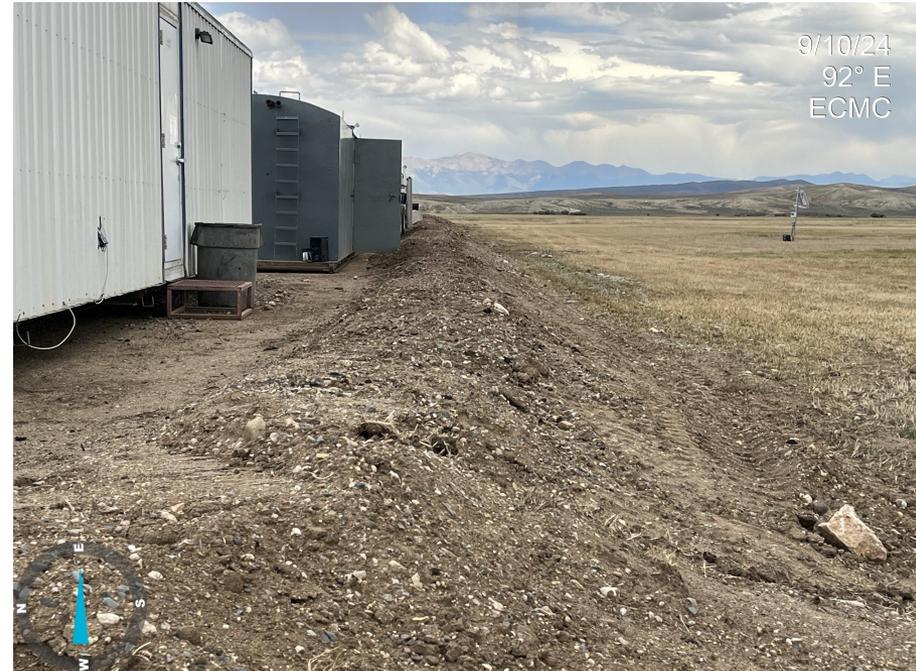
**Photo 6.** Photo taken from the southwestern edge of Location, facing east. Photo illustrates perimeter stormwater BMPs.

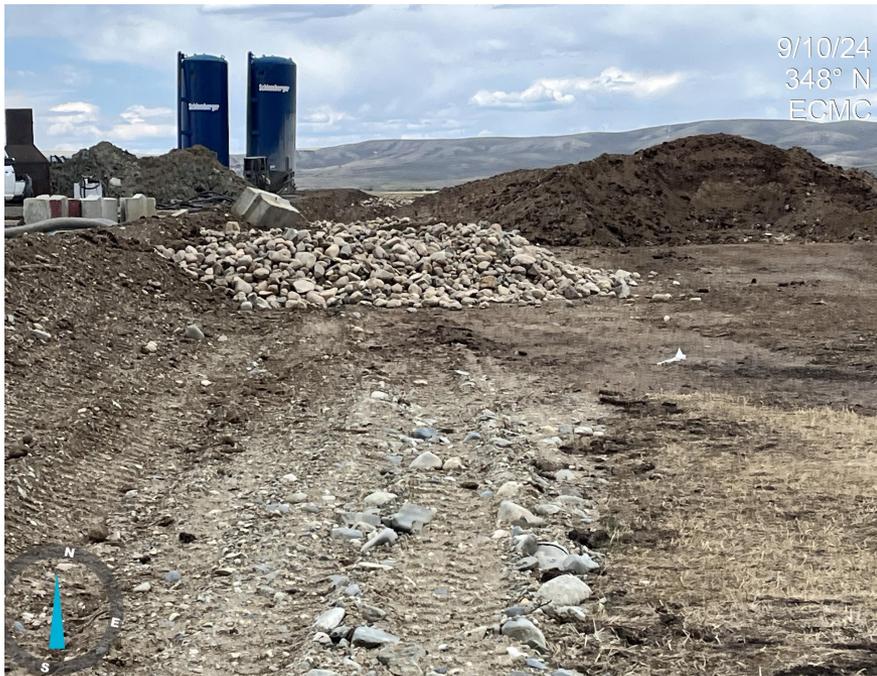
**Photo 7.** Photo taken from the southeastern edge of Location, facing north. Photo illustrates perimeter stormwater BMP, stormwater outlet, and topsoil stockpile.

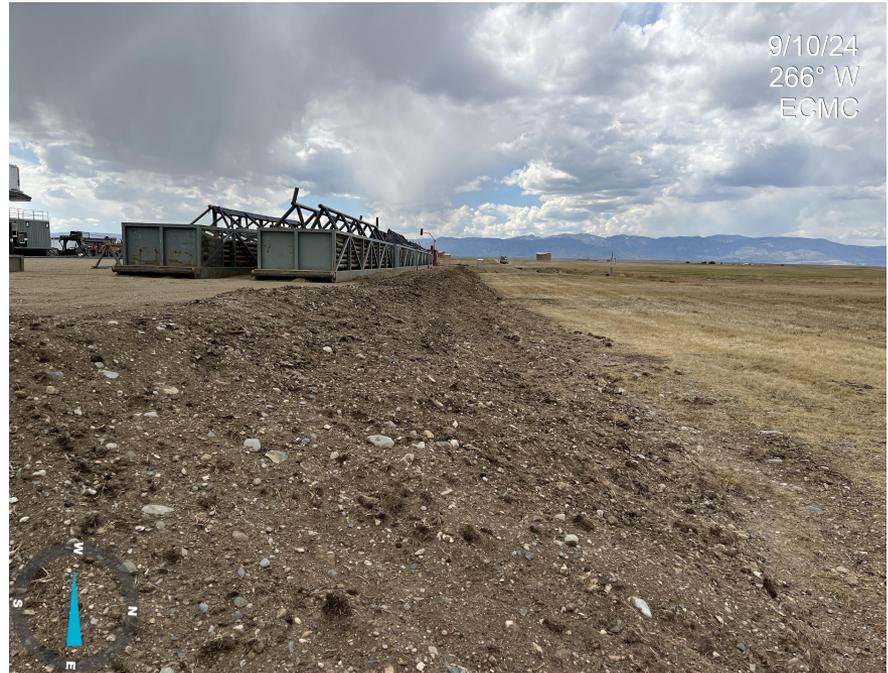
**Photo 8.** Photo taken from the northeastern edge of Location, facing west. Photo illustrates perimeter stormwater BMP.

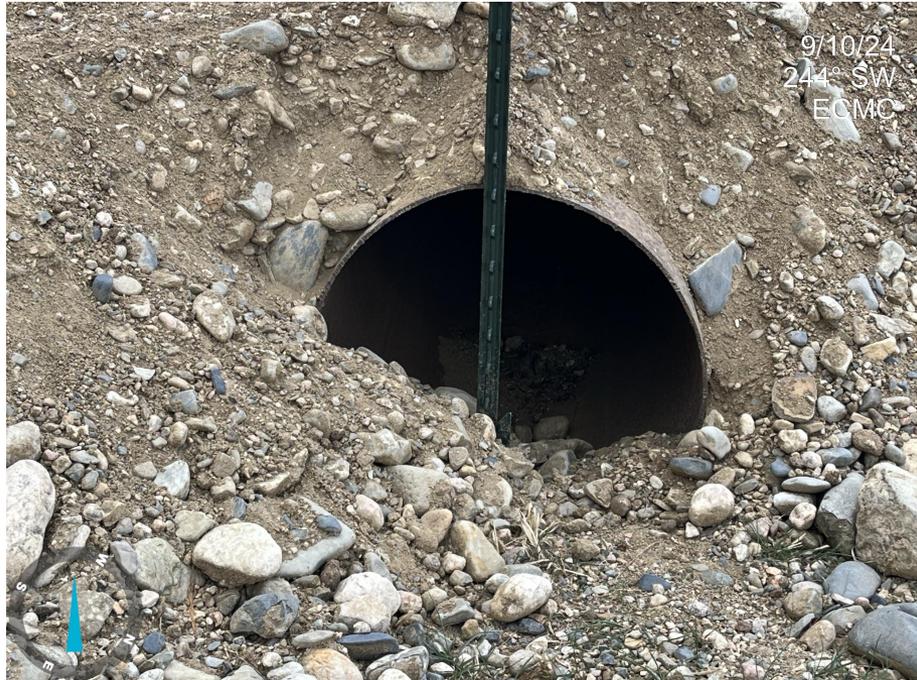
**Photo 9.** Photo taken from entrance of Location, facing SW. Photo illustrates culvert with no inlet/outlet protection.

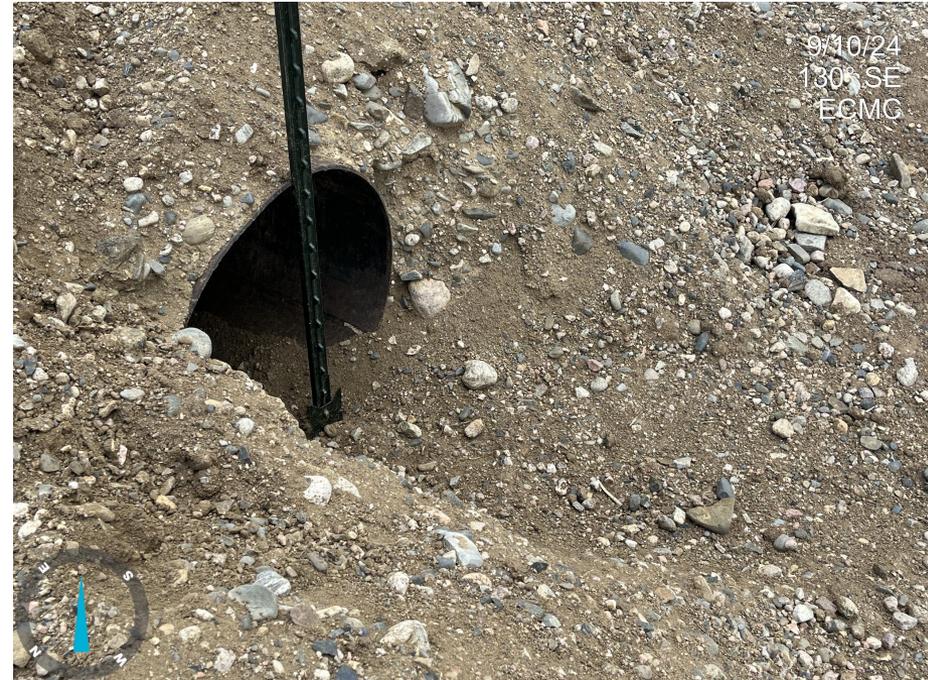
**Photo 10.** Photo taken from entrance of Location, facing SE (i.e., other side of road). Photo illustrates culvert with no inlet/outlet protection.

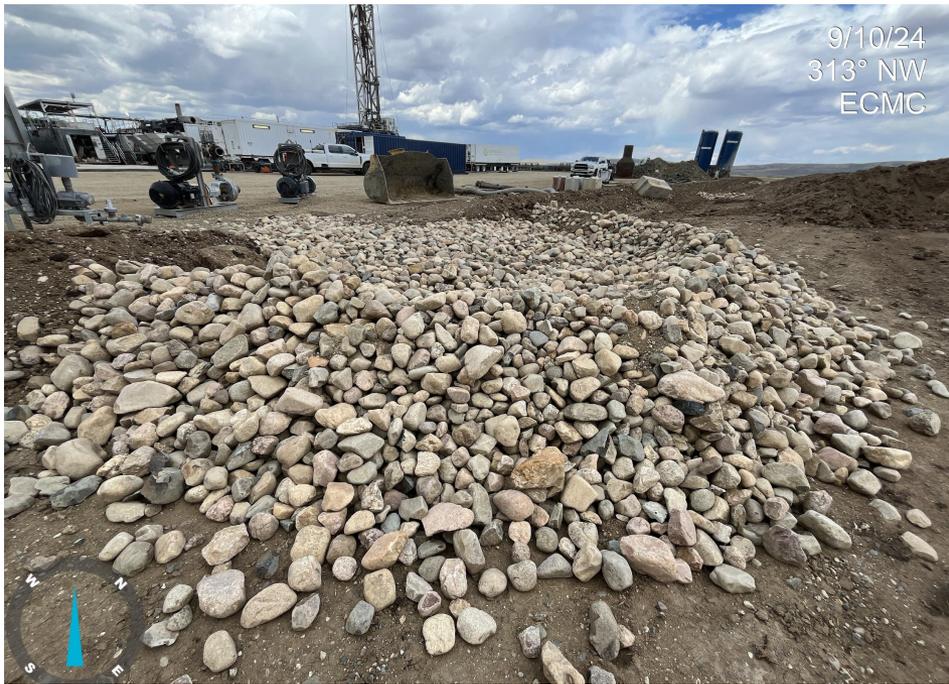
**Photo 11.** Photo taken from the eastern edge of Location.. Photo illustrates stormwater outlet. It was observed that round river rock was implemented not per good engineering practices.

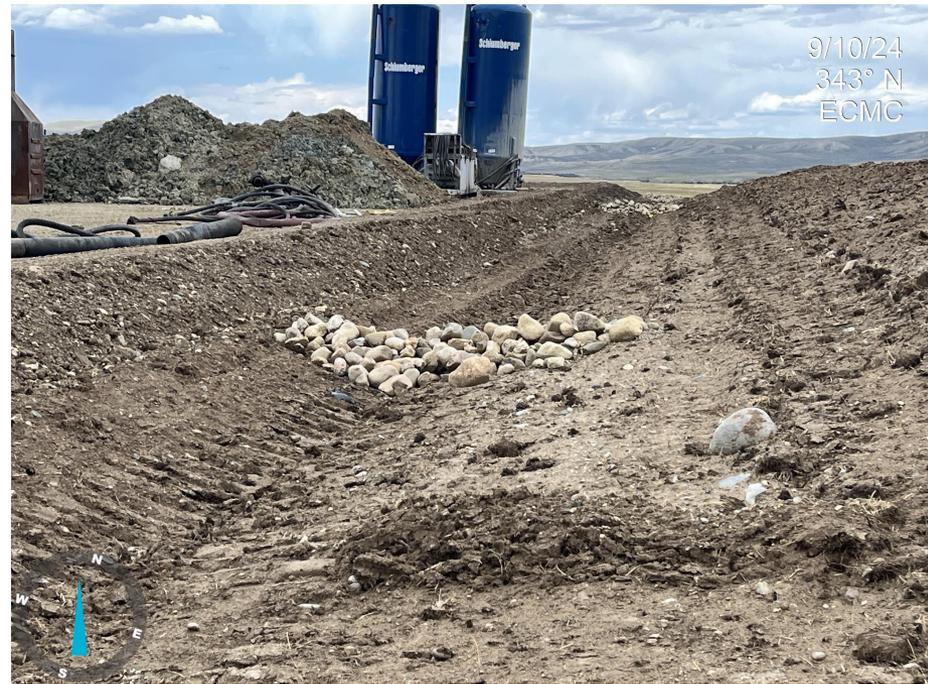
**Photo 12.** Photo taken from the eastern edge of Location. Photo illustrates check dams in perimeter ditch.

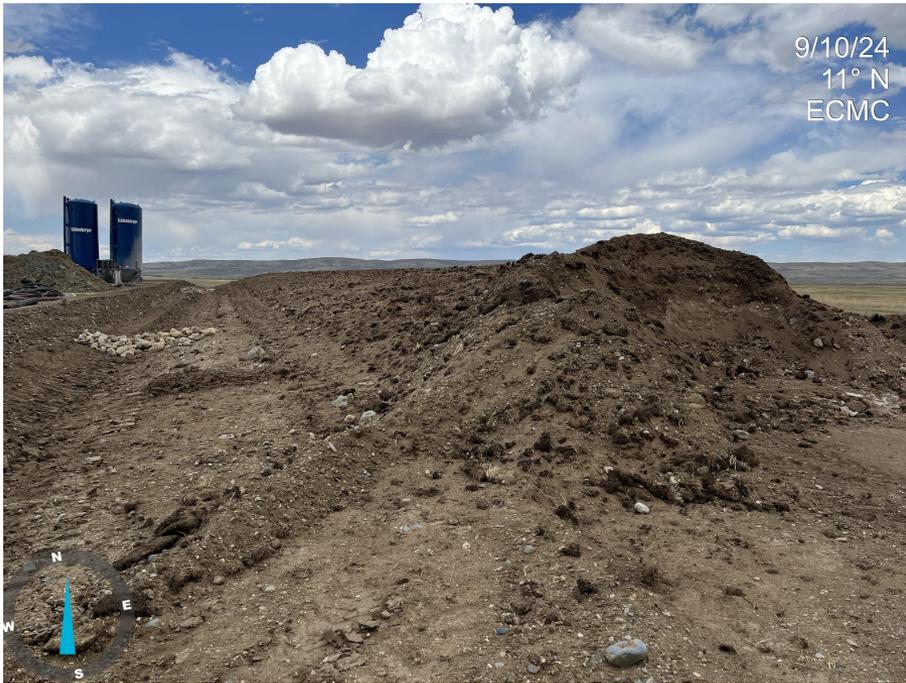
**Photo 13.** Photo taken on eastern edge of Location. Photo illustrates topsoil stockpile. It was observed that the topsoil was temporarily tracked. No other BMPs have been implement in conjunction with tracking to minimize erosion, degradation and sediment transport per good engineering practices.

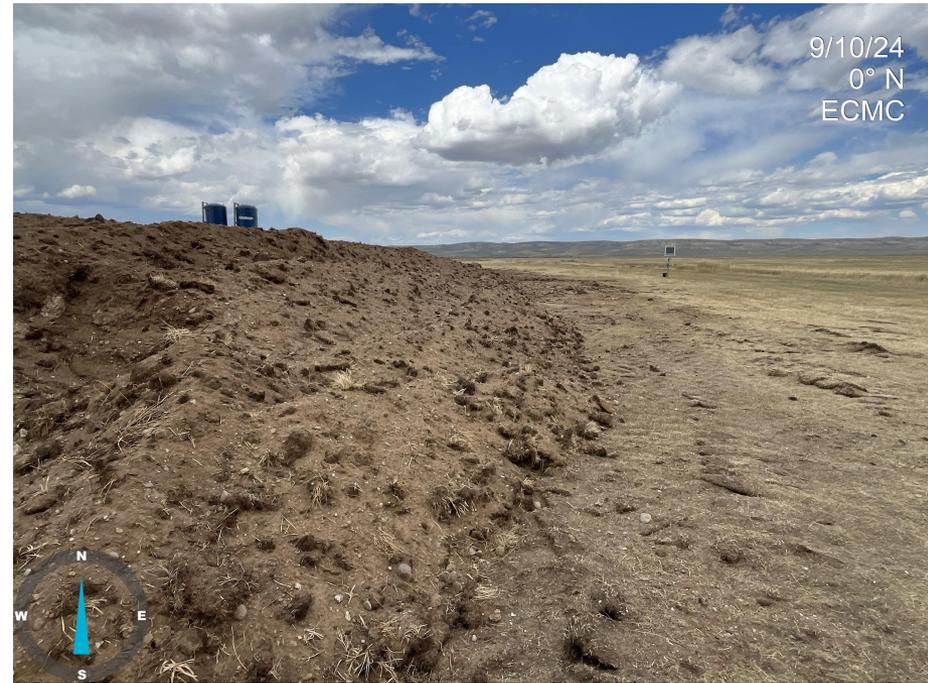
**Photo 14.** Photo taken on eastern edge of Location. Photo illustrates topsoil stockpile with no perimeter stormwater BMPs. Operator shall implement topsoil stormwater BMPs per Rule 1002.f.(2).

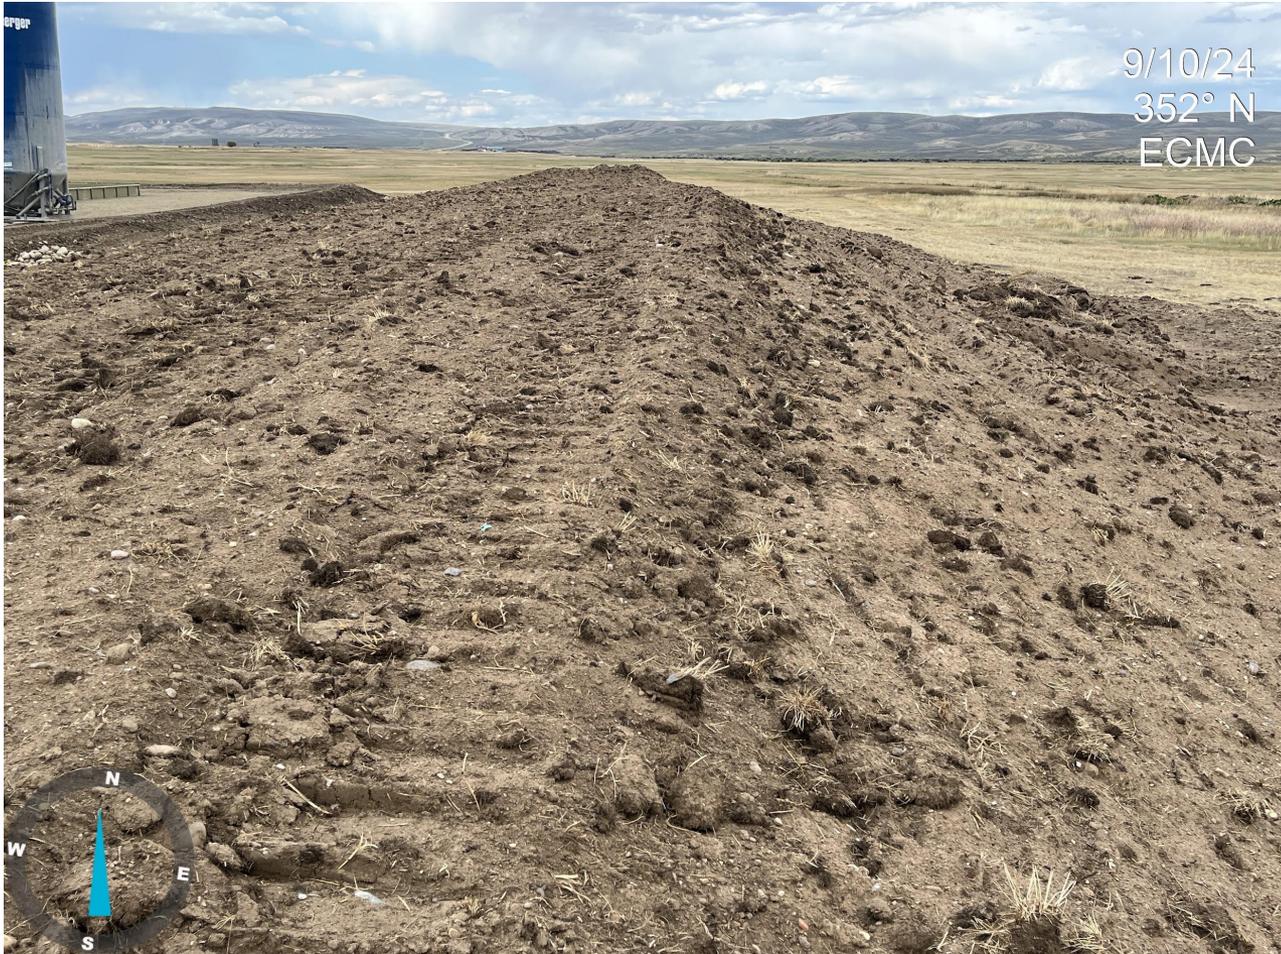
**Photo 15.** Photo taken on top of topsoil stockpile. It was observed that temporary stabilization/roughening was implemented.

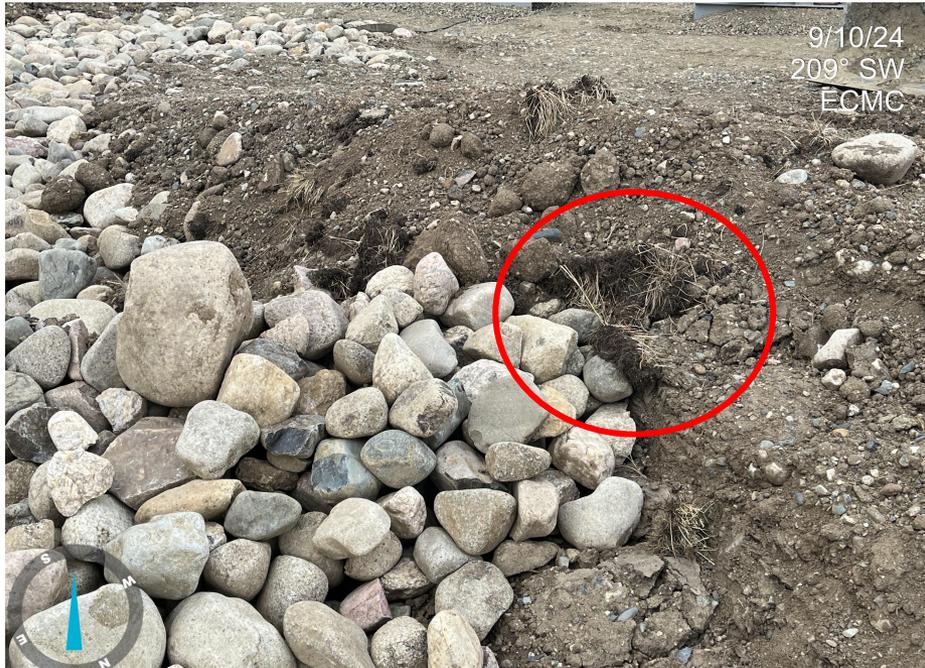
**Photo 16.** Photo taken on eastern edge of Location. Photo illustrates topsoil was used in sediment trap. Utilization of topsoil material as part of stormwater controls does not comport with Rule 1002.c, as this places the topsoil resource at risk to degradation, contamination (commingling with sediment), and loss of the resource.

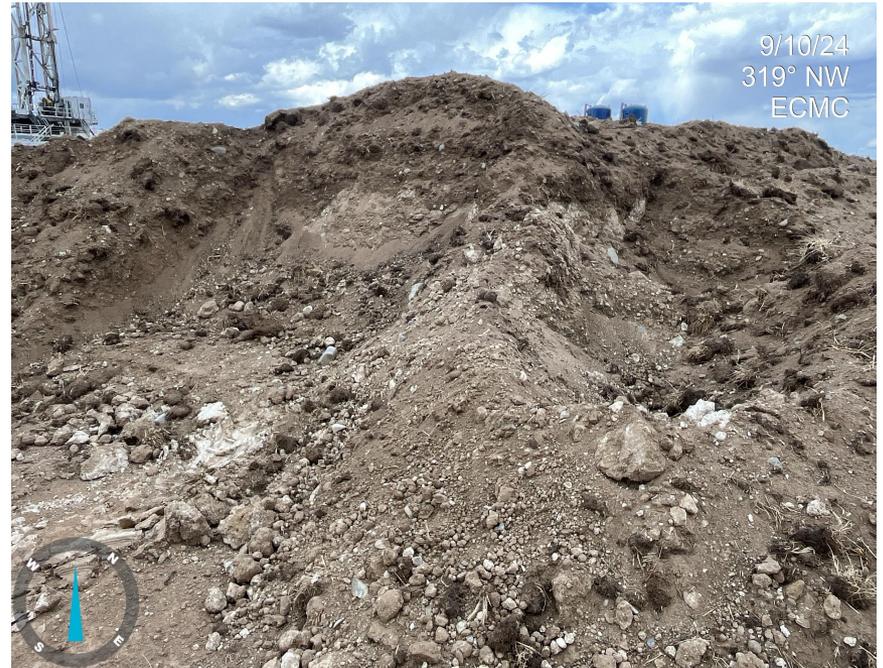
**Photo 17.** Photo taken on eastern edge of Location. Photo illustrates topsoil stockpile. It was observed and staff was informed that some topsoil was removed by the Surface Owner.

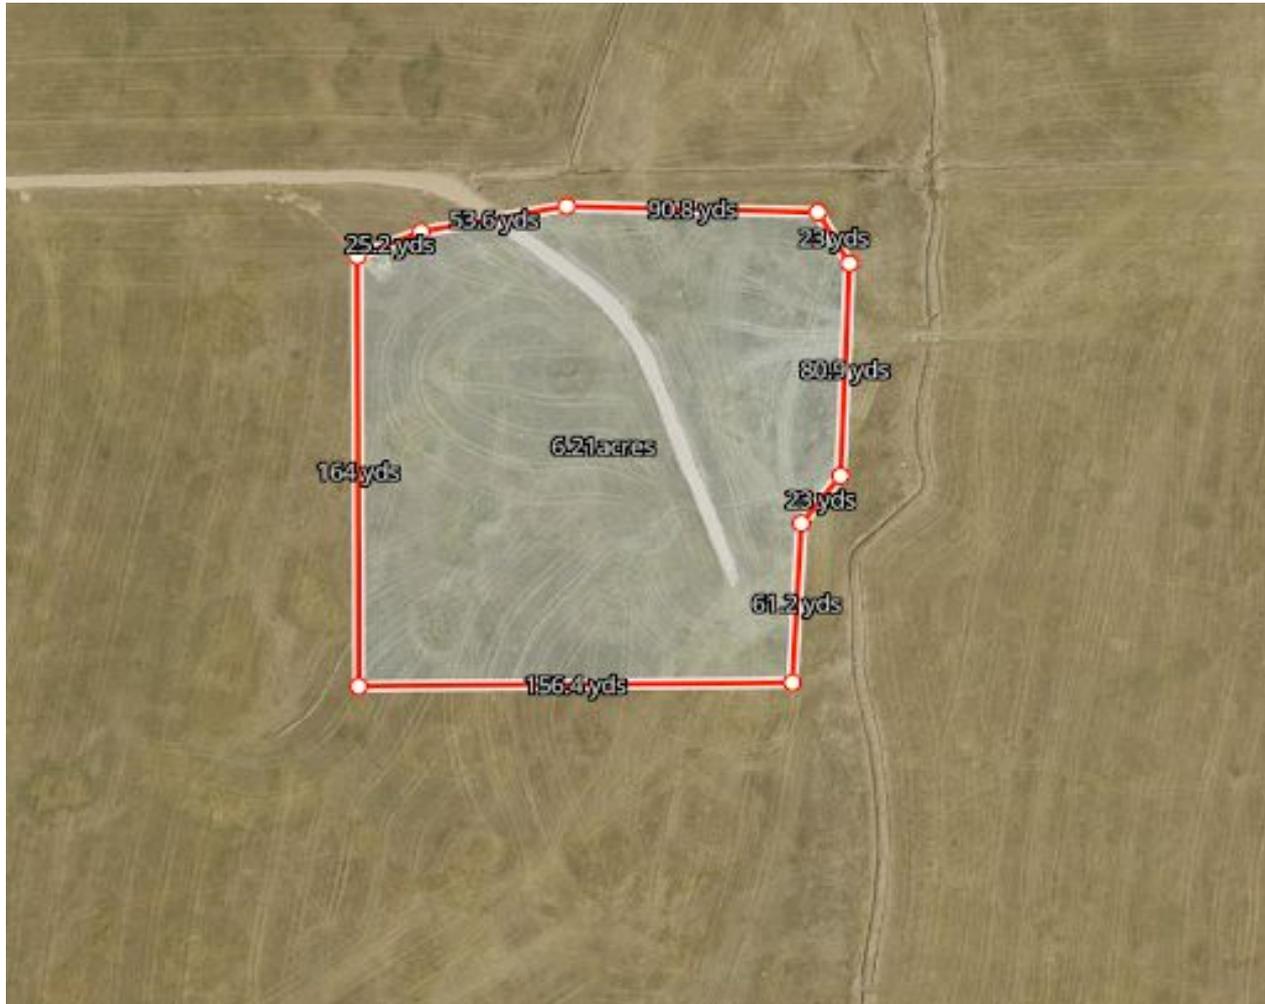
**Photo 18.** Satellite imagery and perimeter of Location after construction. The Location is approximately 6.2 acres.
