Inspection Photos

Location Name: FLETCHER GULCH 33-44

Location ID: 316575

Inspection Date: September 24, 2024

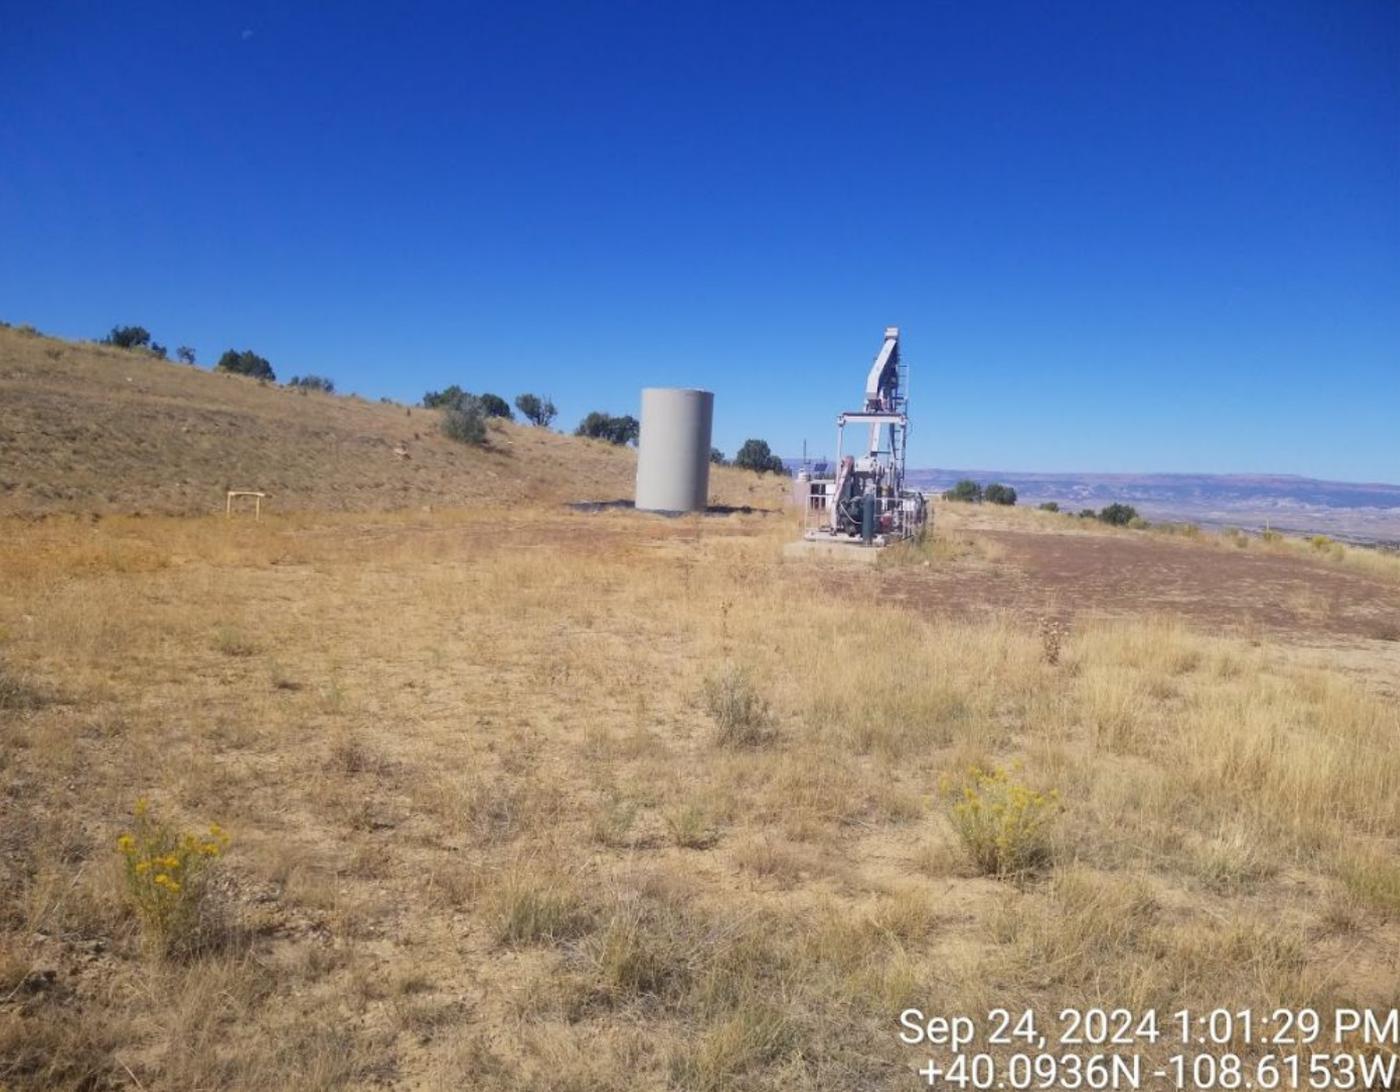
FLETCHER GULCH
33-44 location.

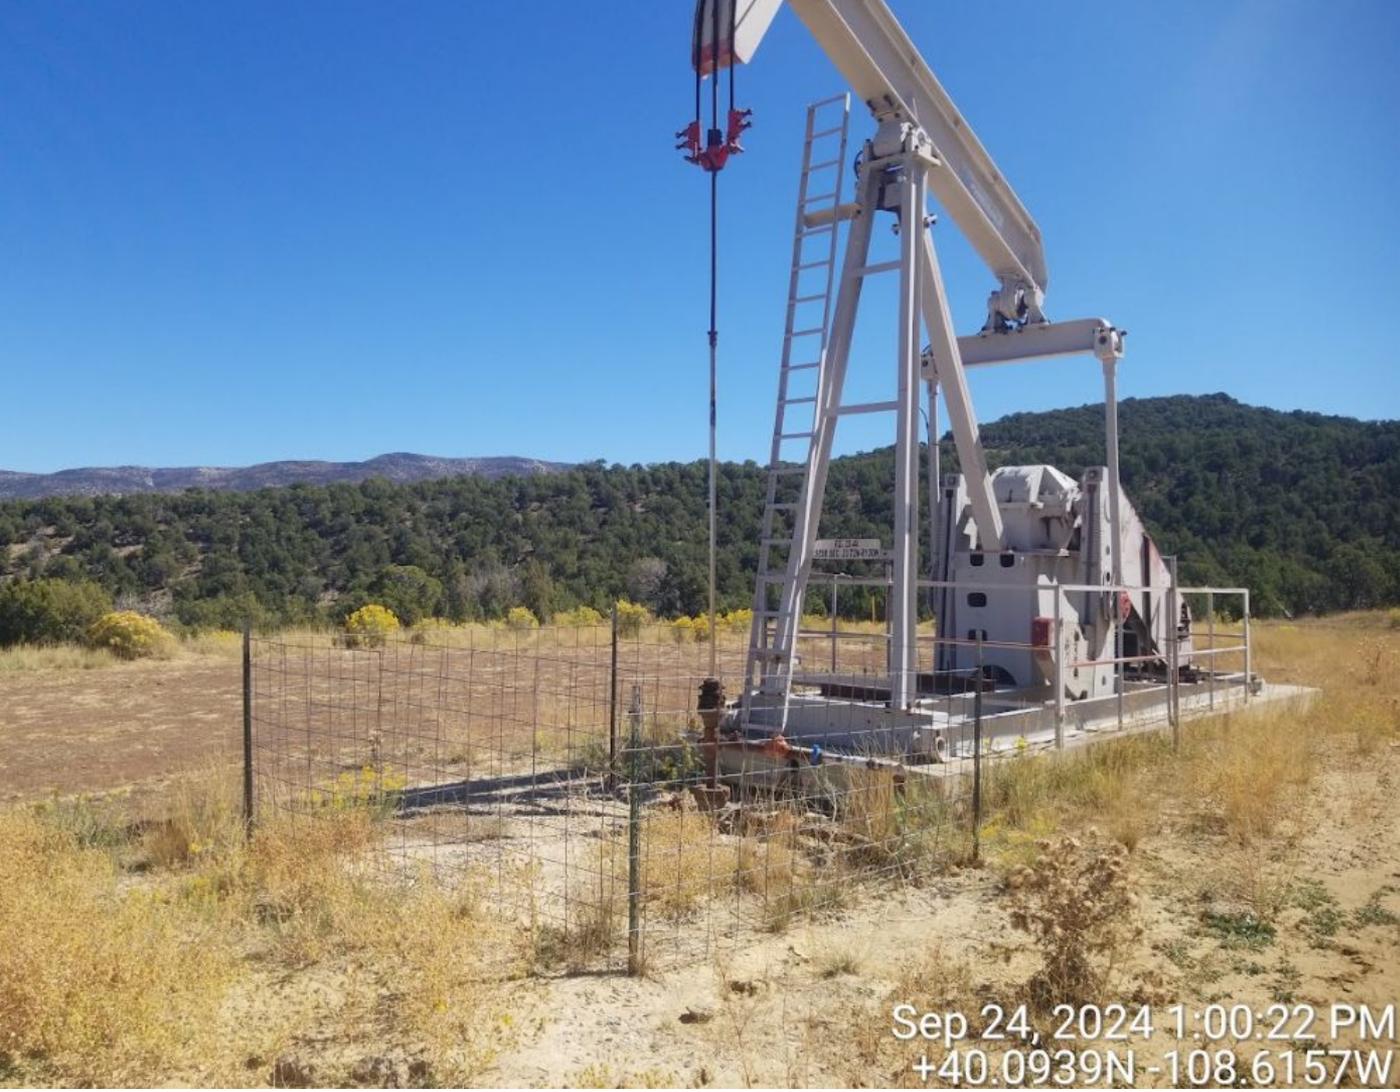
Pump jack and wellhead

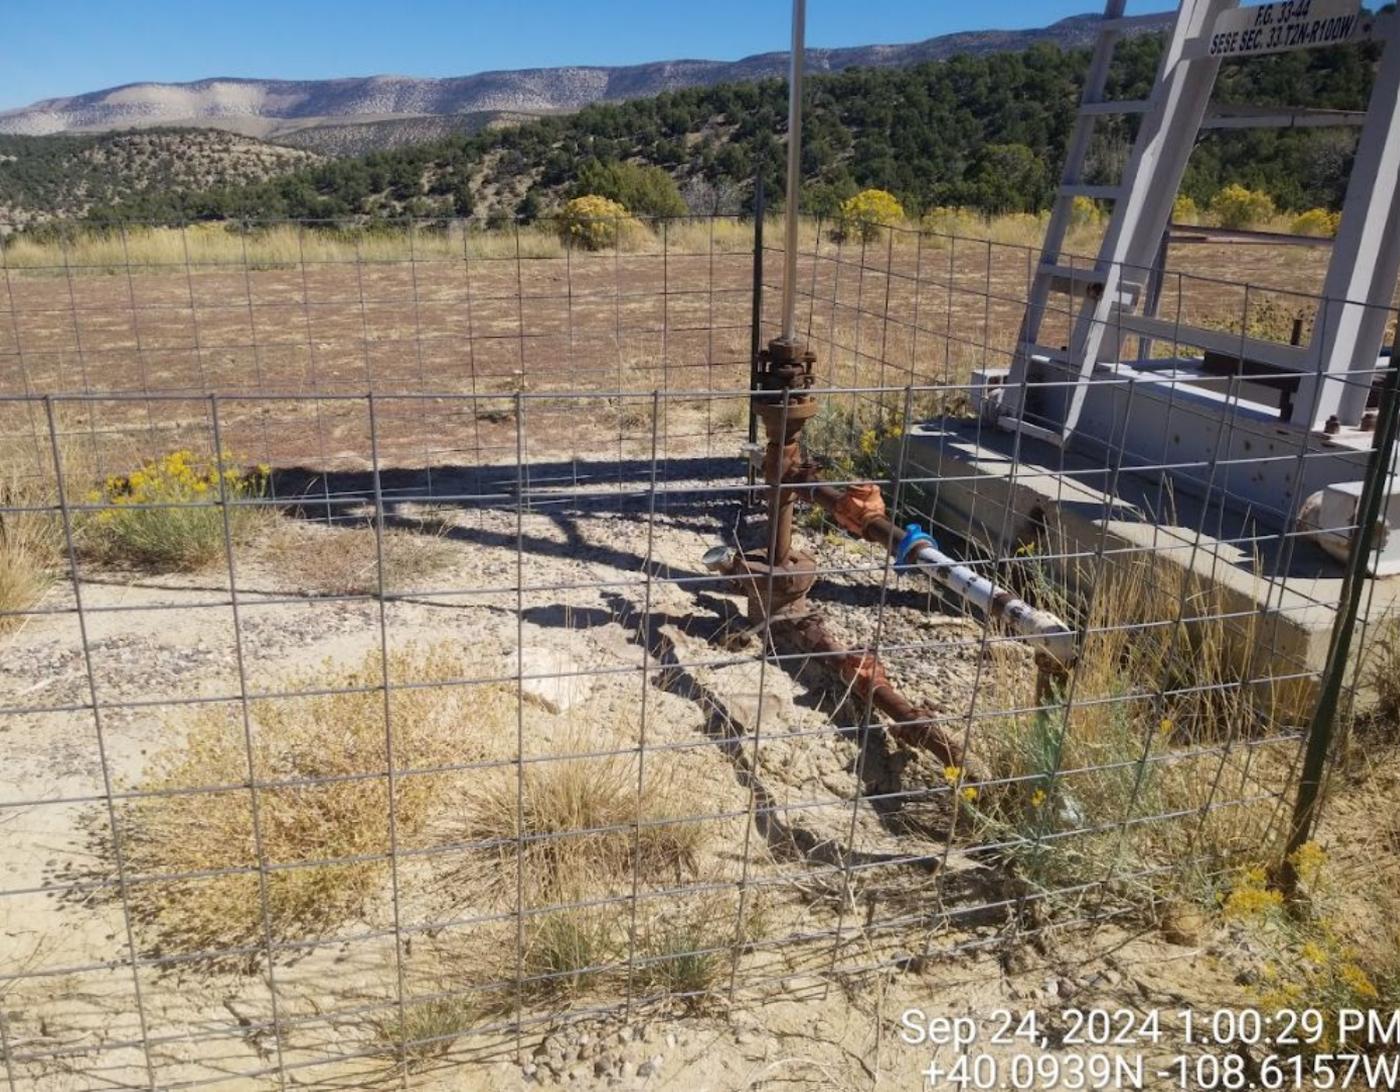
Fig. 33-44
SESE SEC. 33 T2N-R100W

Wellhead. Potentially impacted material adjacent to the wellhead, note the salt staining and lack of vegetation.

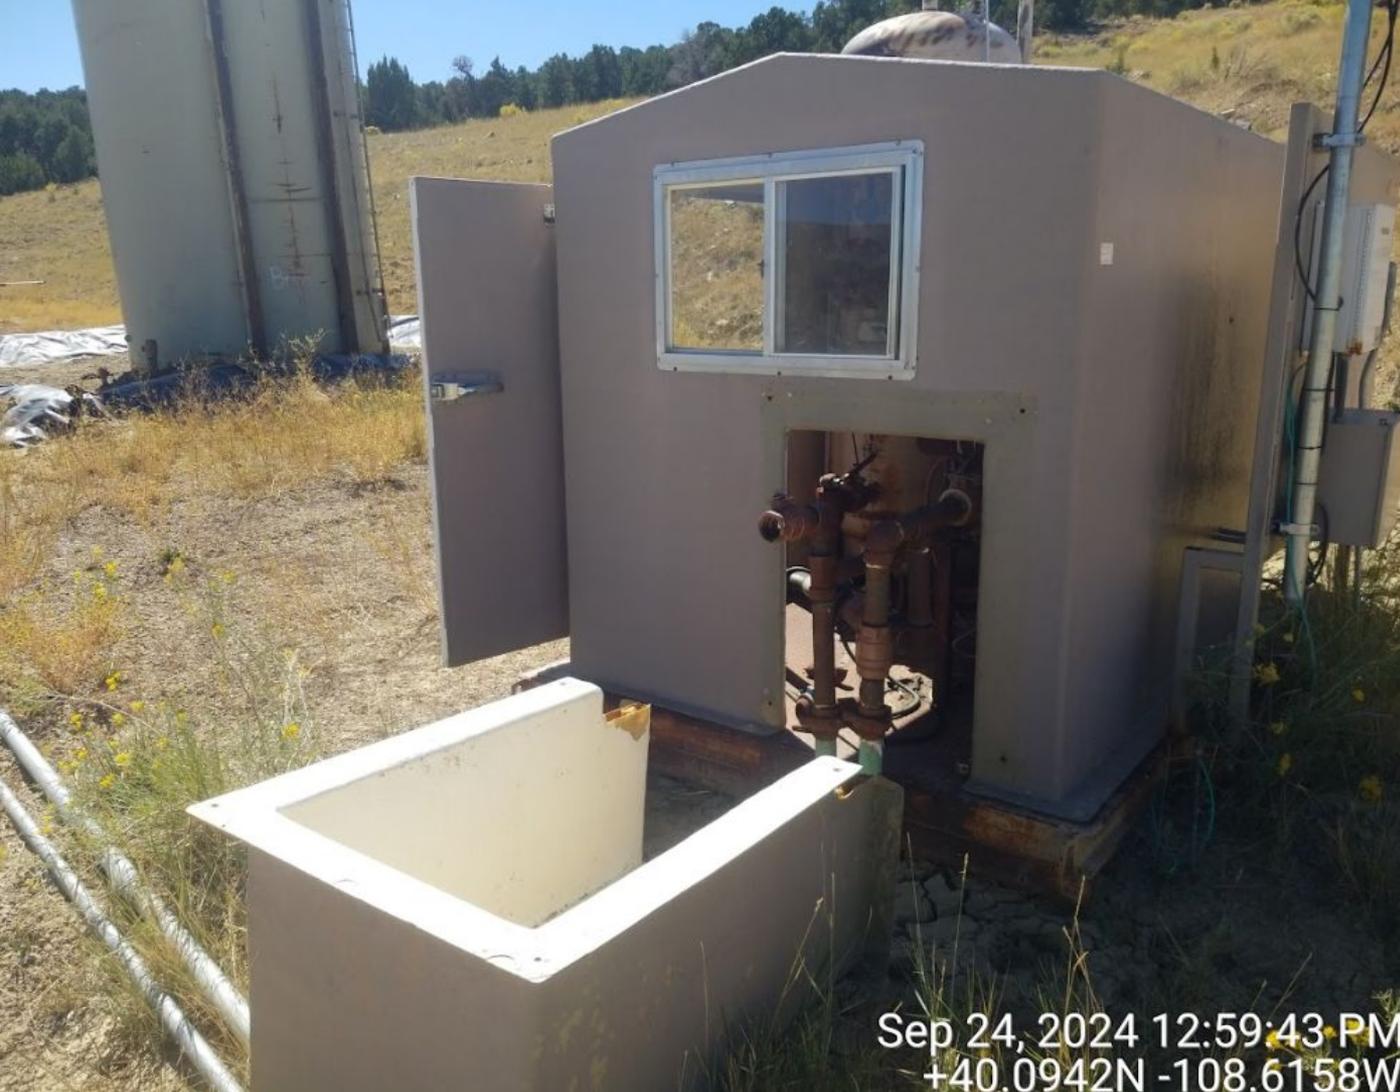
Meter house. Note the unnecessary equipment

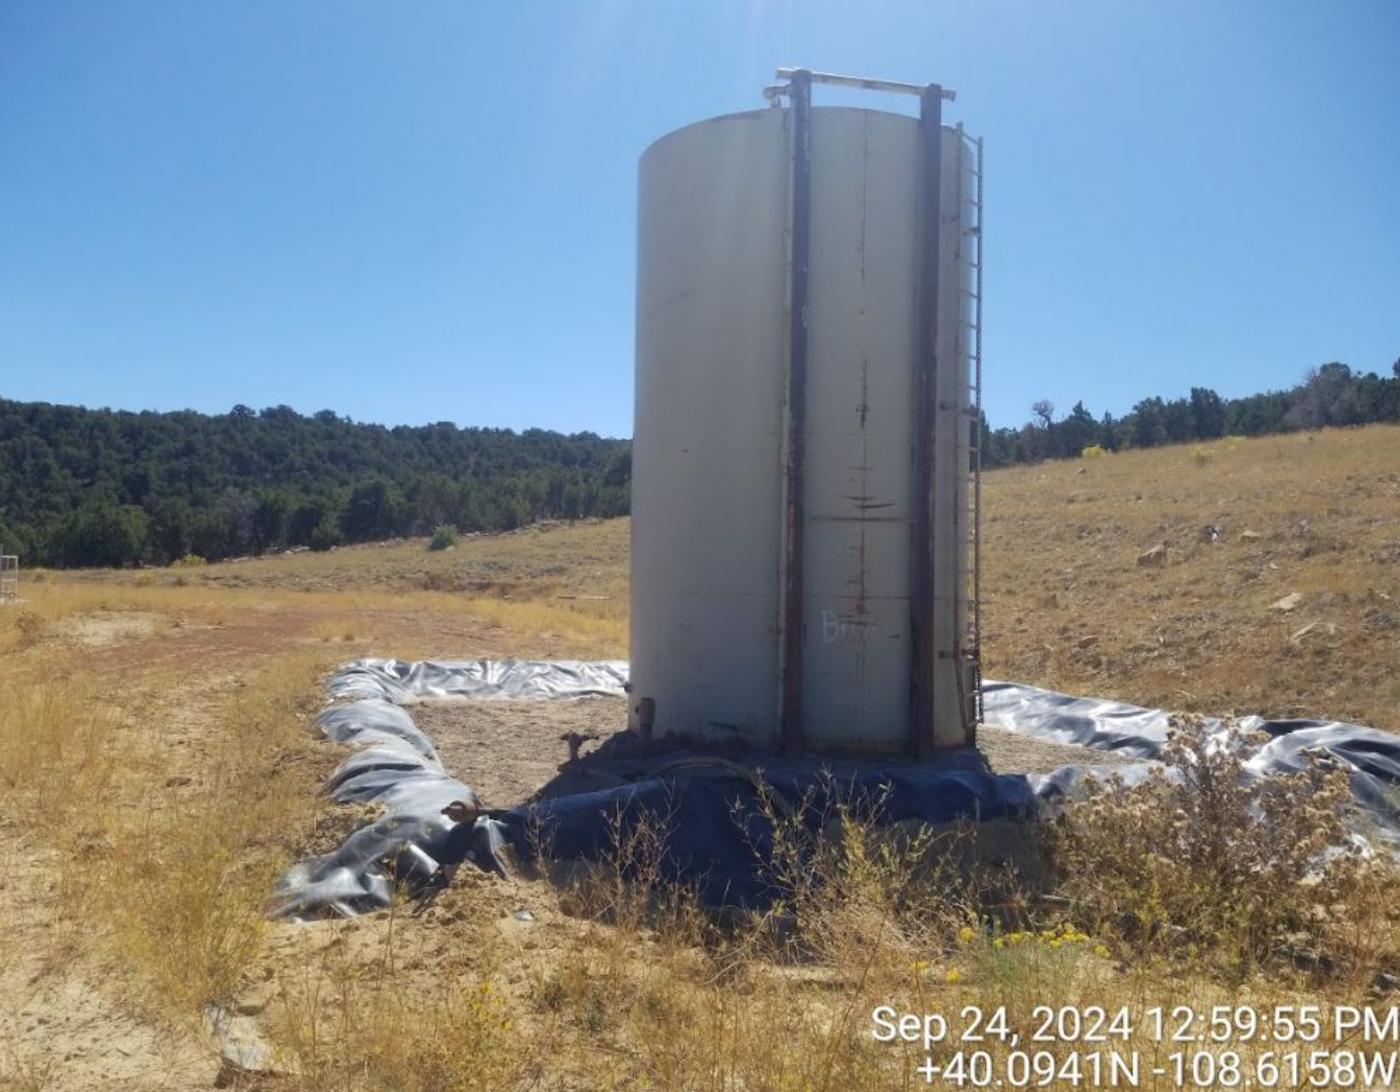
Tank battery.

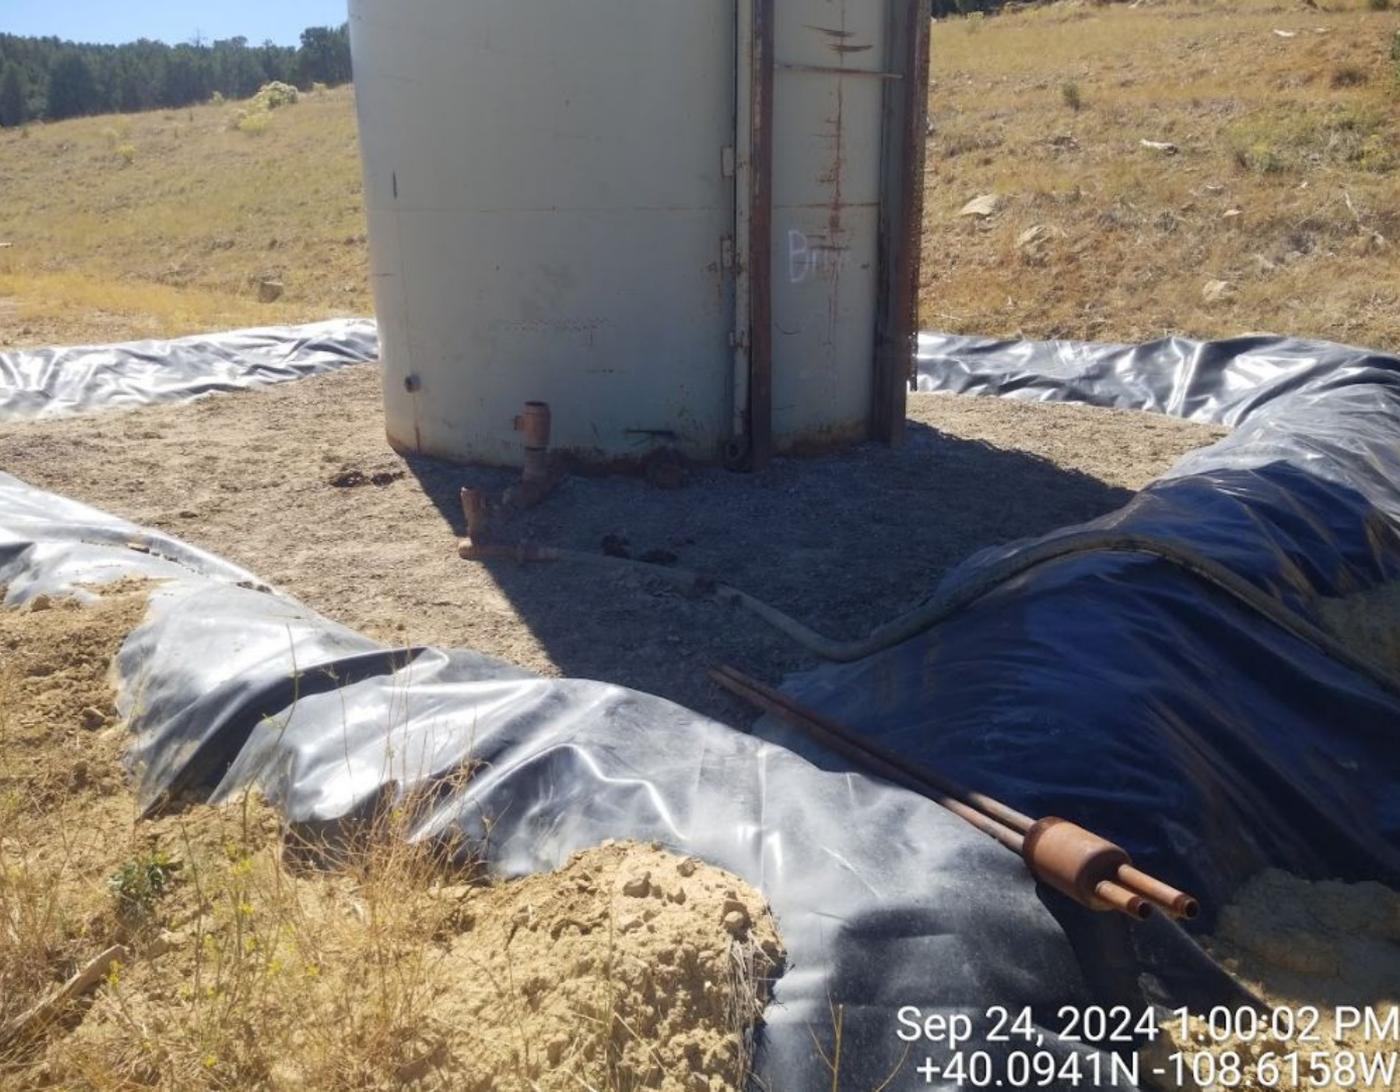
Tank battery secondary
containment structure.
