Inspection Photos
Facility 3 @ Rasmussen Flowline
Spill ID 487690

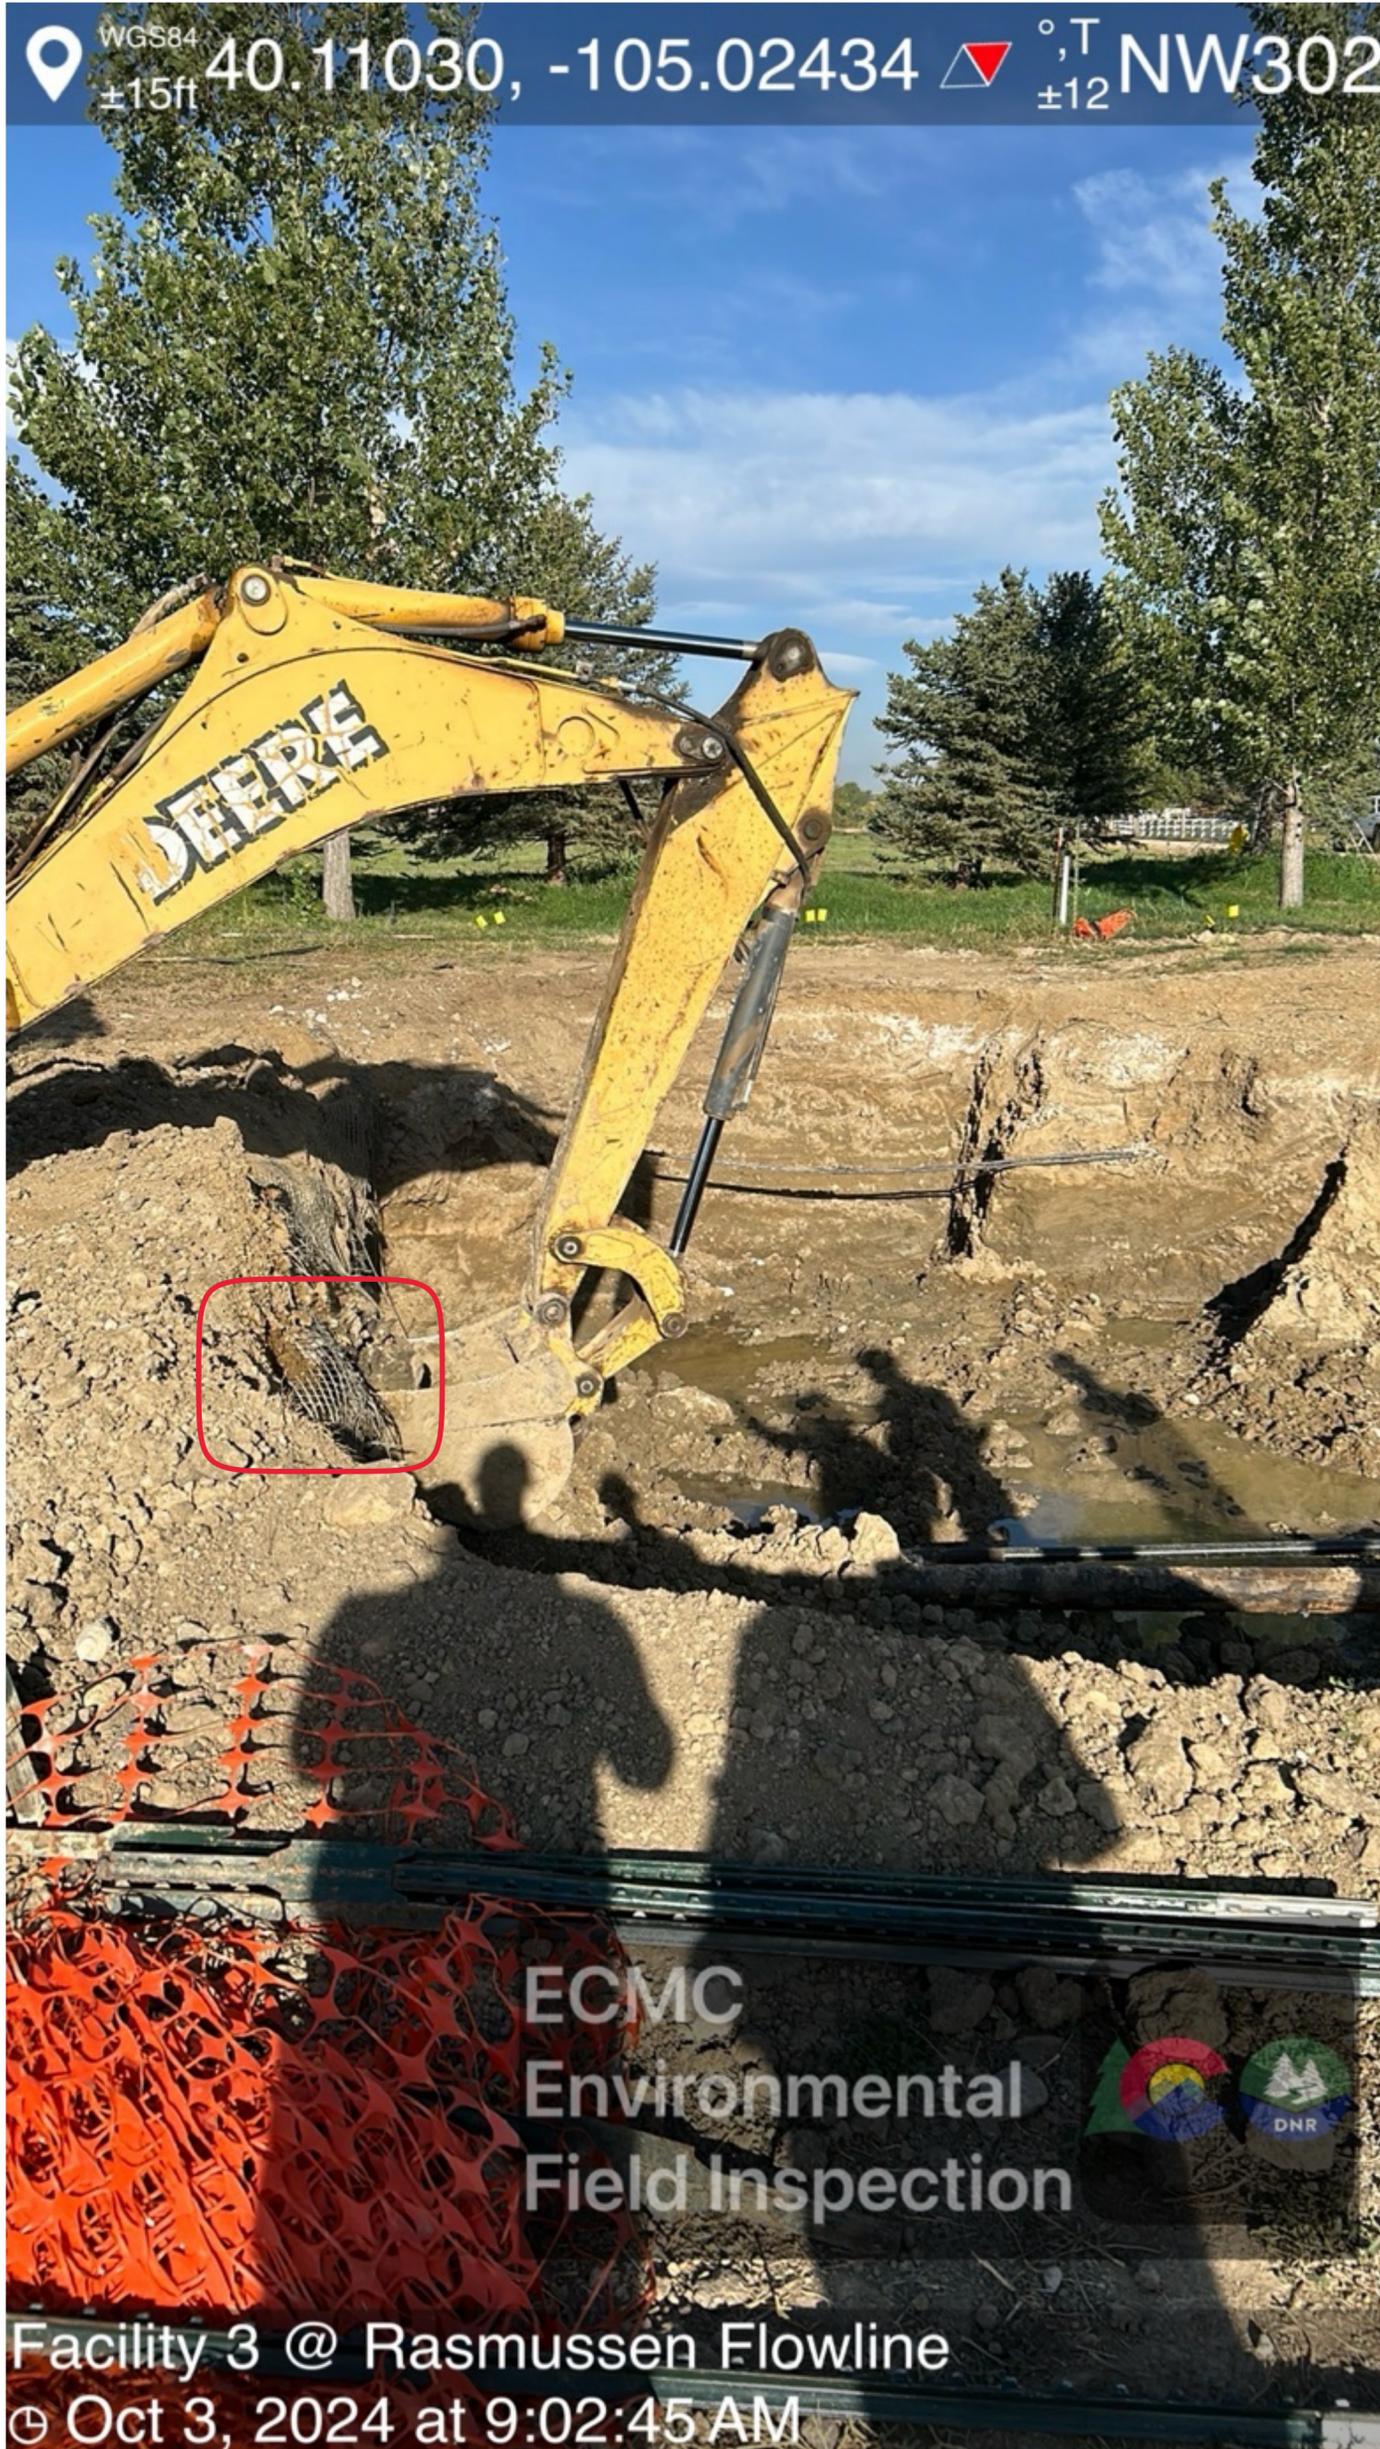
Confirmation soil sampling was conducted by Operator during ECMC inspection. Soil samples were collected in accordance with Rule 915.e.(2).b.

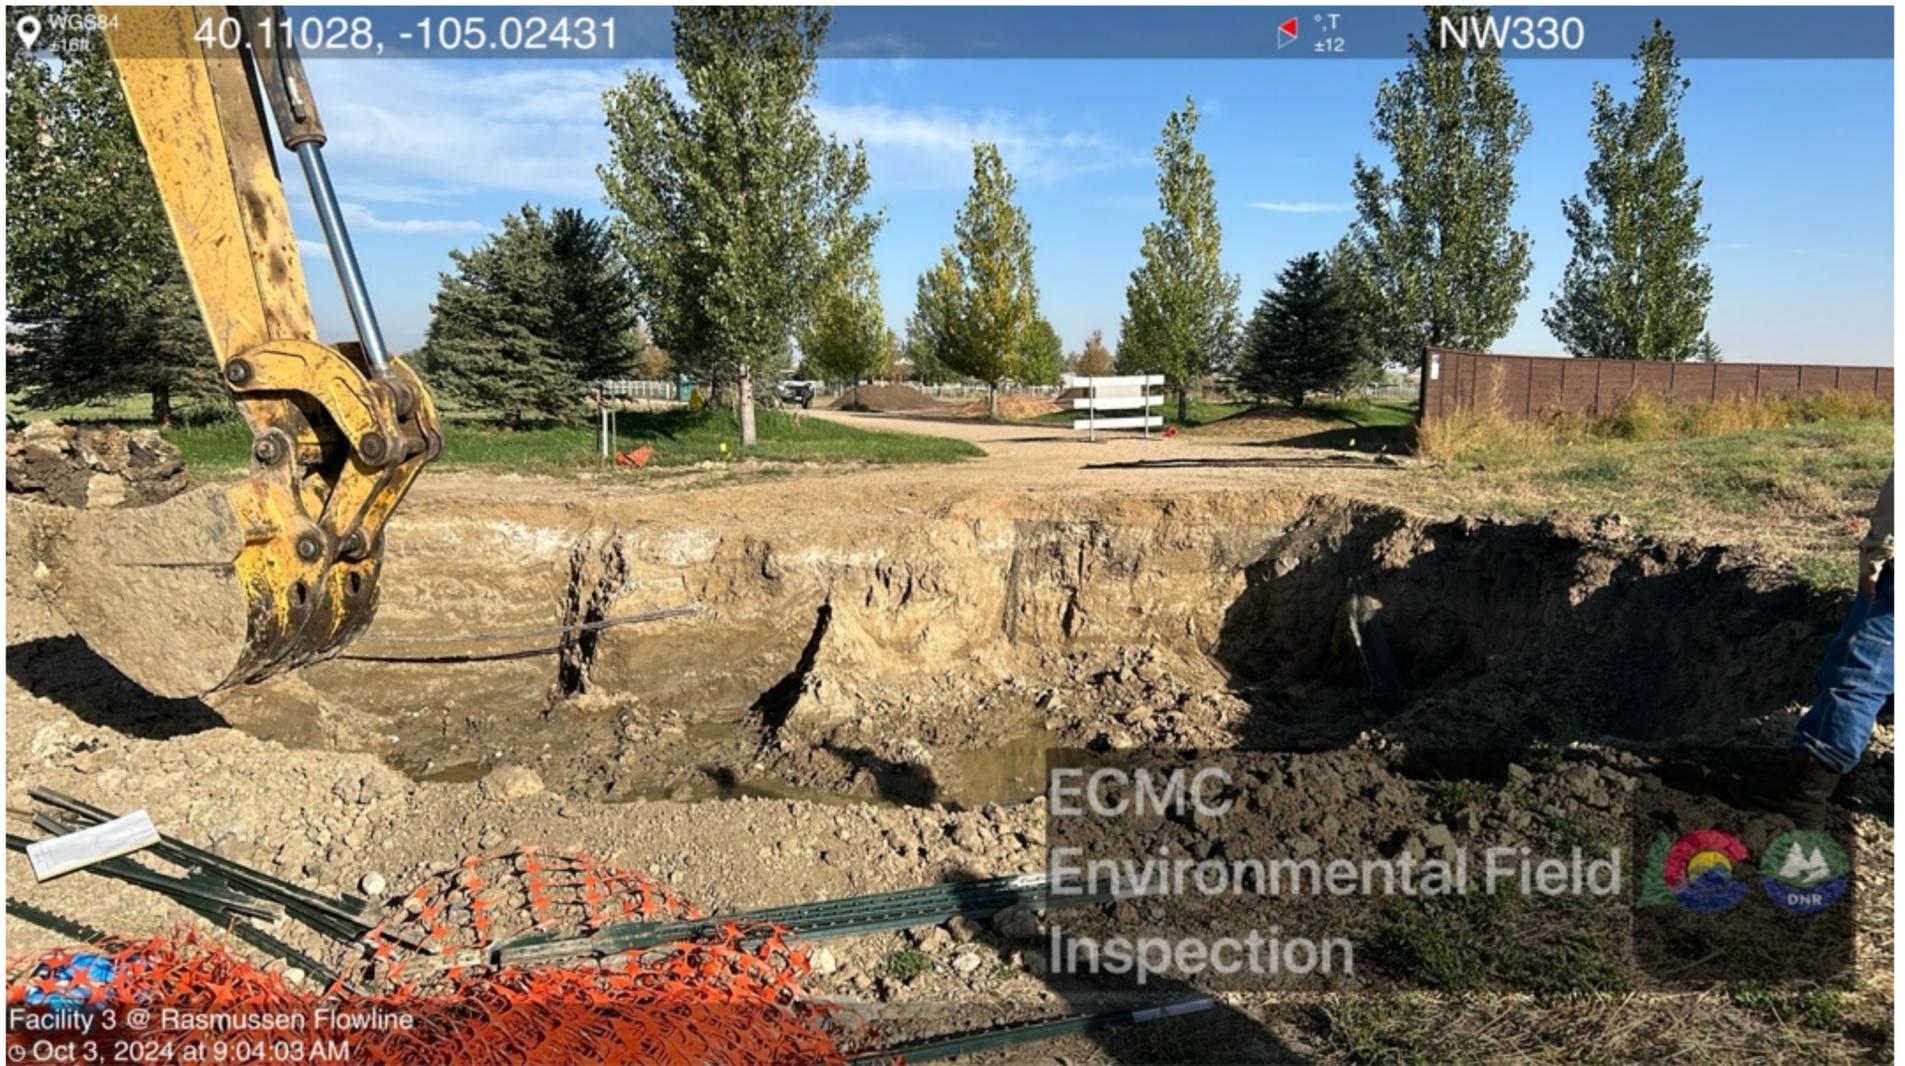
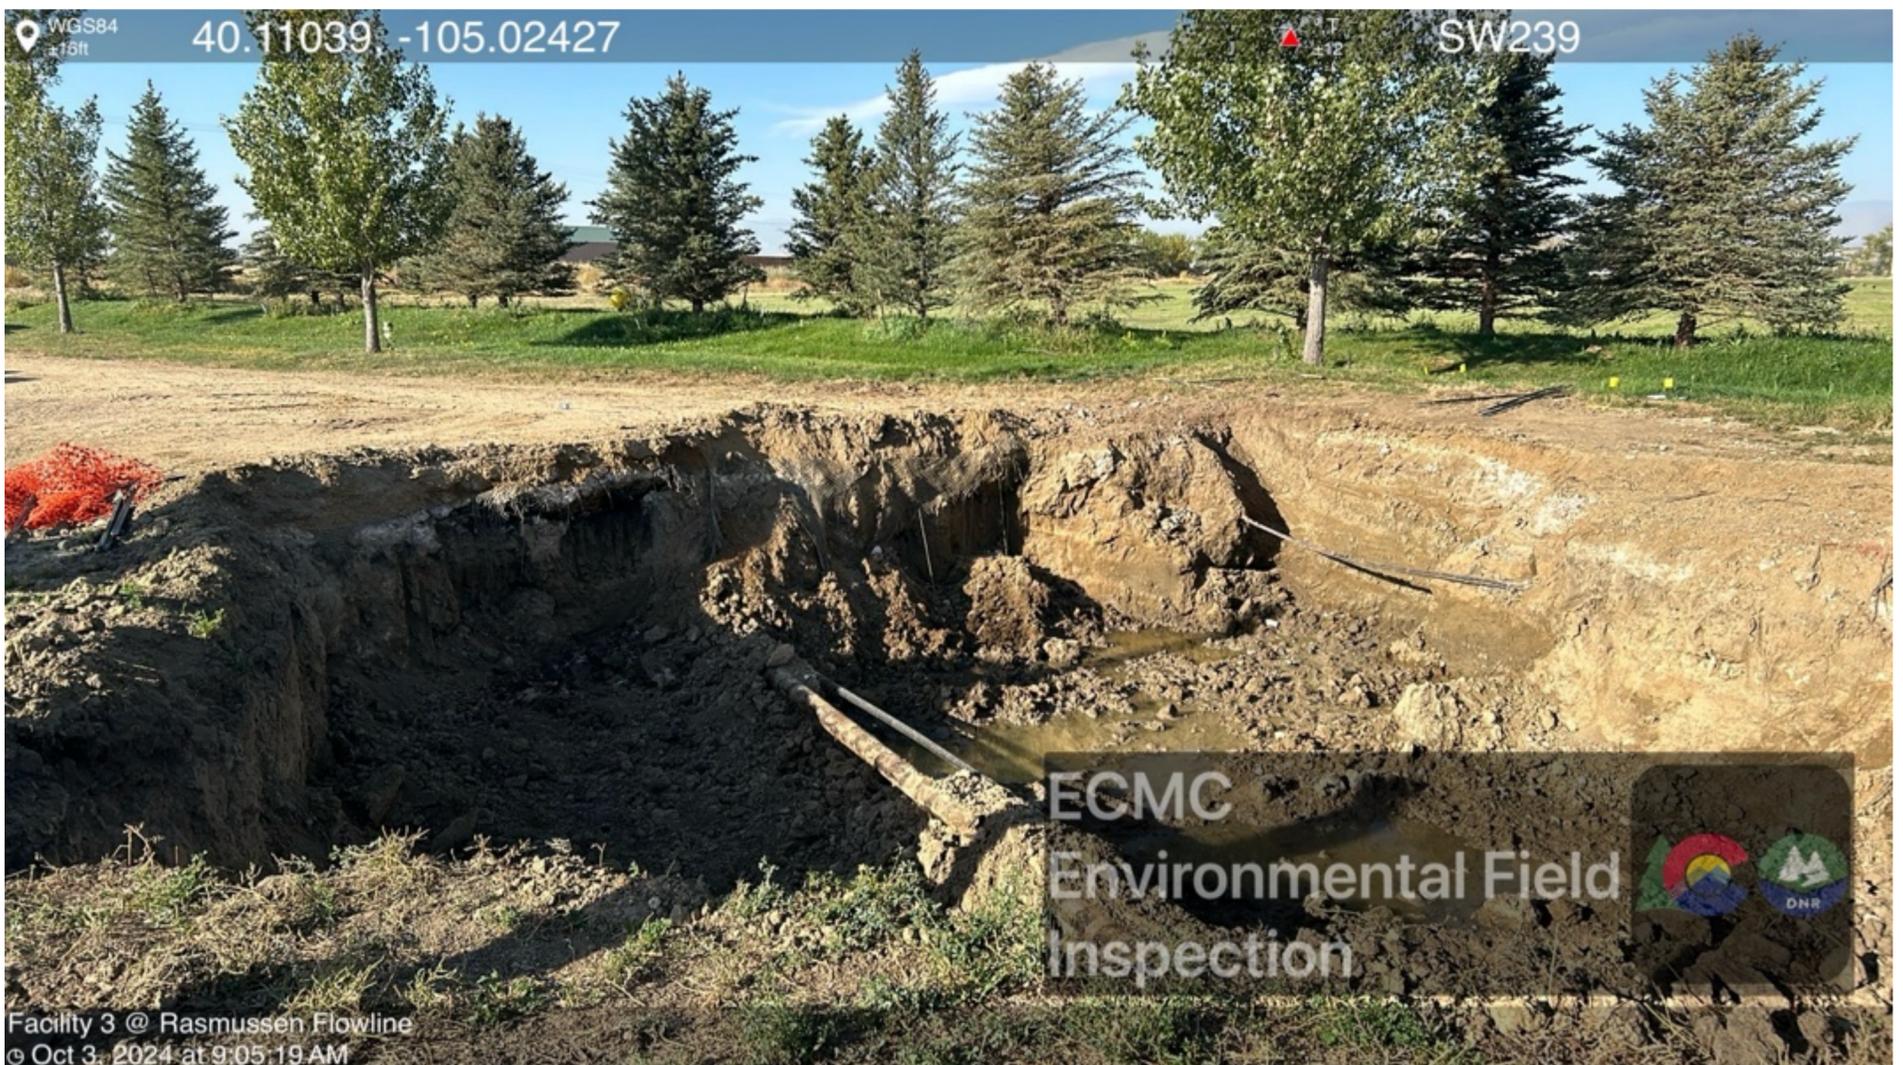
Confirmation soil sampling was conducted by Operator during ECMC inspection. Soil samples were collected in accordance with Rule 915.e.(2).b.

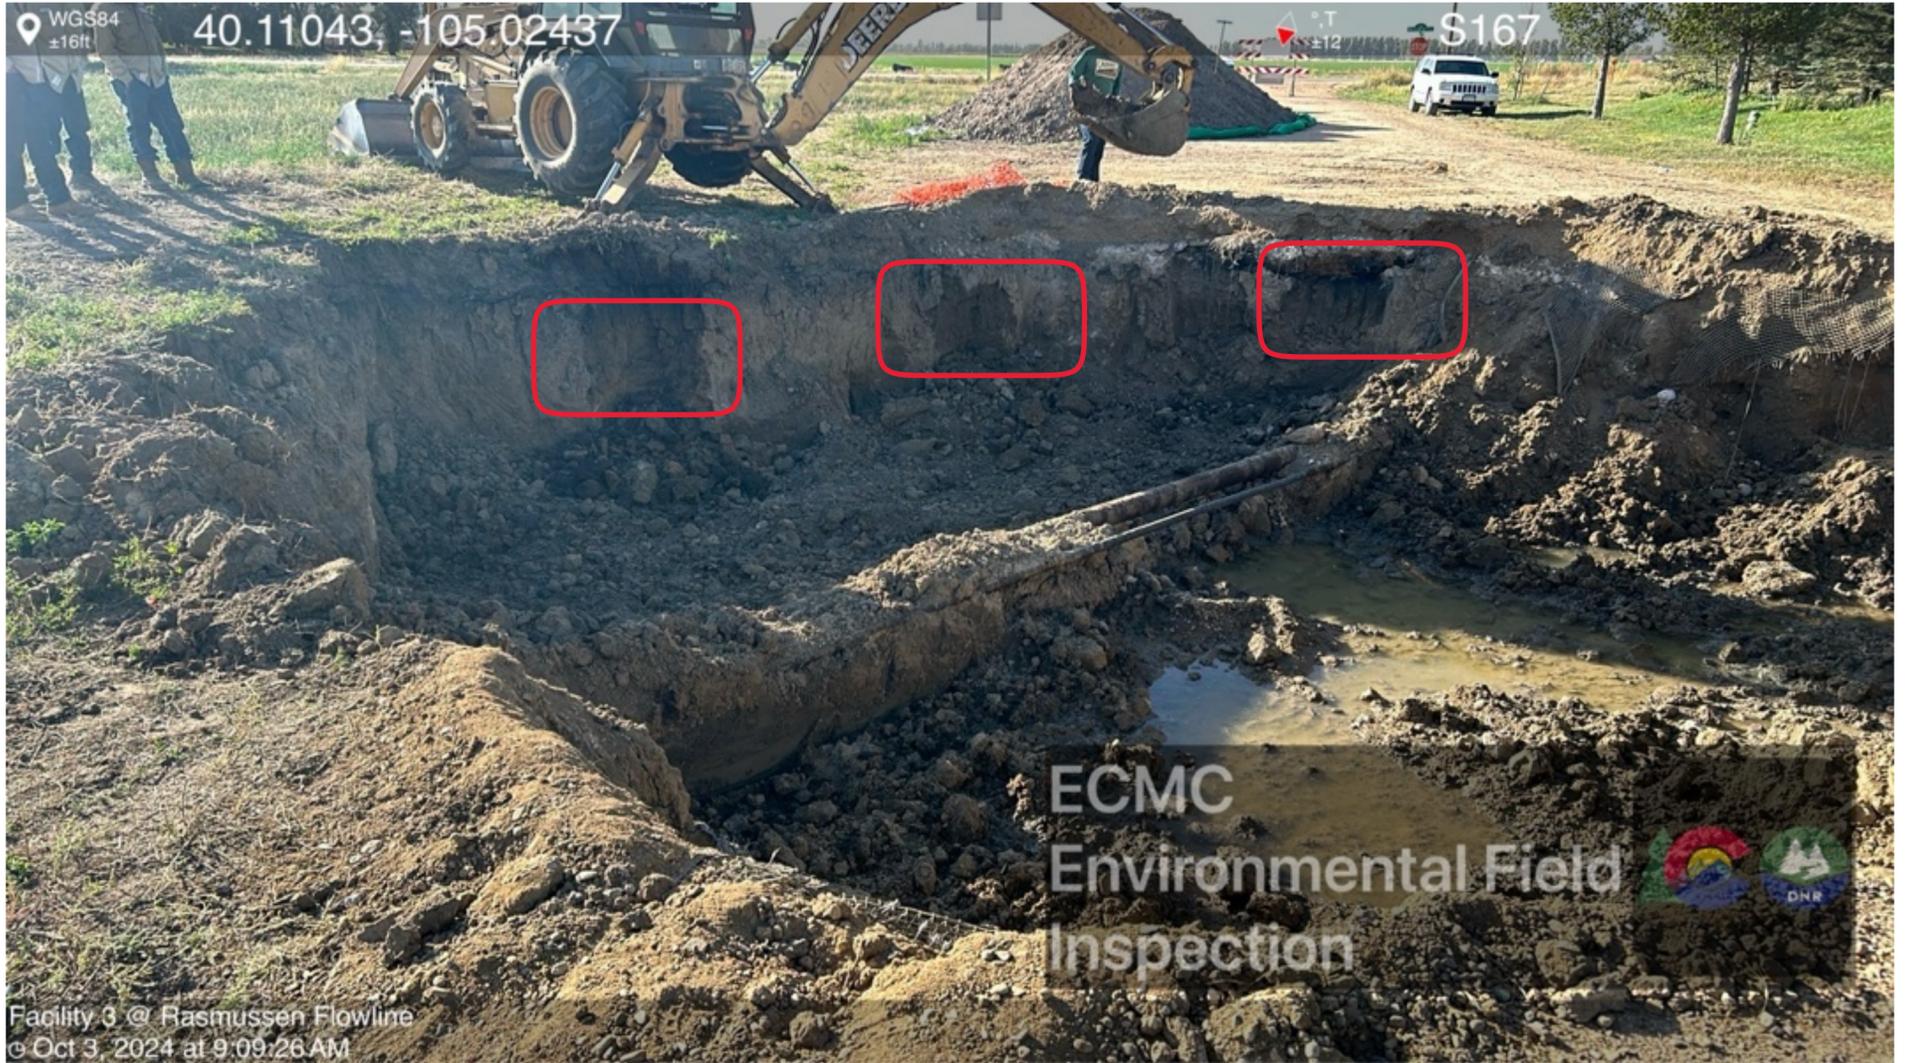
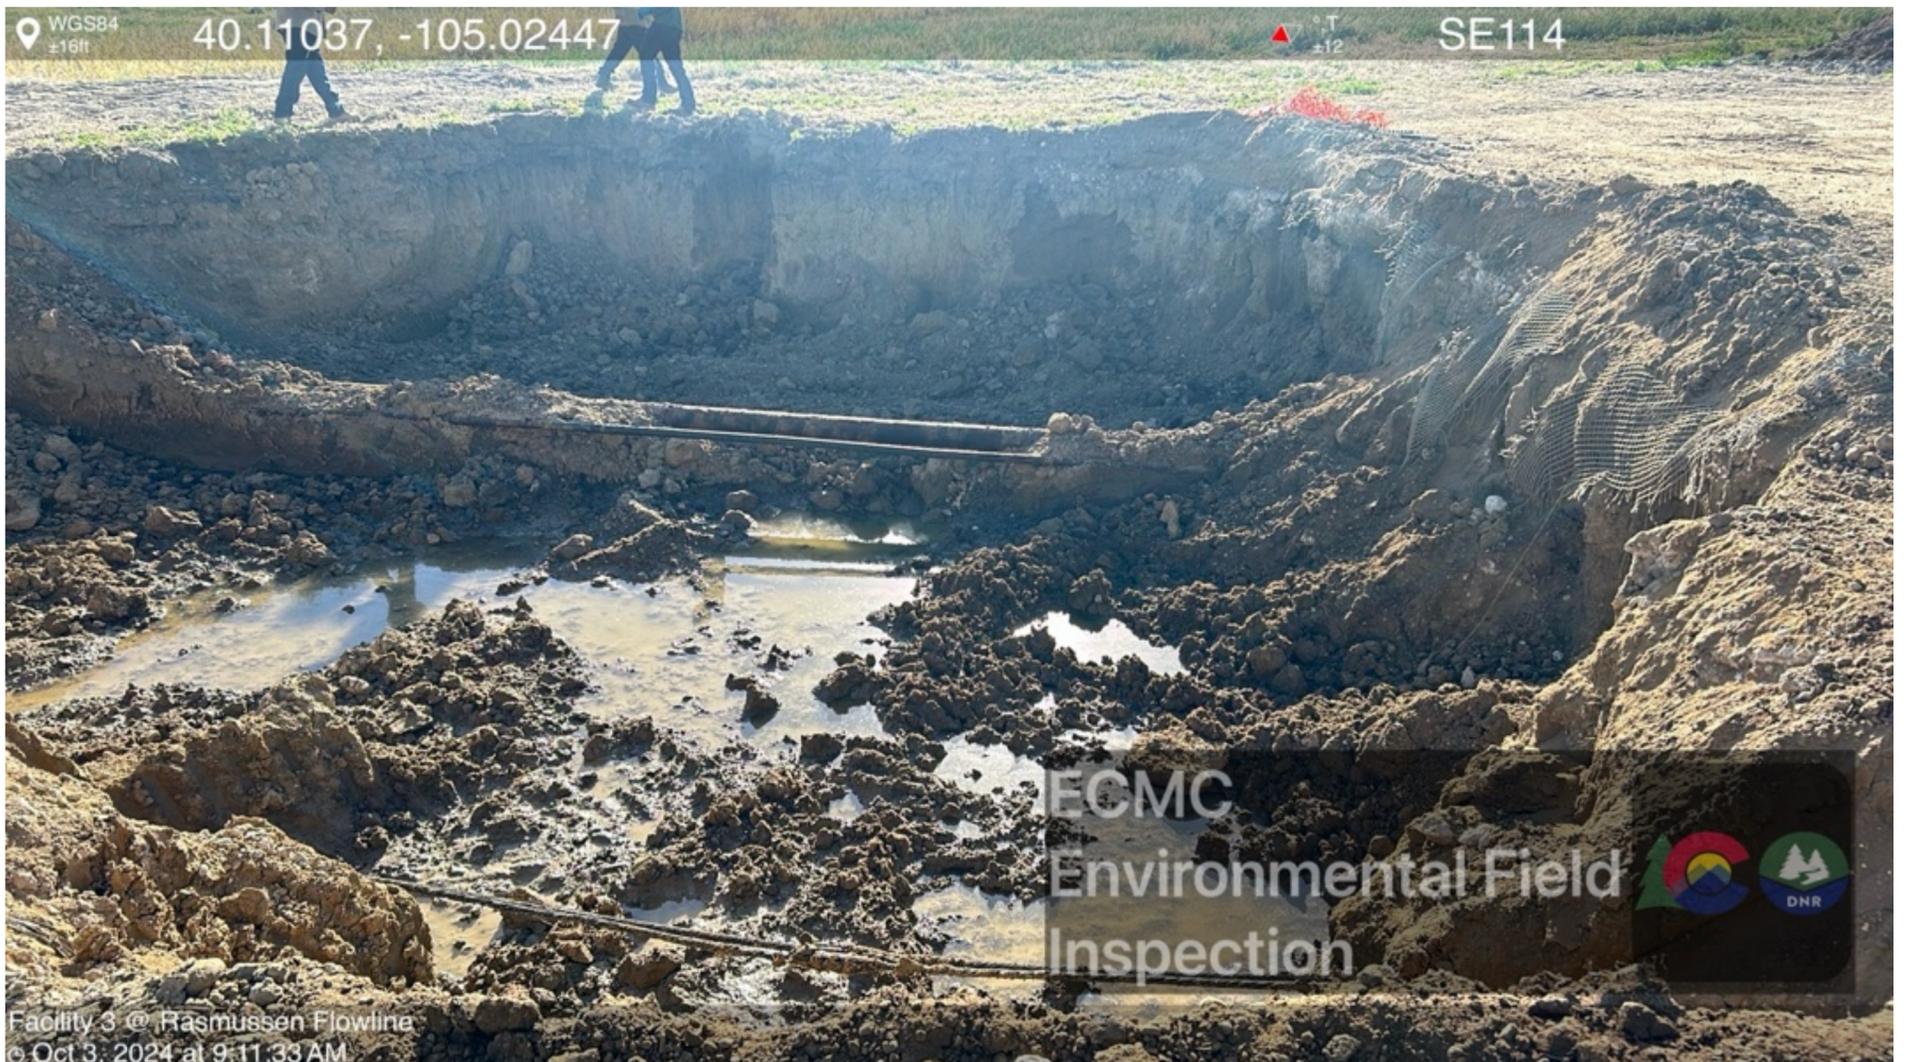
Confirmation soil sampling was conducted by Operator during ECMC inspection. Soil samples were collected in accordance with Rule 915.e.(2).b.

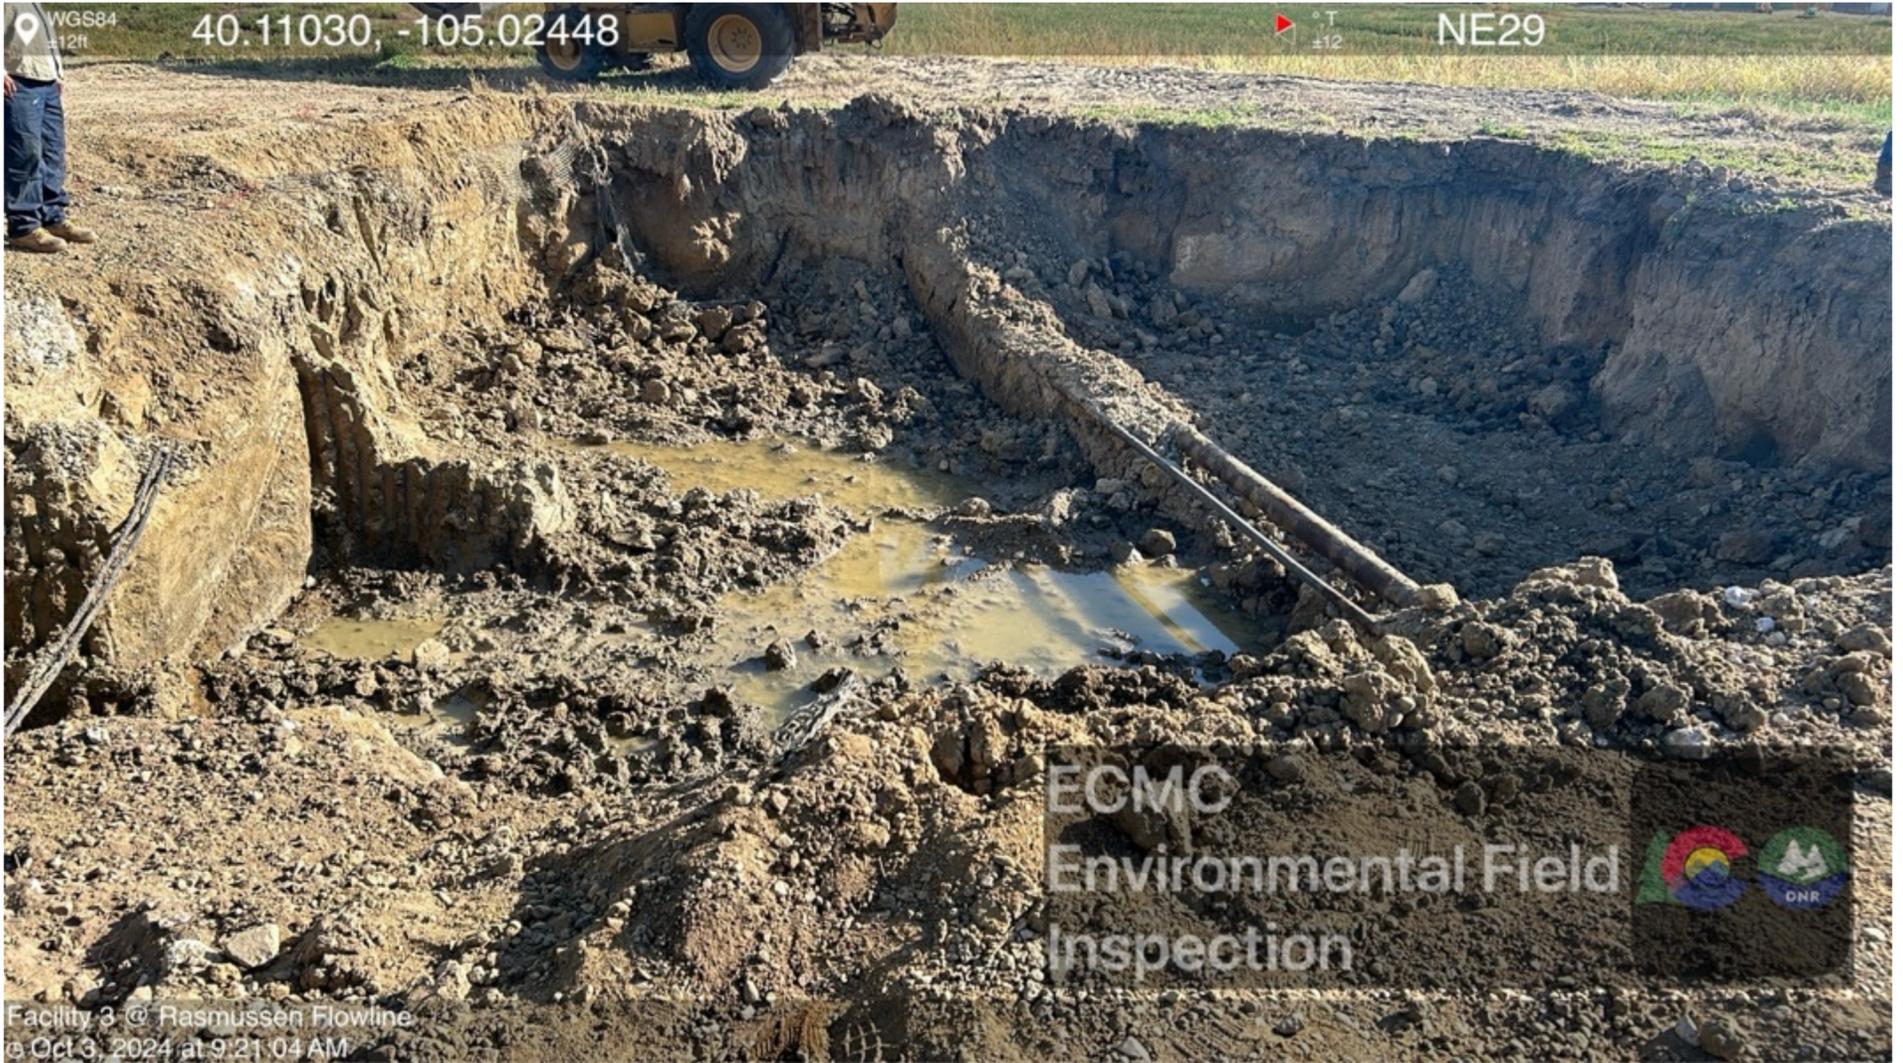
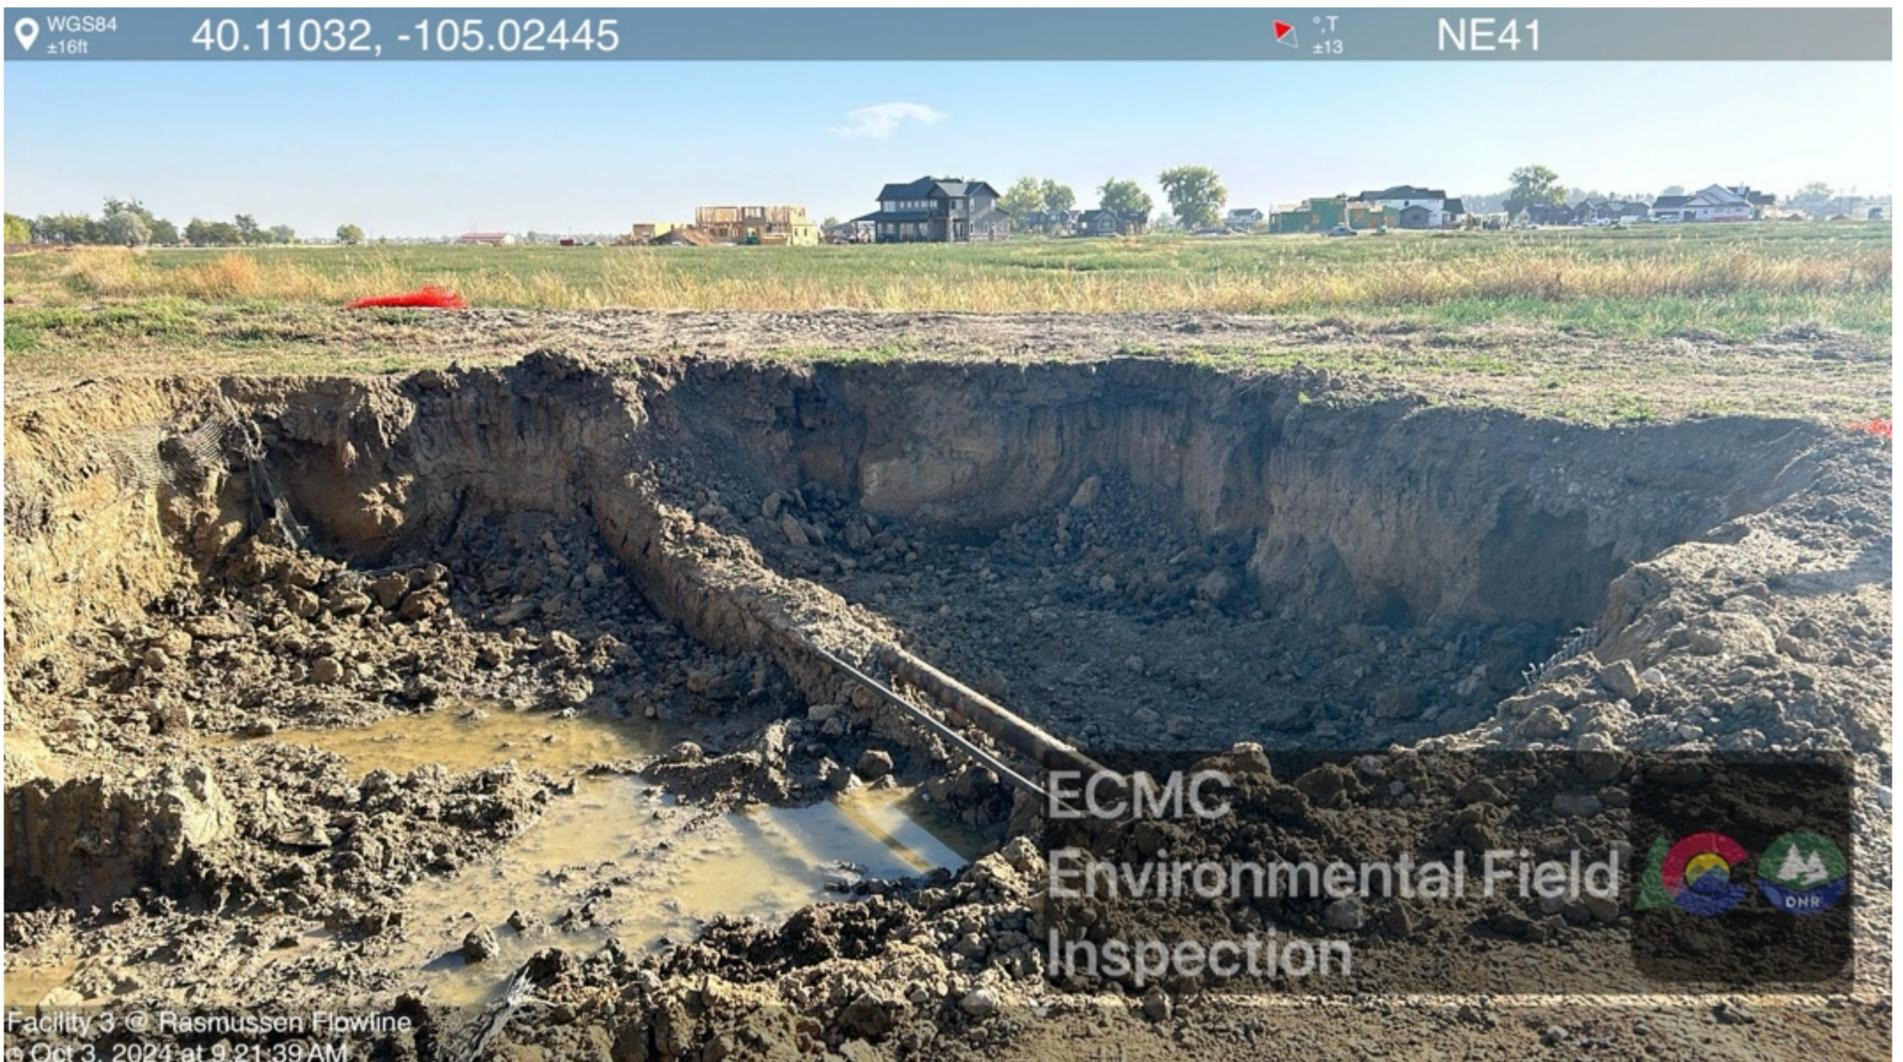
Groundwater with free product was observed at the base of the excavation.

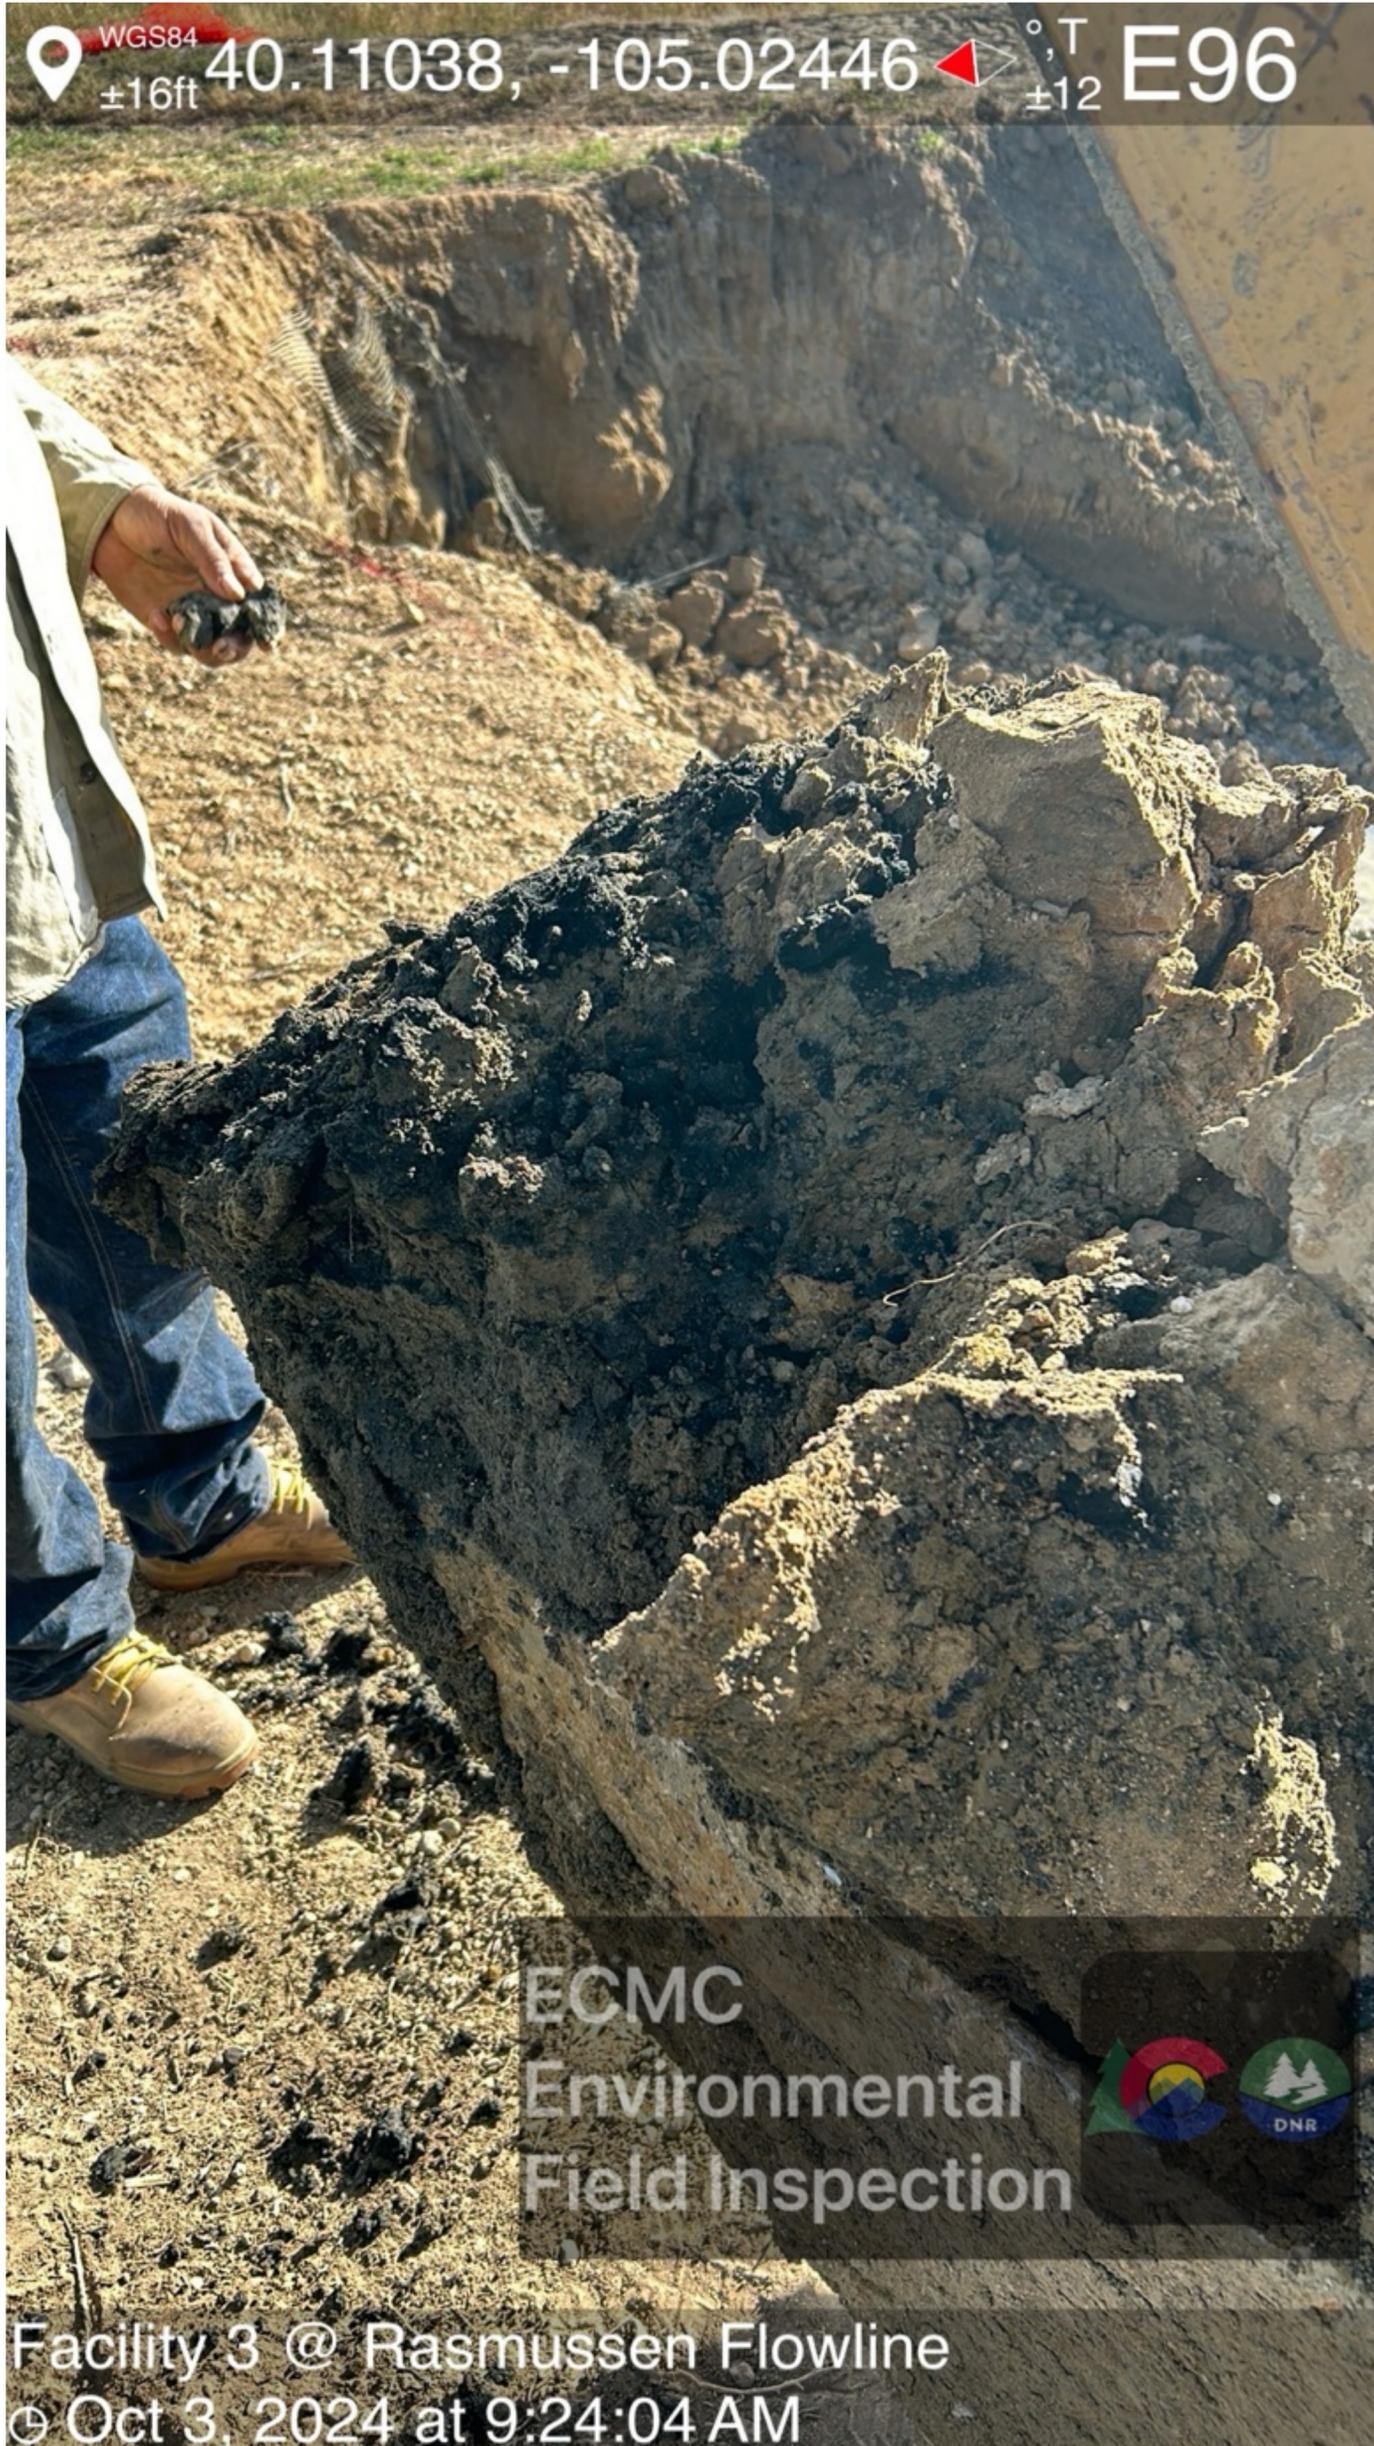
Black staining was observed along portions of the western sidewall. A strong petroleum hydrocarbon odor was observed when soil in this area was disturbed.

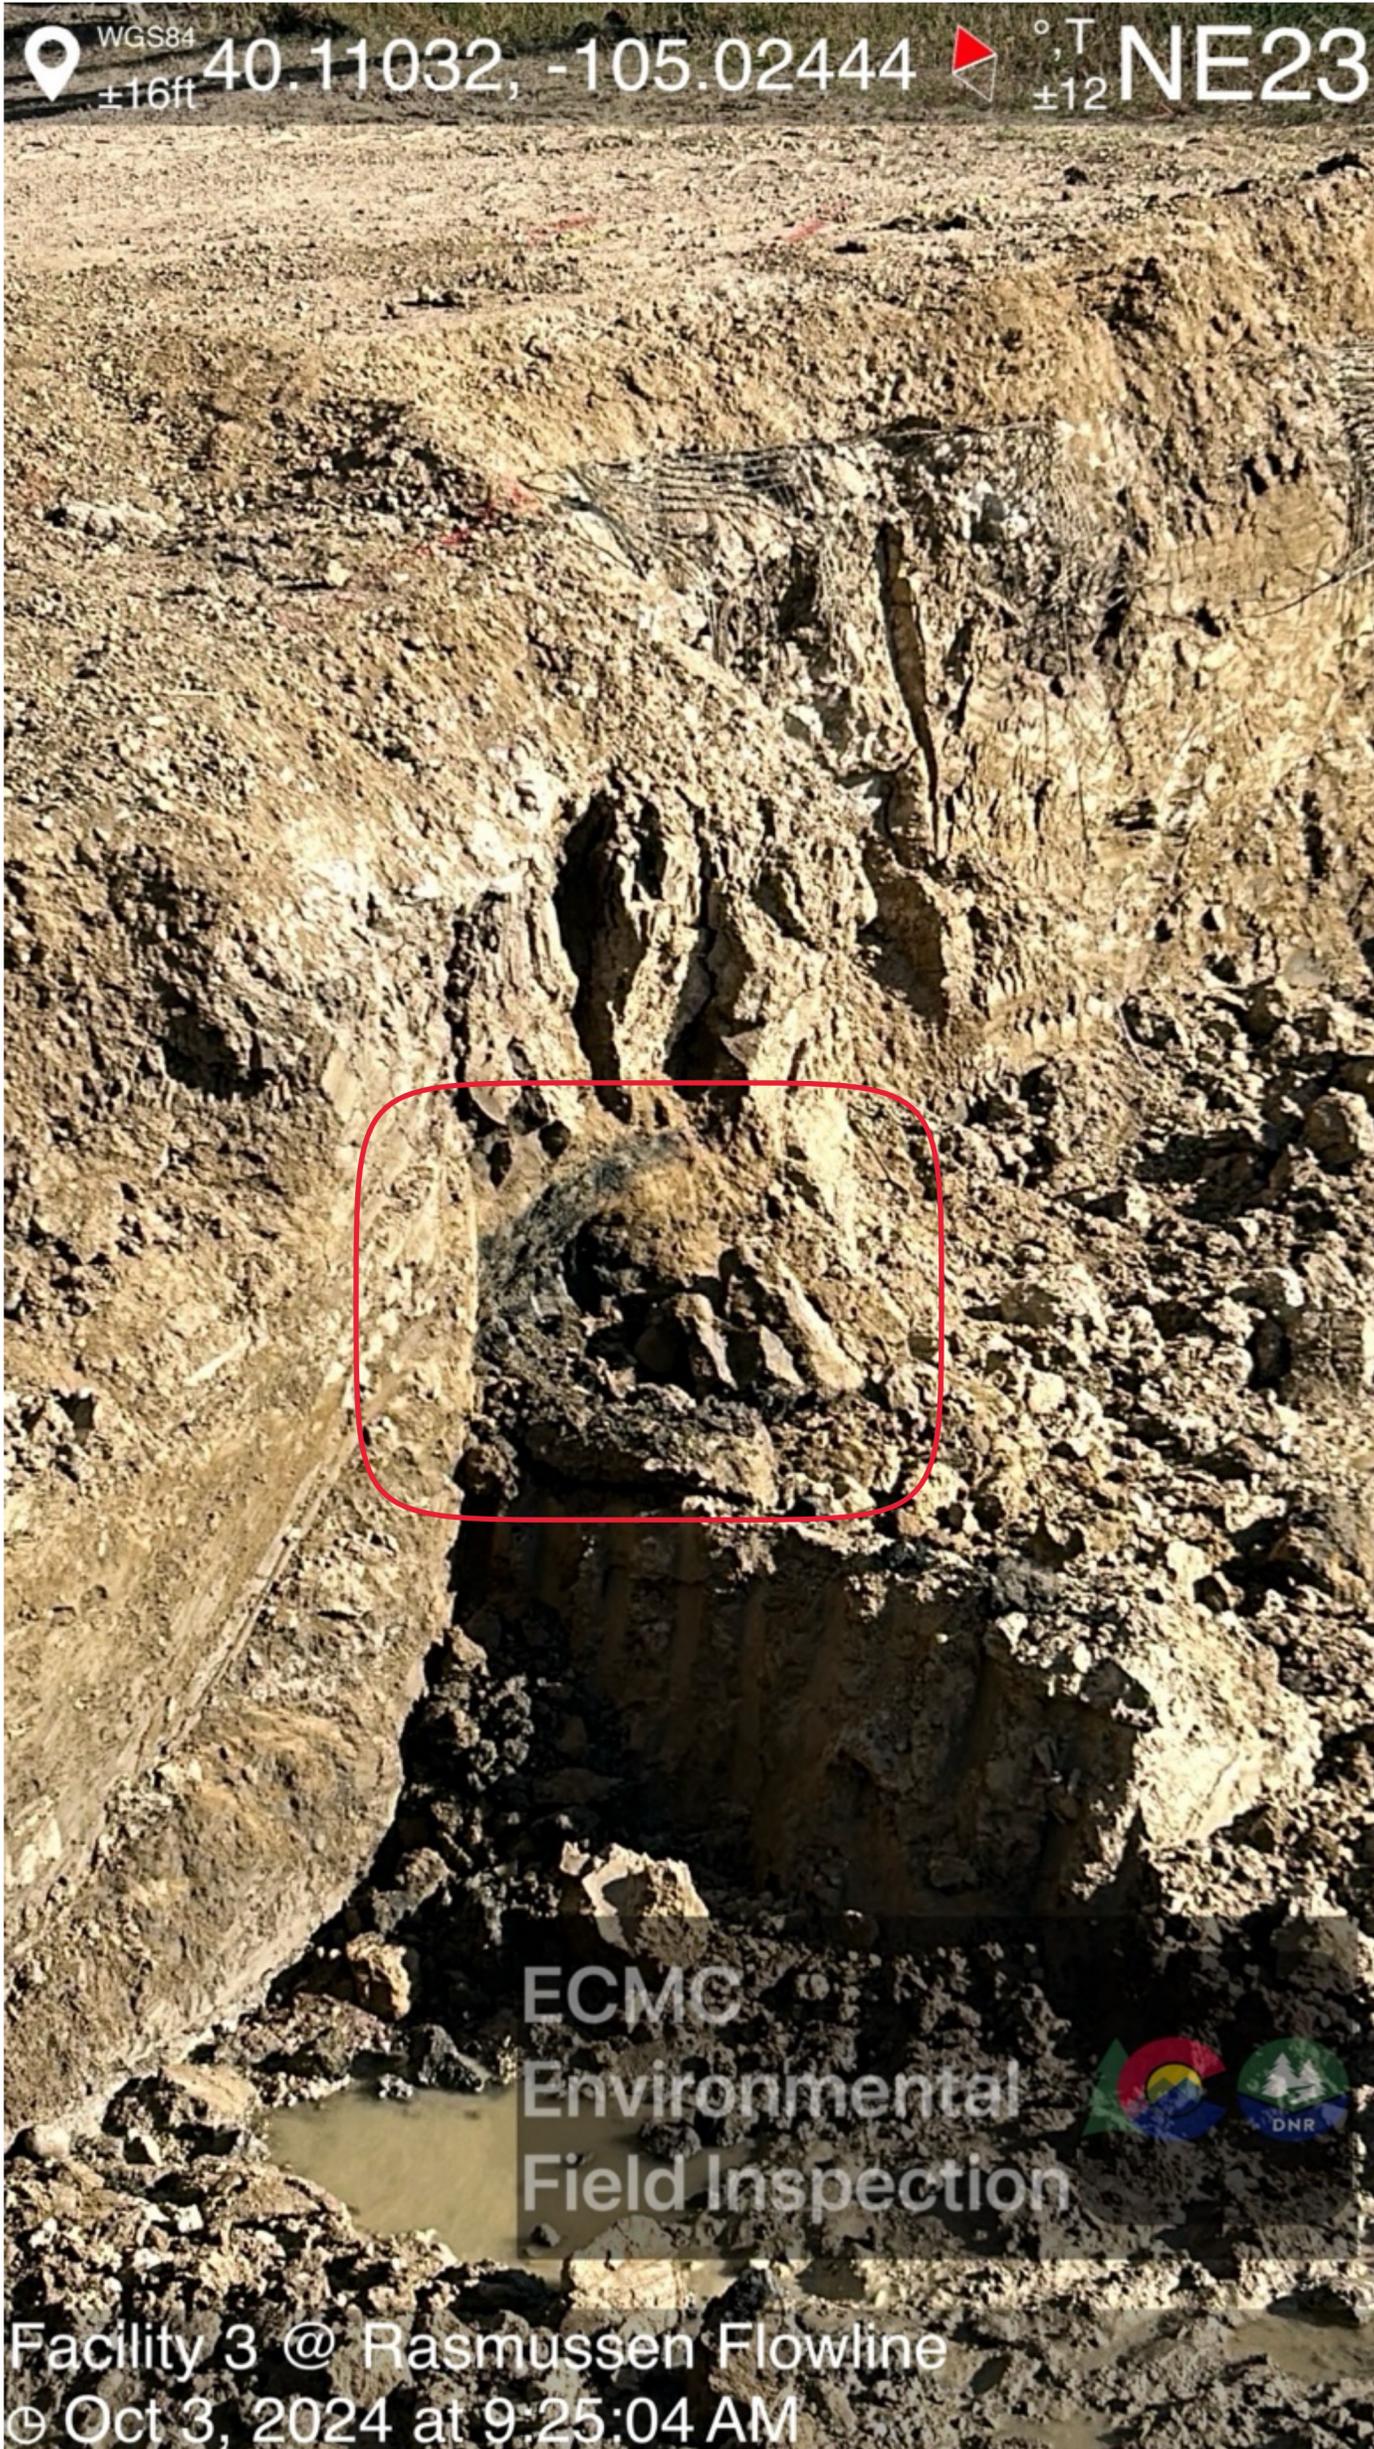
Black staining was observed along portions of the western sidewall. A strong petroleum hydrocarbon odor was observed when soil in this area was disturbed.
