Inspection Photos
Facility 3 @ Rasmussen Flowline
Spill ID 487690

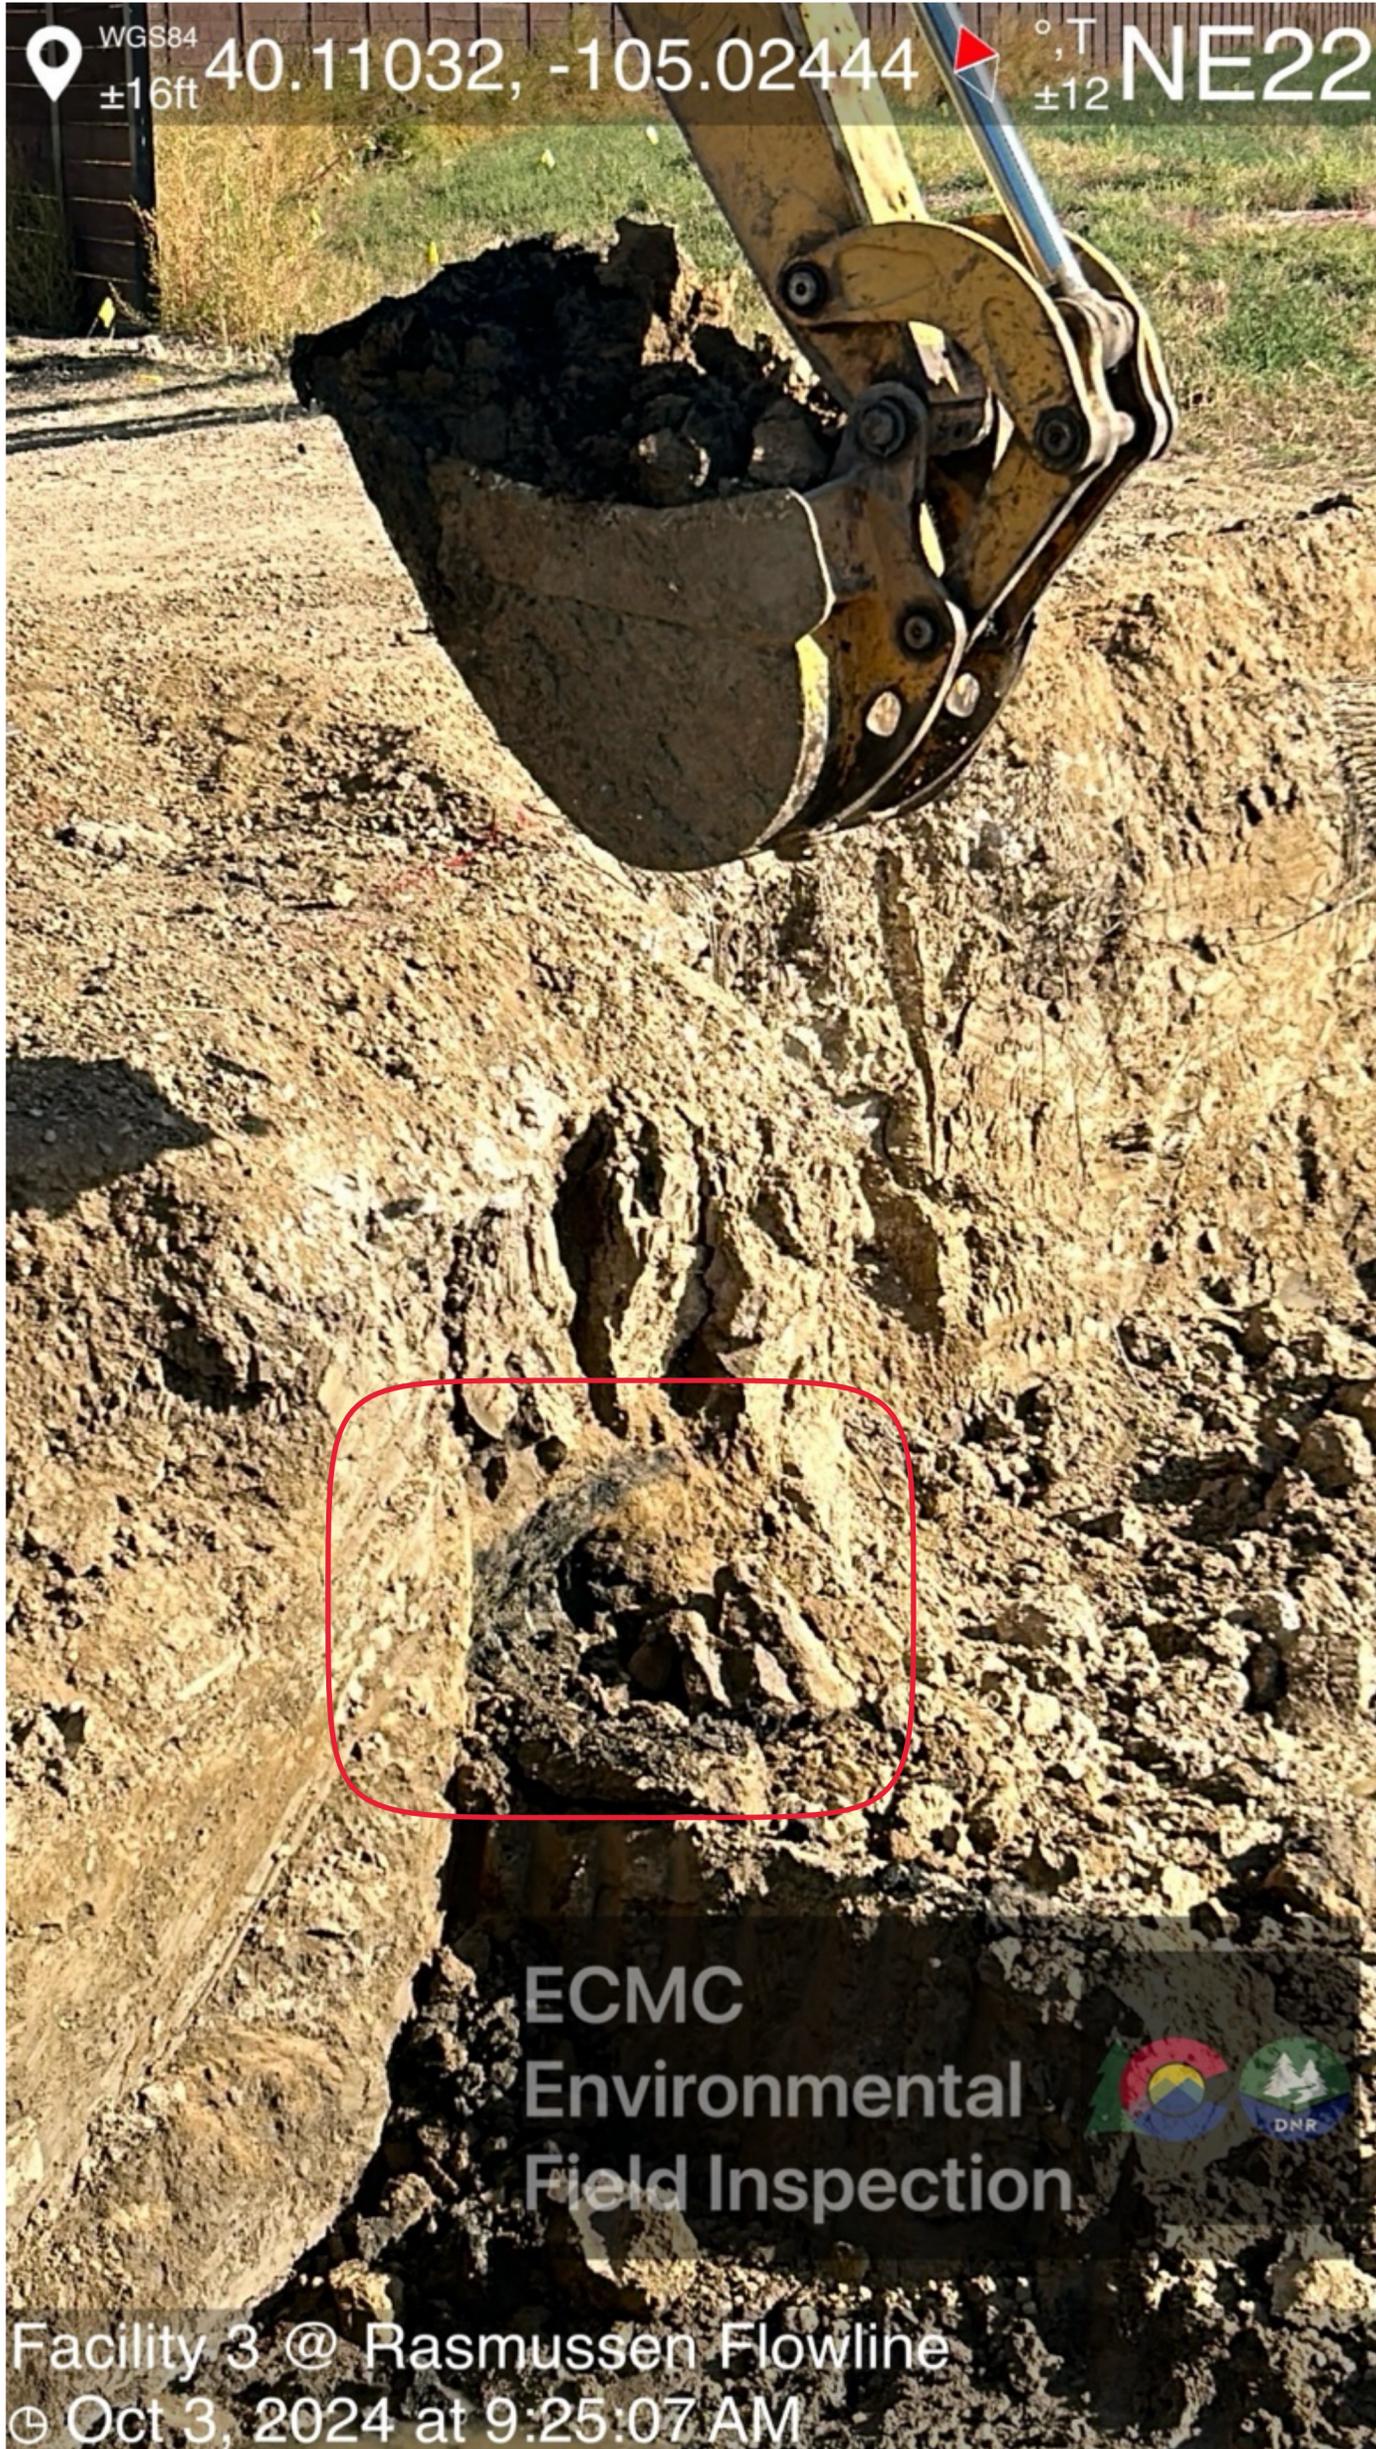
Black staining was observed along portions of the western sidewall. A strong petroleum hydrocarbon odor was observed when soil in this area was disturbed.

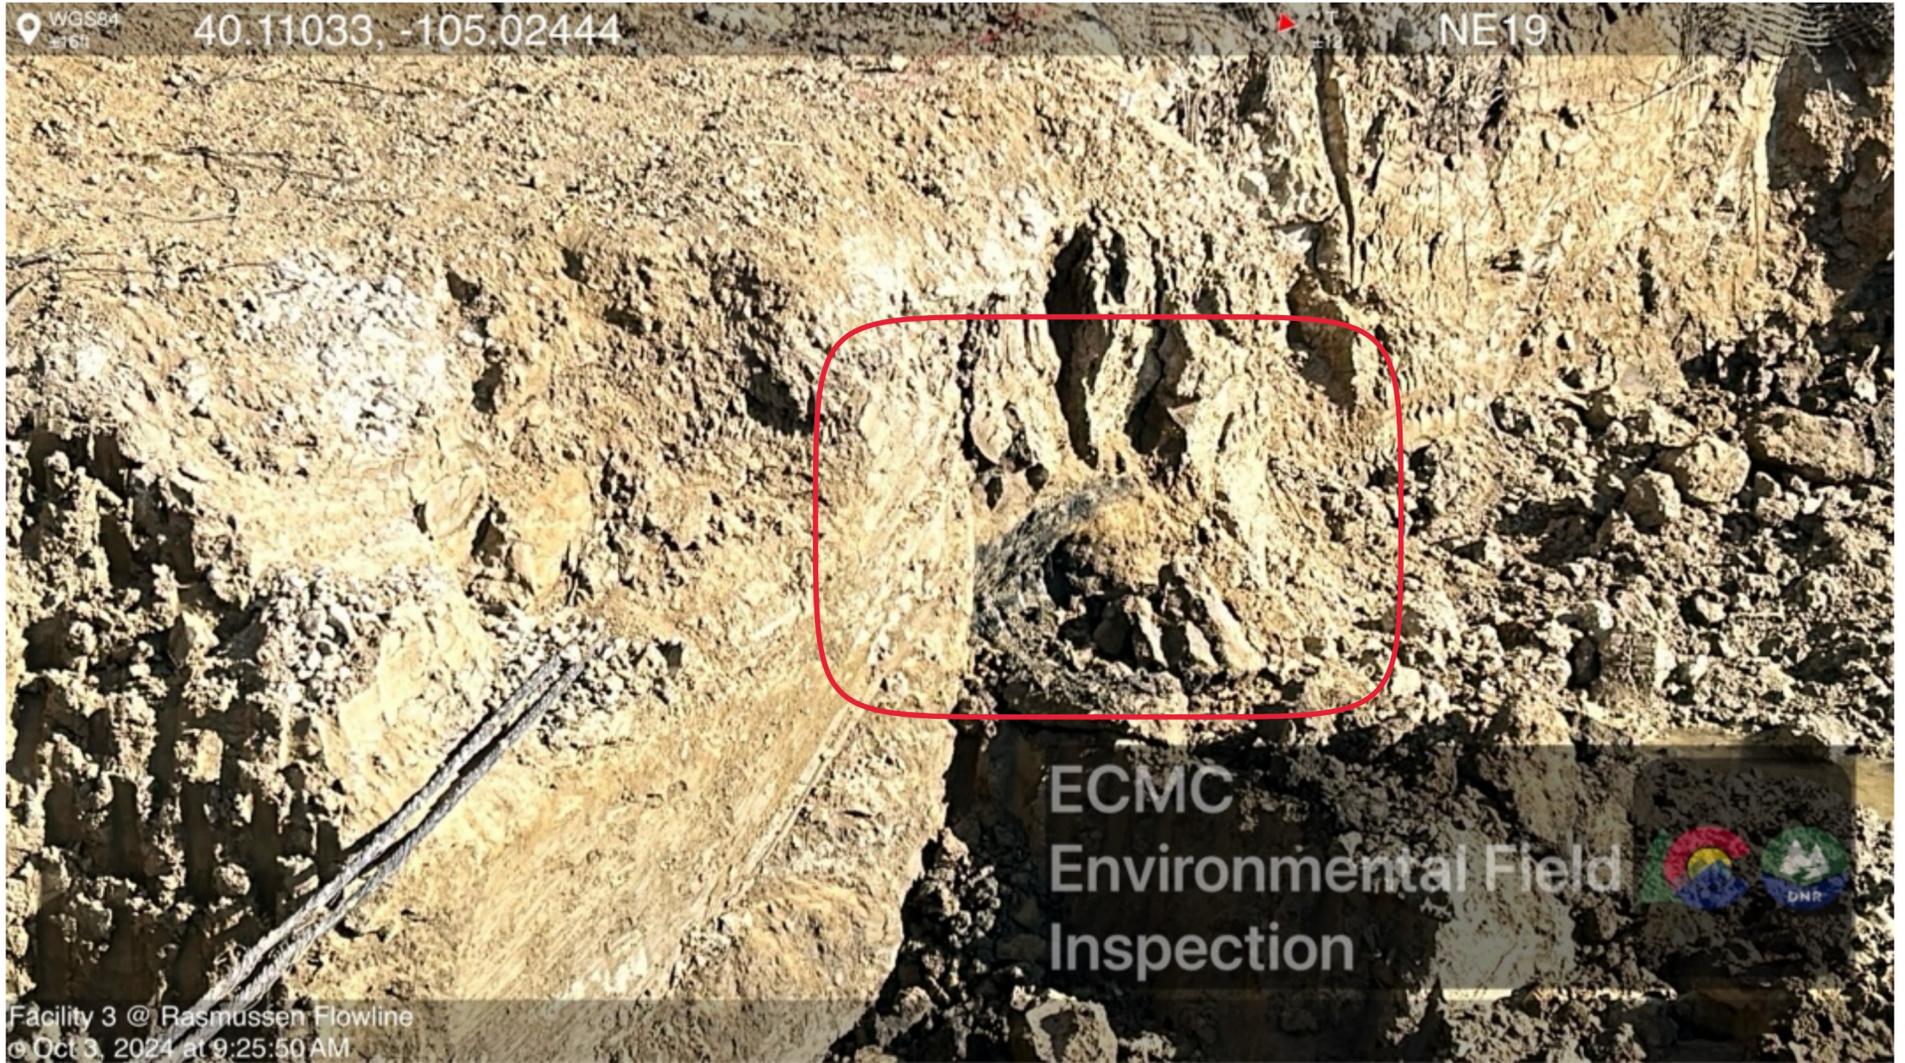
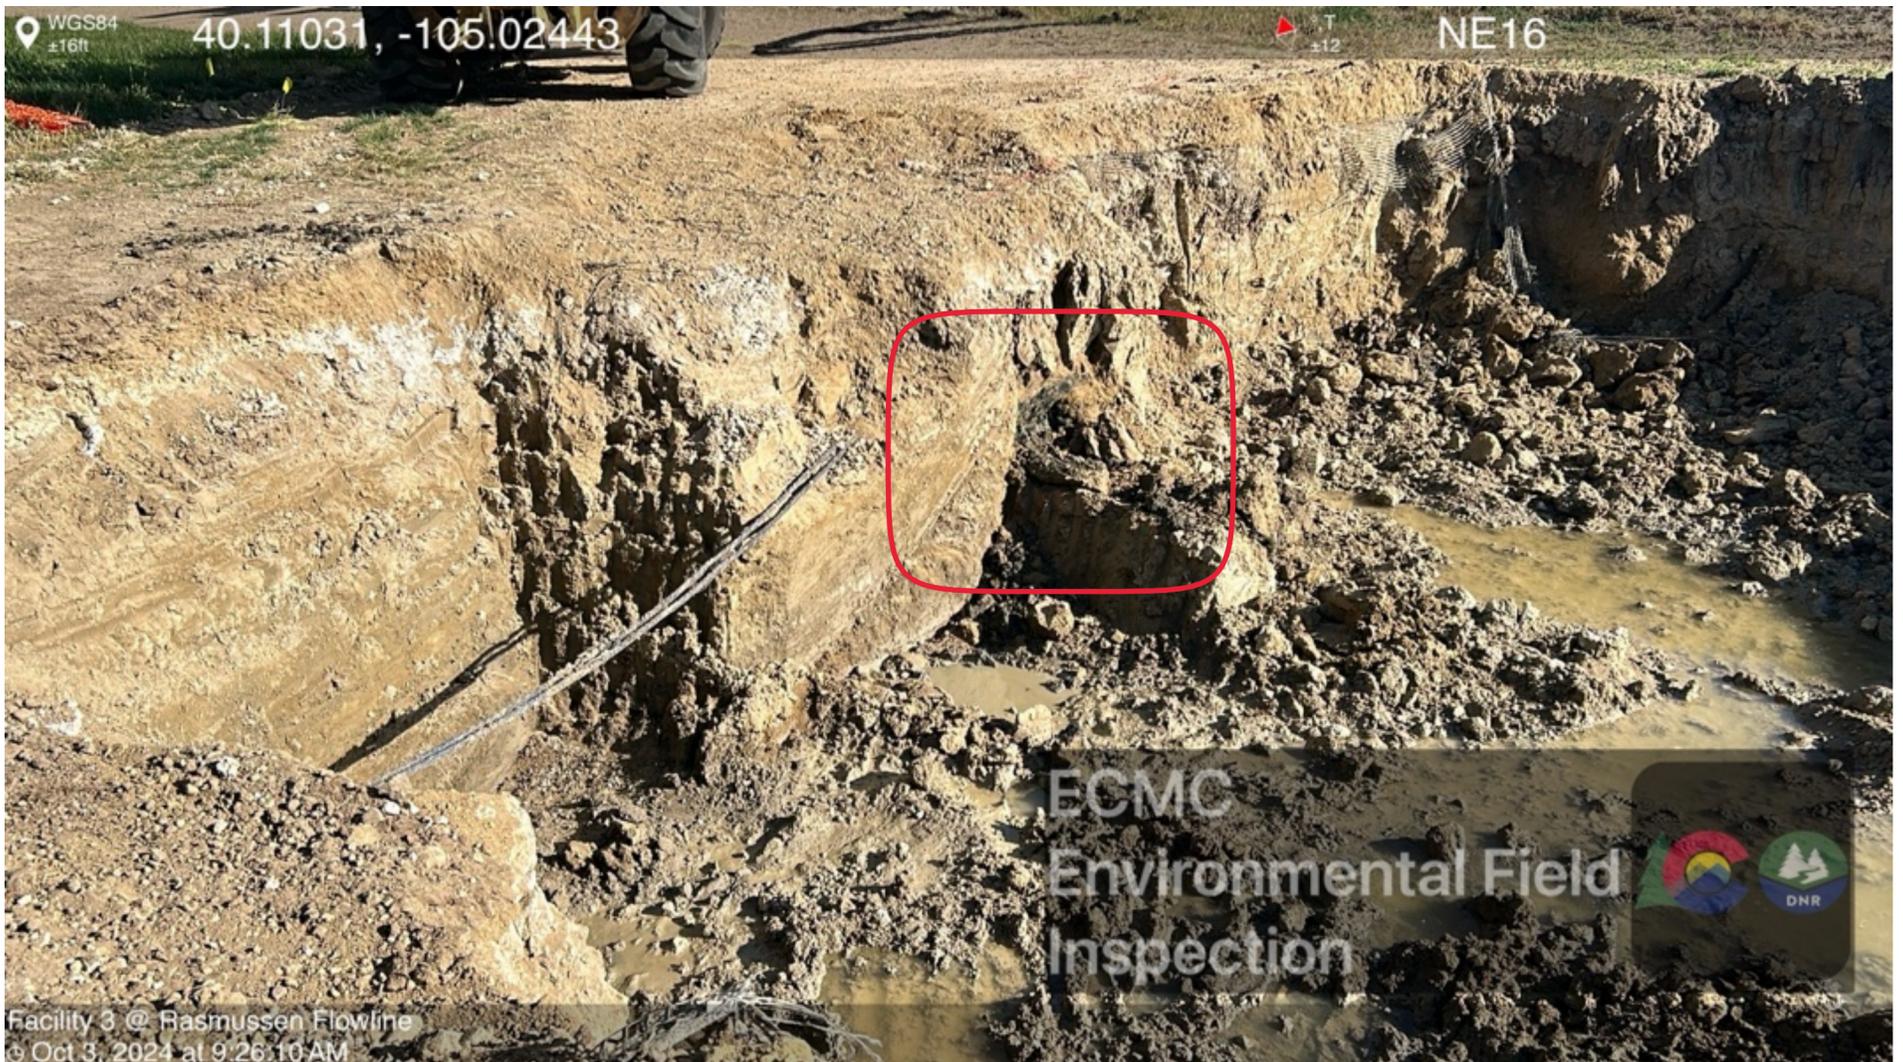
Black staining was observed along portions of the western sidewall. A strong petroleum hydrocarbon odor was observed when soil in this area was disturbed.

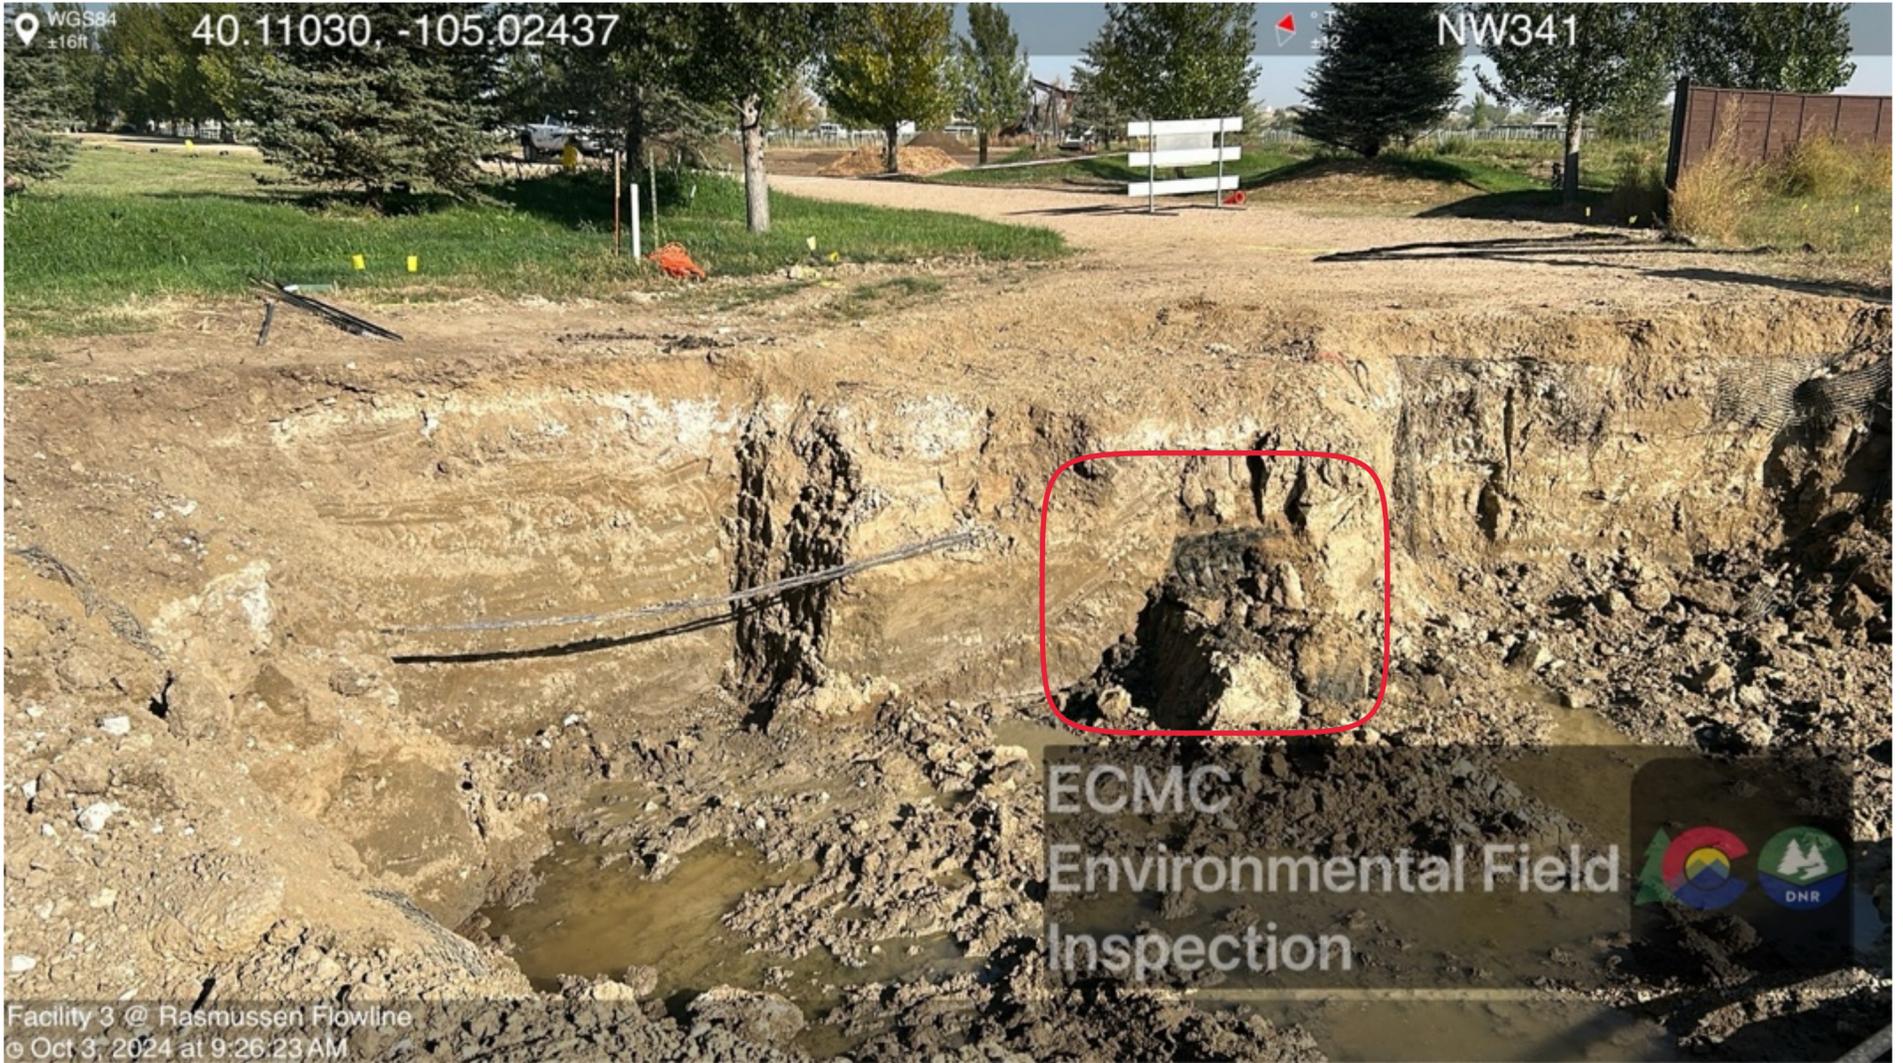
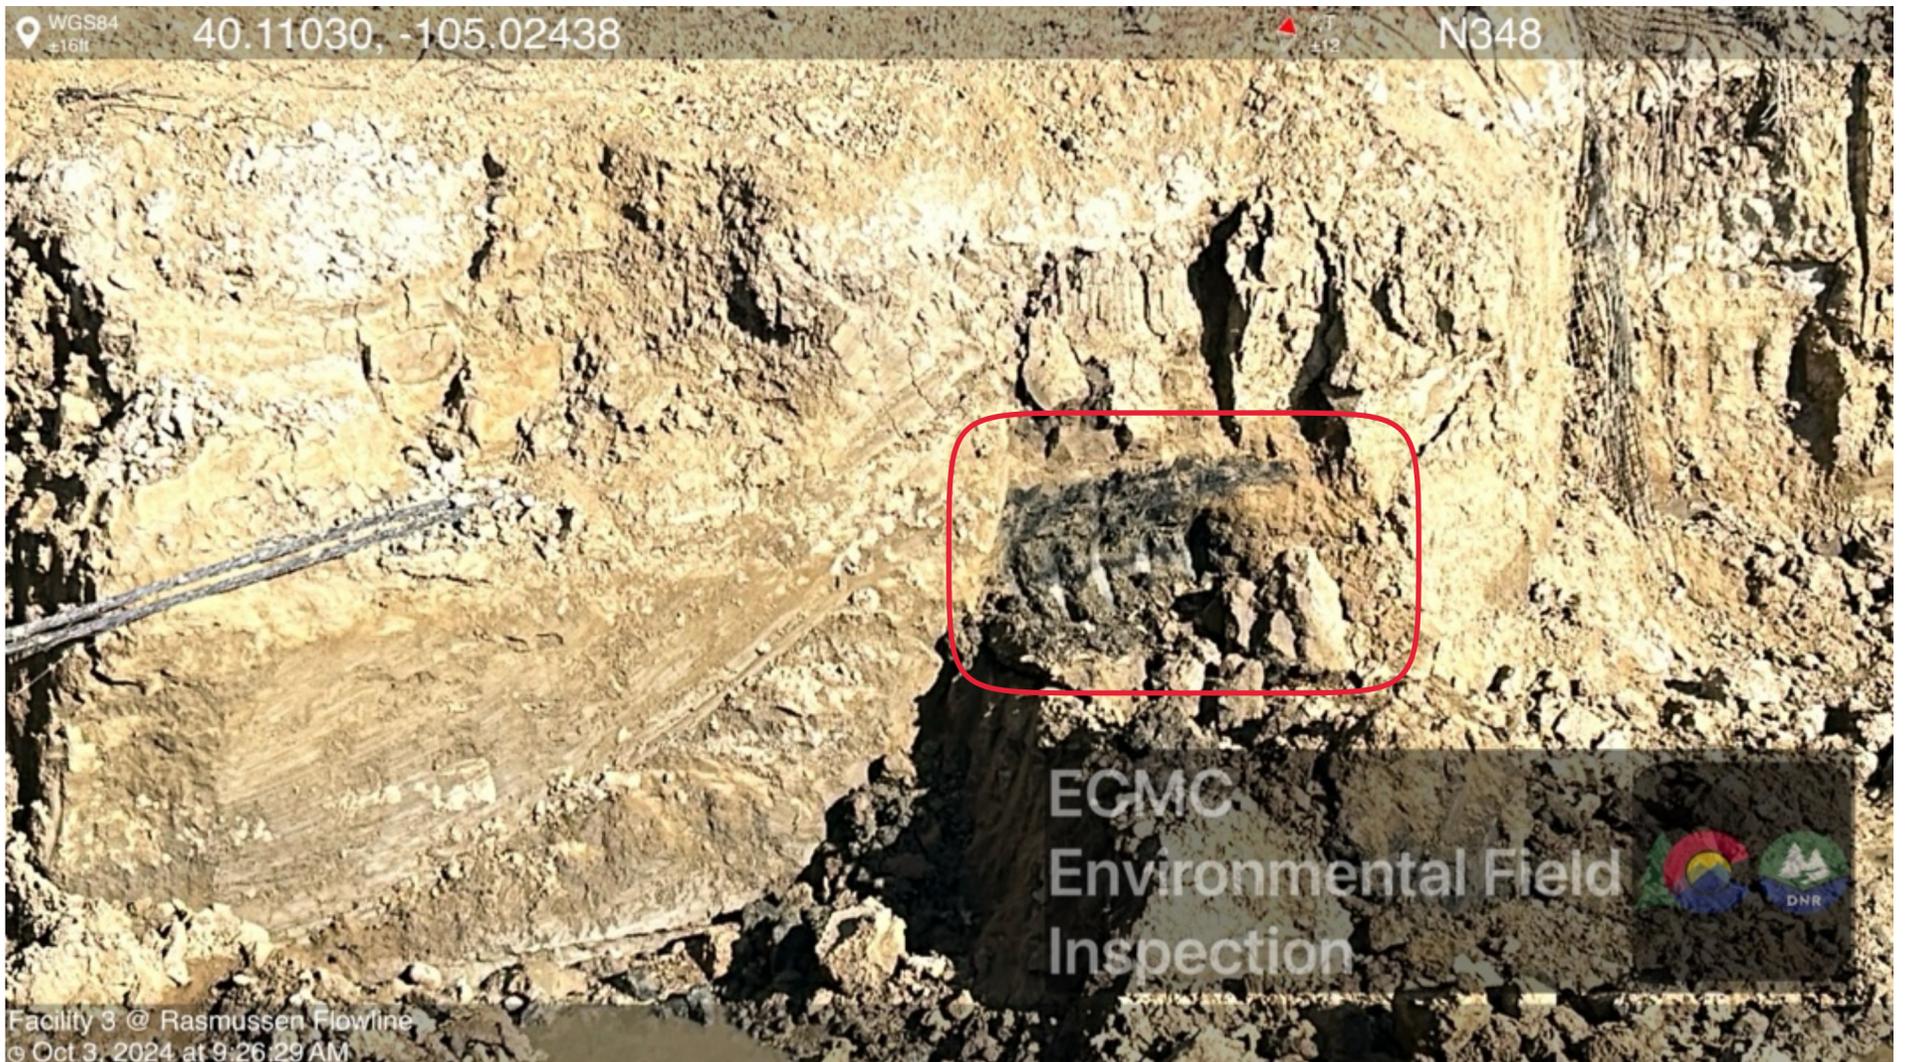
Black staining was observed along portions of the western sidewall. A strong petroleum hydrocarbon odor was observed when soil in this area was disturbed.

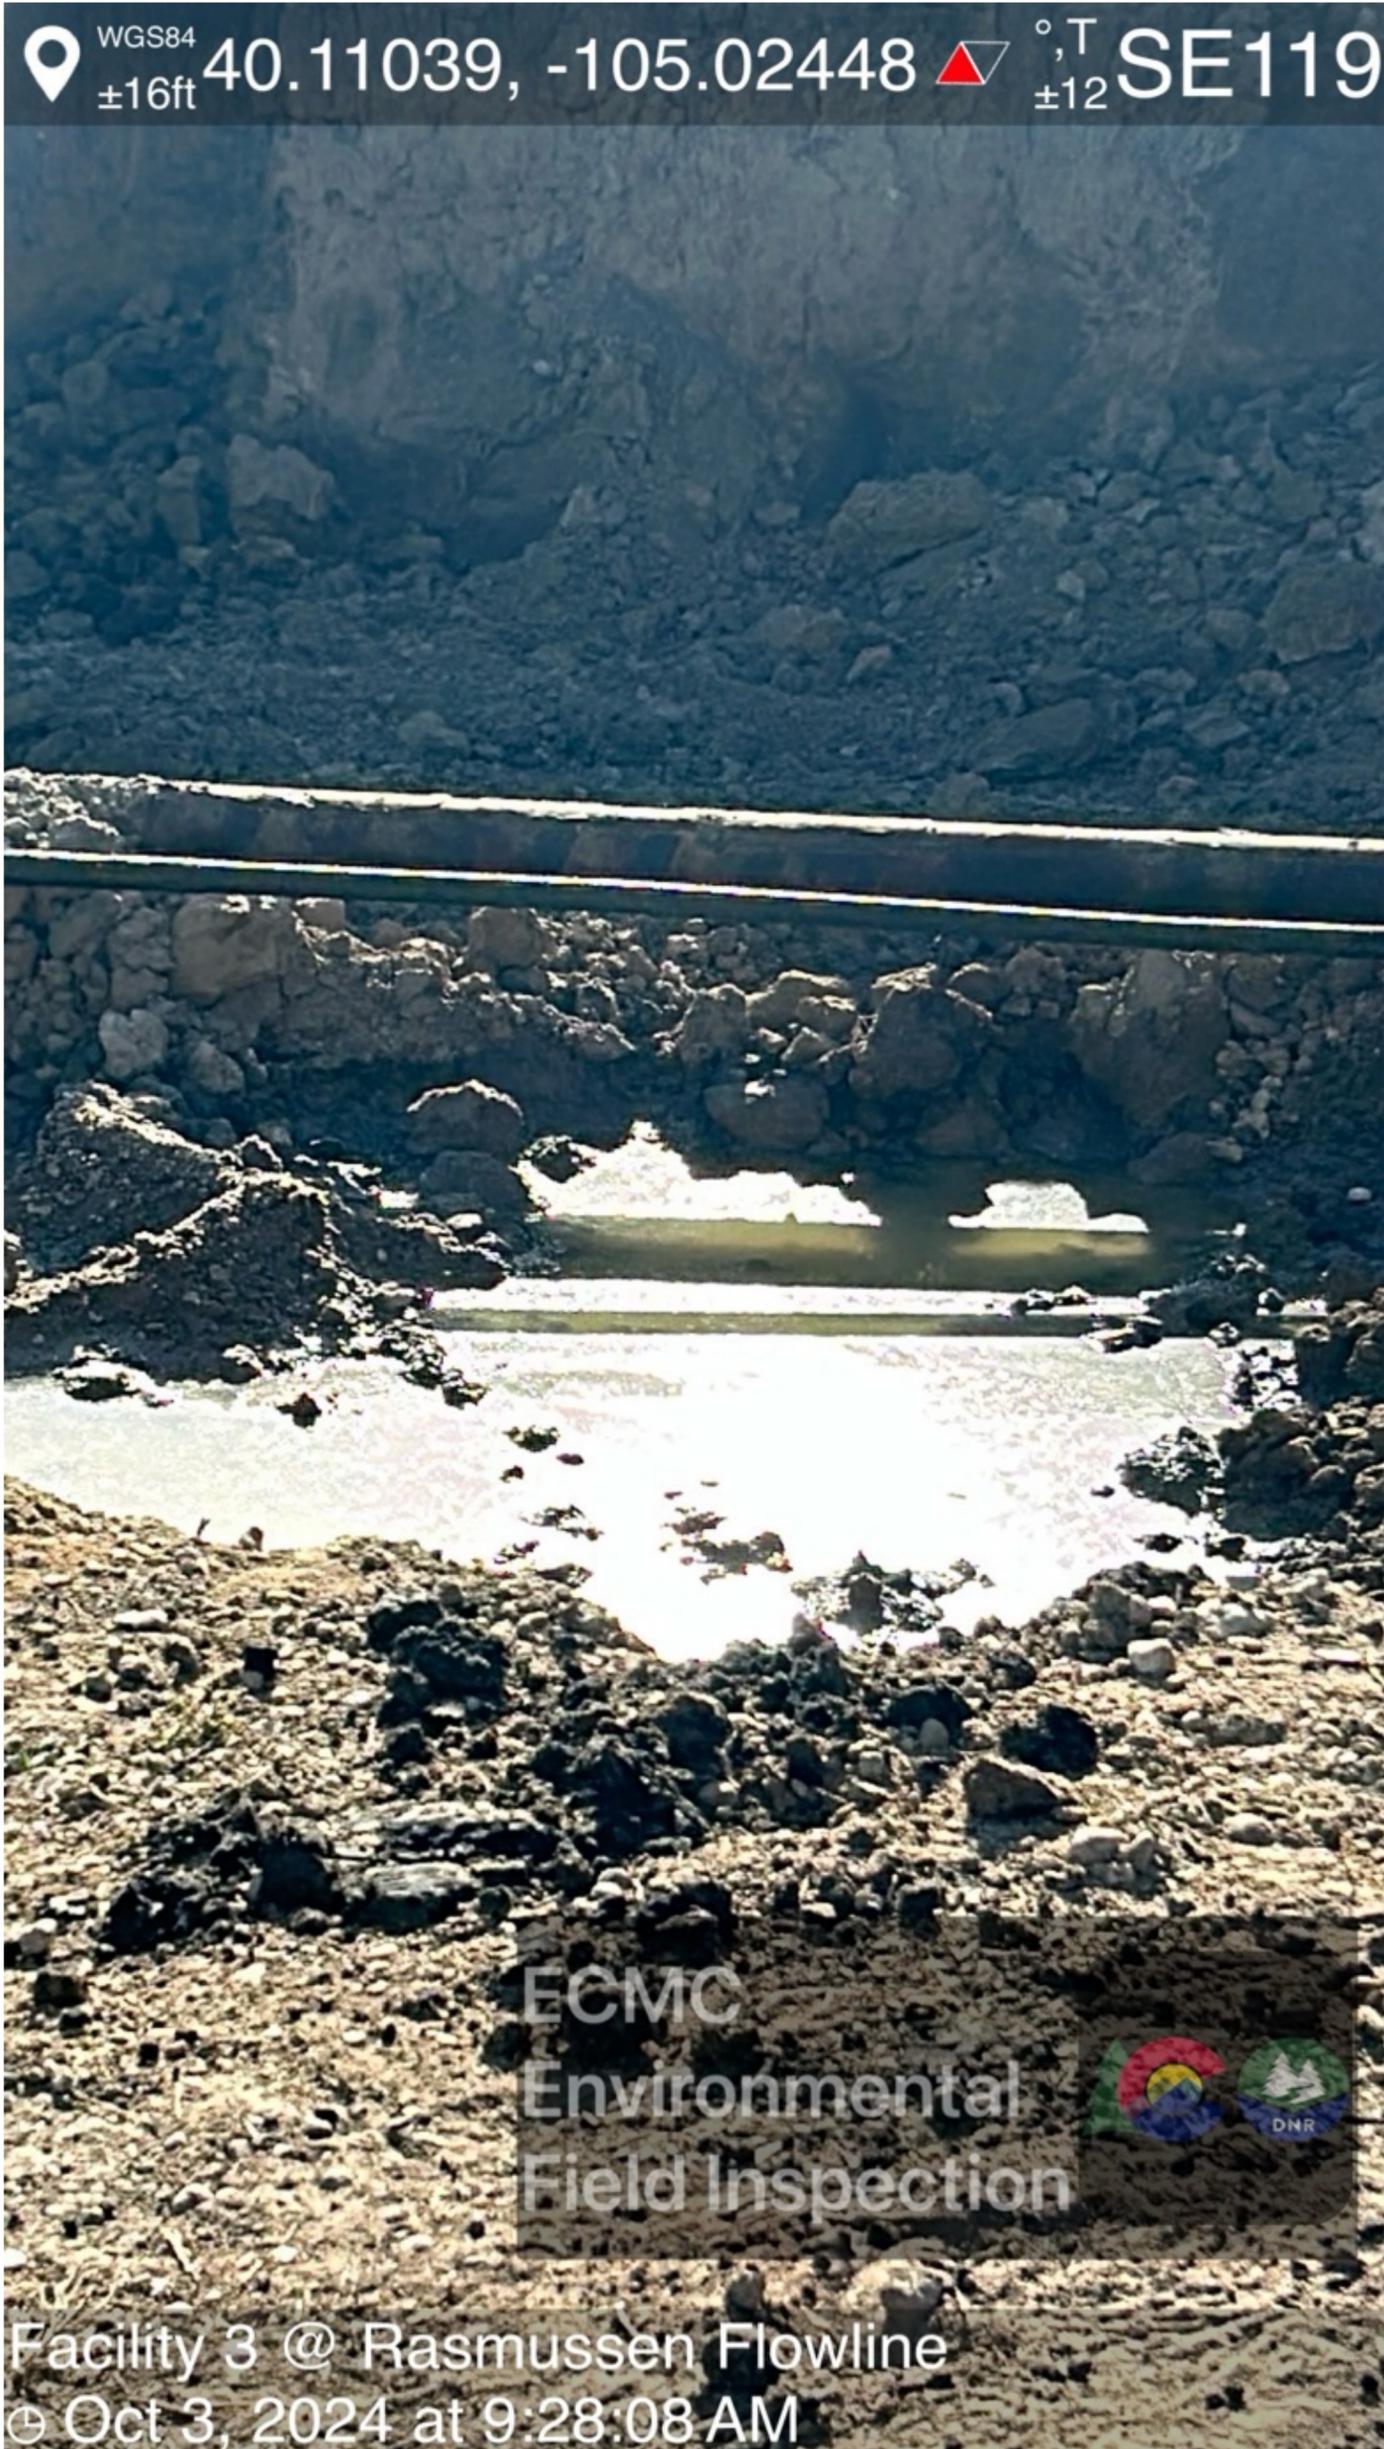
Groundwater with free product was observed at the base of the excavation.

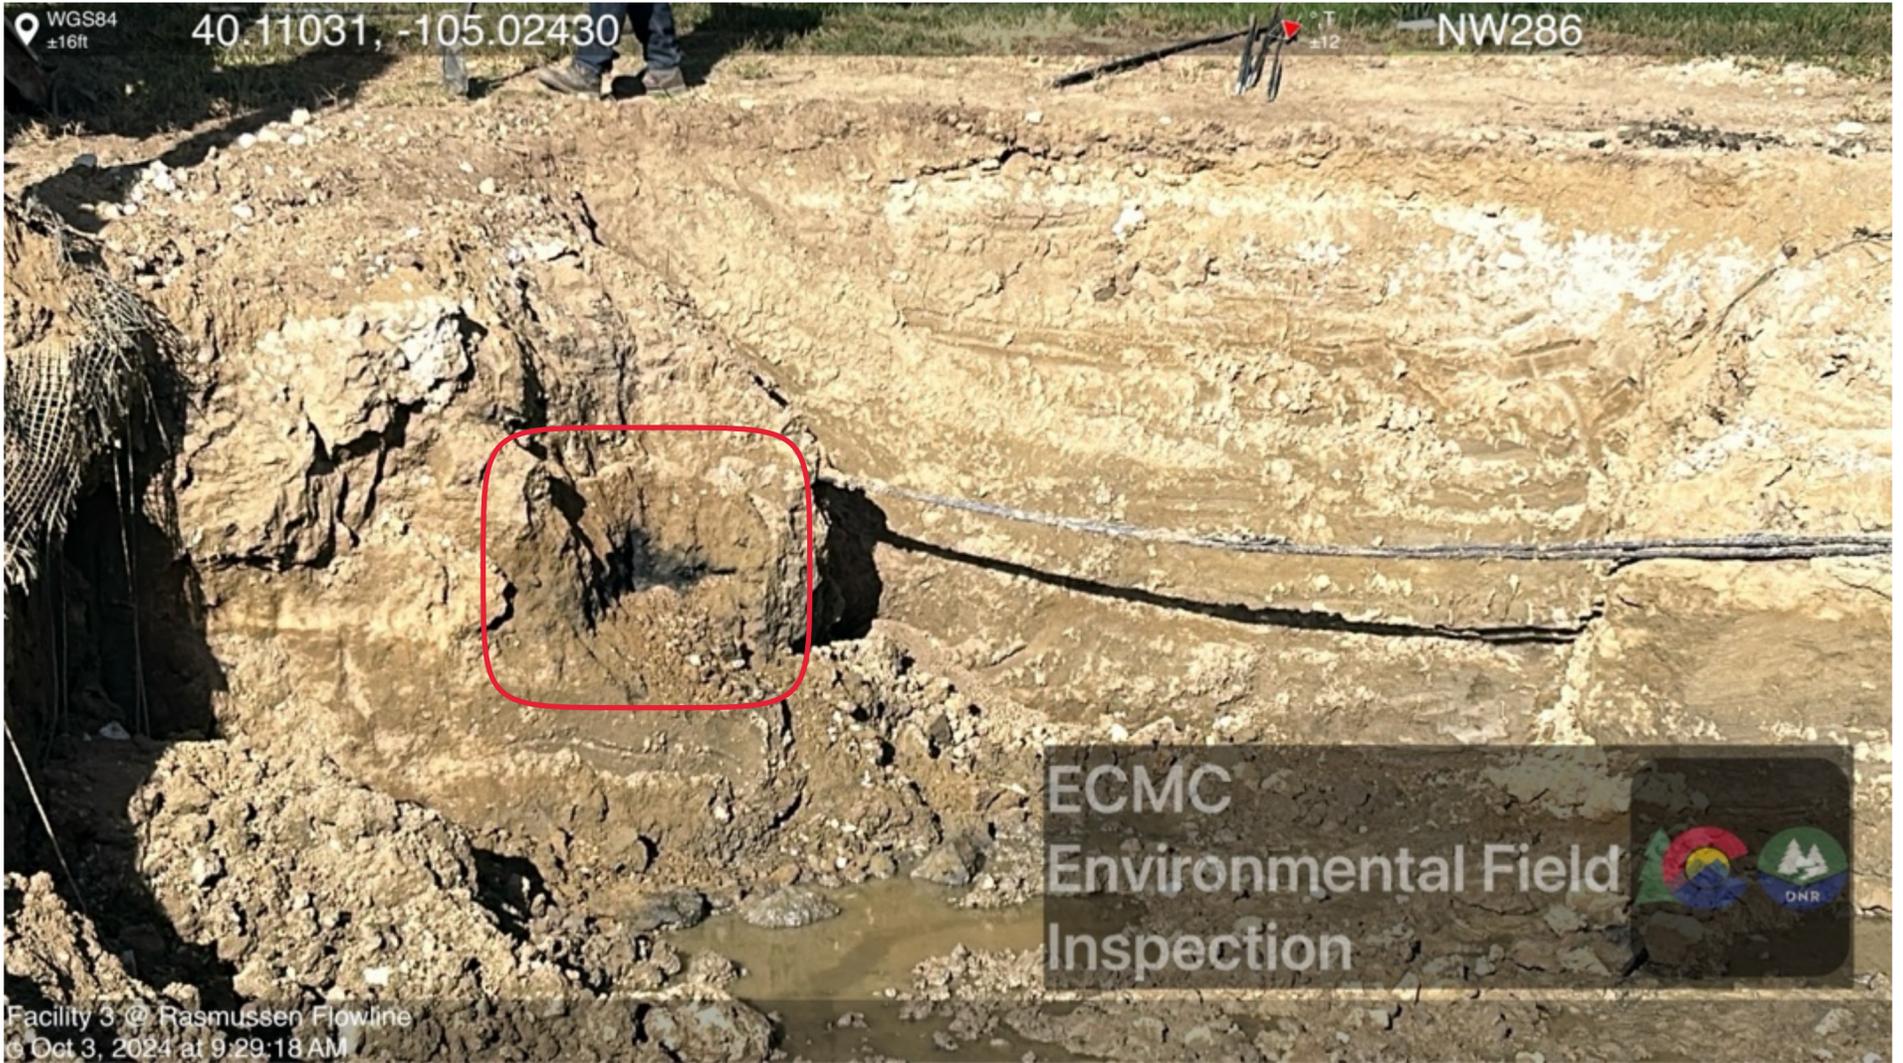
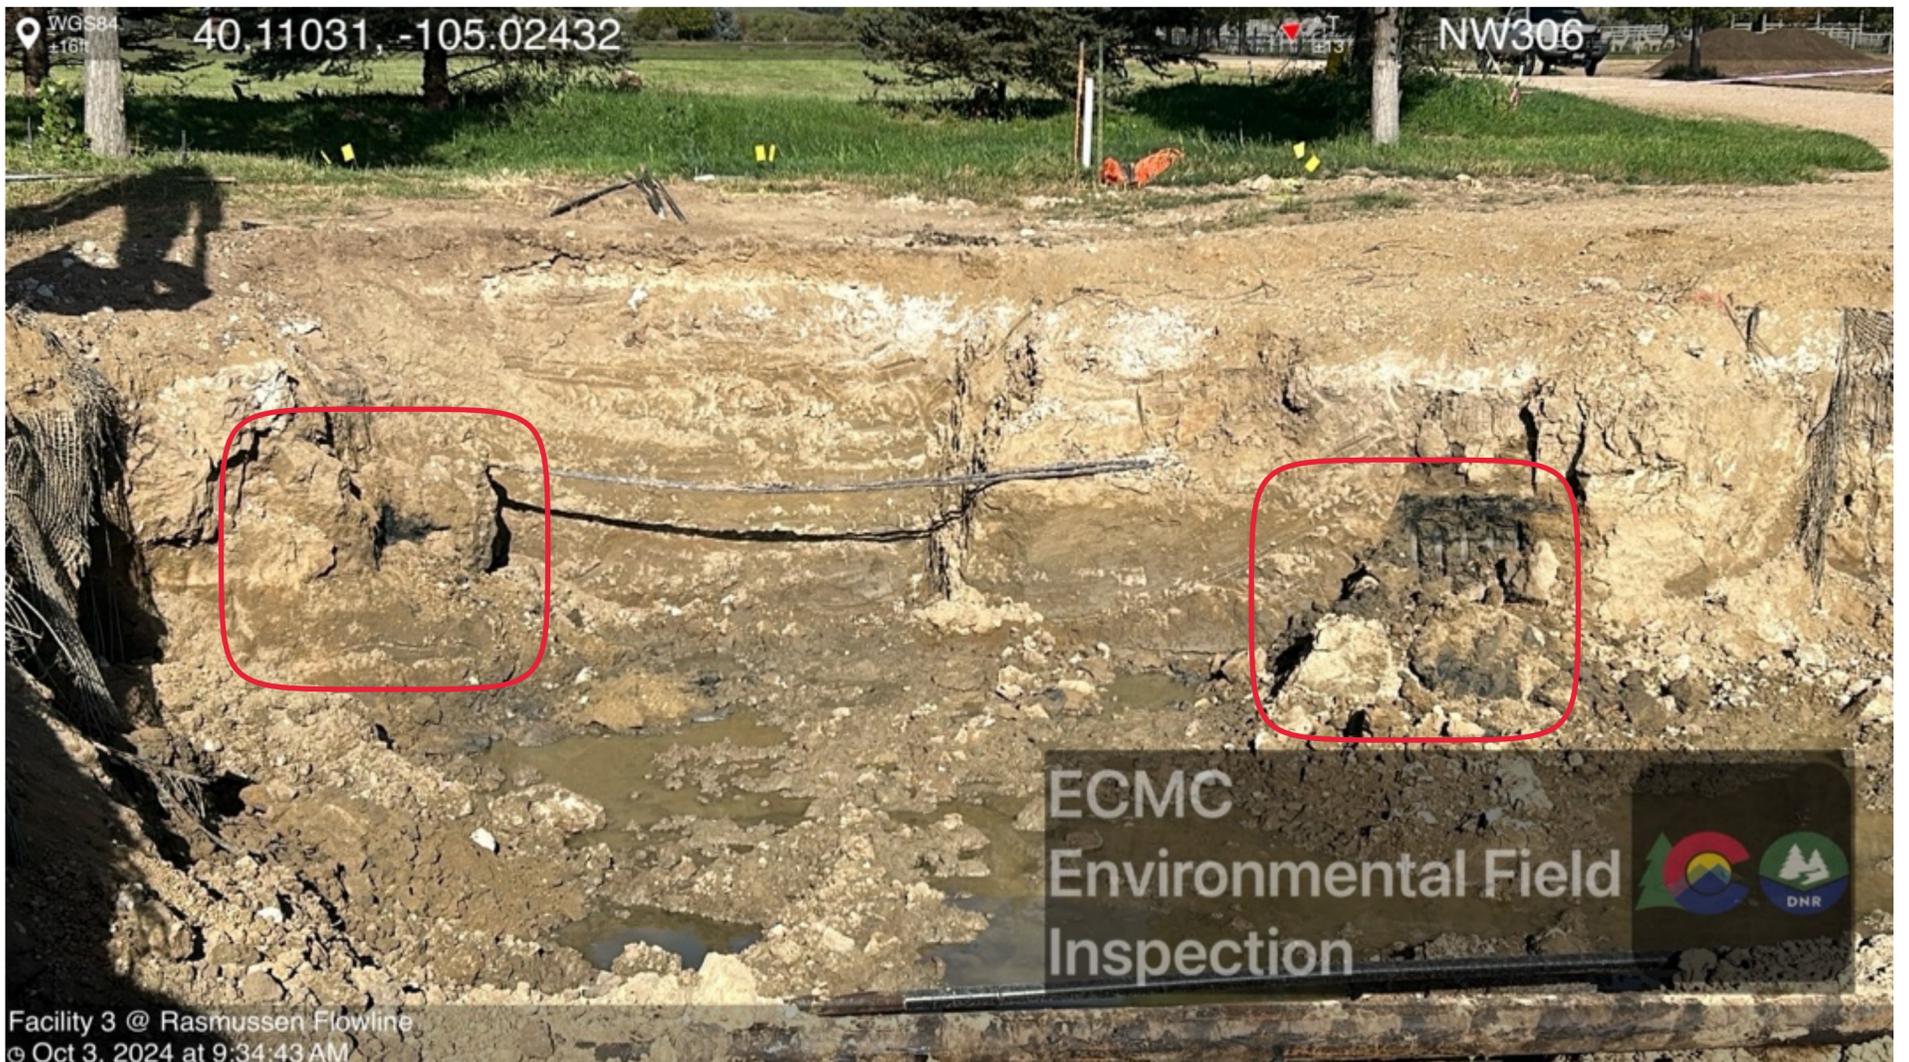
Black staining was observed along portions of the western sidewall. A strong petroleum hydrocarbon odor was observed when soil in this area was disturbed.

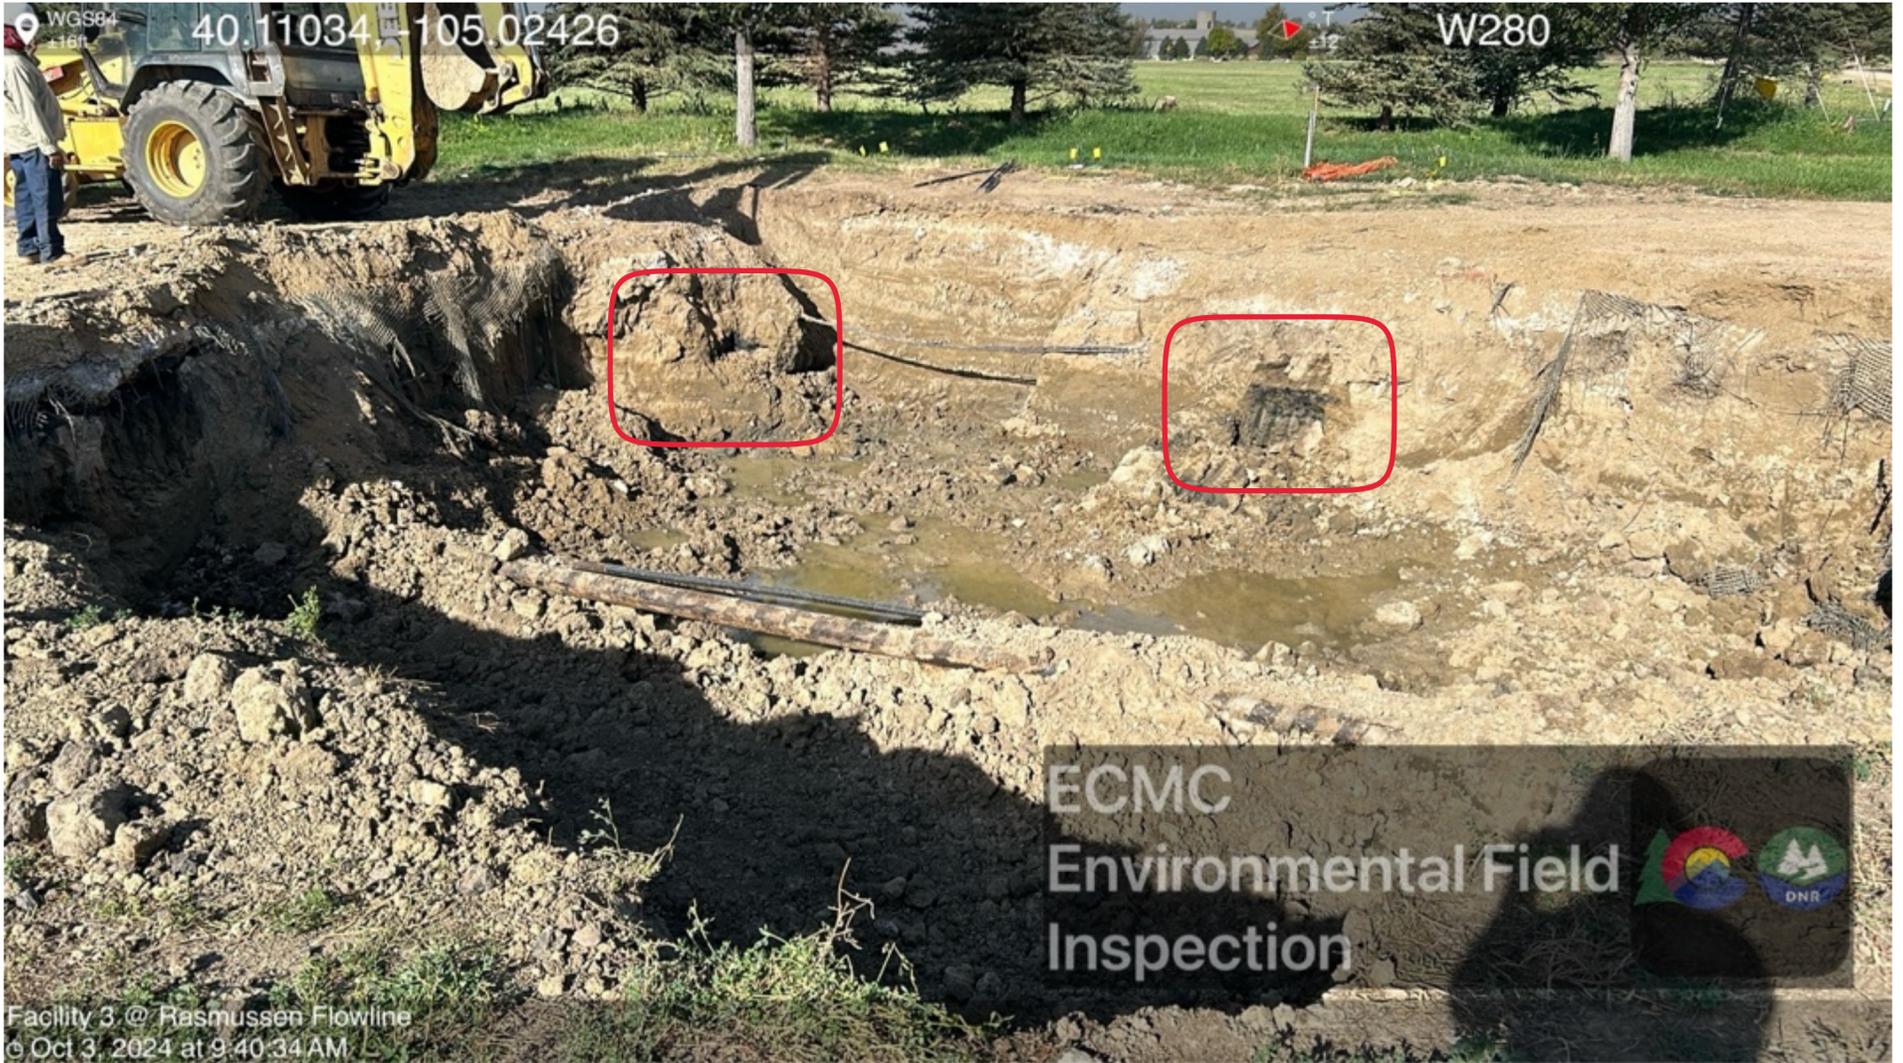
Black staining was observed along portions of the western sidewall. A strong petroleum hydrocarbon odor was observed when soil in this area was disturbed.

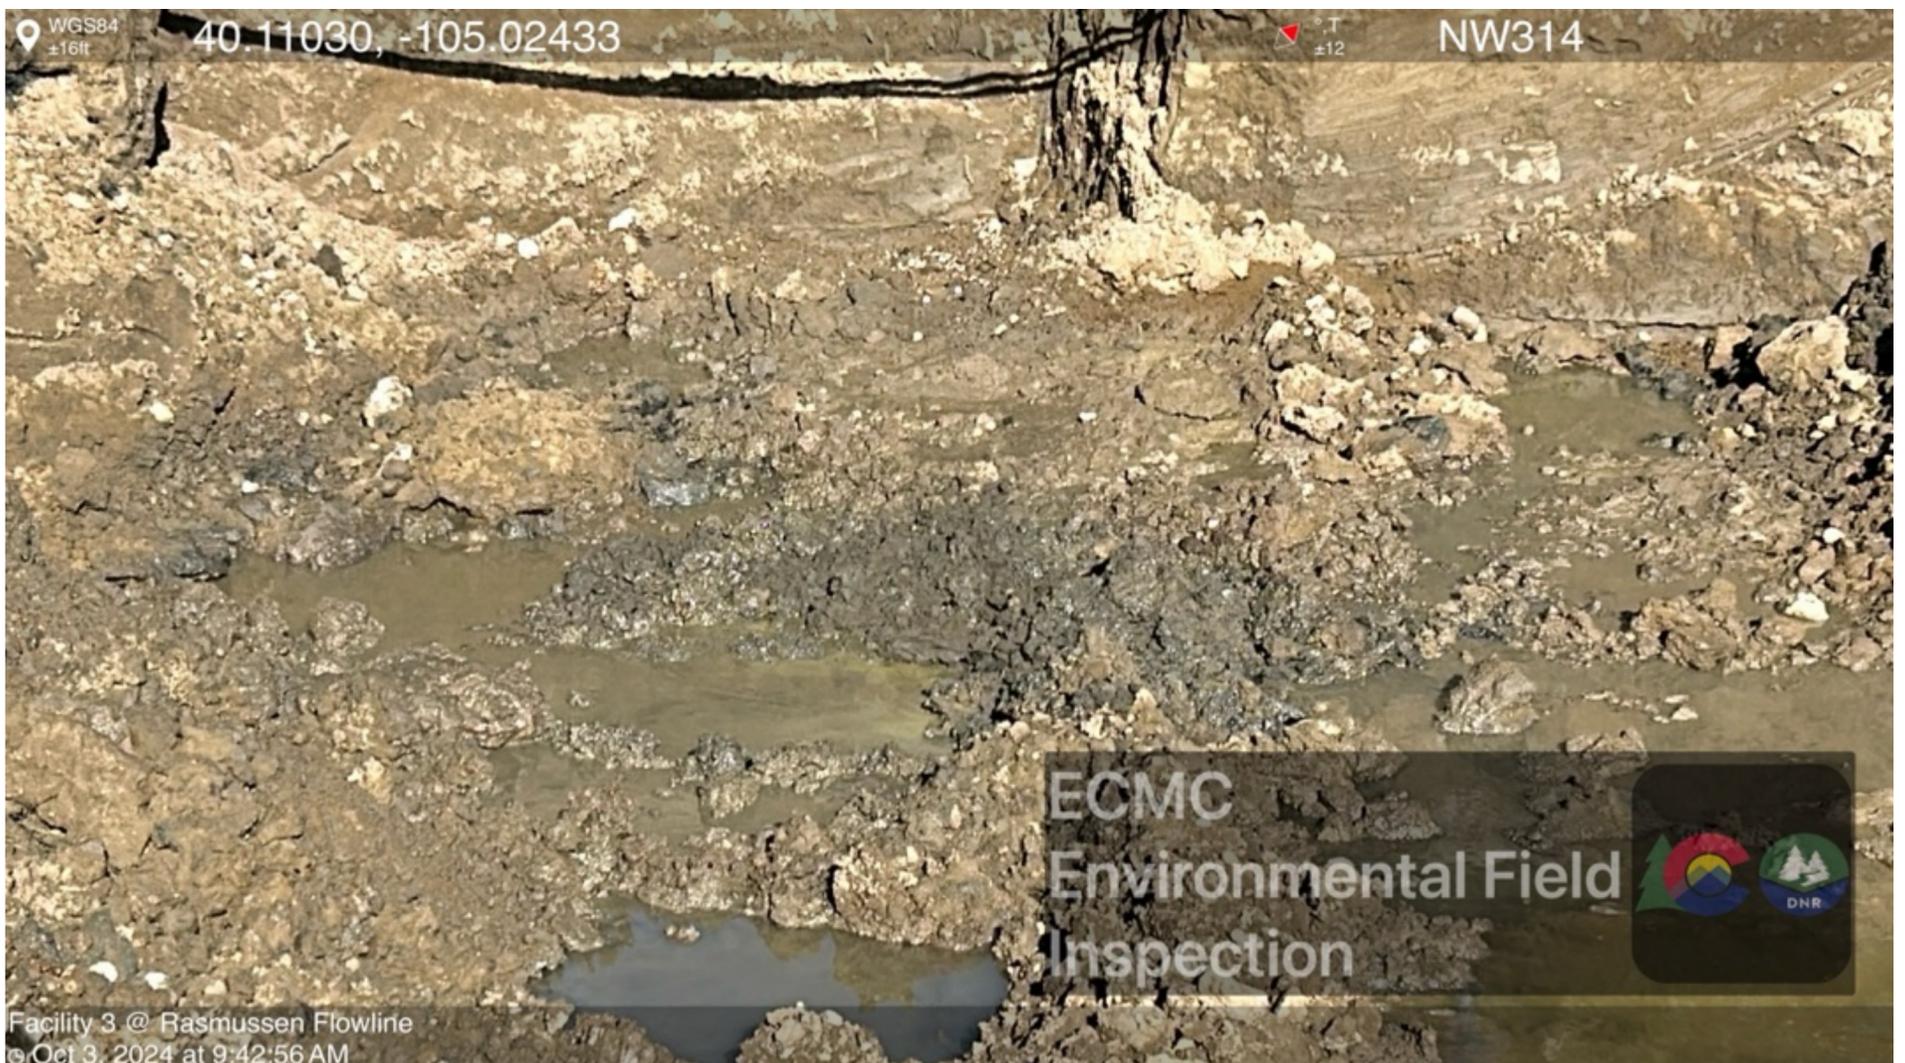
Groundwater with free product was observed at the base of the excavation.
