Inspection Photos
Facility 3 @ Rasmussen Flowline
Spill ID 487690

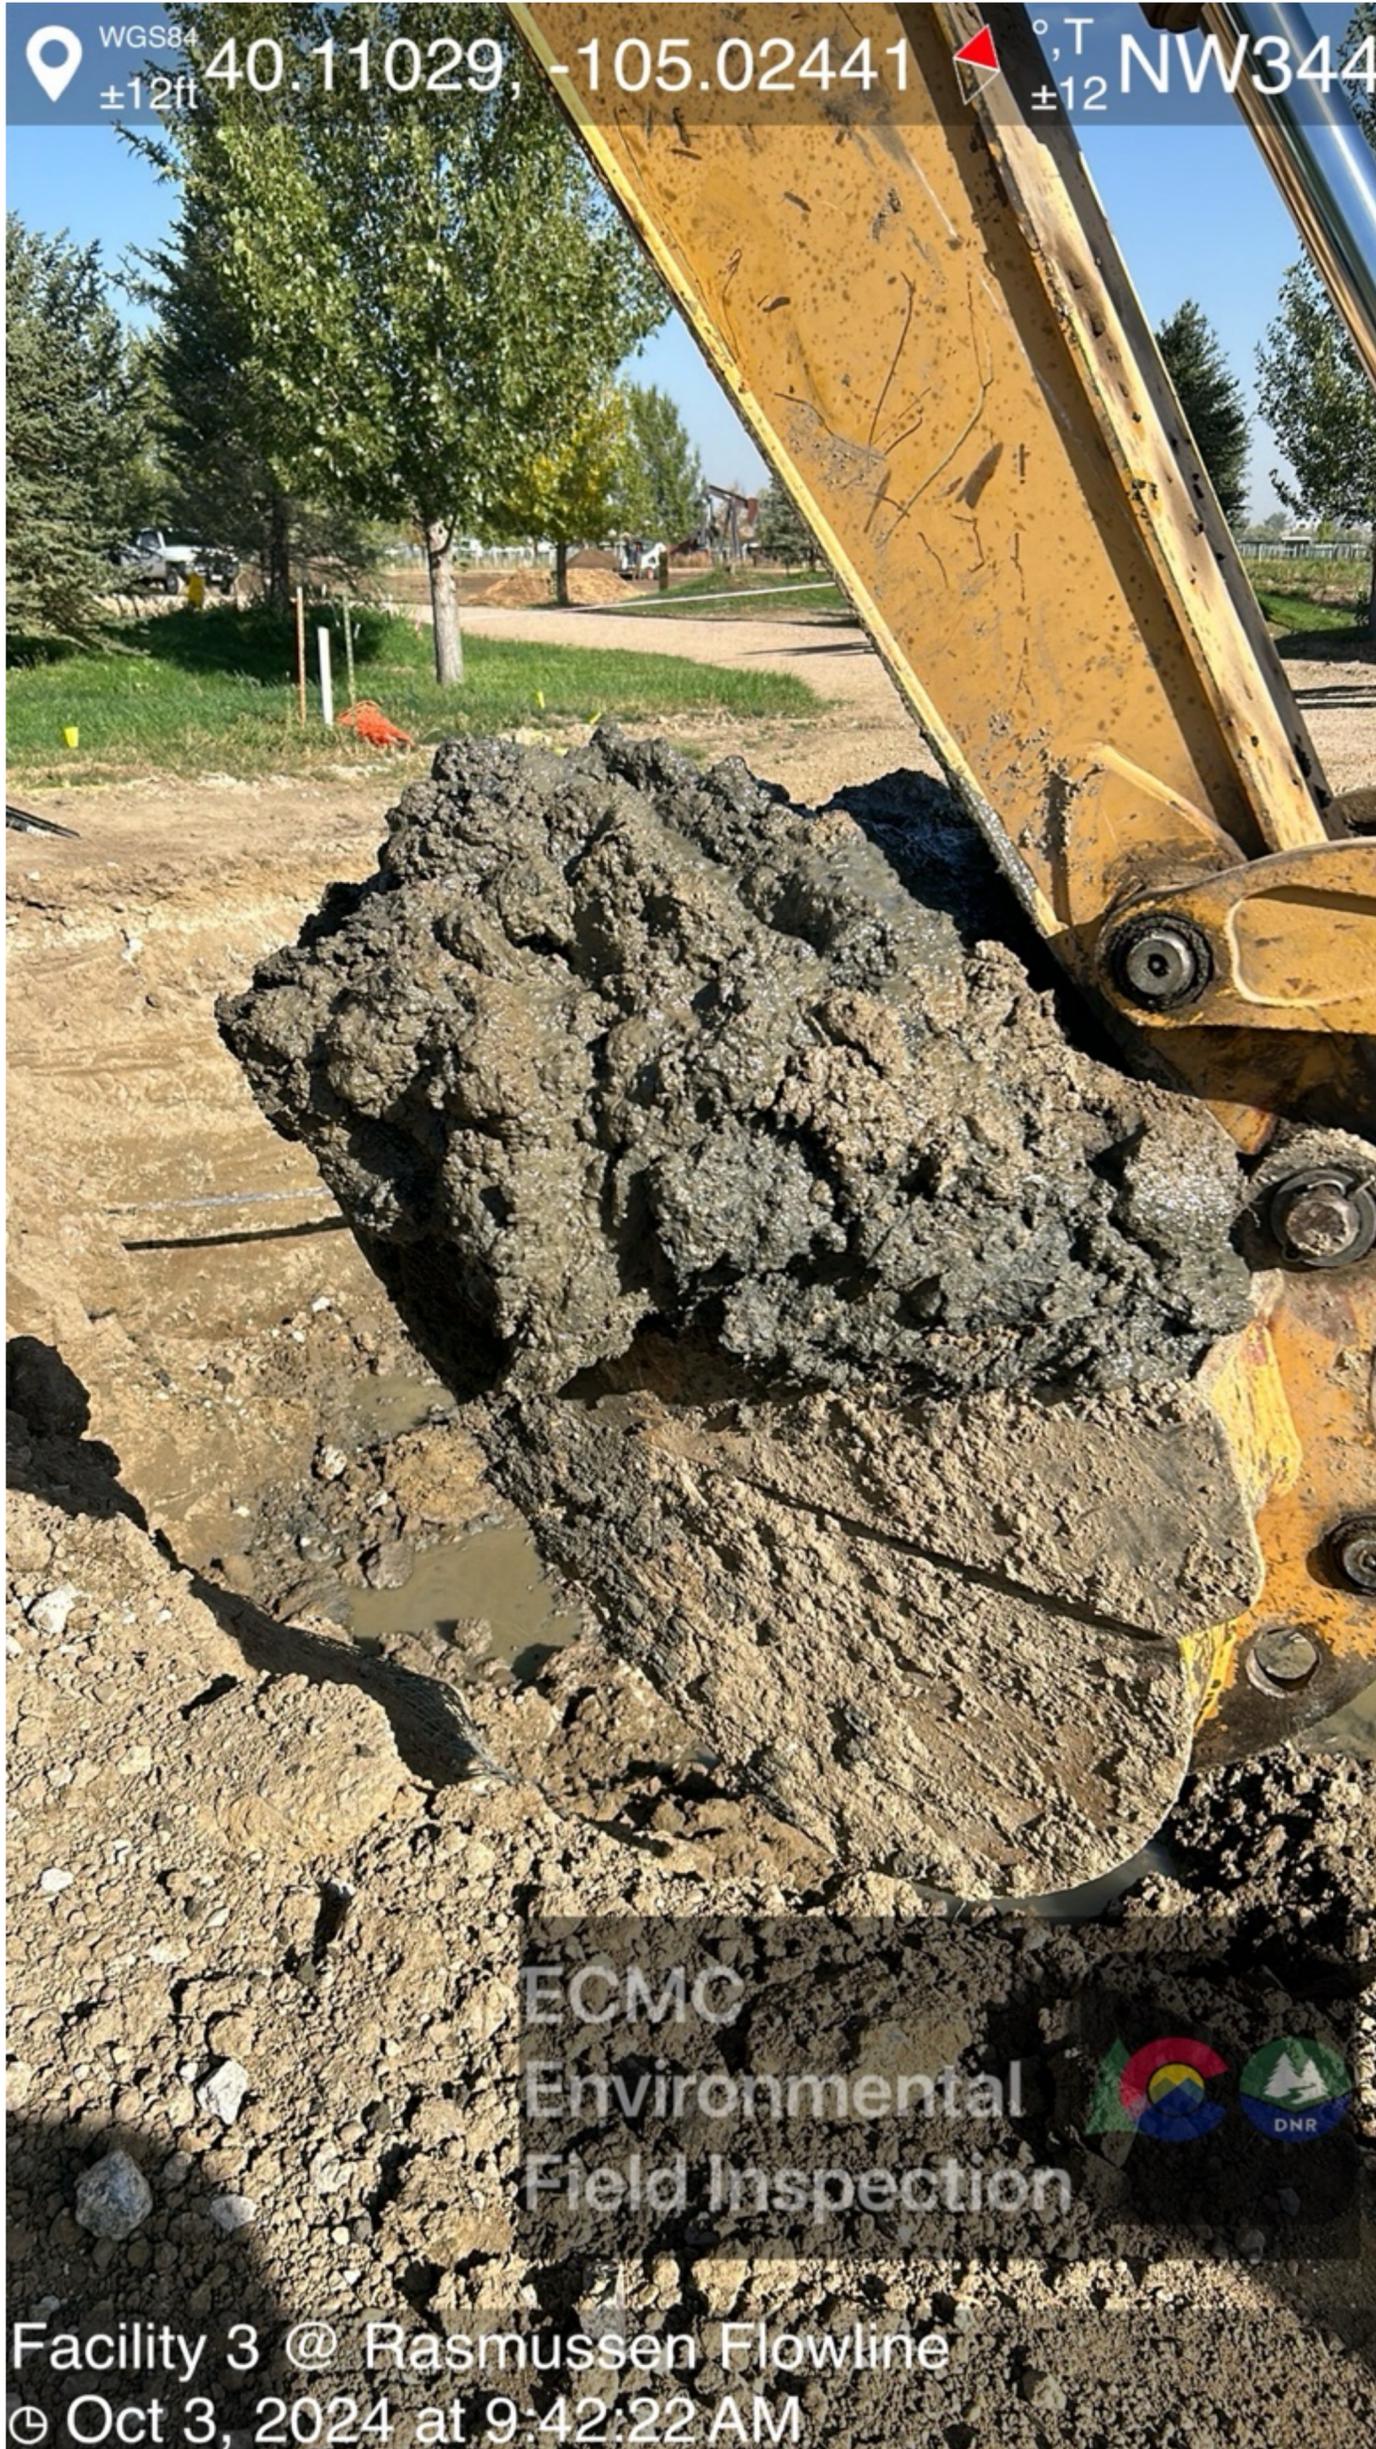
Confirmation soil samples were collected from each quadrant of the base of the excavation. Gray to black staining was observed at the base of the excavation. A strong petroleum hydrocarbon odor was observed when soil and groundwater at the base of the excavation were disturbed.

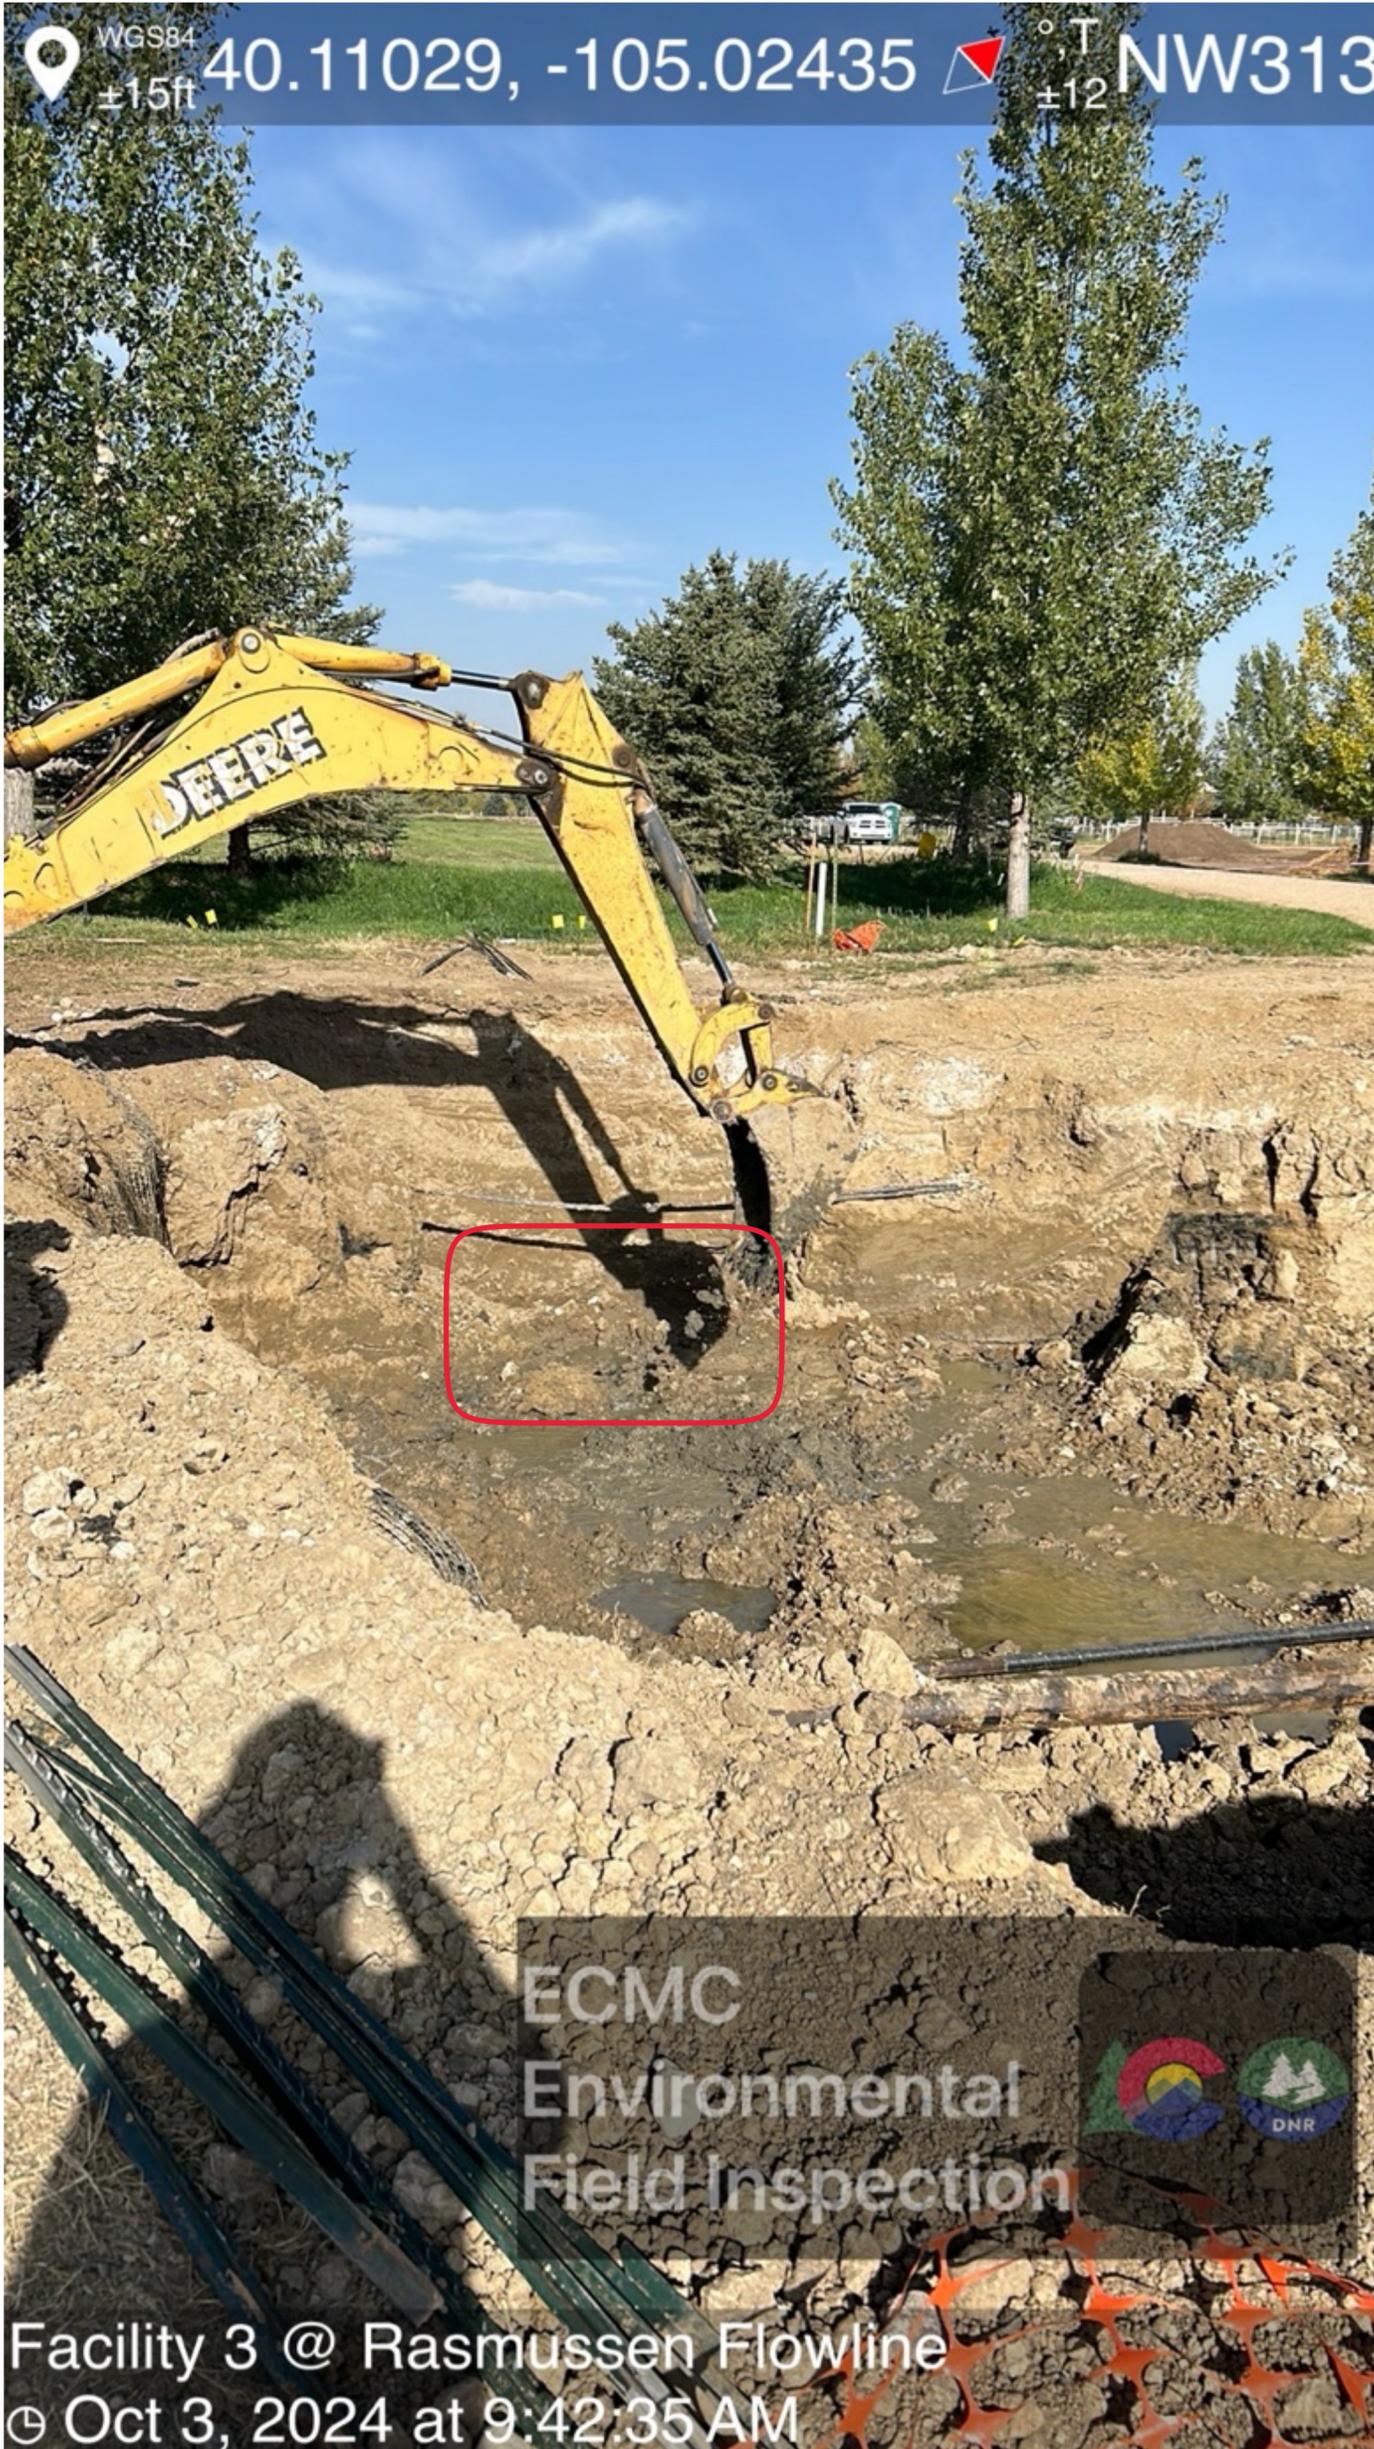
Confirmation soil samples were collected from each quadrant of the base of the excavation. Gray to black staining was observed at the base of the excavation. A strong petroleum hydrocarbon odor was observed when soil and groundwater at the base of the excavation were disturbed.

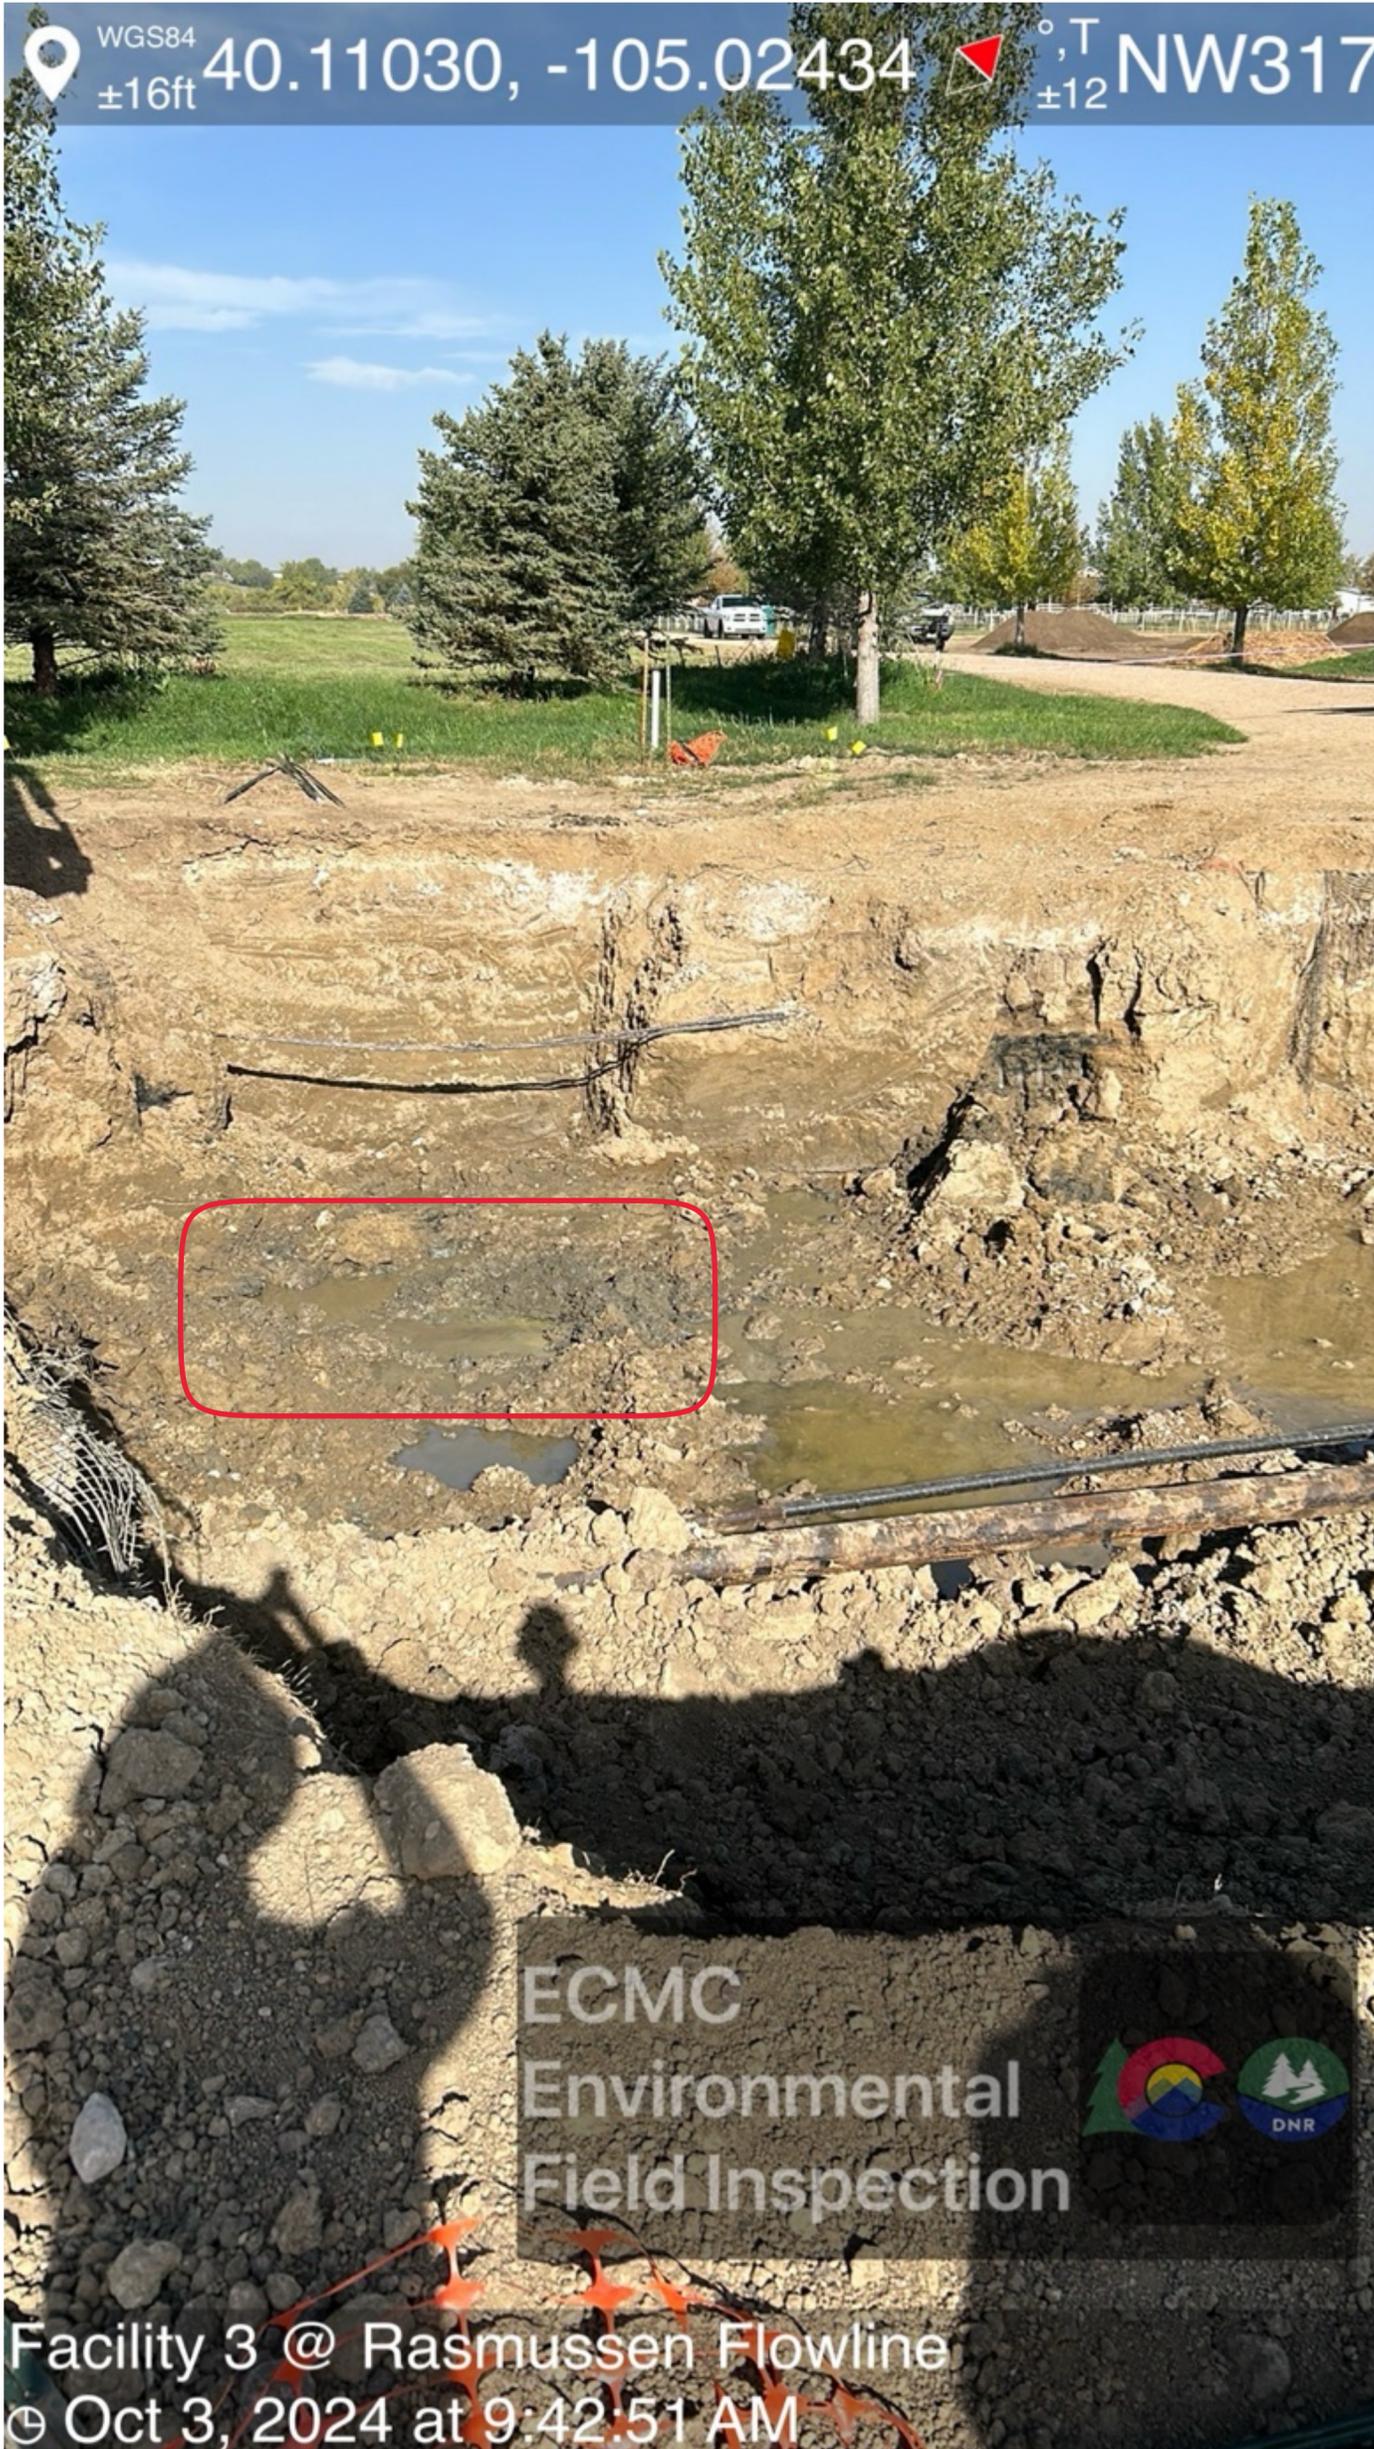
Free product was observed migrating into the area of disturbance following sample collection from the base of the excavation.

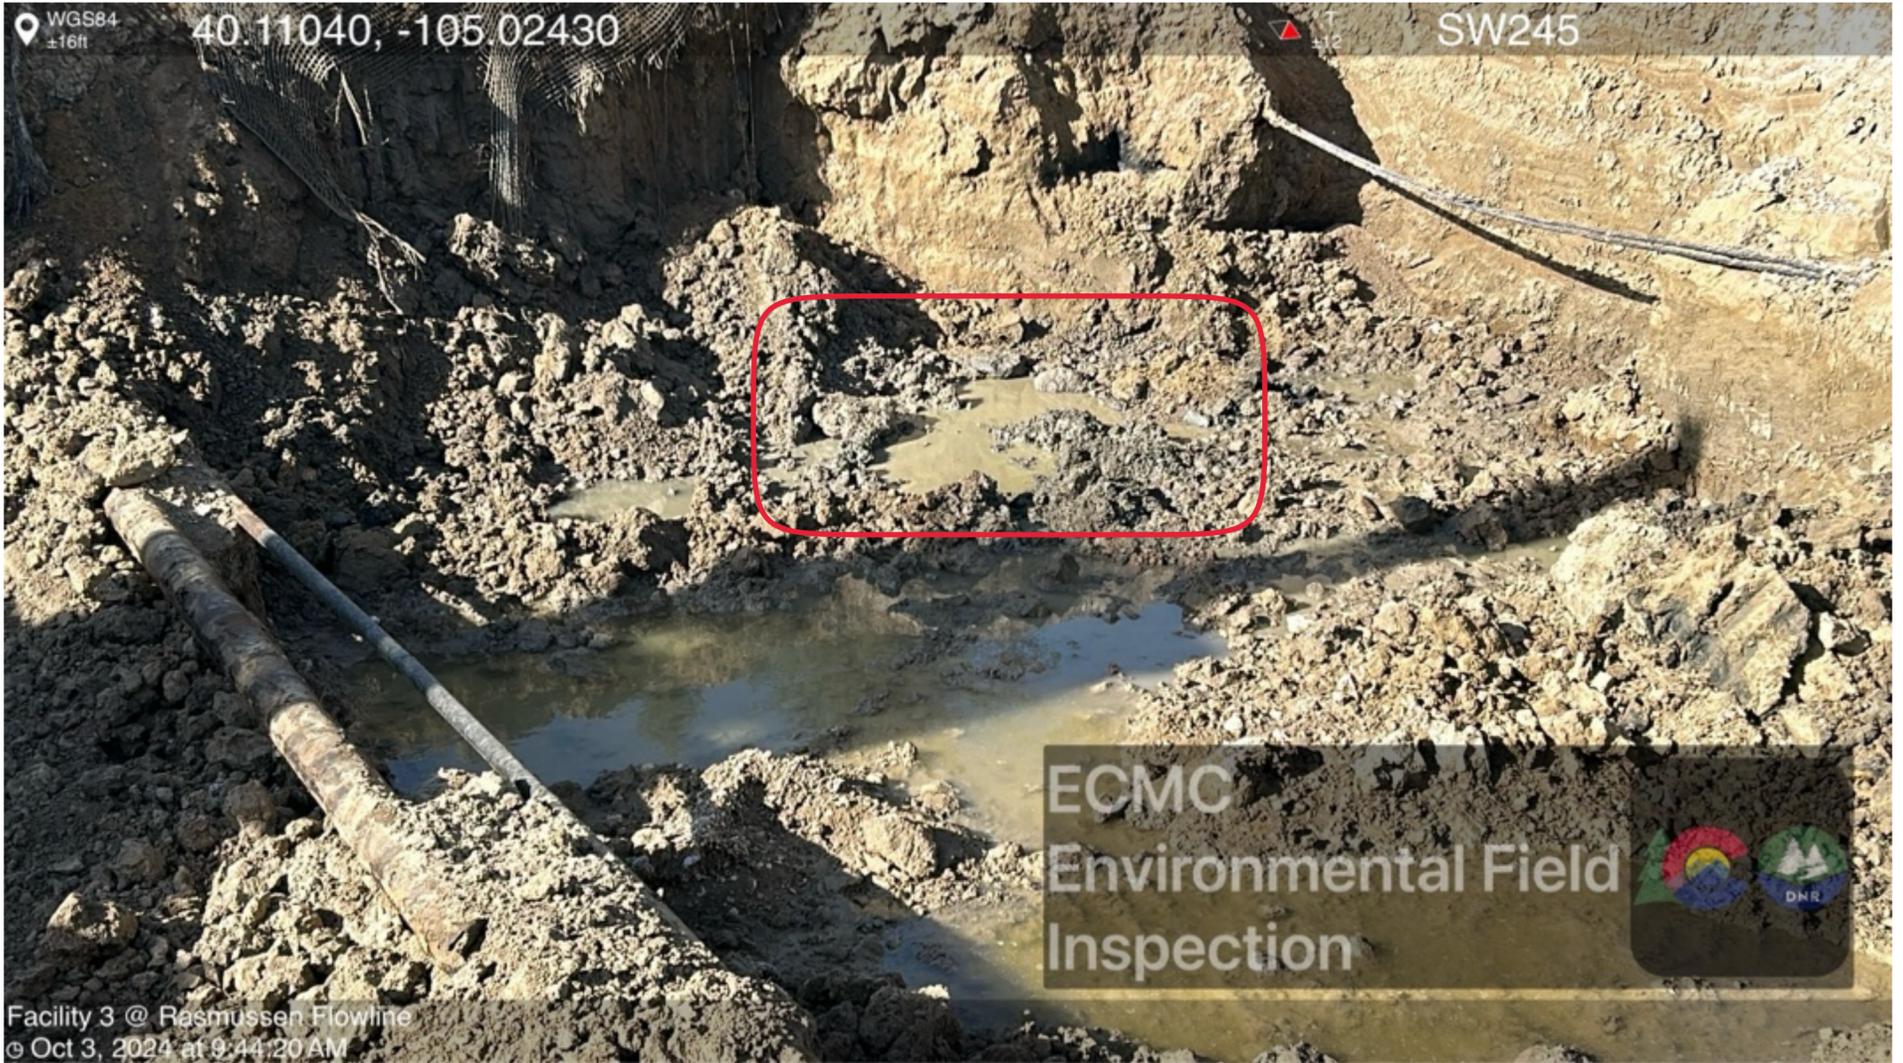
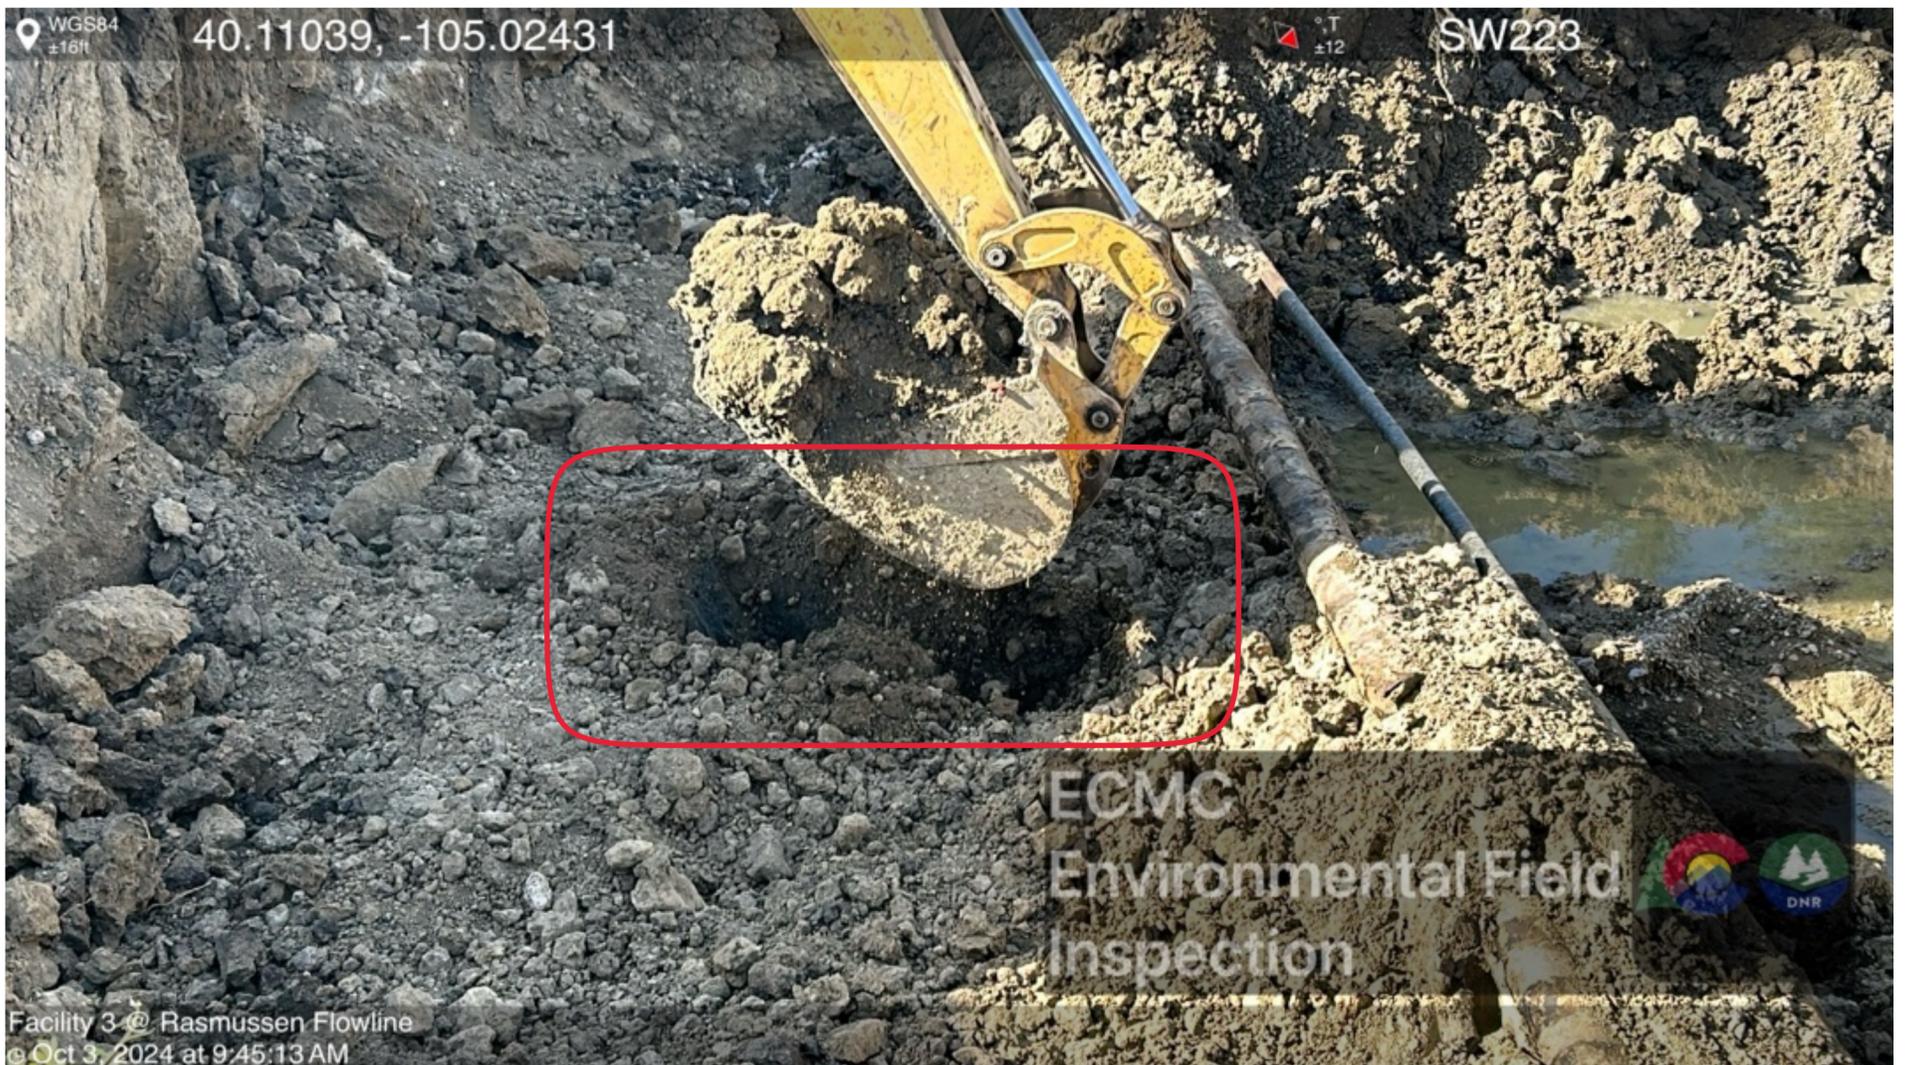
Free product was observed migrating into the area of disturbance following sample collection from the base of the excavation.

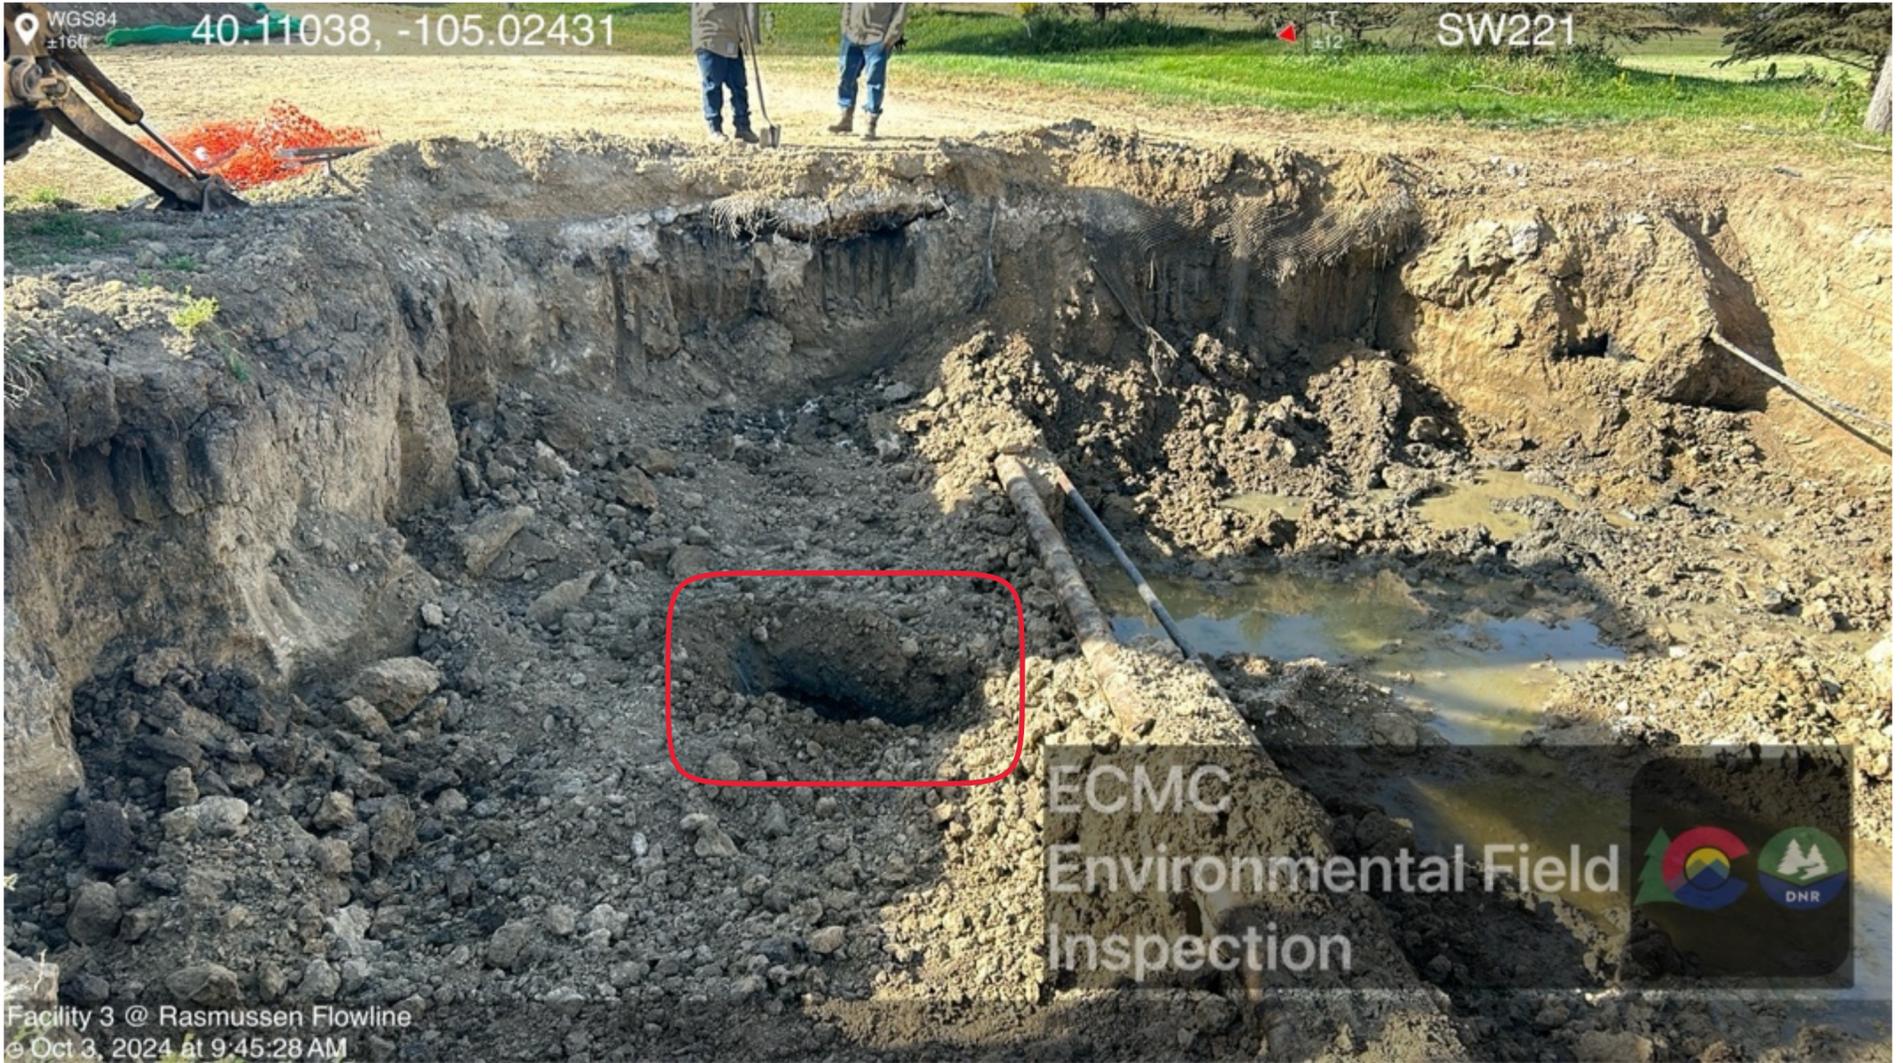
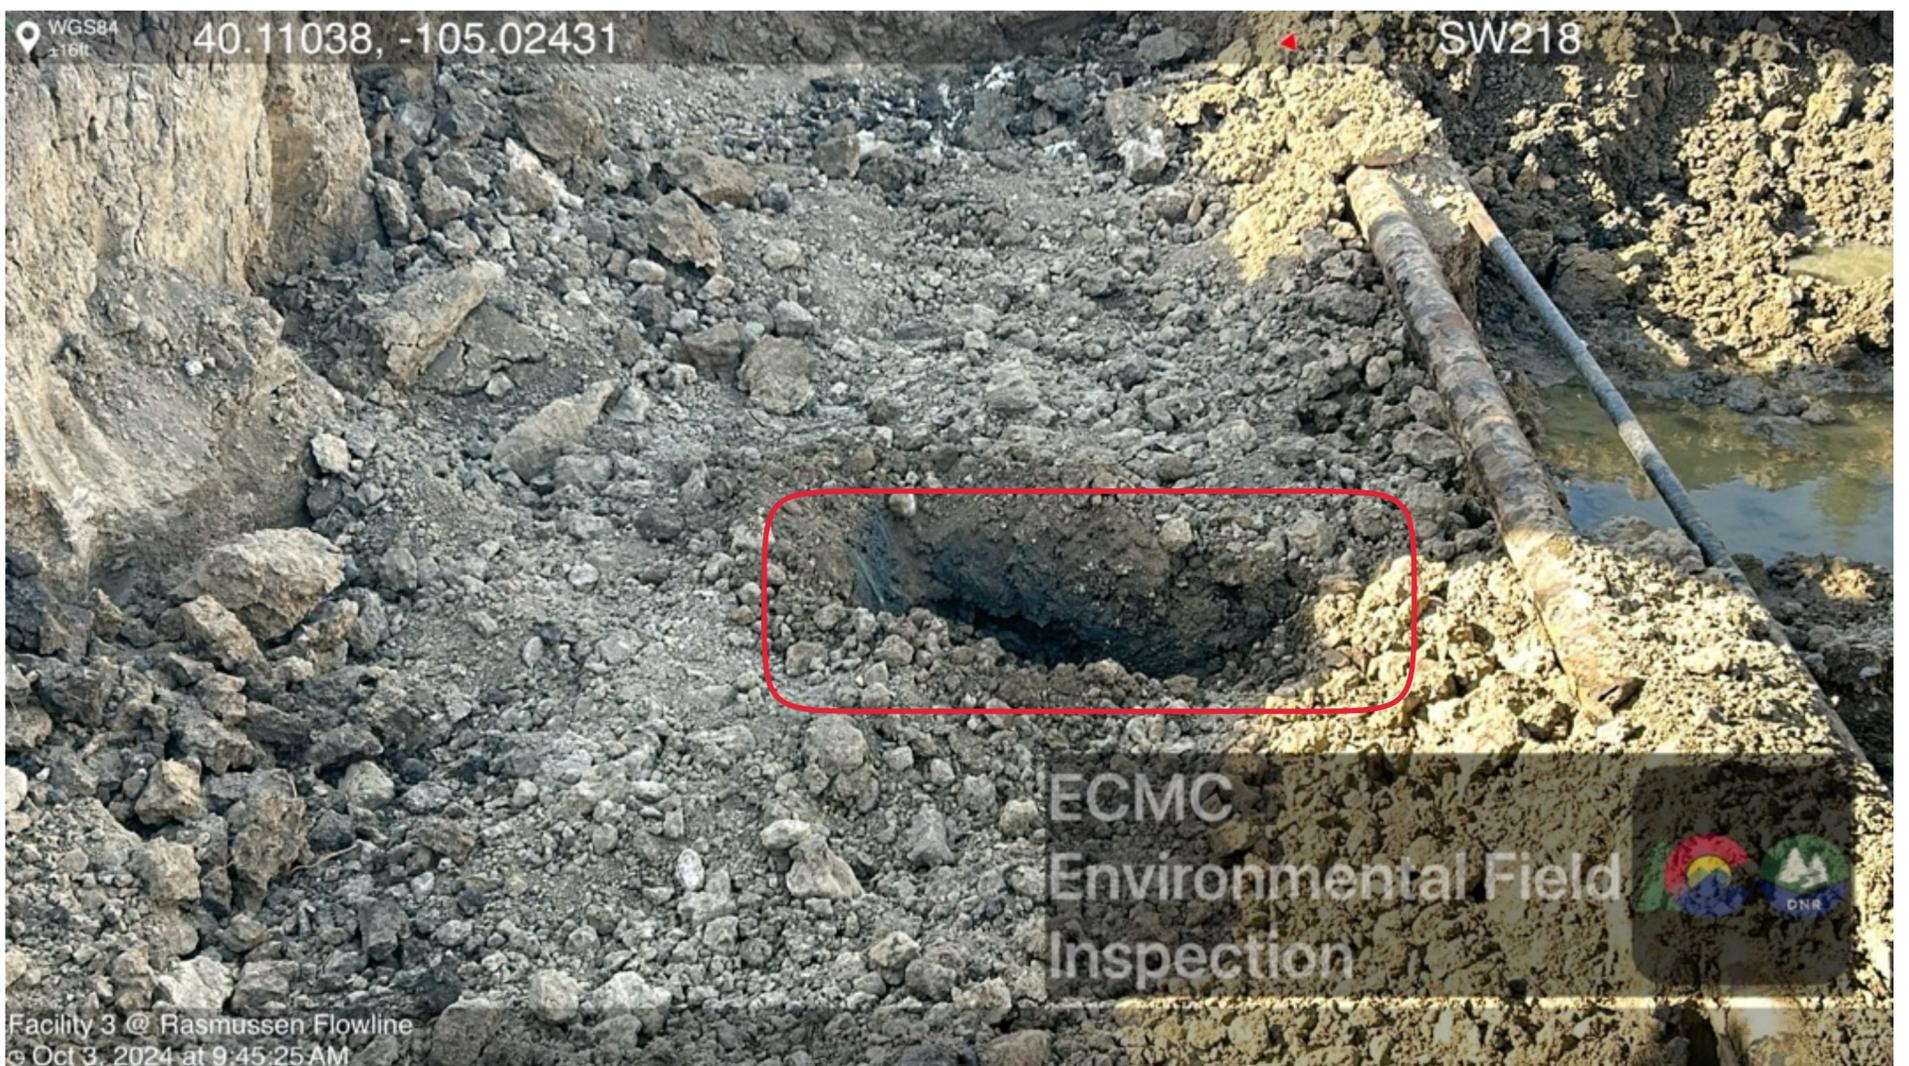
Confirmation soil samples were collected from each quadrant of the base of the excavation. Gray to black staining was observed at the base of the excavation. A strong petroleum hydrocarbon odor was observed when soil at the base of the excavation was disturbed.

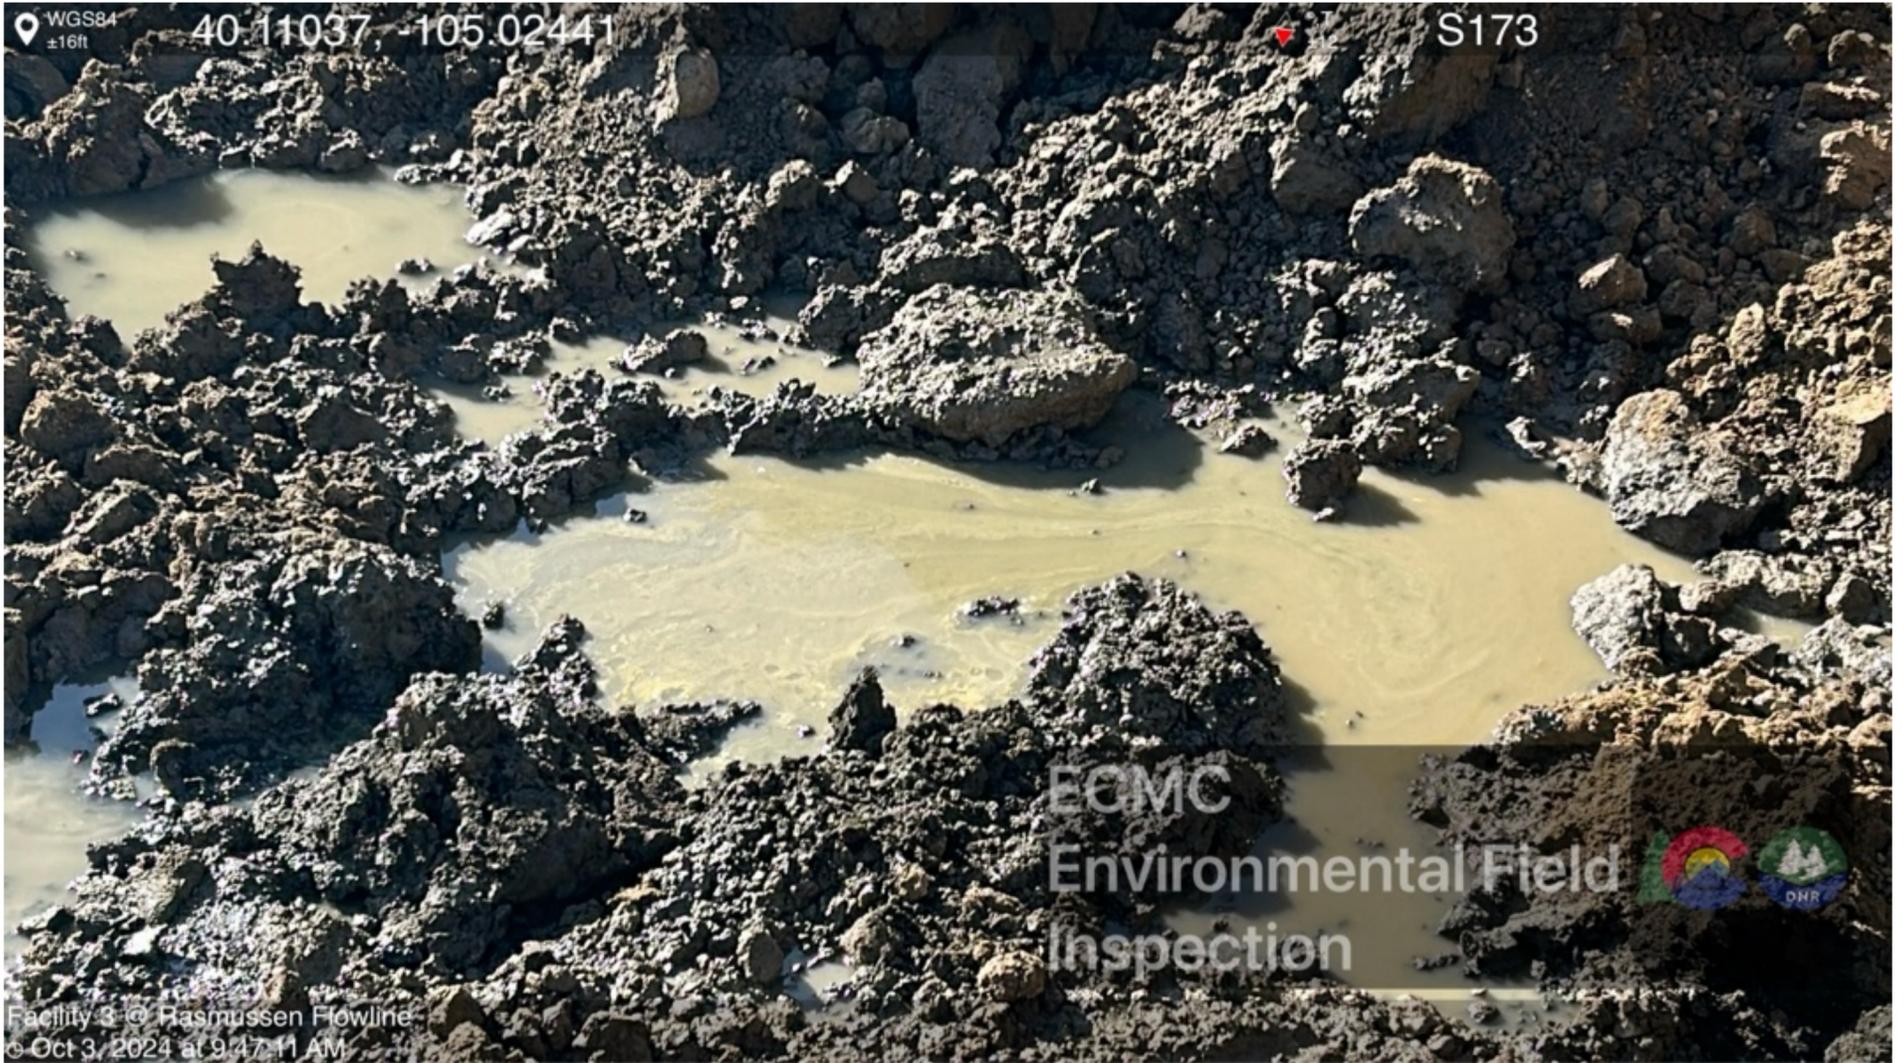
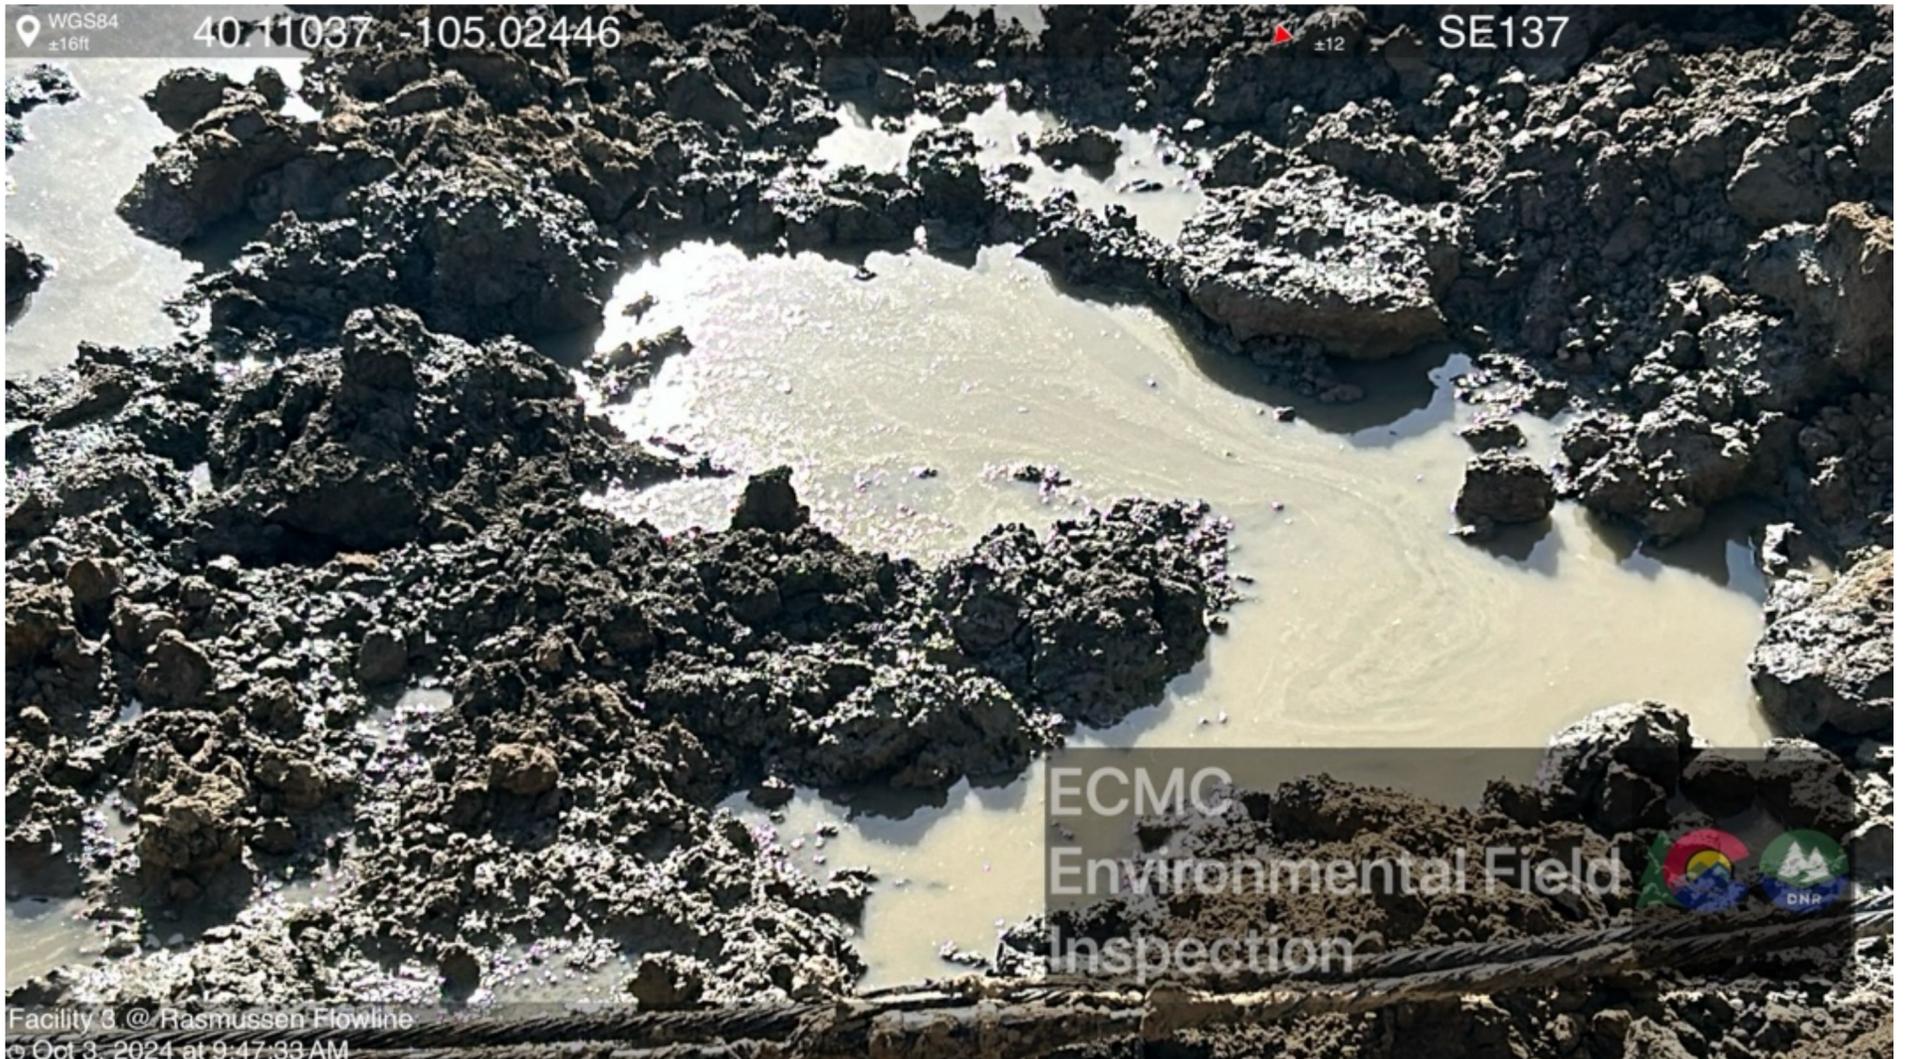
Groundwater with free product was observed at the base of the excavation.
