Inspection Photos
Facility 3 @ Rasmussen Flowline
Spill ID 487690

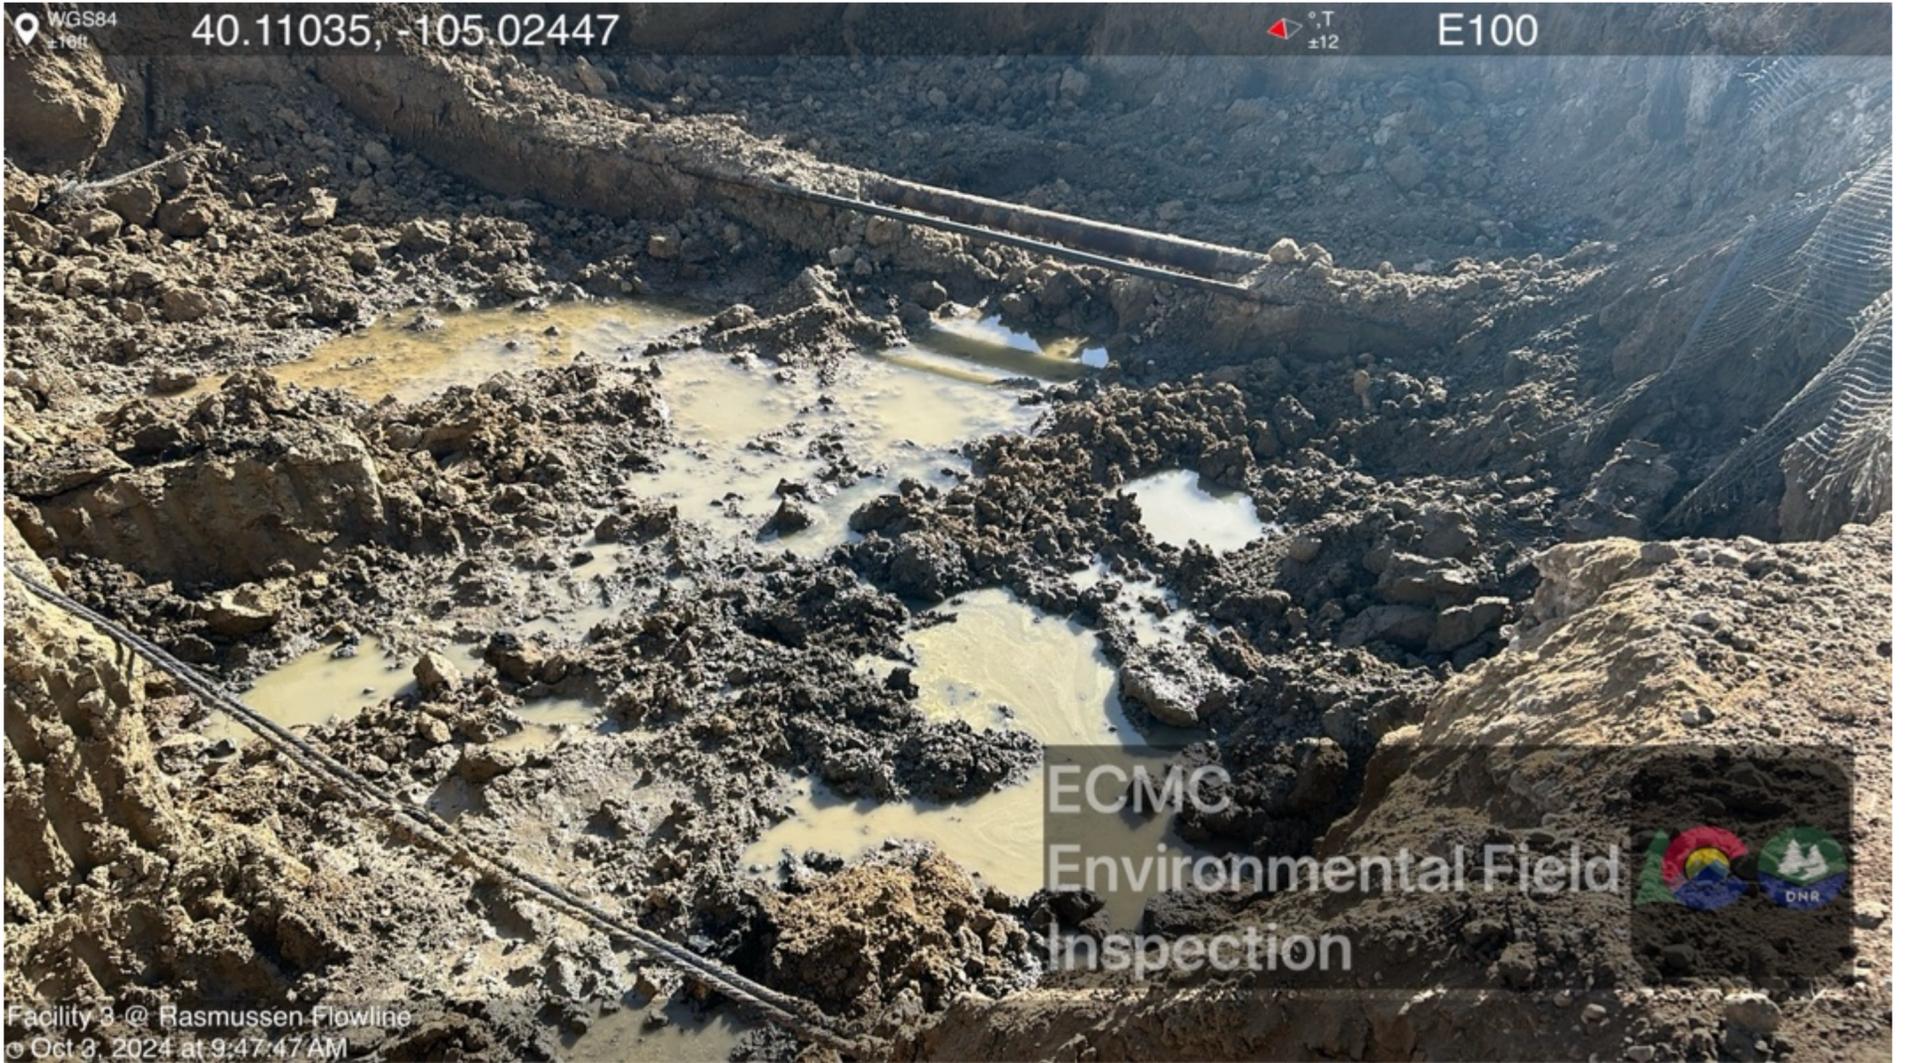
Gray to black staining was observed at the base of the excavation and along portions of the western sidewall. Groundwater with free product was observed at the base of the excavation. A strong petroleum hydrocarbon odor was observed when impacted media was disturbed.

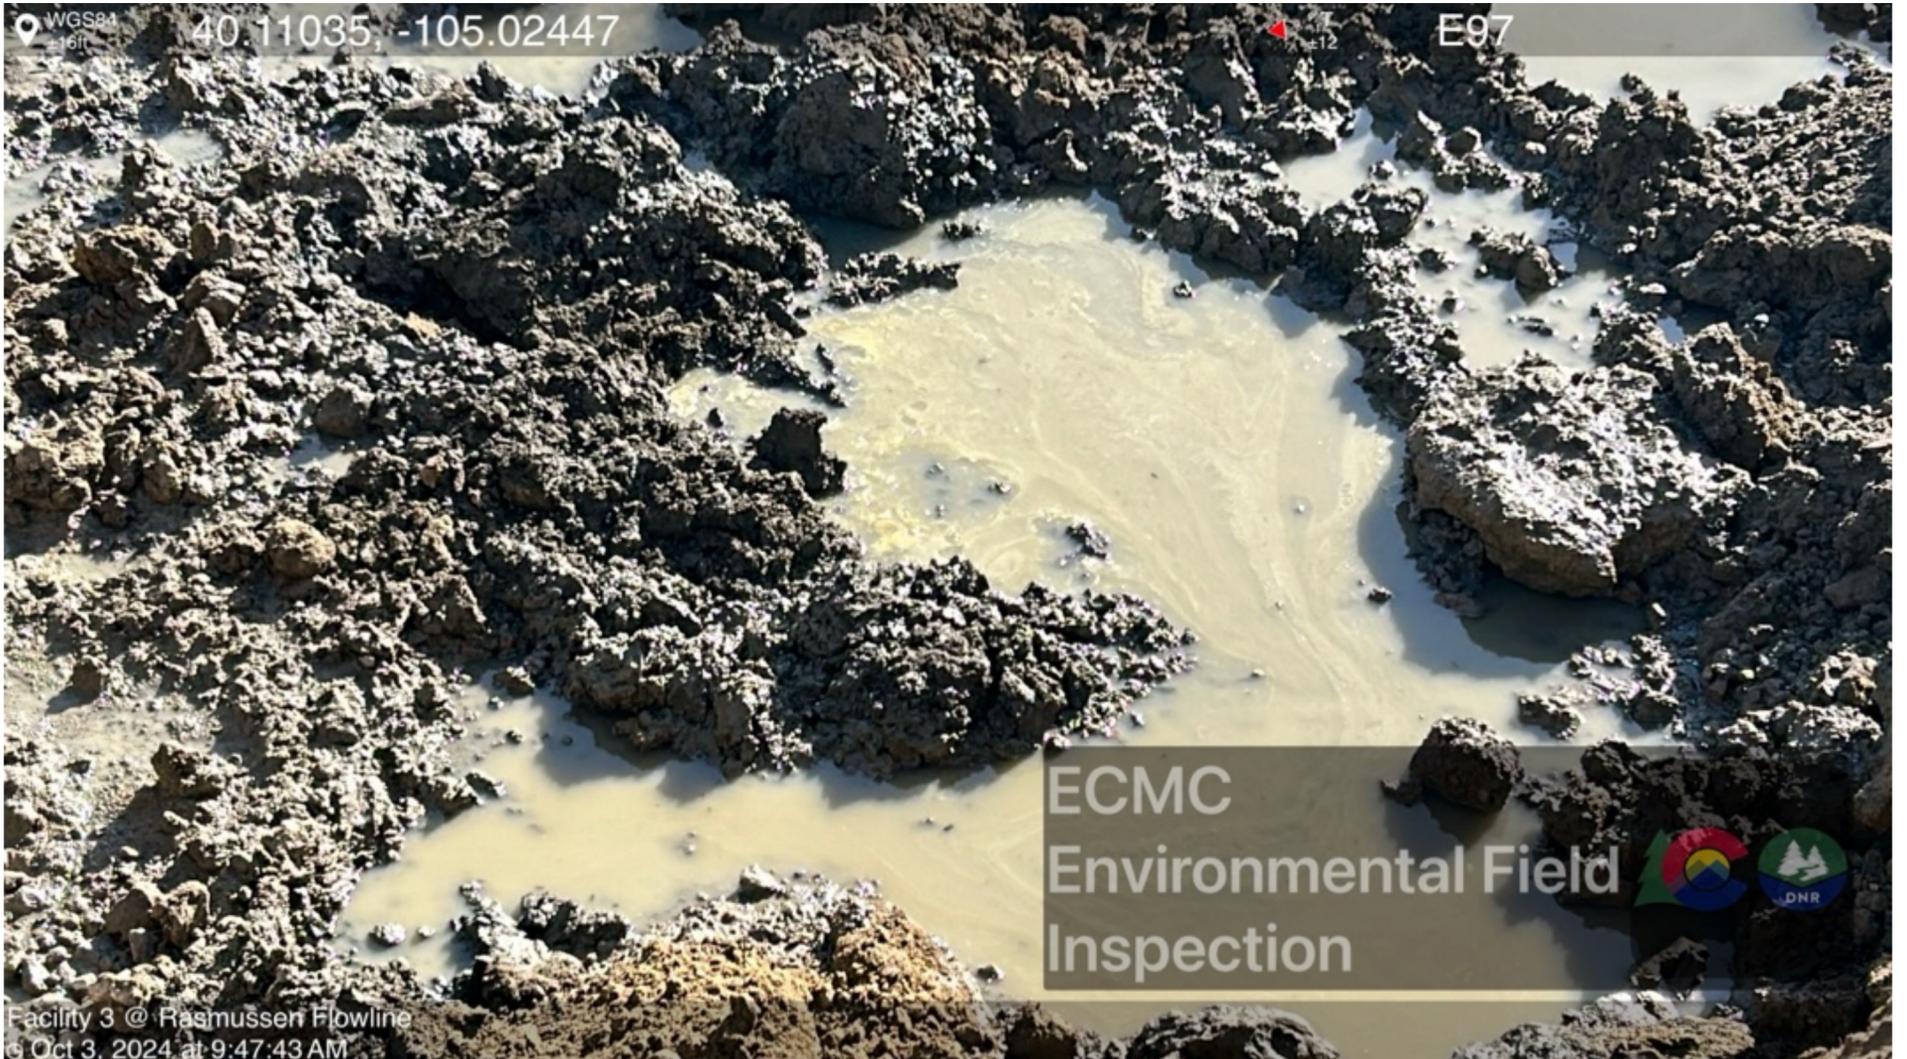
Groundwater with free product was observed at the base of the excavation.

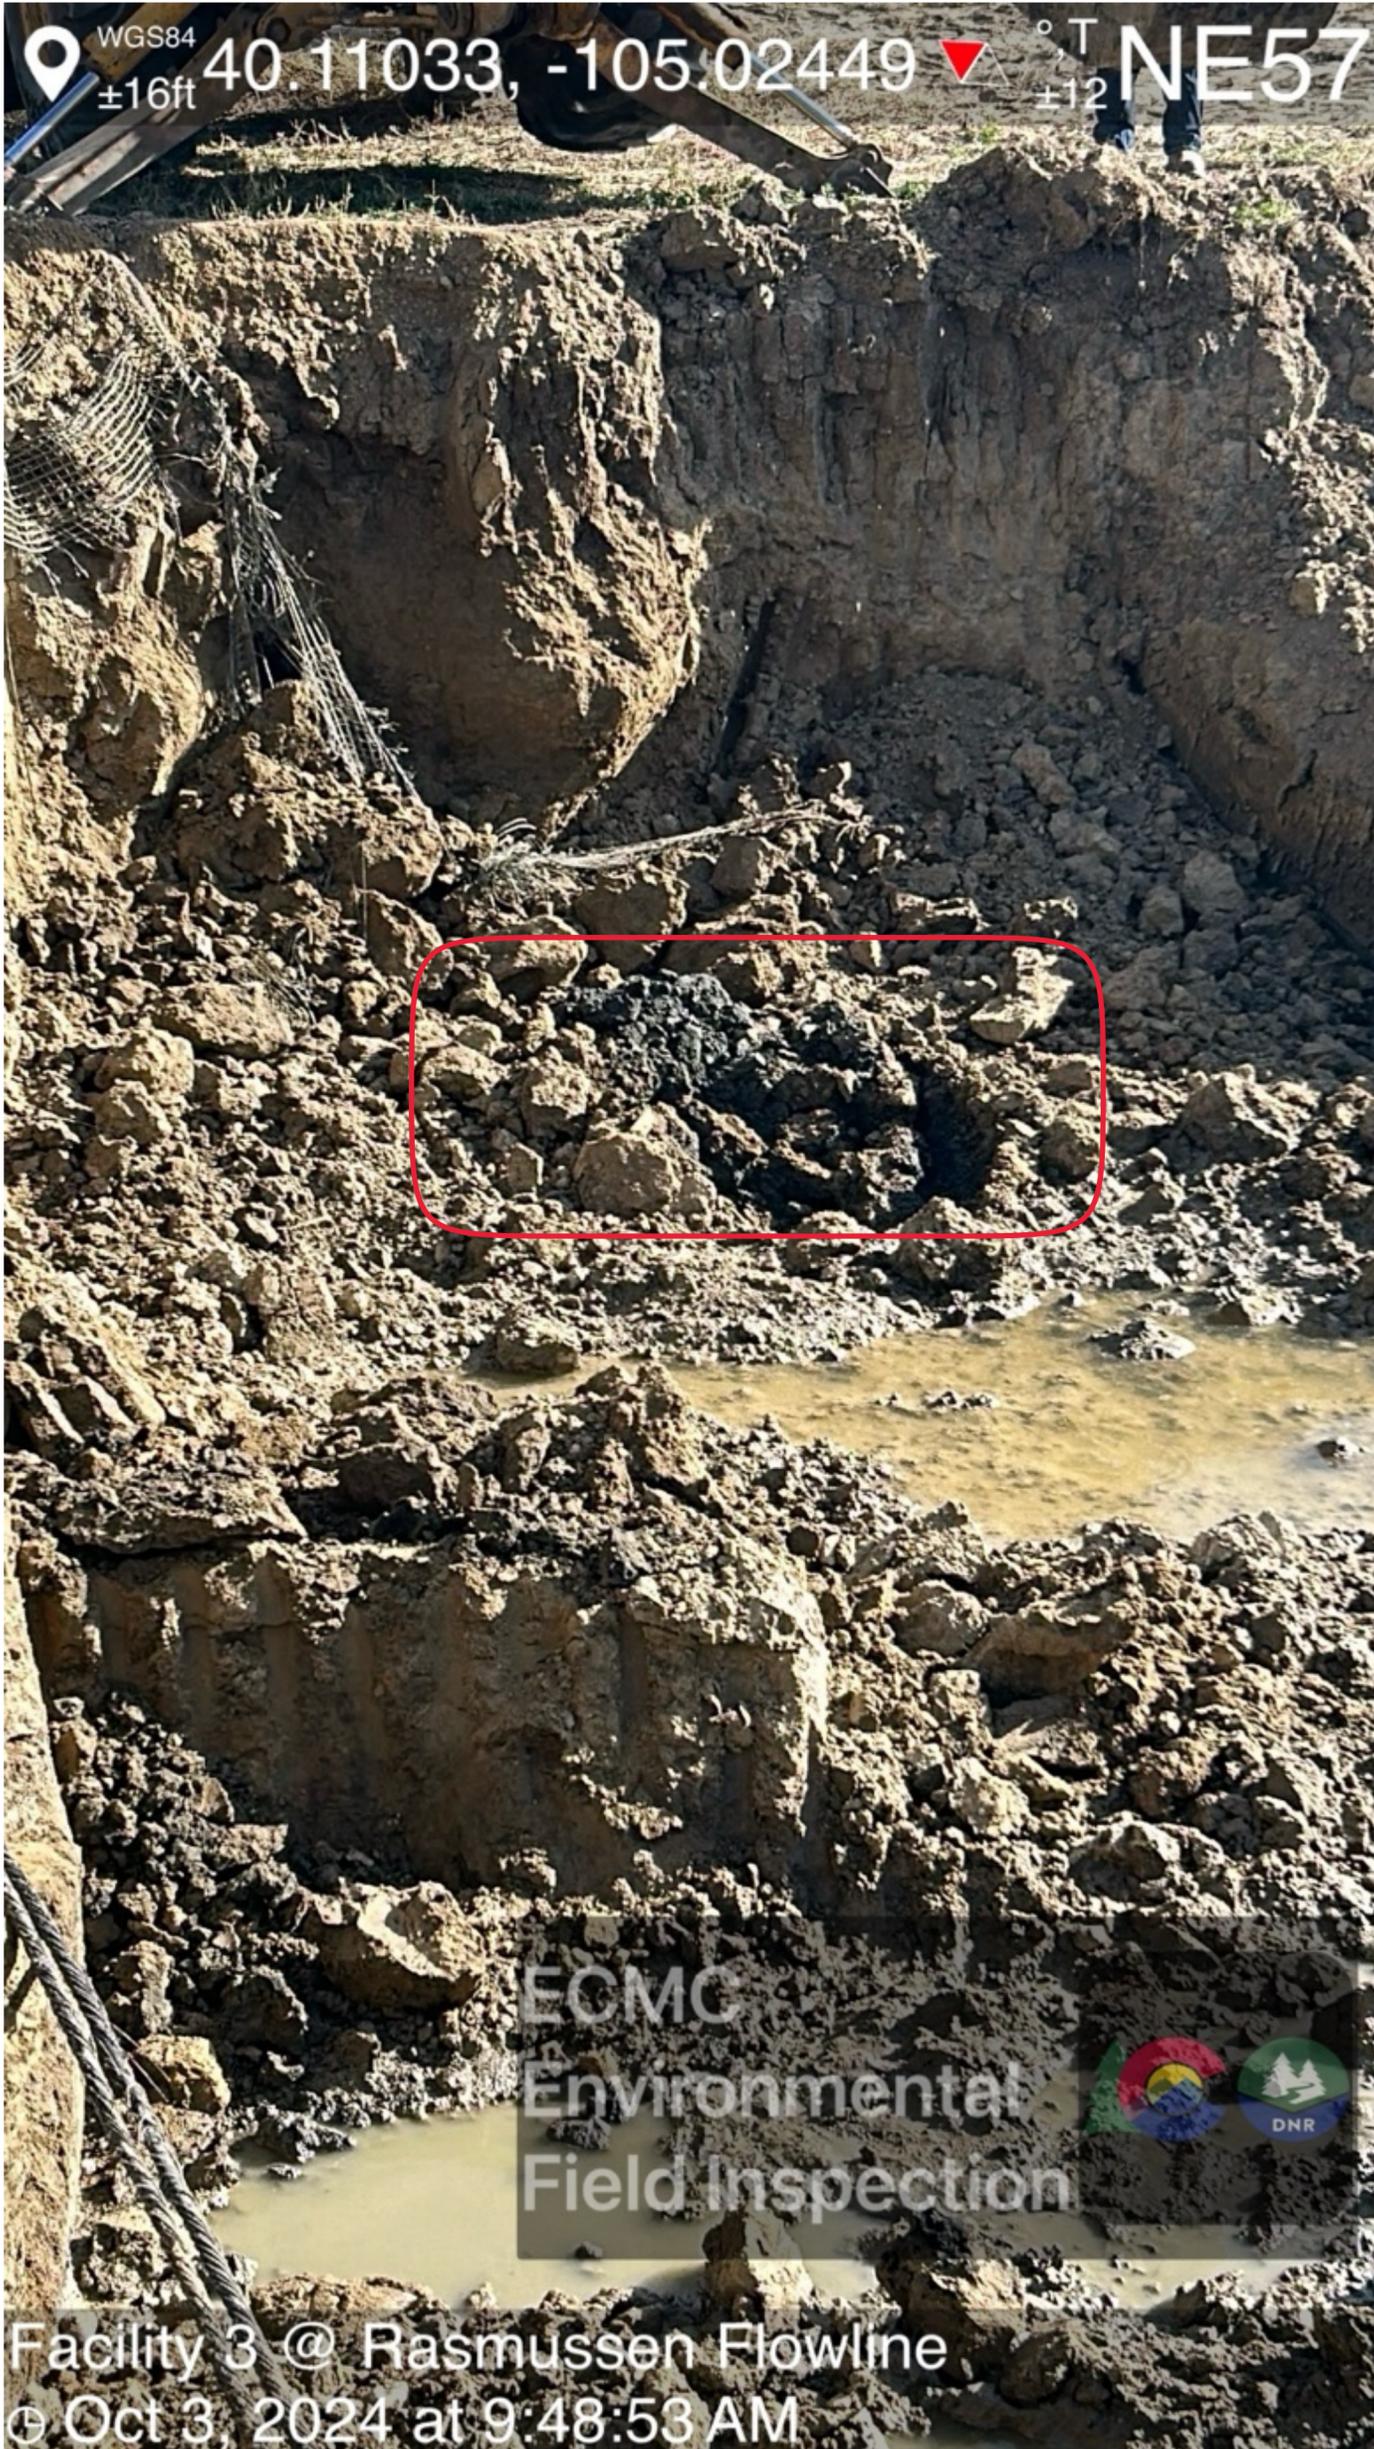
Gray to black staining was observed at the base of the excavation and along portions of the western sidewall. Groundwater with free product was observed at the base of the excavation. A strong petroleum hydrocarbon odor was observed when impacted media was disturbed.

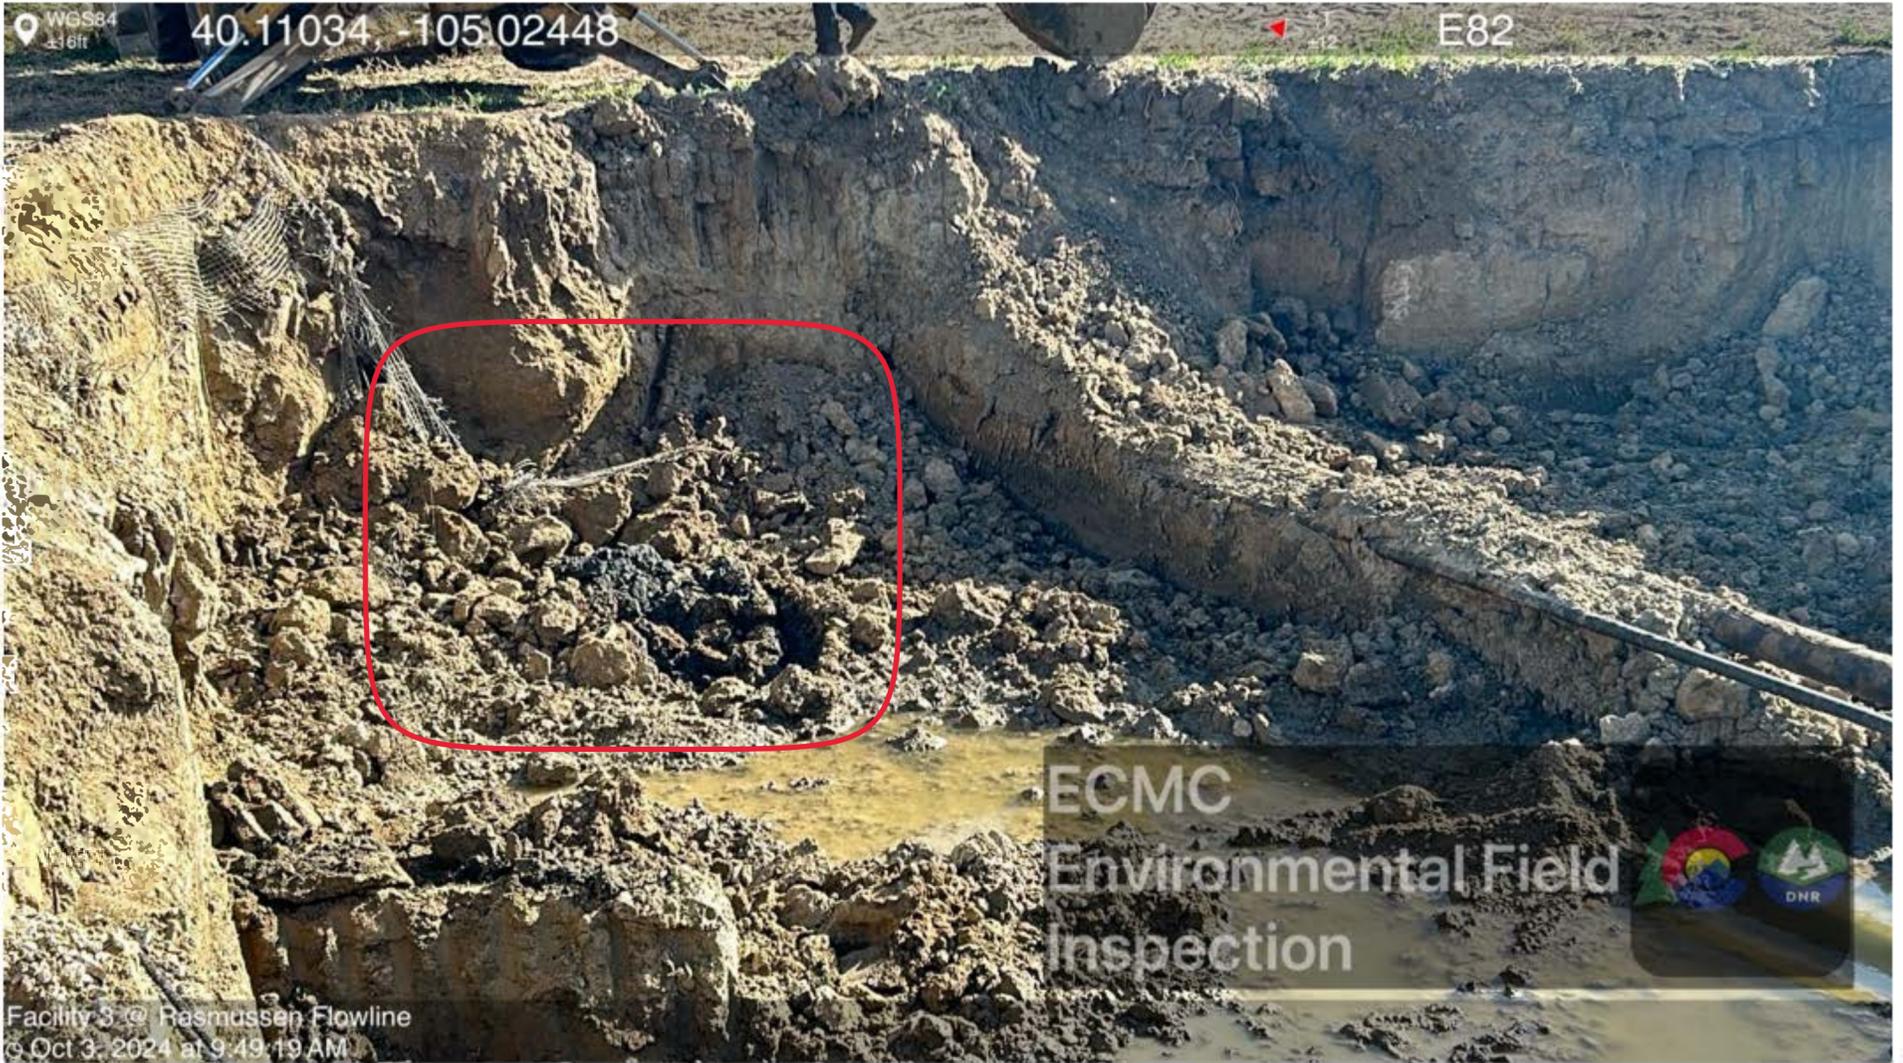
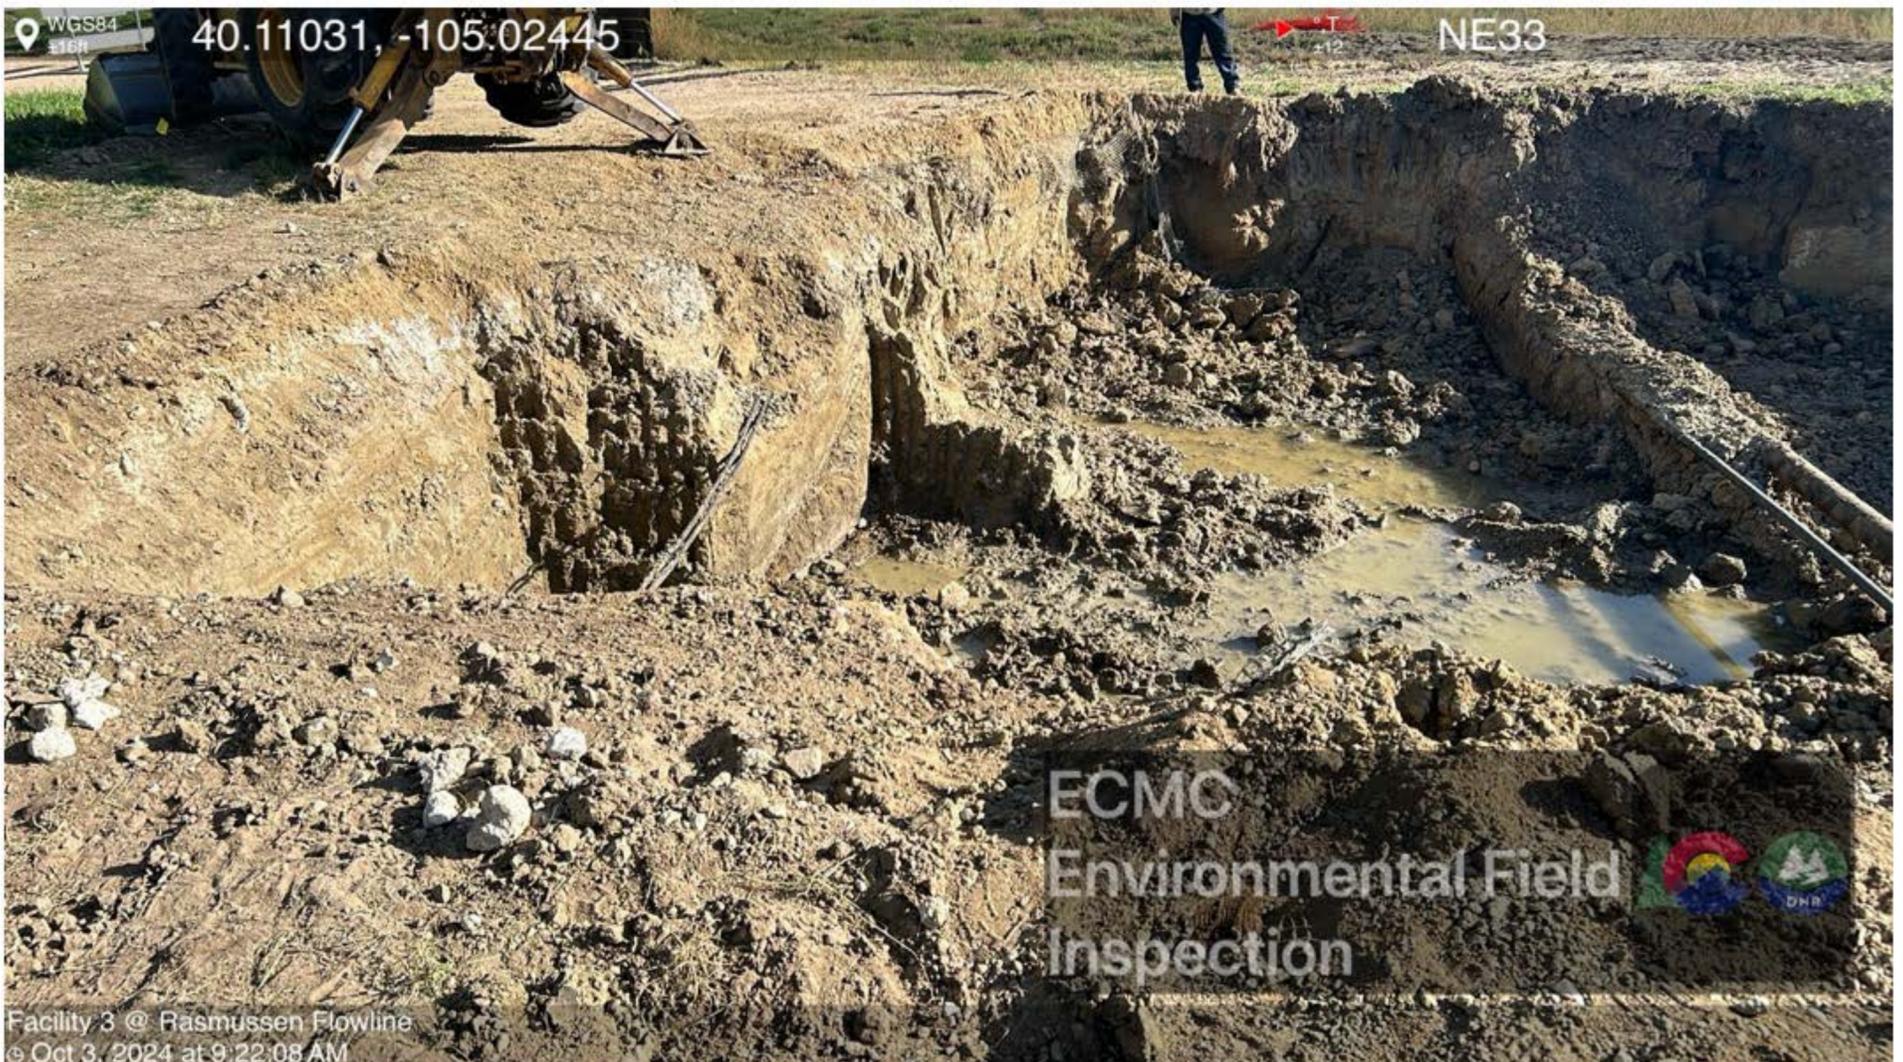
Gray to black staining was observed at the base of the excavation and along portions of the western sidewall. Groundwater with free product was observed at the base of the excavation. A strong petroleum hydrocarbon odor was observed when impacted media was disturbed.

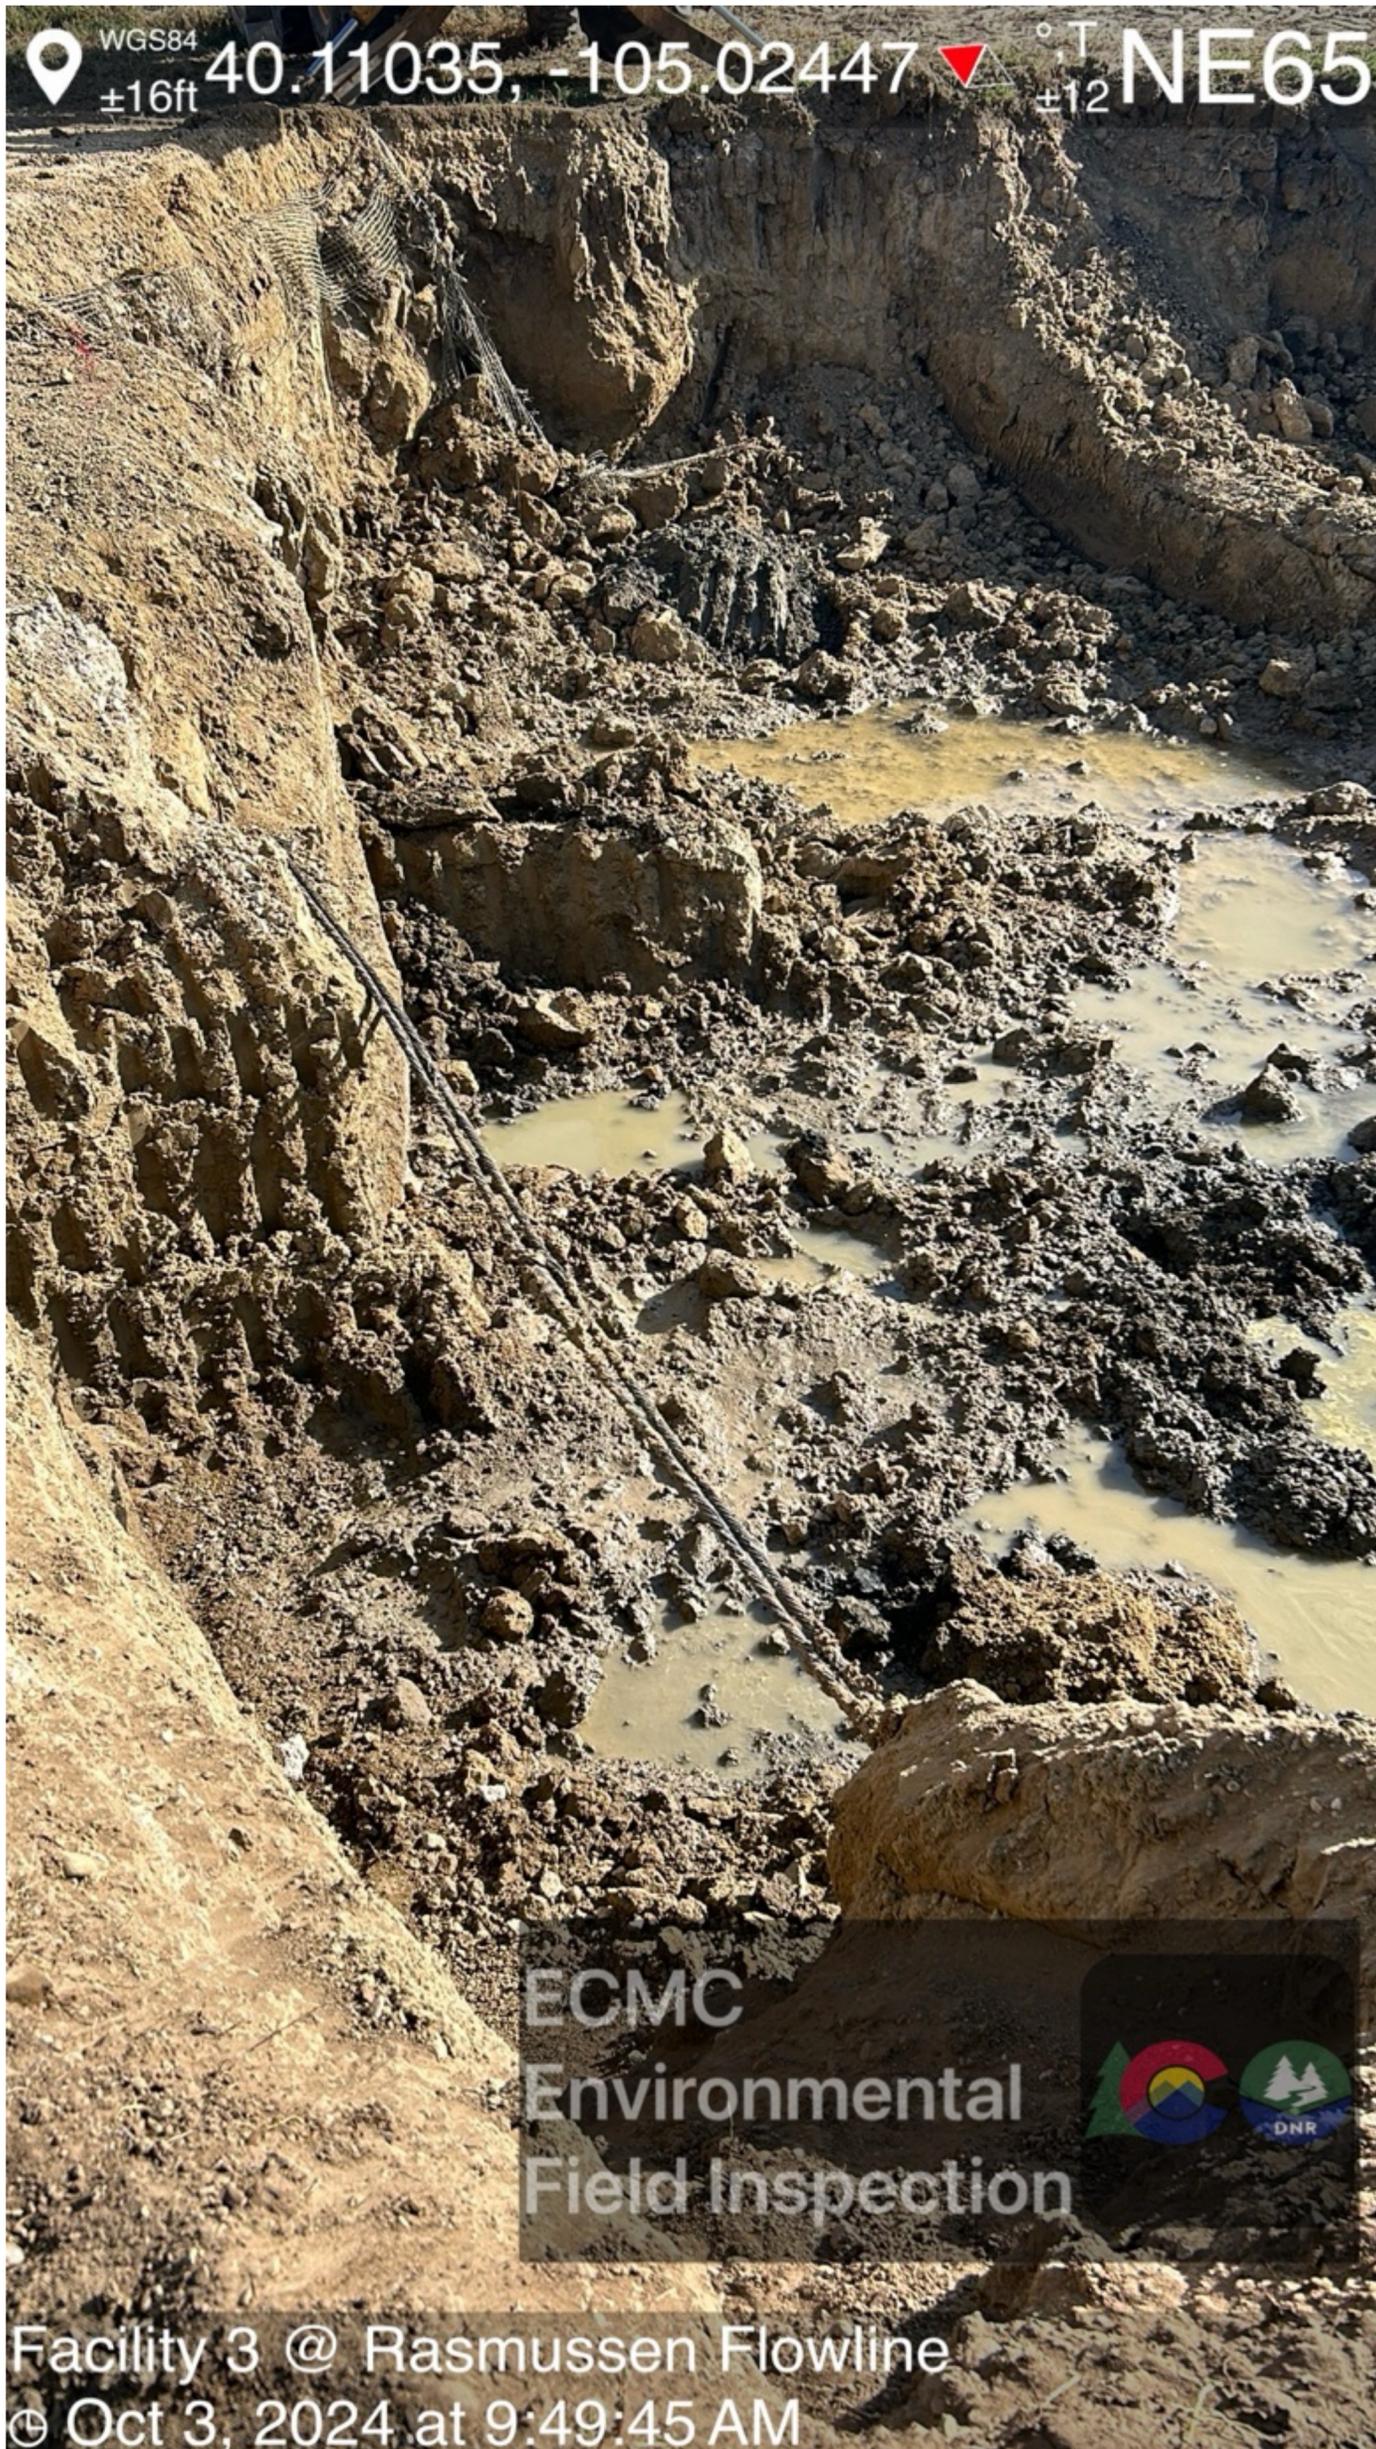
Gray to black staining was observed at the base of the excavation and along portions of the western sidewall. Groundwater with free product was observed at the base of the excavation. A strong petroleum hydrocarbon odor was observed when impacted media was disturbed.
