Inspection Photos

Location Name: FLETCHER GULCH 3-21

Location ID: 316580

Inspection Date: September 24, 2024

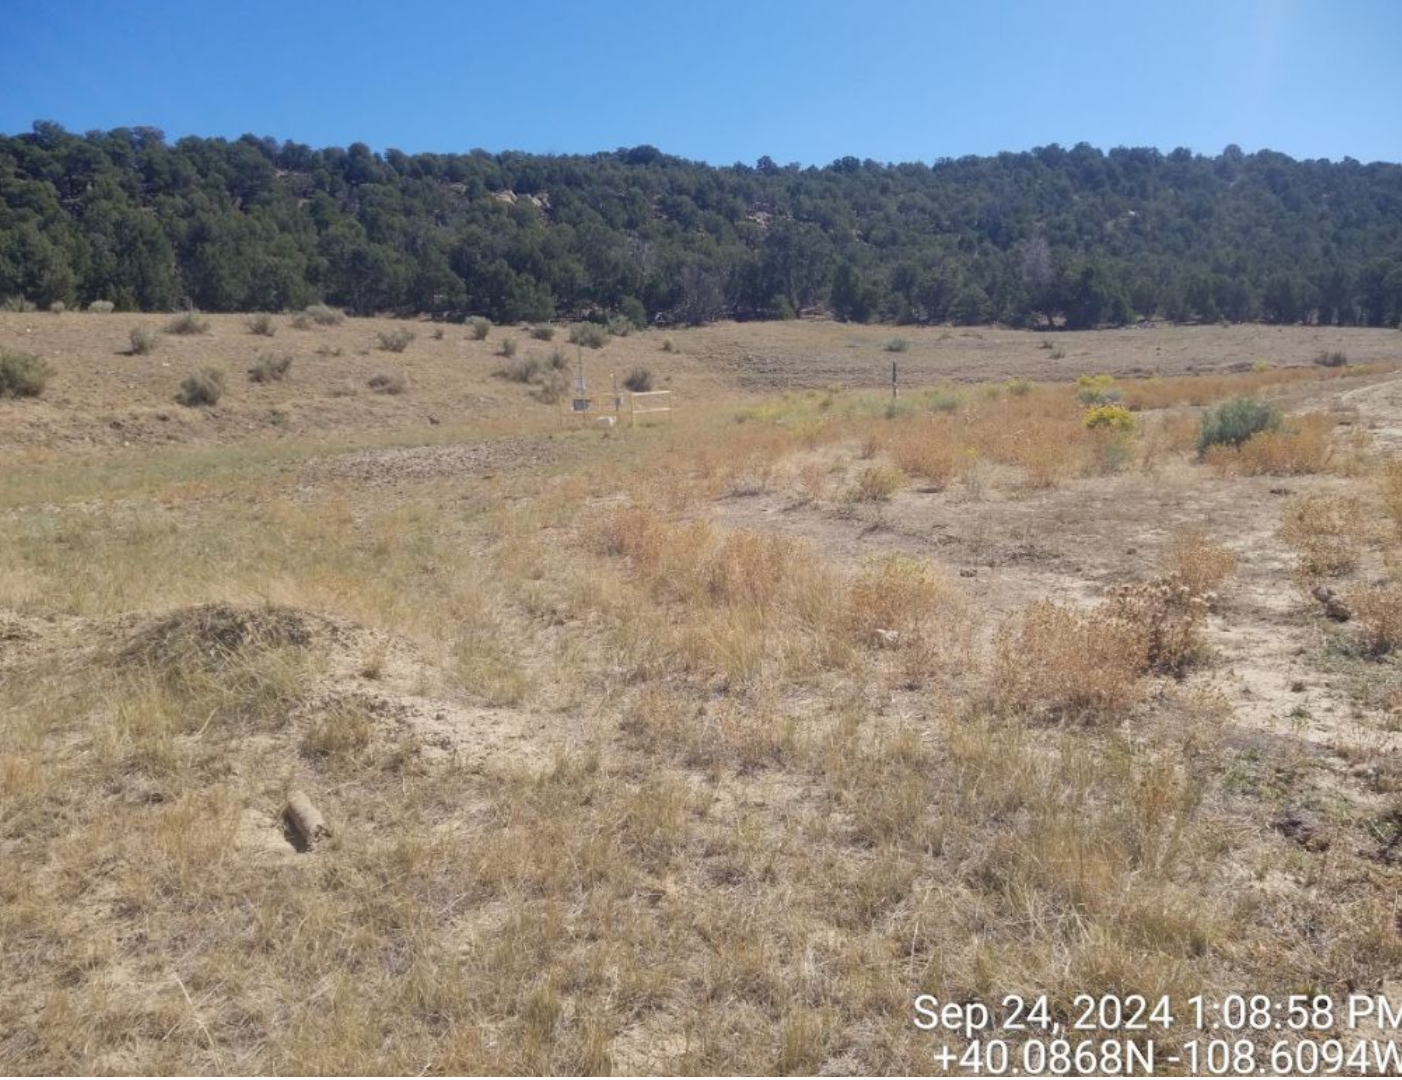
Unnecessary equipment.
