## Inspection Photos

**Operator: AMERICAN HELIUM OPERATING LLC - 10841**

**Location Name: ANDY'S MESA FEDERAL #36      API #: 05-113-06124**

**Inspection Date: 10/10/2024    Inspection Doc#: 693807804**

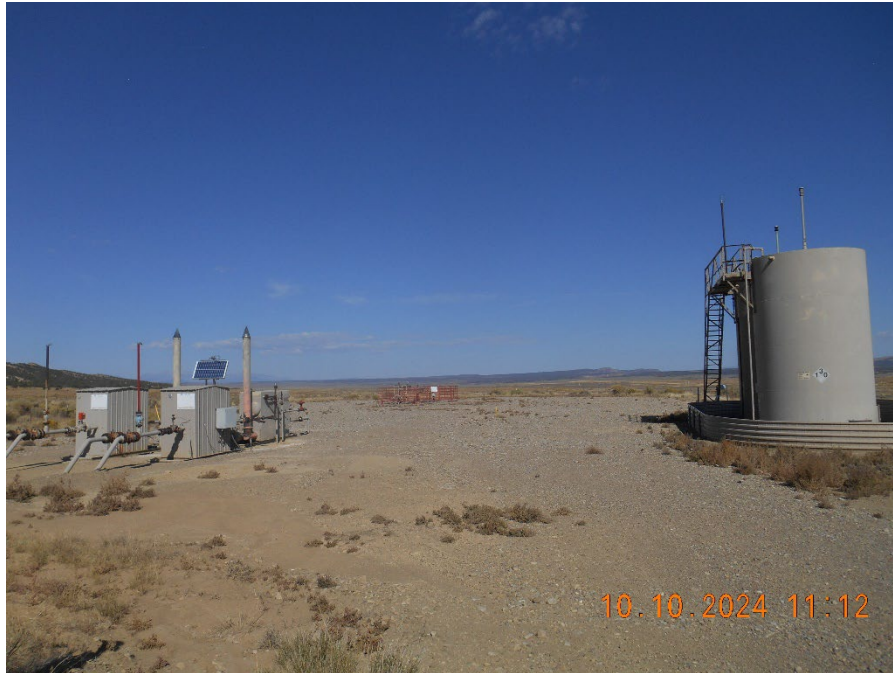
**Location overview looking NW**

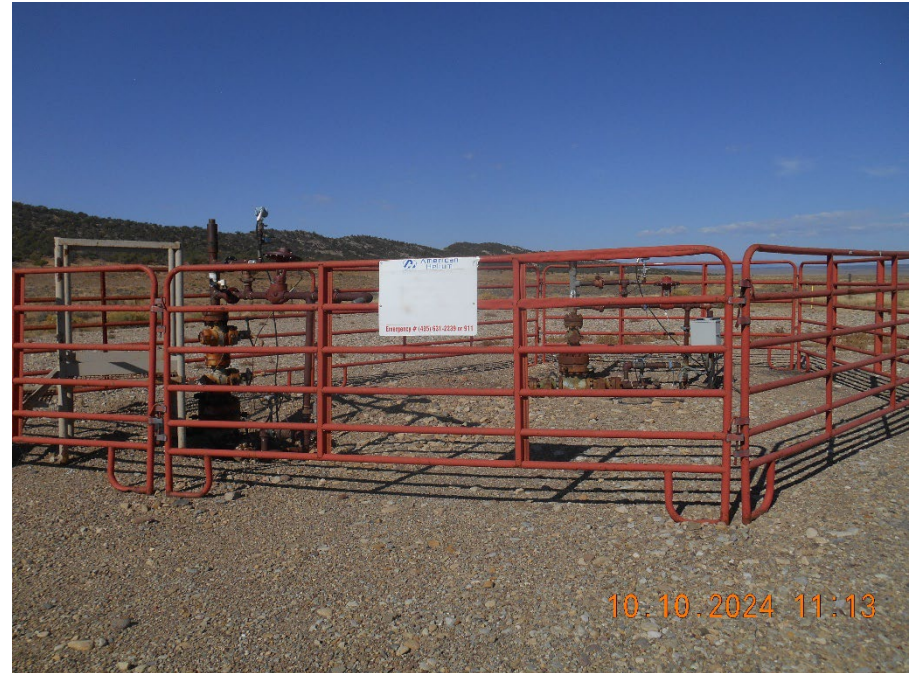
**Wellheads with fence and signs**

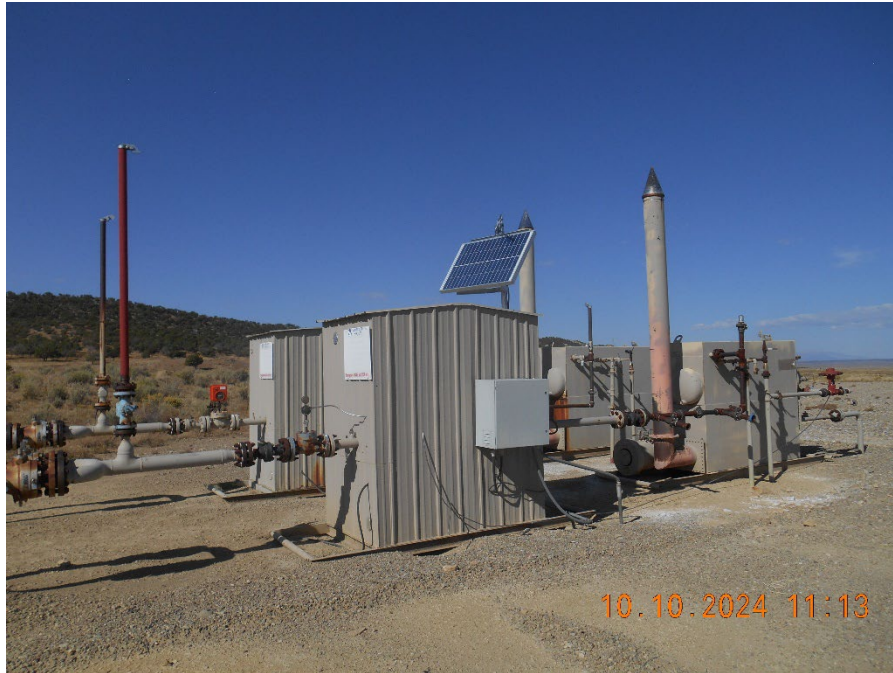
**Separators and Meter housings**

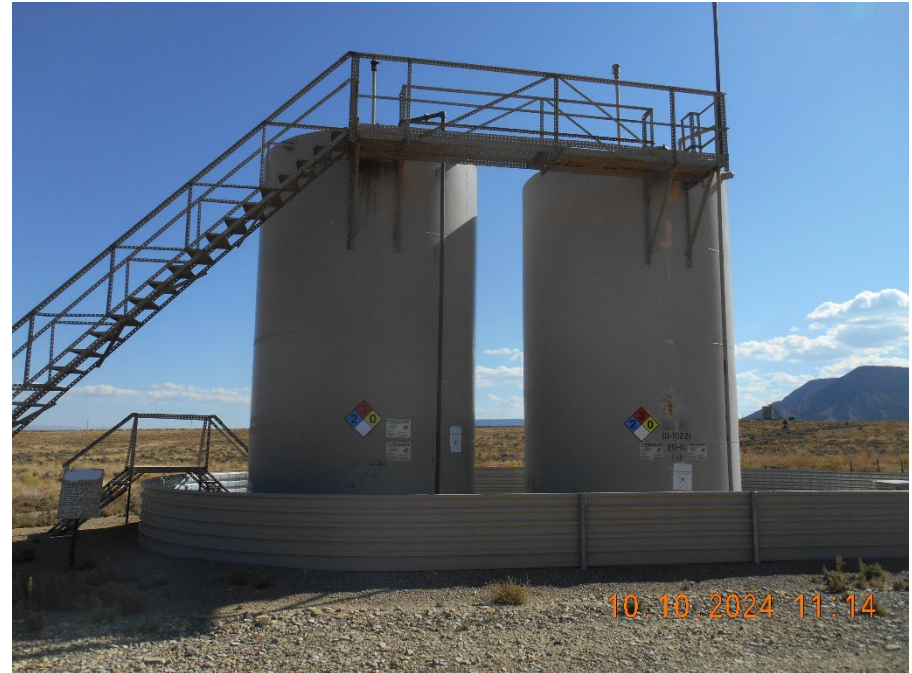
**Tank Battery.**

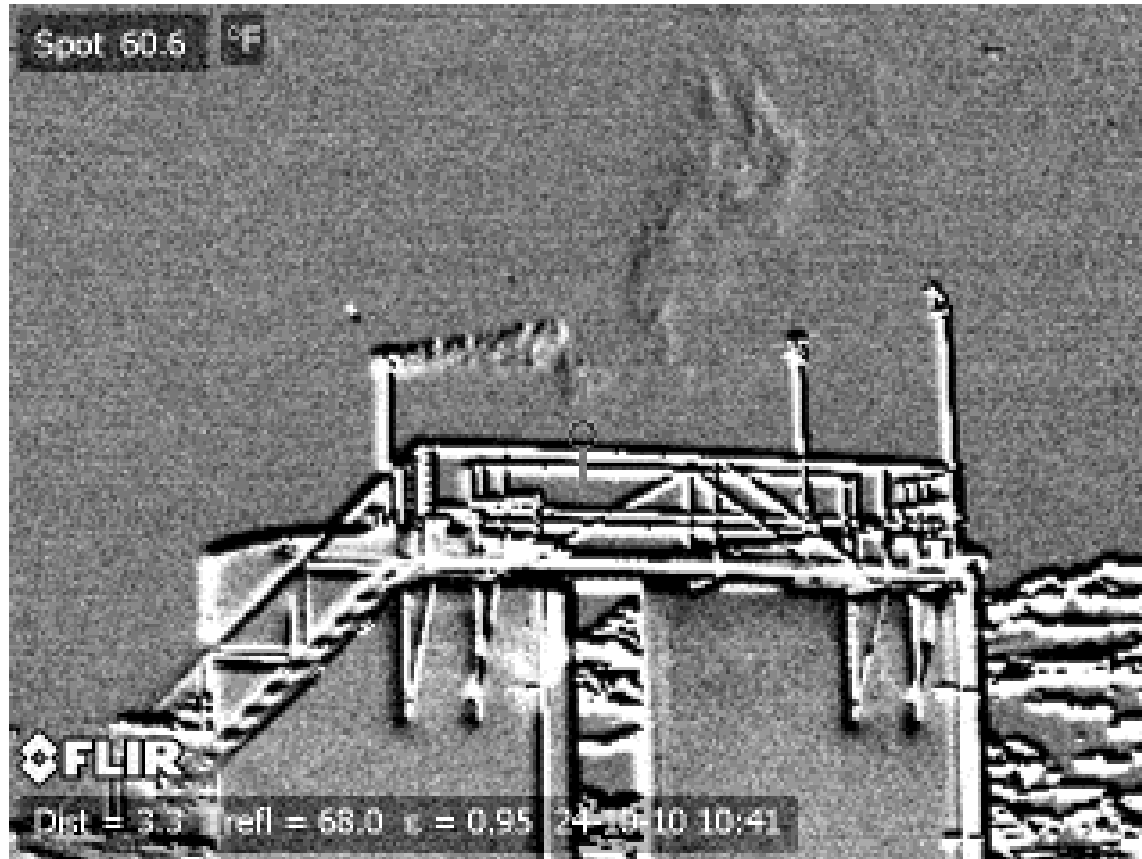
FLIR video of leaking enardo valve on tank battery.
