## Inspection Photos

Location Name: TEP ROCKY MOUNTAIN LLC Savage RWF 23-25 Pad

Location ID: 432398

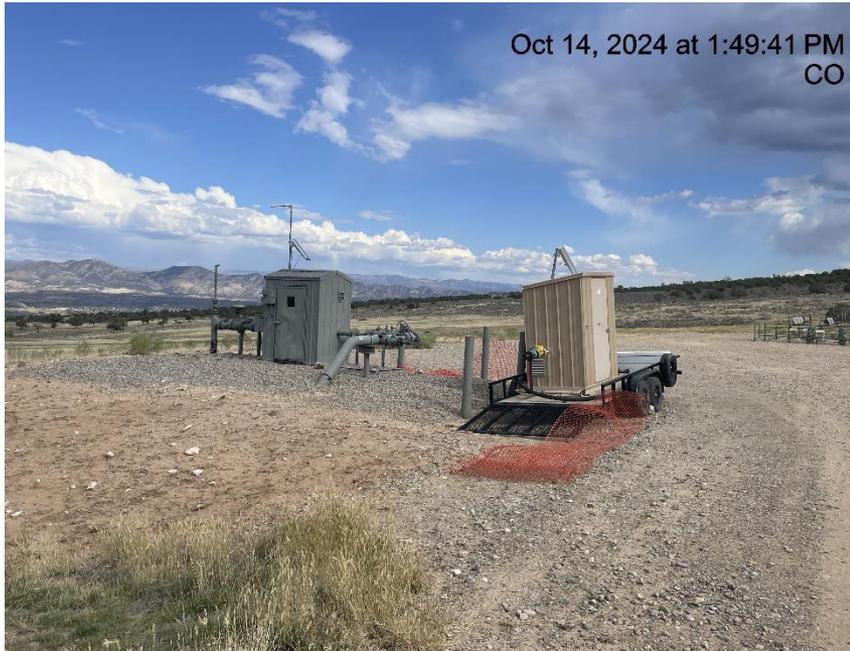
Photo # 5320 From entrance to location

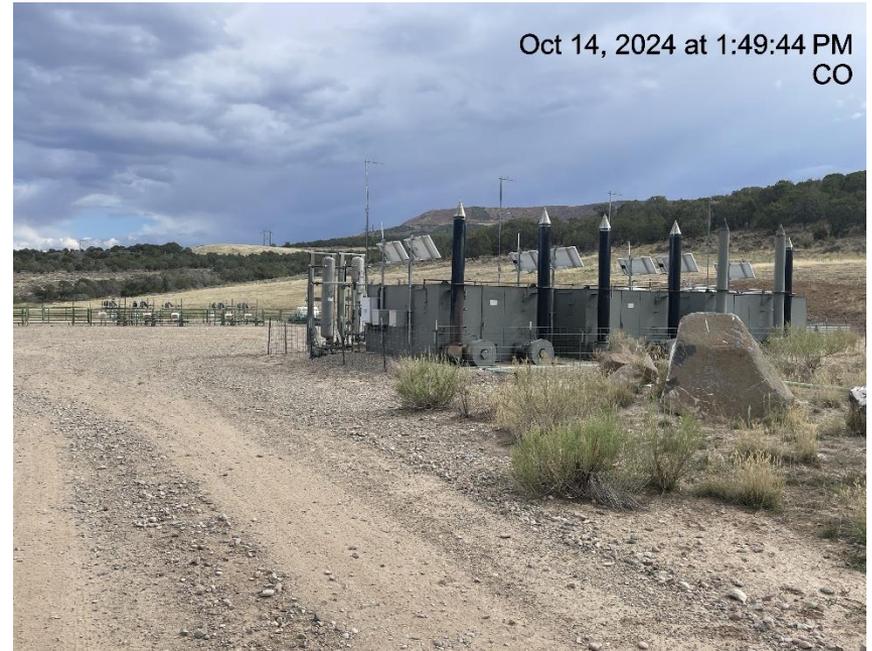
Photo # 5321 From entrance to location

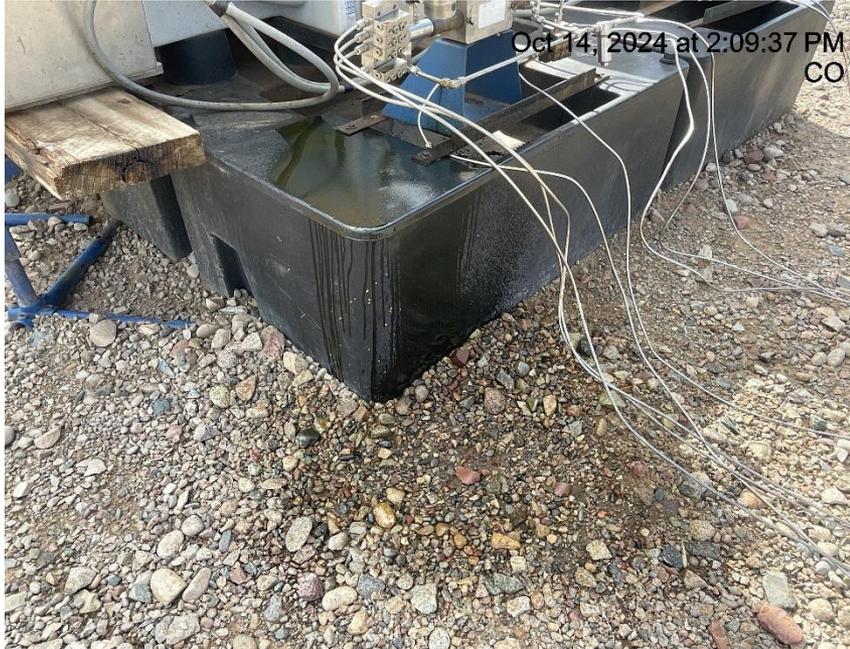
**Photo # 5332 Mechanical Condition – possible leak on chemical tank pump/equipment**

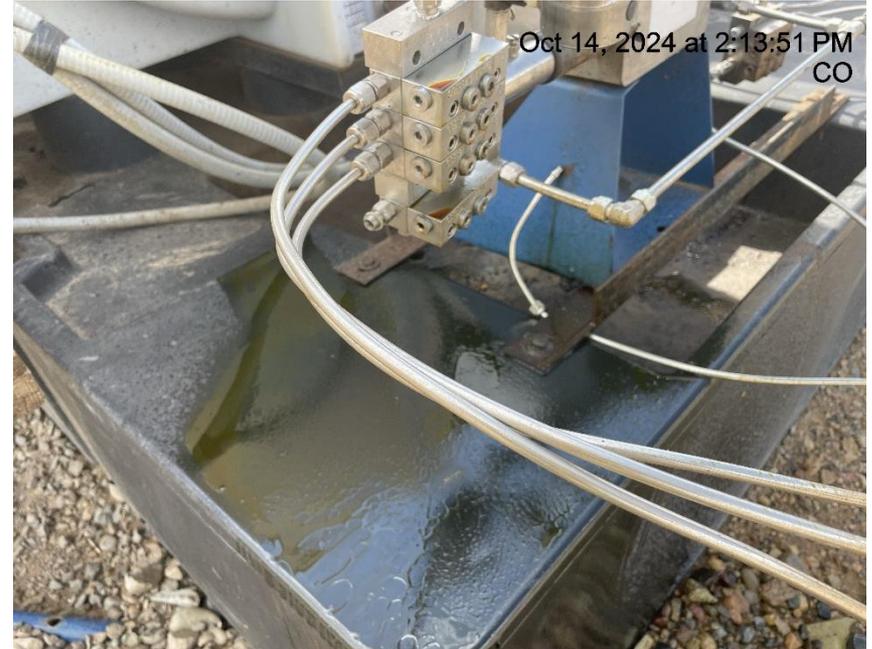
**Photo # 5333 Mechanical Condition – possible leak on chemical tank pump/equipment**

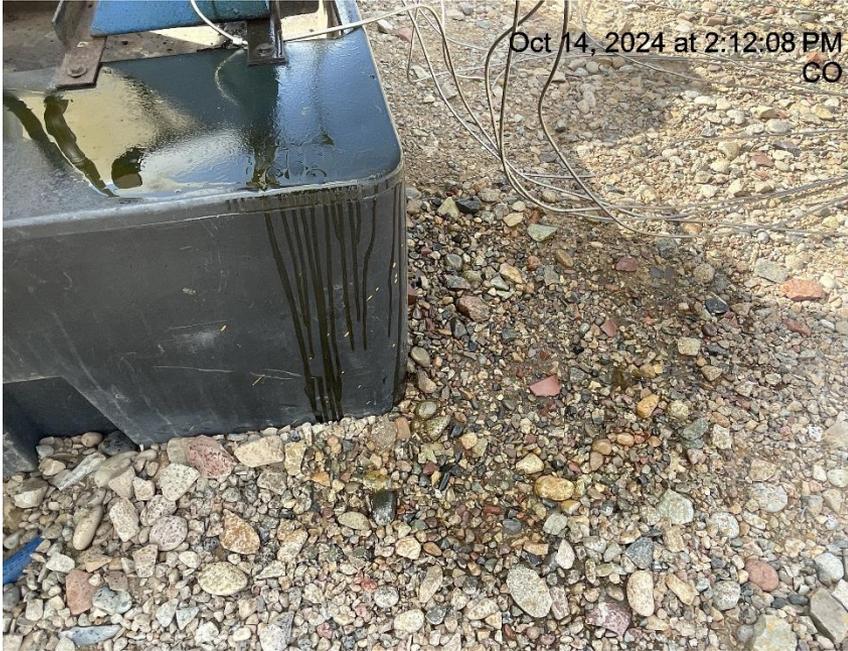
**Photo # 5334 Mechanical Condition – possible leak on chemical tank pump/equipment**

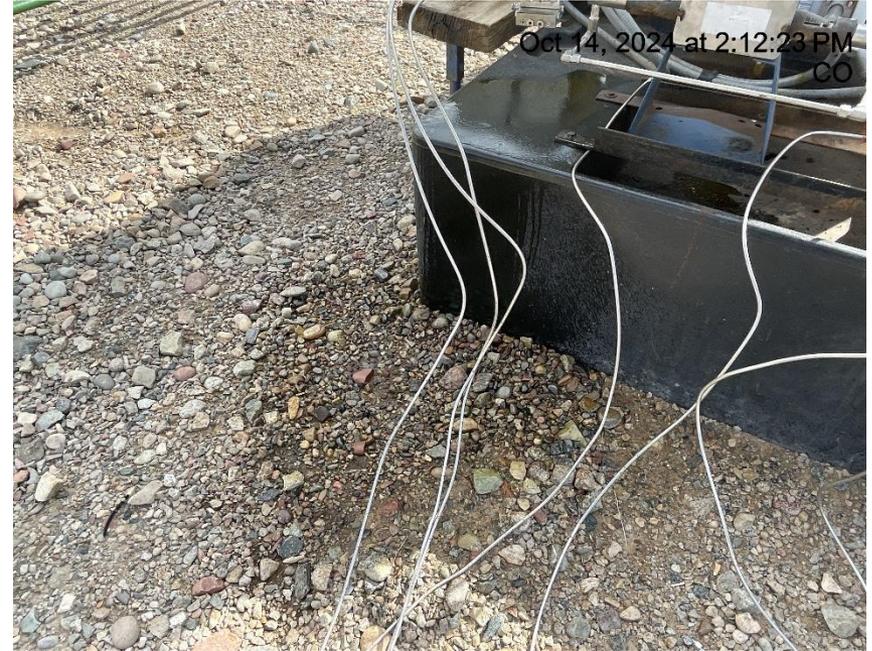
**Photo # 5335 Mechanical Condition – possible leak on chemical tank pump/equipment**

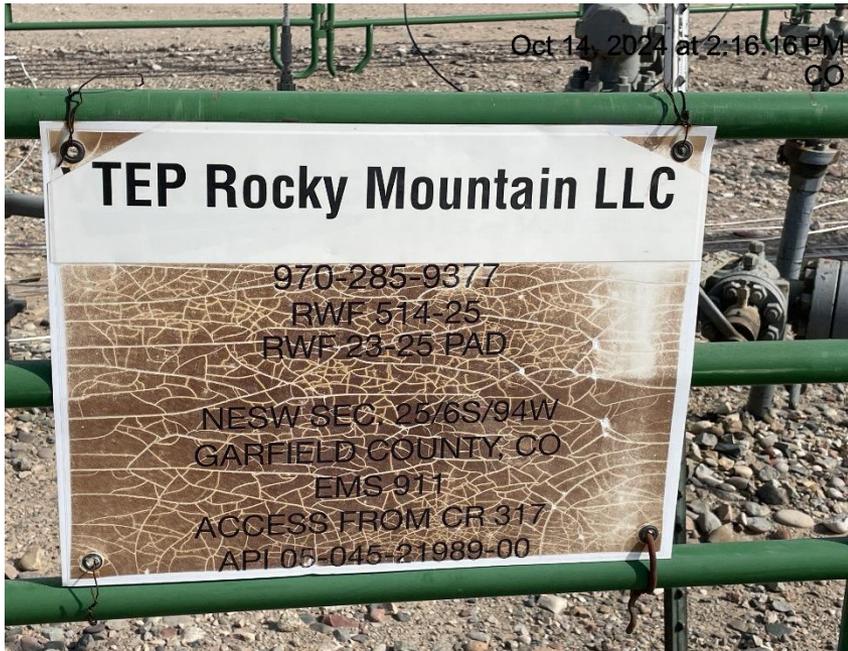
Photo # 5336 Wellhead sign weathered & cracking

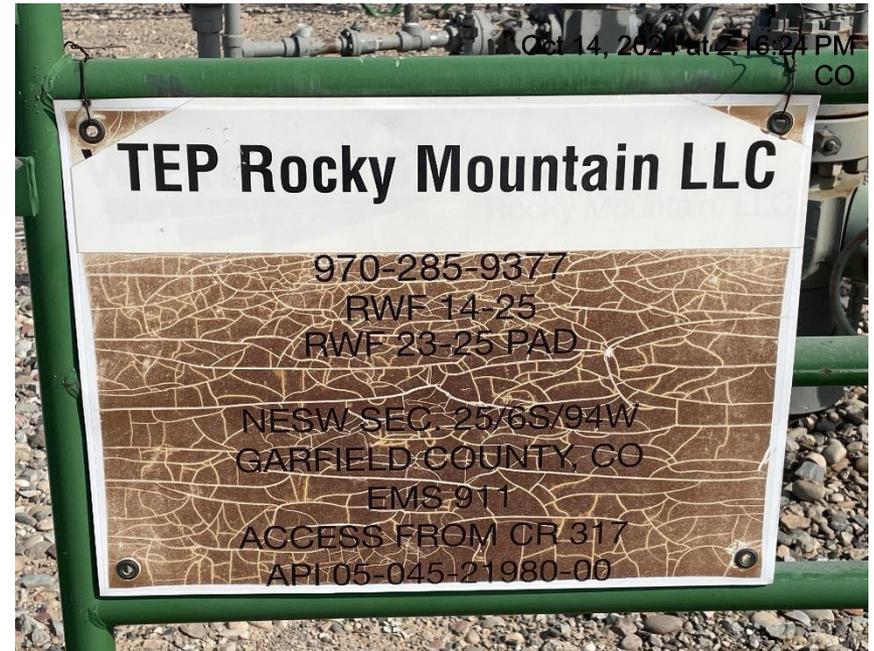
Photo # 5337 Wellhead sign weathered & cracking
