Inspection Photos

Location Name: COCKROFT USX A-66N64W/11SENE

Location #: 333034

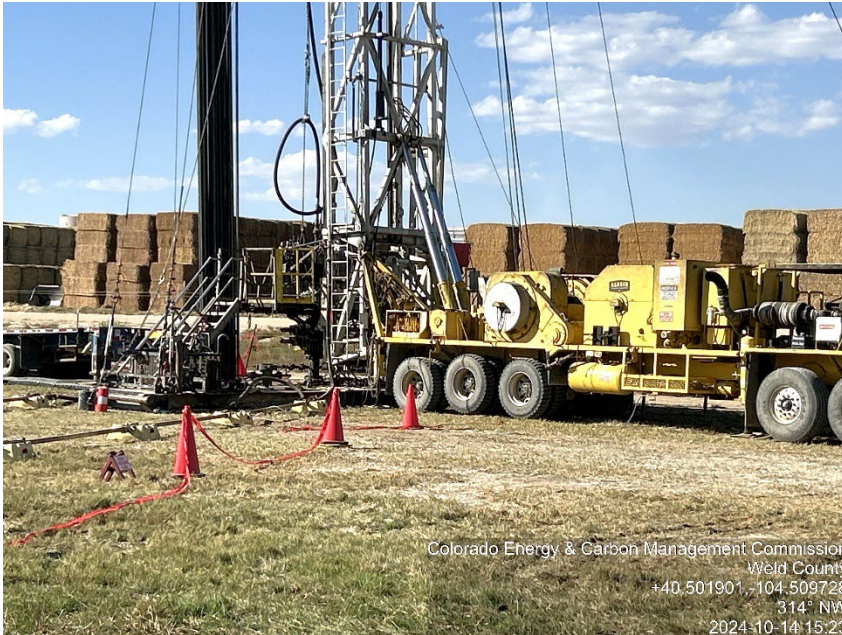
Photo #1

Plugging Ops; Workover: kill well, pull tubing

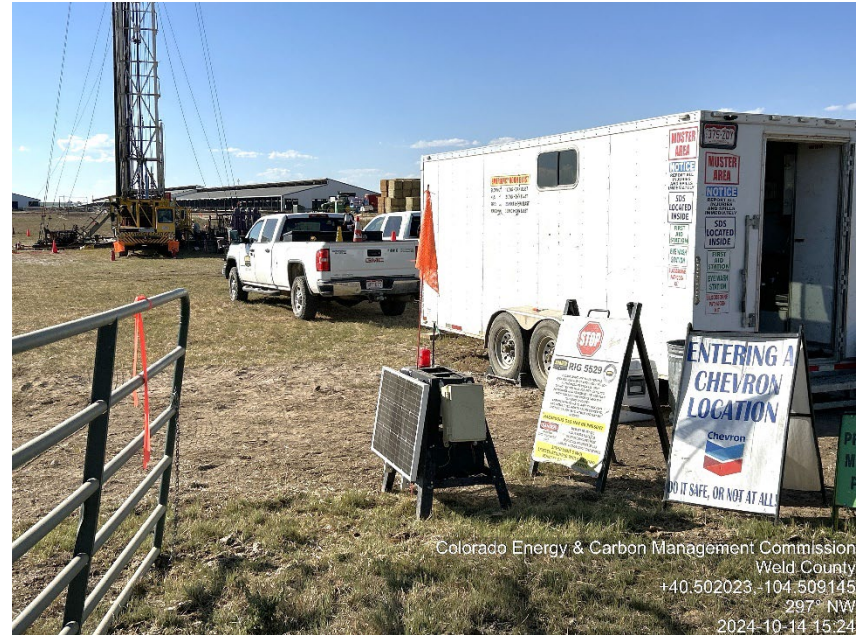
Photo #2

Plugging Ops; Workover: kill well, pull tubing

Site safety signage

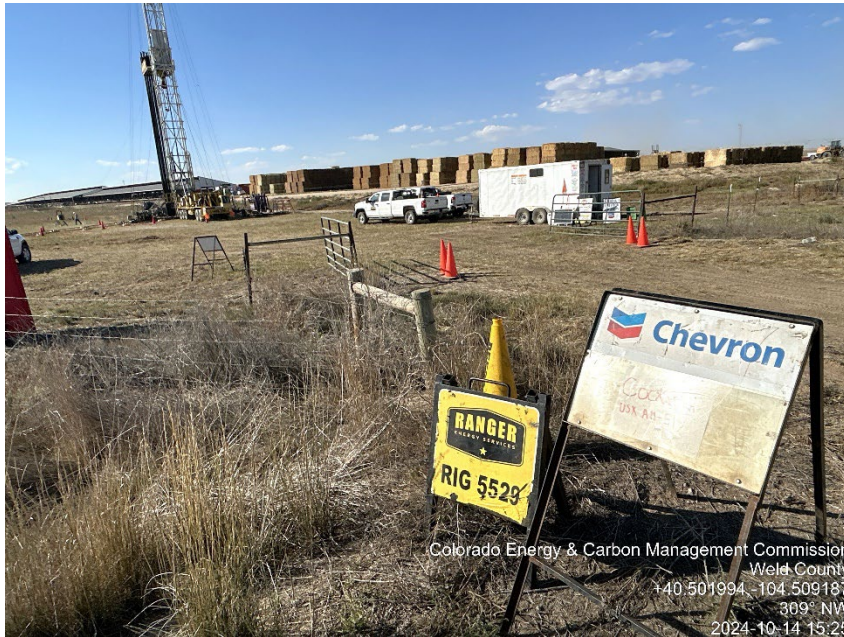
Photo #3

Plugging Ops; Workover: kill well, pull tubing

Wellsite entrance

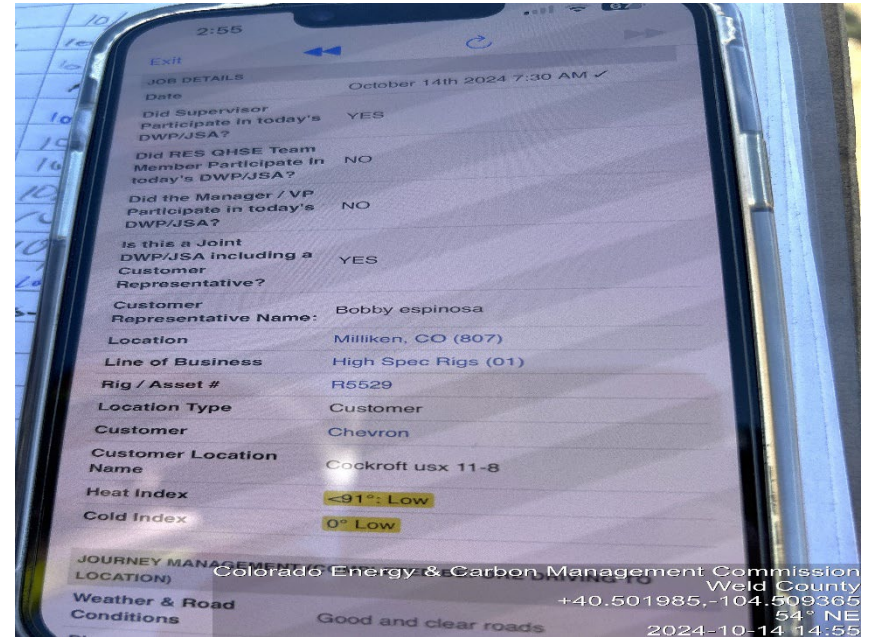
Photo #4

Plugging Ops; Workover: kill well, pull tubing

JSA: 2024-10-14
