Inspection Photos

Location Name: TEP ROCKY MOUNTAIN LLC FEDERAL RMV 146-19 Pad

Location ID: 335345

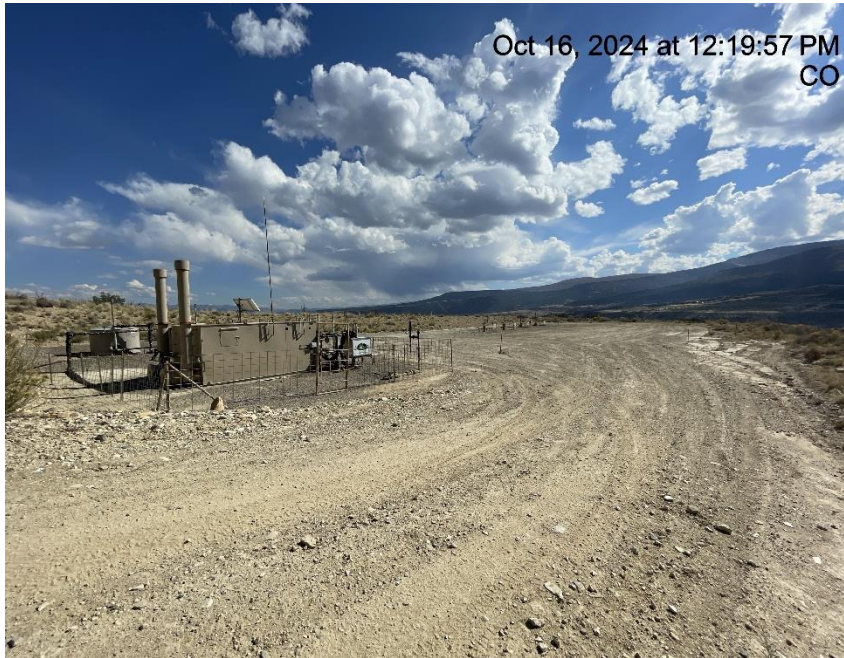
Photo # 5999 From entrance to location

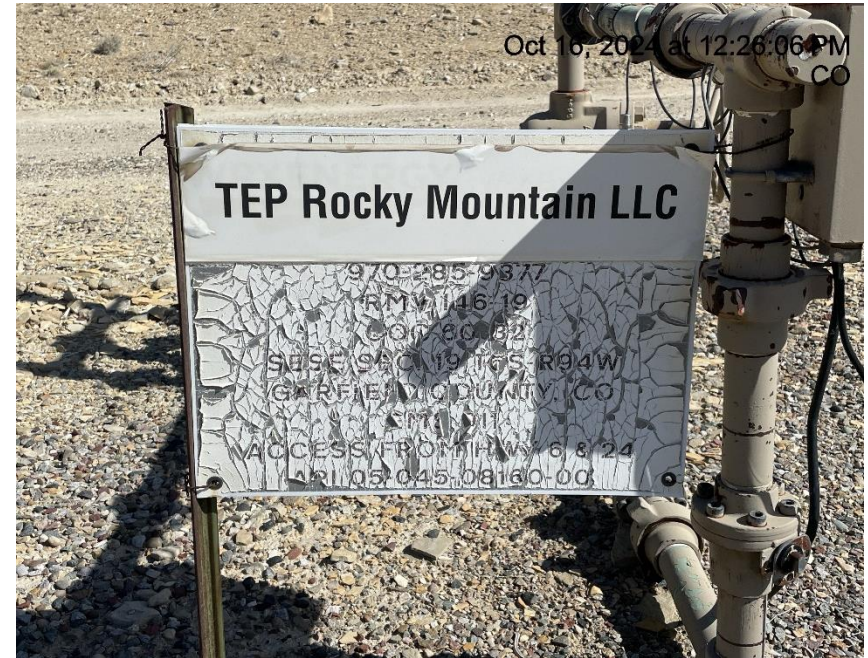
Photo # 6004 RMV 146-19 wellhead sign cracking & peeling/some required info starting to become illegible

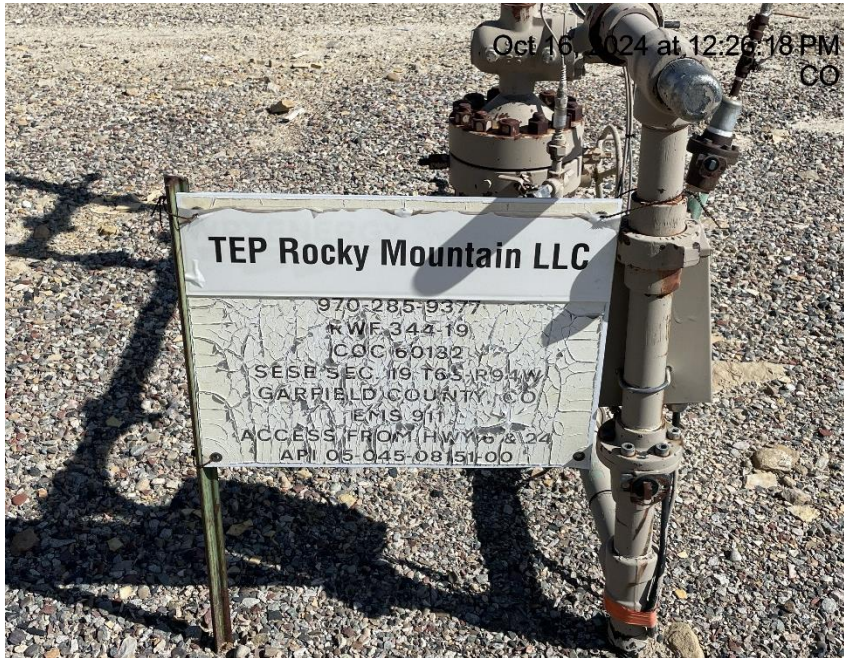
Photo # 6005 RWF 344-19 wellhead sign cracking & peeling

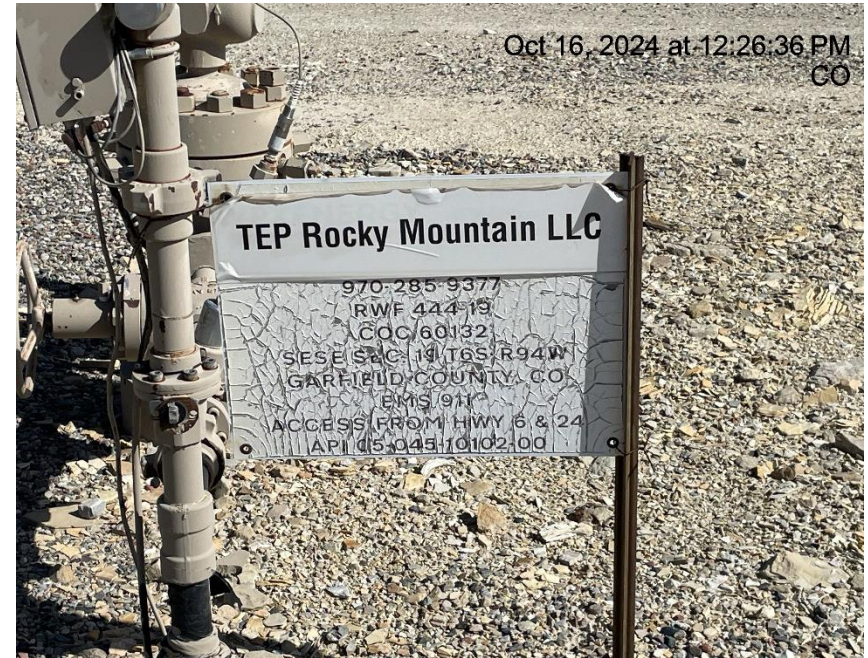
Photo # 6006 RWF 444-19 wellhead sign cracking & peeling

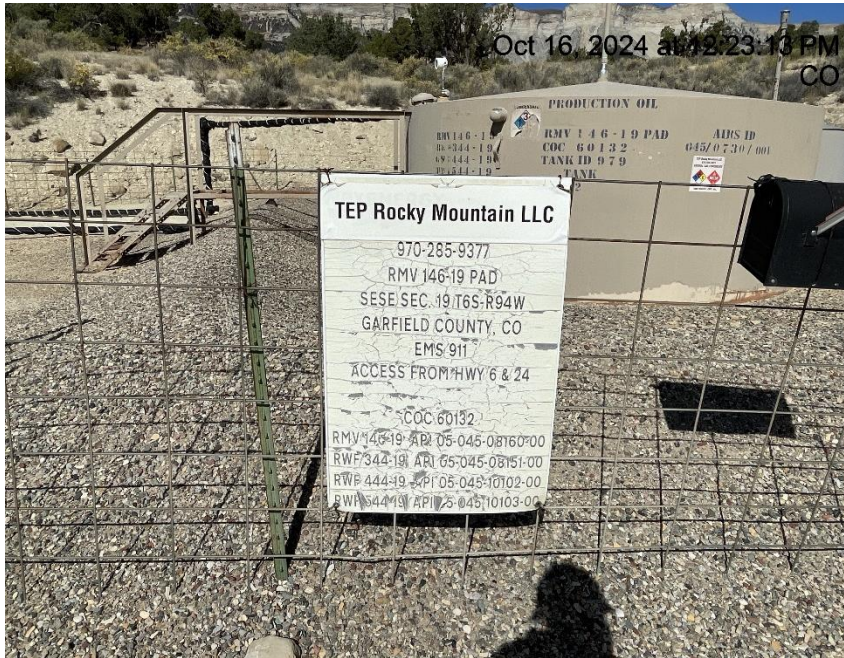
Photo # 6007 Battery sign cracking & peeling/some info starting to become illegible
