Inspection Photos

Location: SG INTERESTS I LTD FEDERAL-610S91W/26SESE

Location ID: 322005

Date: 10/21/2024

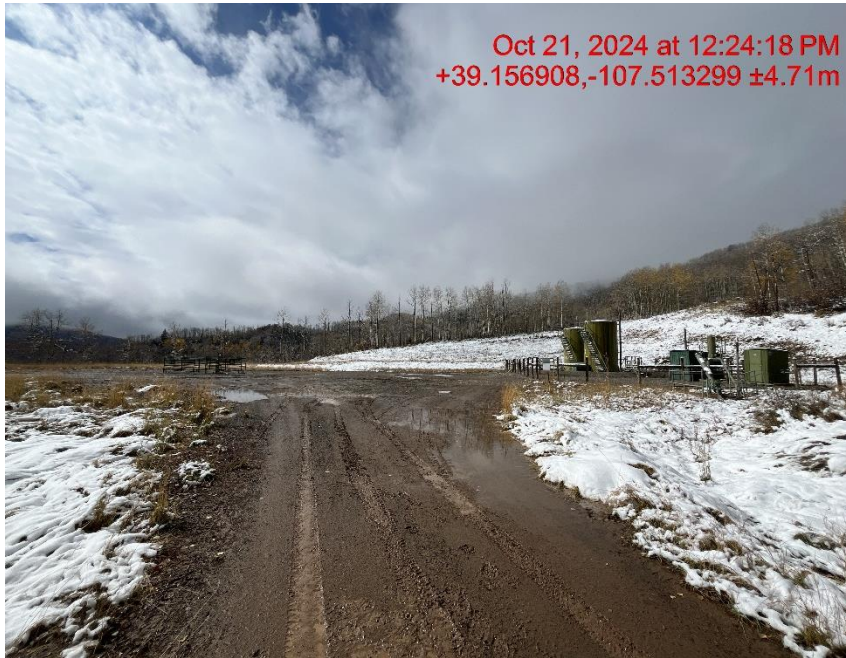
Photo # 7653 Entrance to location

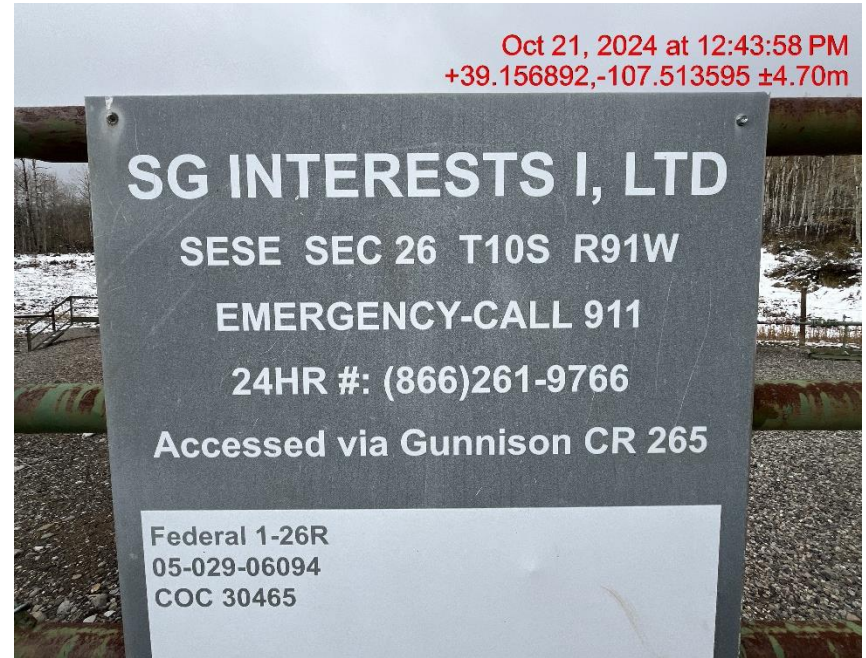
Photo # 7672 Location

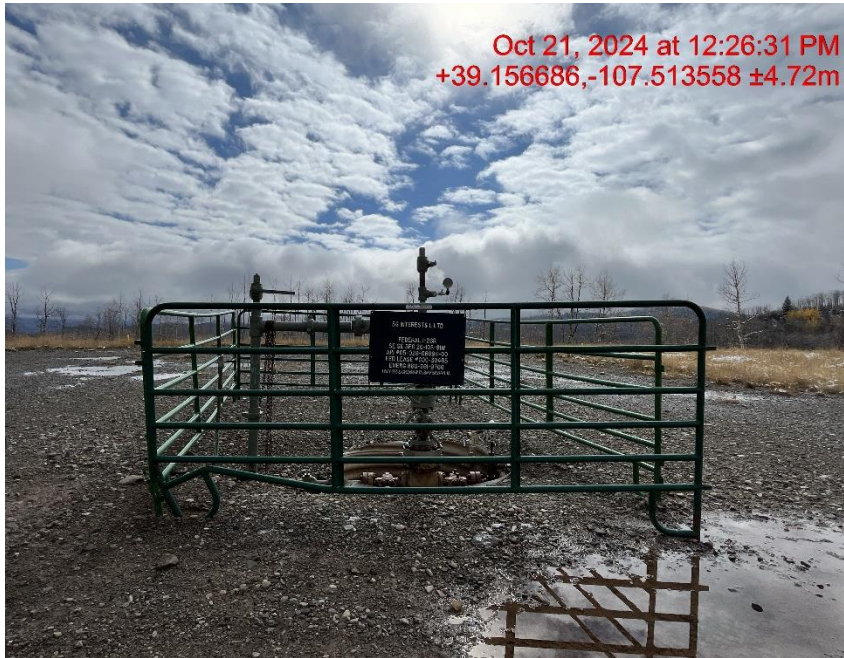
Photo # 7655 Location

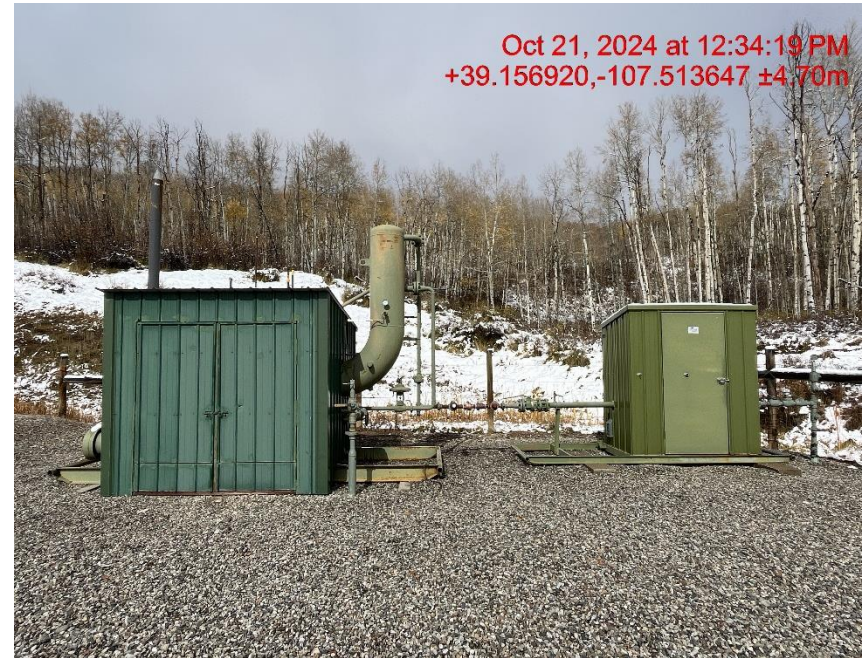
Photo # 7660 Location

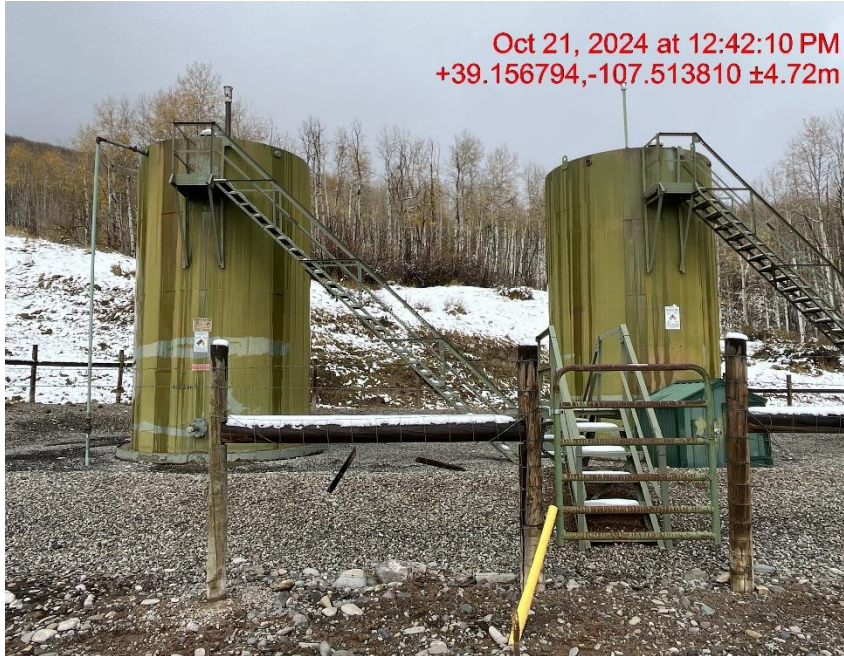
Photo # 7671 Location

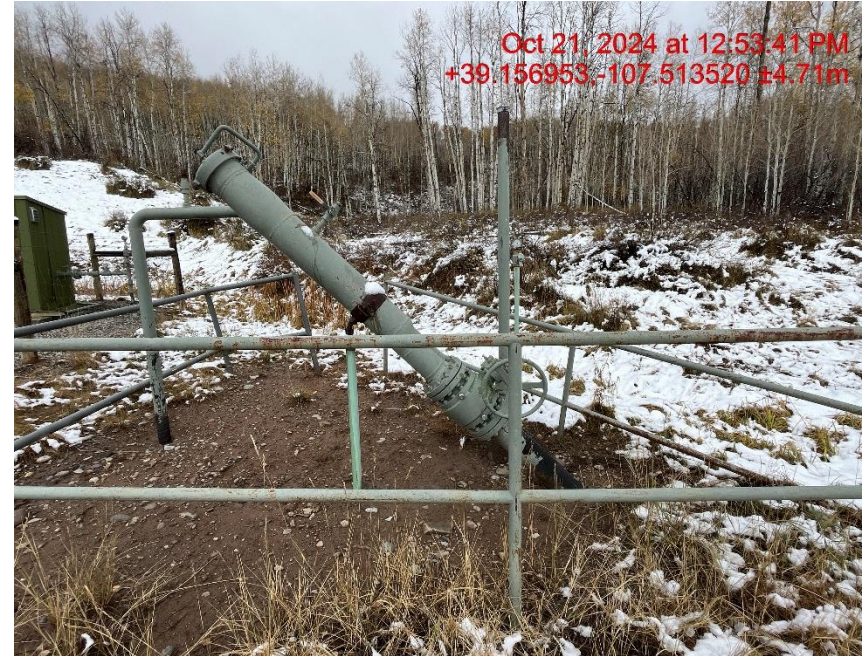
Photo # 7684 Location

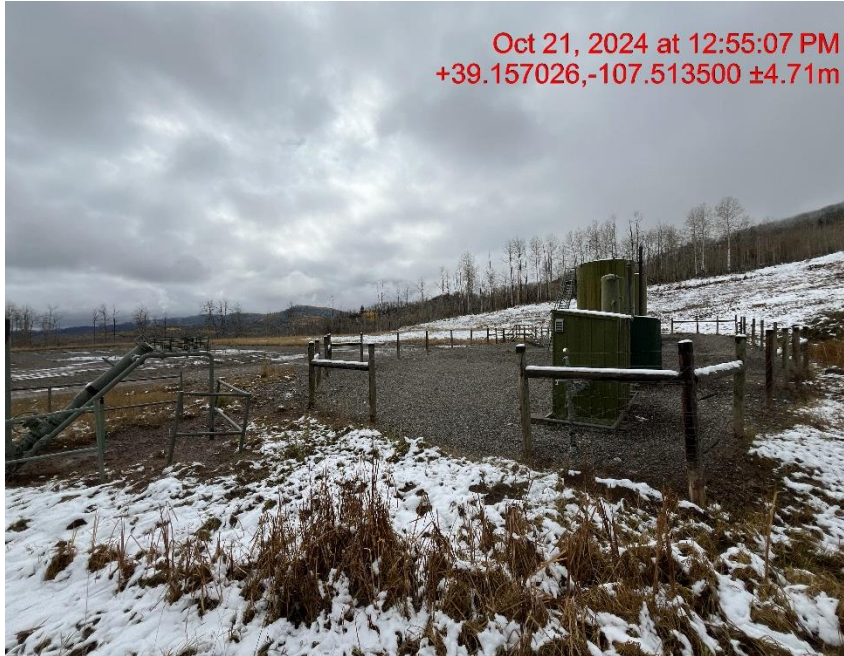
Photo # 7685 NE corner of location

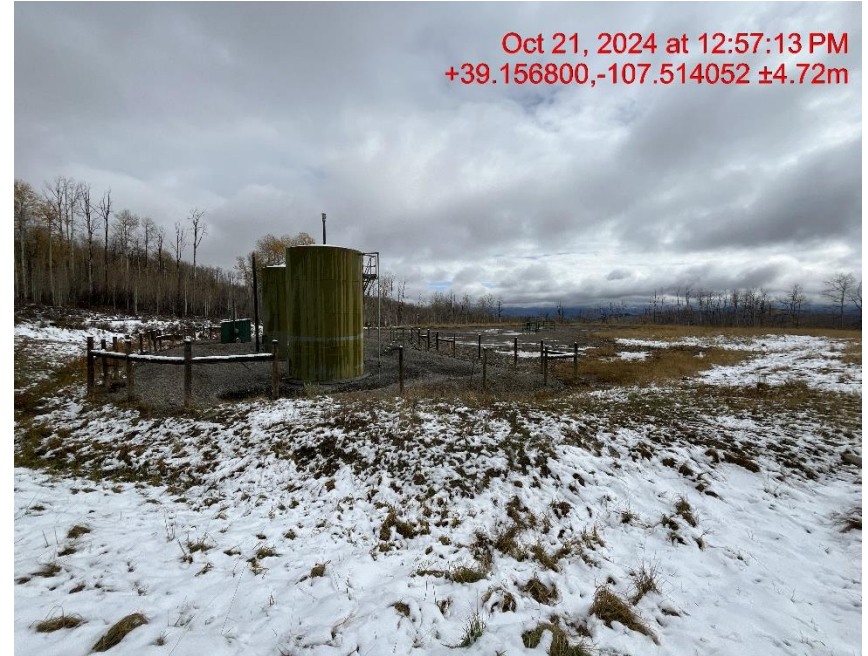
Photo # 7686 NW corner of location

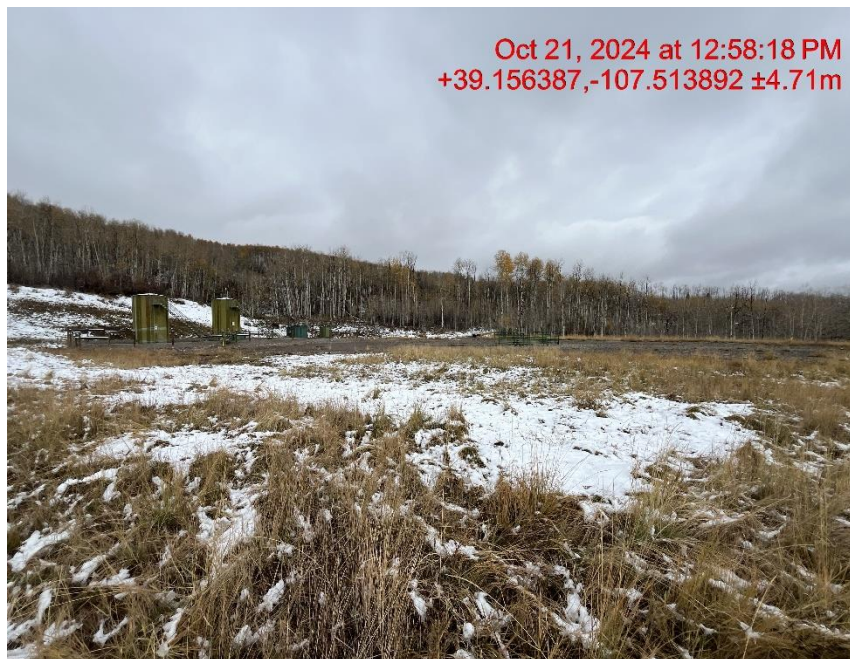
Photo # 7687 SW corner of location

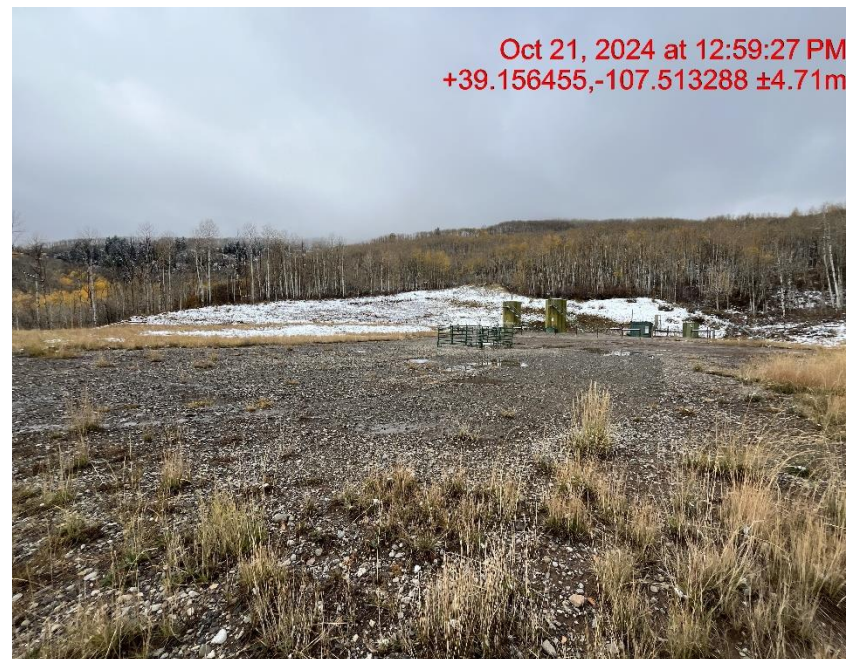
Photo # 7688 SE corner of location

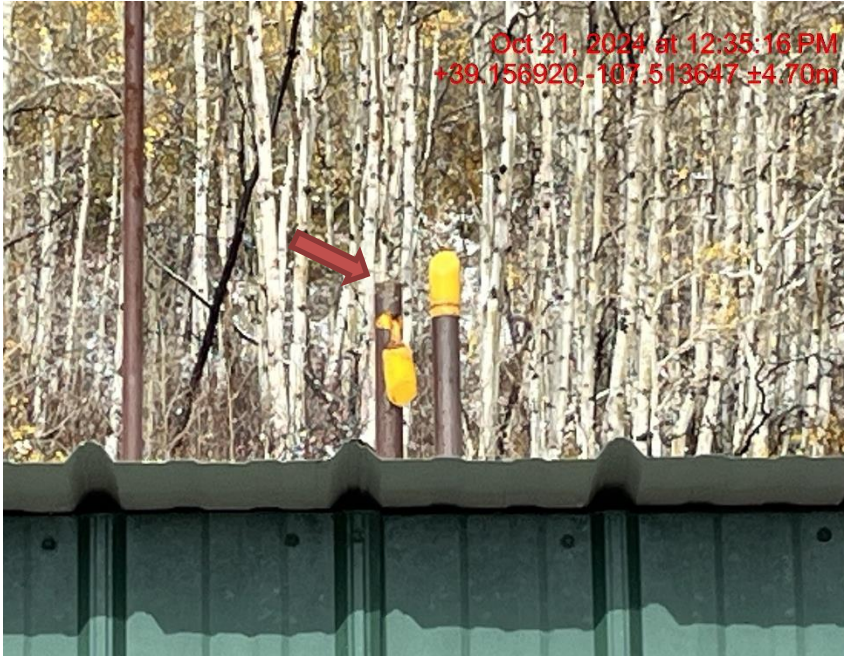
Photo # 7662 PRV vent line does not comply with CECMC pressure safety device rules

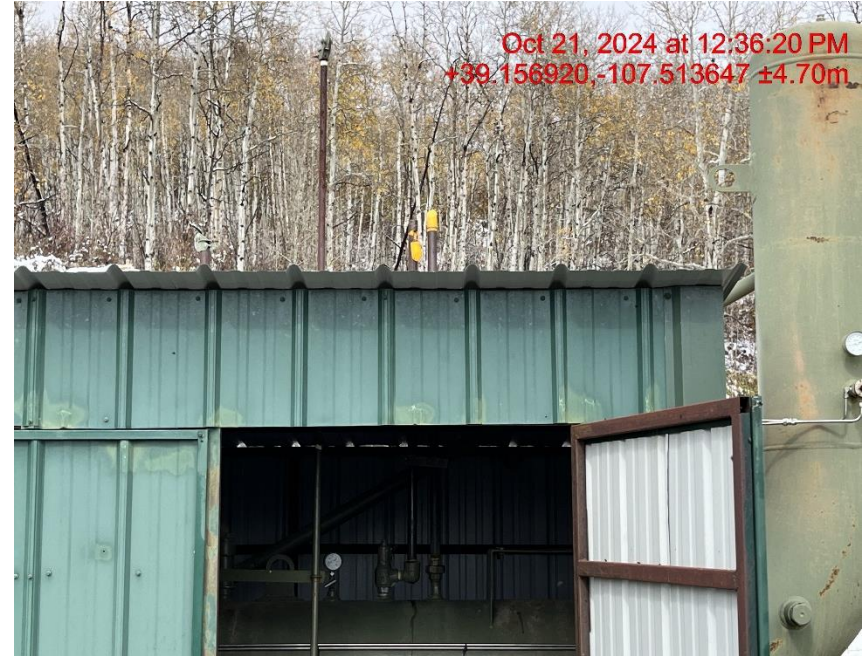
Photo # 7664 PRV vent line does not comply with CECMC pressure safety device rules
