**Operator: XOG**

**Location Name: ALMA 1S-66-2524 PAD**

**Loc ID: 449925**

**Inspection: 708201708**

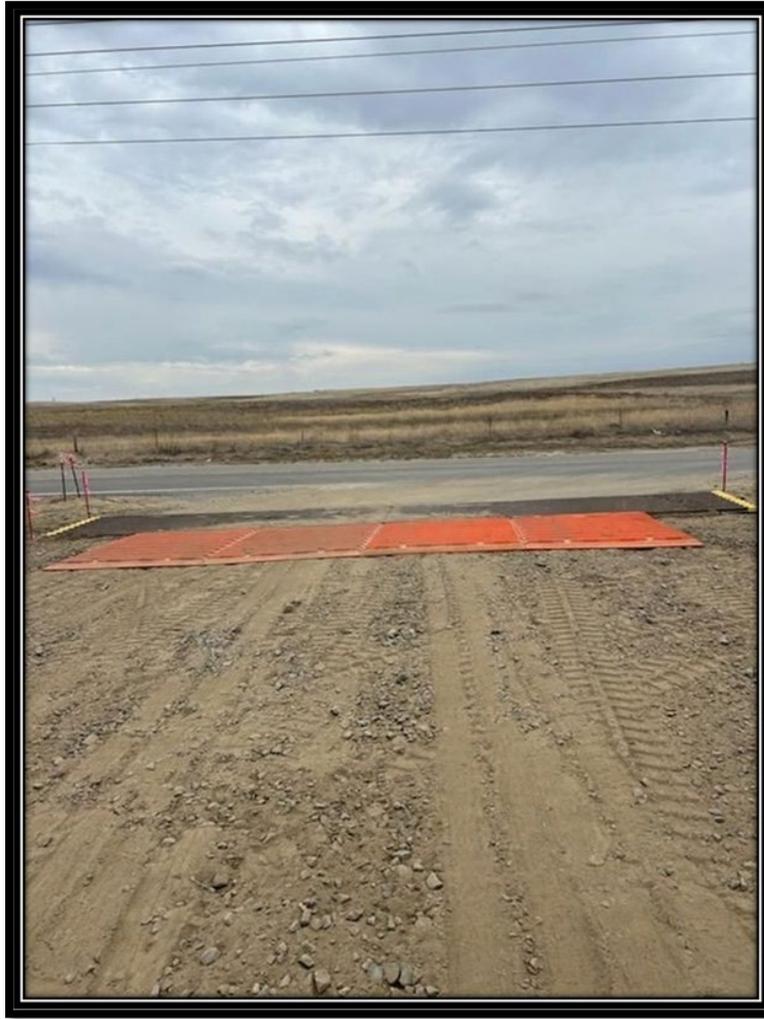
**CA:** At the time of this inspection, it was observed that the vehicle track out pad did not appear to be properly functioning with evidence of sediment and debris accumulating on the adjacent roadway. ECMC Staff contacted Operator representative (E. Craig) while on location to inform of the vehicle track out. Operator representative stated that the track out would be cleaned with a sweeper and that additional BMPs would be implemented. Maintain vehicle tracking BMPs on the oil and gas location to comply with rule 1002.f.(2)F. Additionally, if material is tracked onto county or public roads, contact the appropriate authority.

**CA Resolution:** Operator has reported that there are actions to pour a concrete apron and add VTC tracking pad to assist with tracking issues. It has been noted that an additional tracking pad has been installed to help and street sweeping will continue as needed.
