Inspection Photos

Location: TEP ROCKY MOUNTAIN LLC CHEVRON/TR 24-21-597

Location ID: 324381

Date: 10/23/2024

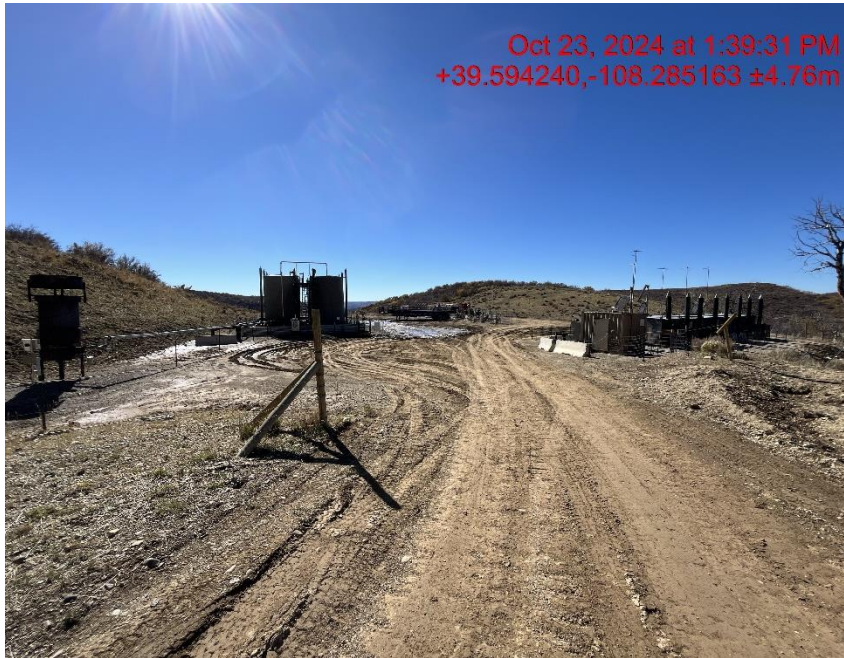
Photo # 7819 Entrance to location

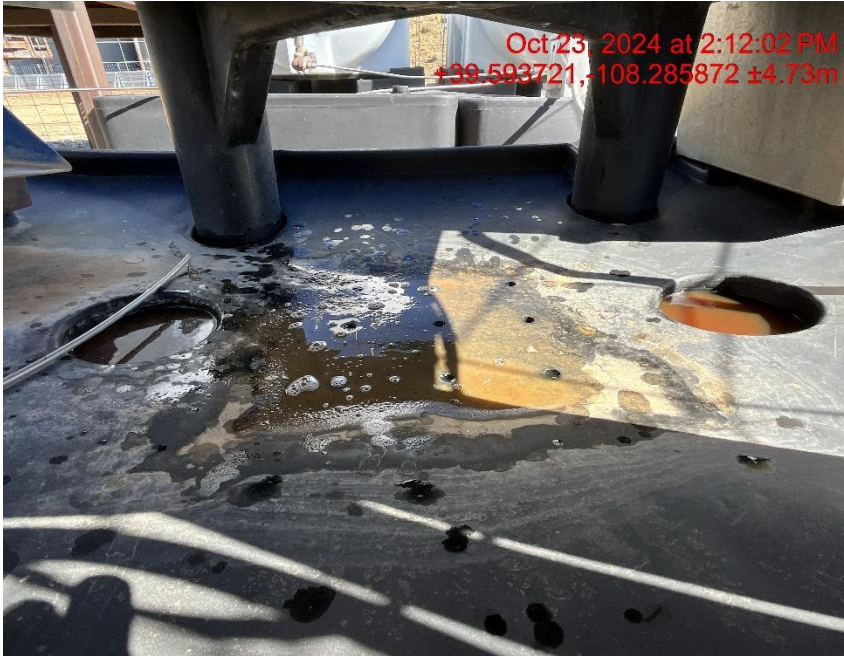
Photo # 7840 Failure to maintain multiple chemical BMP's/chemical tank containments full of fluid/BMP's insufficient to contain possible spill

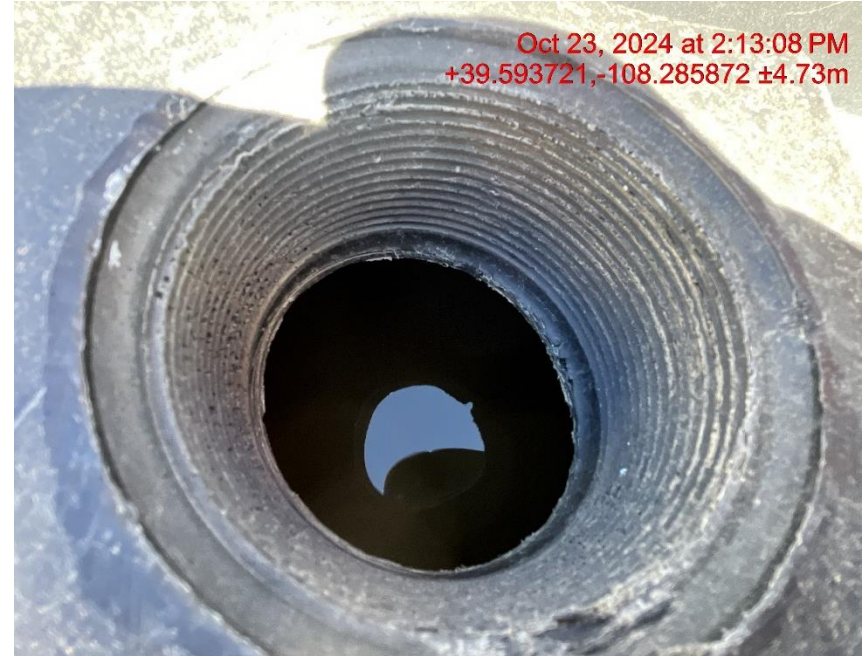
Photo # 7841 Failure to maintain multiple chemical BMP's/chemical tank containments full of fluid/BMP's insufficient to contain possible spill

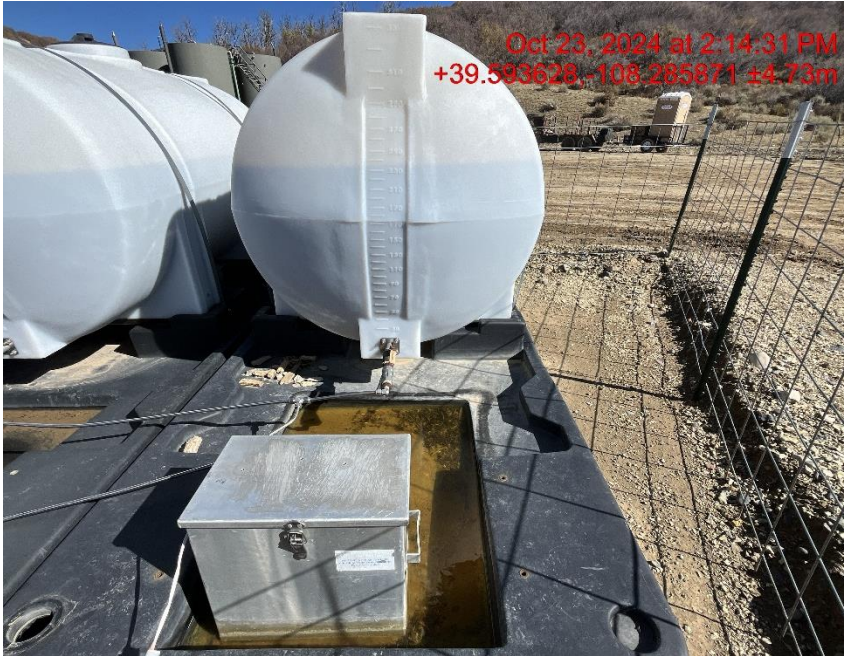
Photo # 7844 Failure to maintain multiple chemical BMP's/chemical tank containments full of fluid/BMP's insufficient to contain possible spill

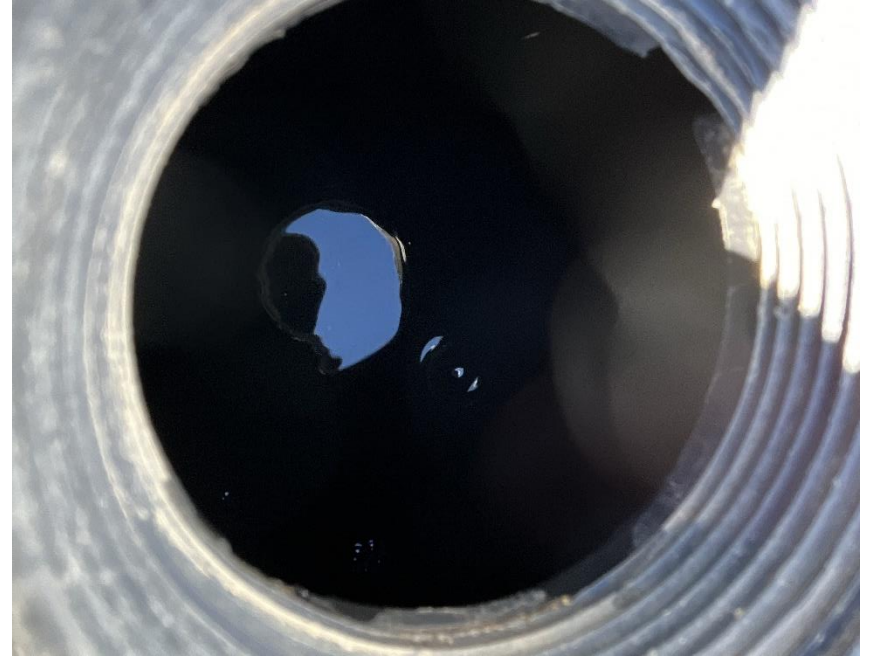
Photo # 7847 Failure to maintain multiple chemical BMP's/chemical tank containments full of fluid/BMP's insufficient to contain possible spill

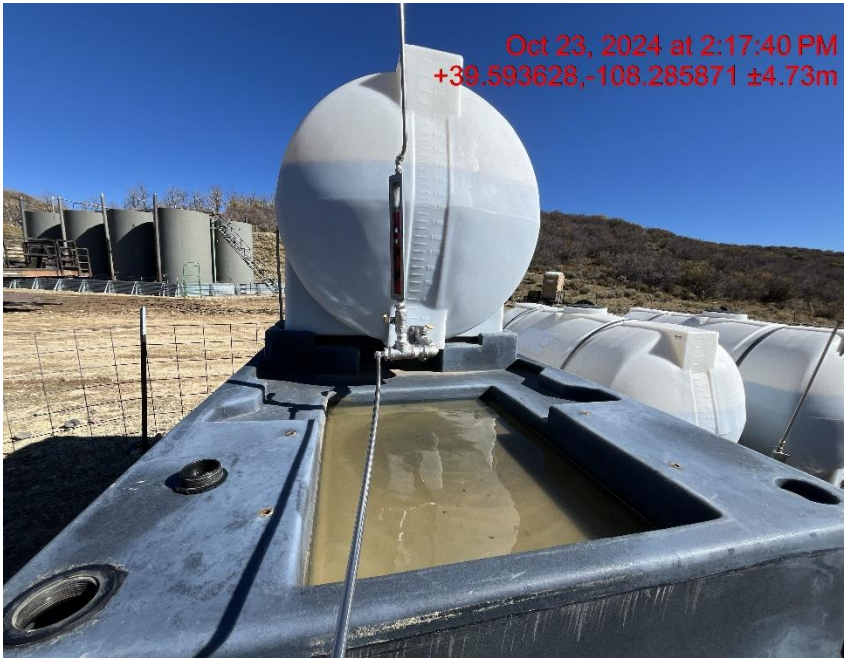
Photo # 7849 Failure to maintain multiple chemical BMP's/chemical tank containments full of fluid/BMP's insufficient to contain possible spill

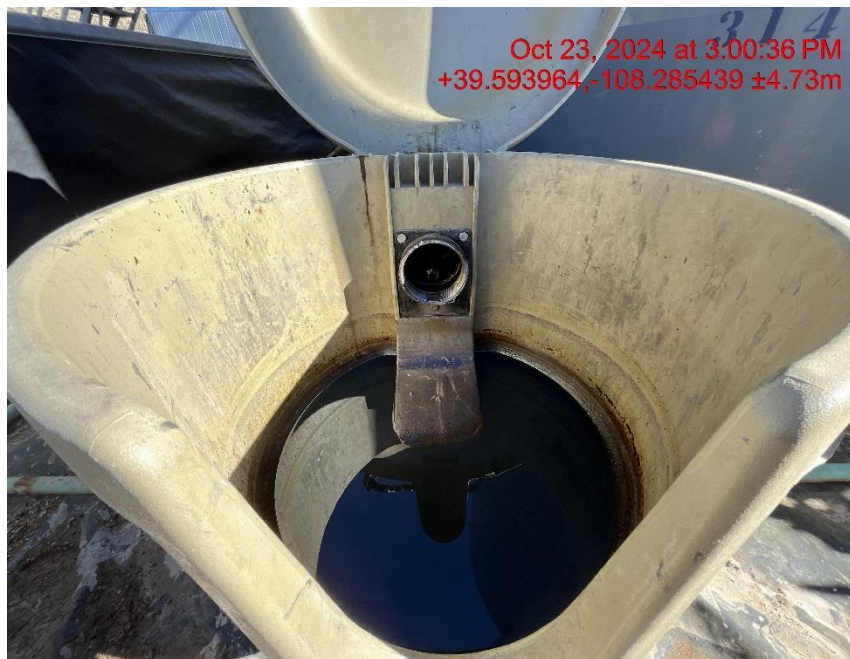
Photo # 7895 Open ended load line

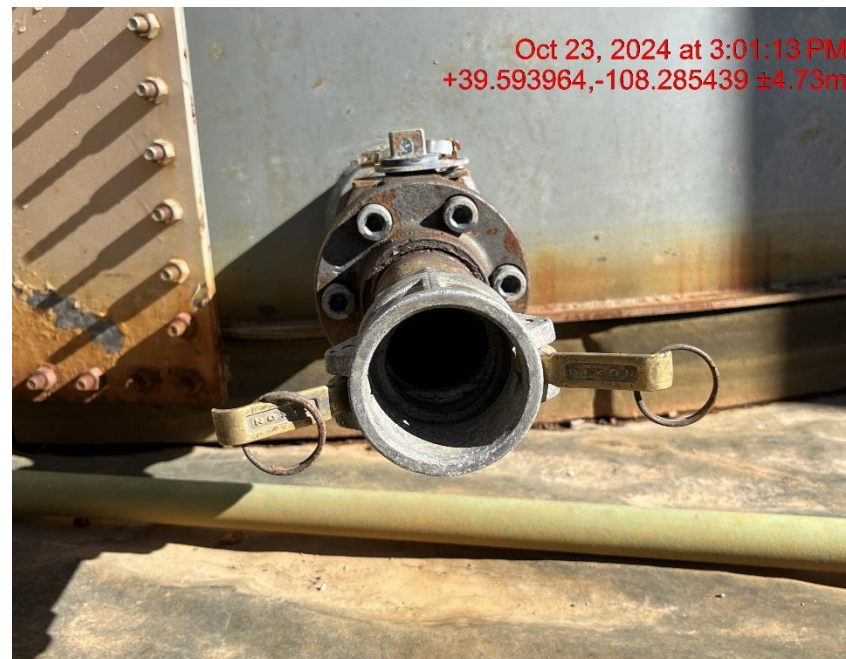
Photo # 7897 Open ended load line

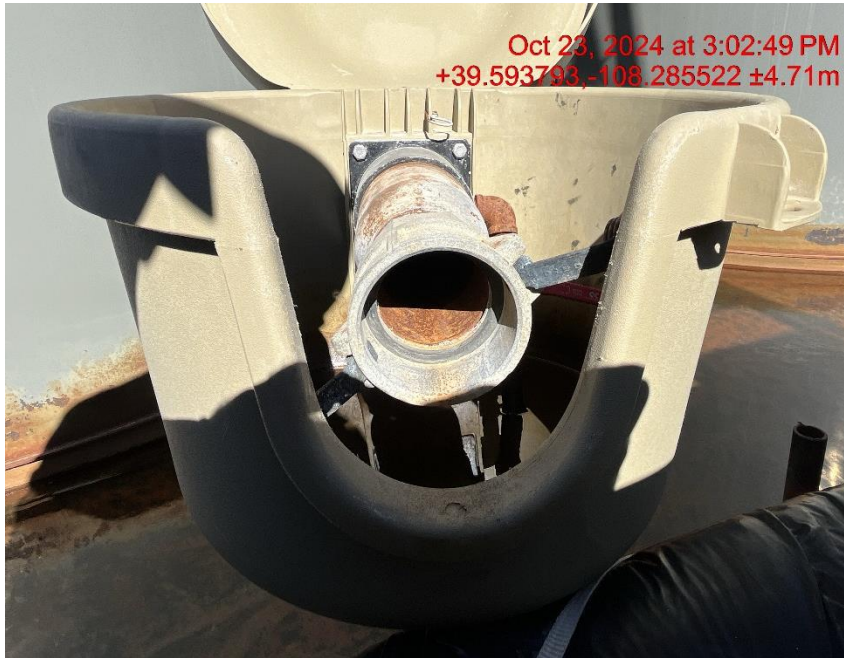
Photo # 7899 Open ended load line

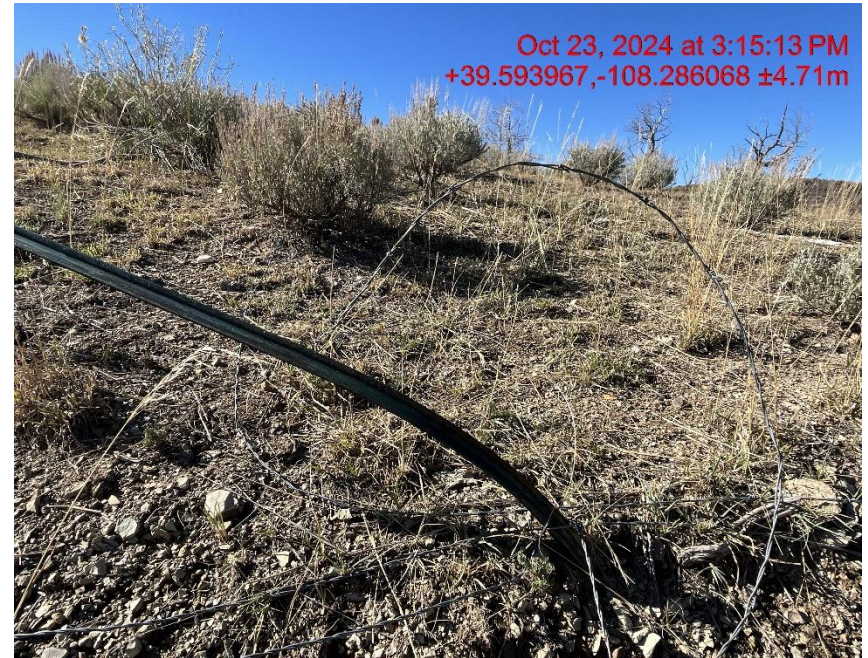
Photo # 7907 Wildlife hazard

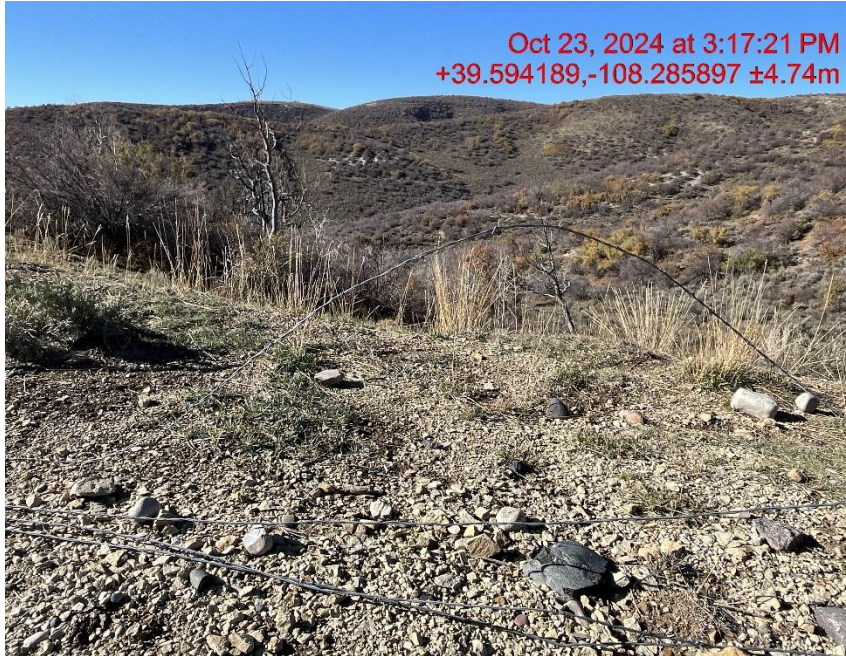
Photo # 7910 Wildlife hazard

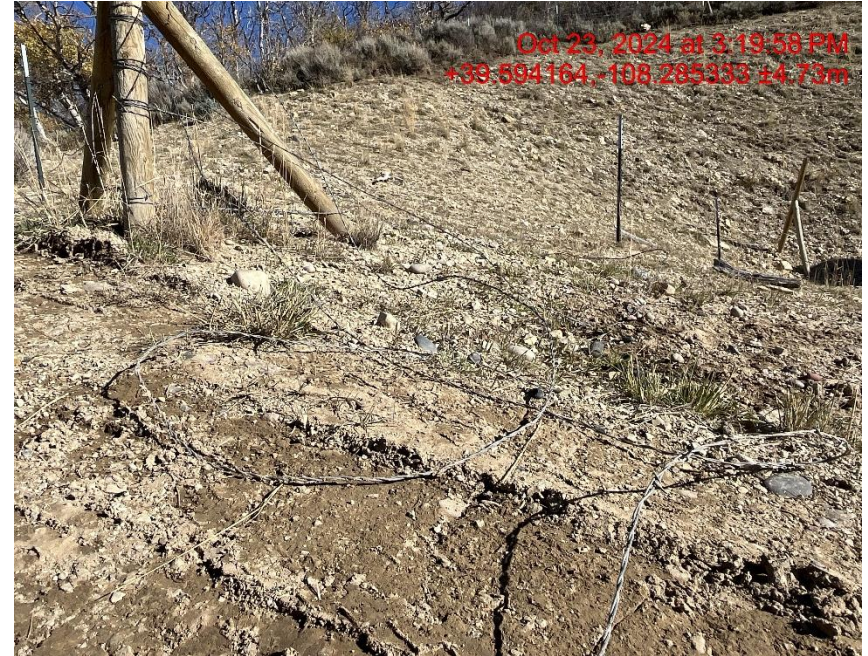
Photo # 7912 Wildlife hazard
