## Inspection Photos

Location: TEP ROCKY MOUNTAIN LLC CHEVRON-65S97W/14NWNW

Location ID: 335686

Date: 10/24/2024

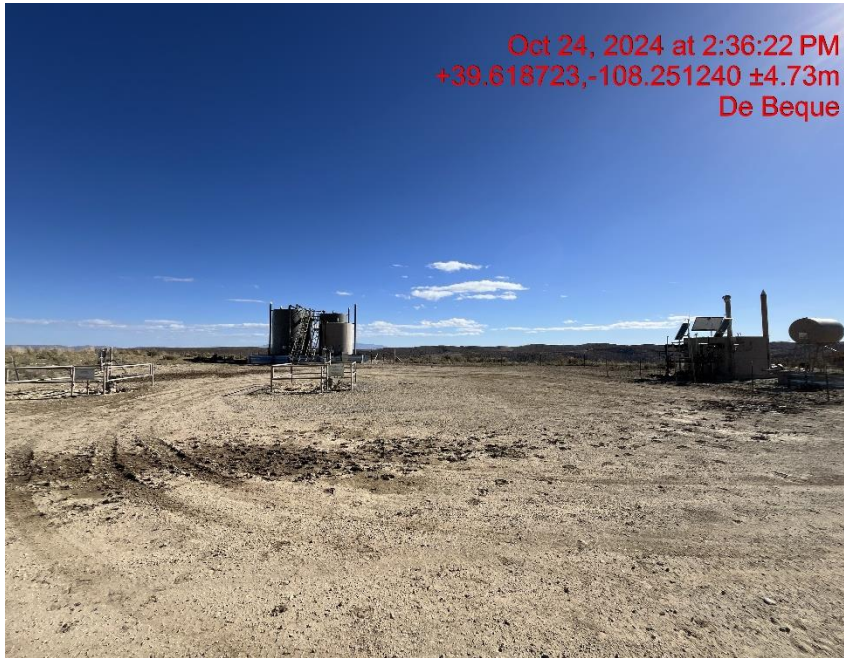
Photo # 8034 Entrance to location

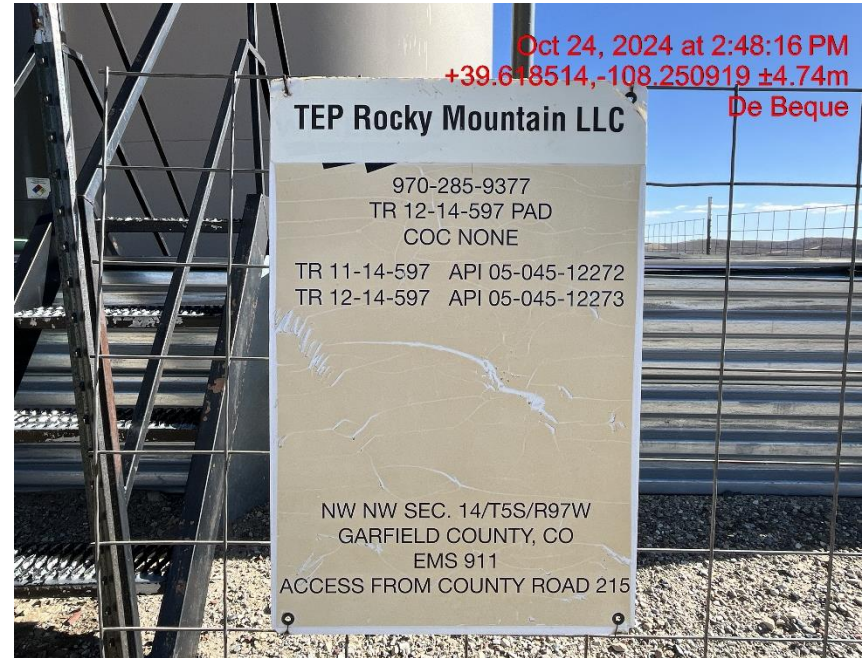
Photo # 8052 Location

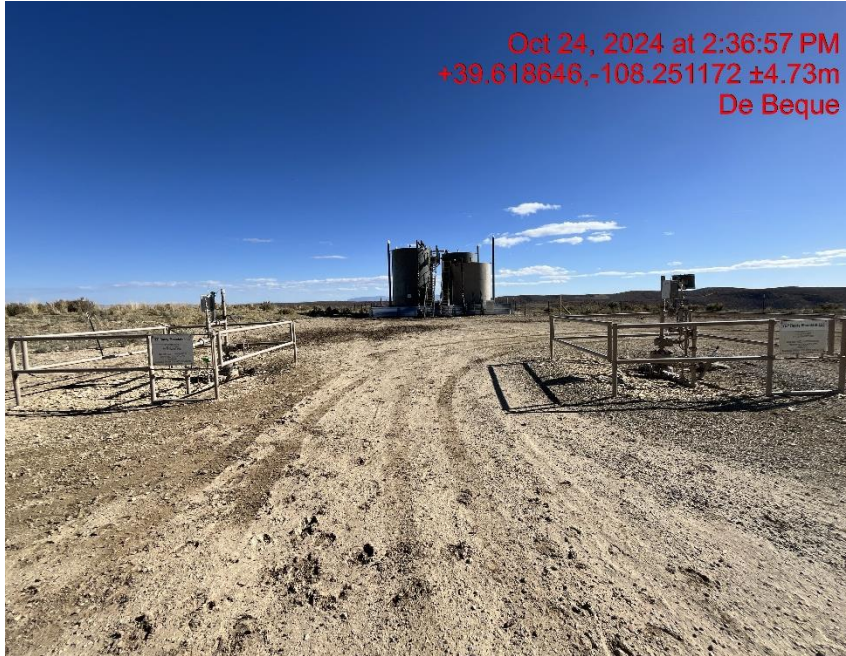
Photo # 8035 Location

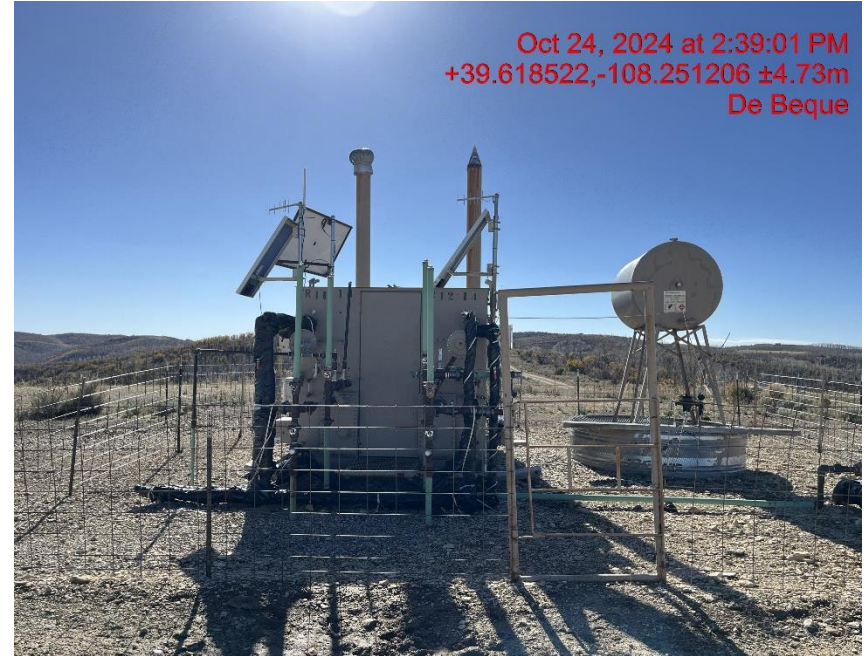
Photo # 8039 Location

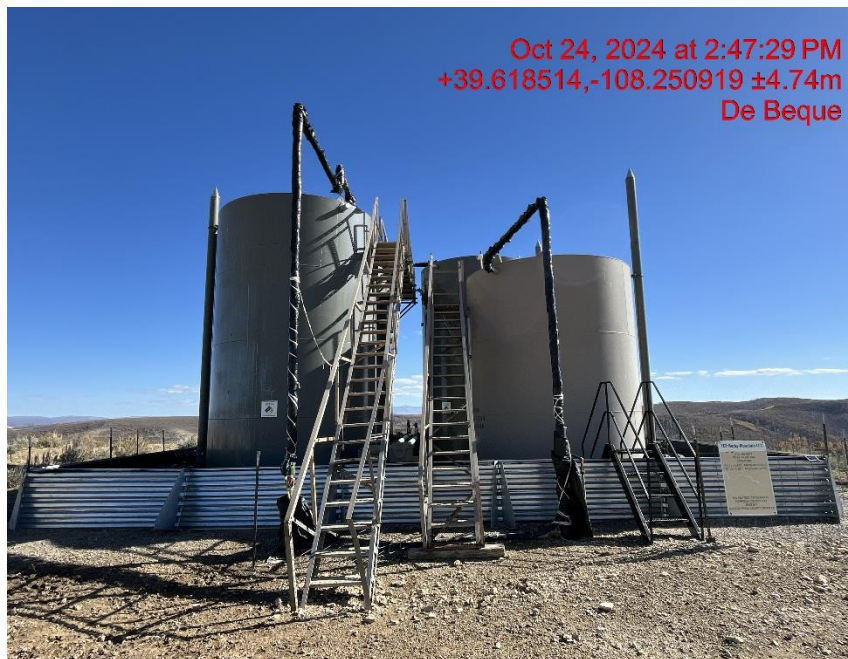
Photo # 8050 Location

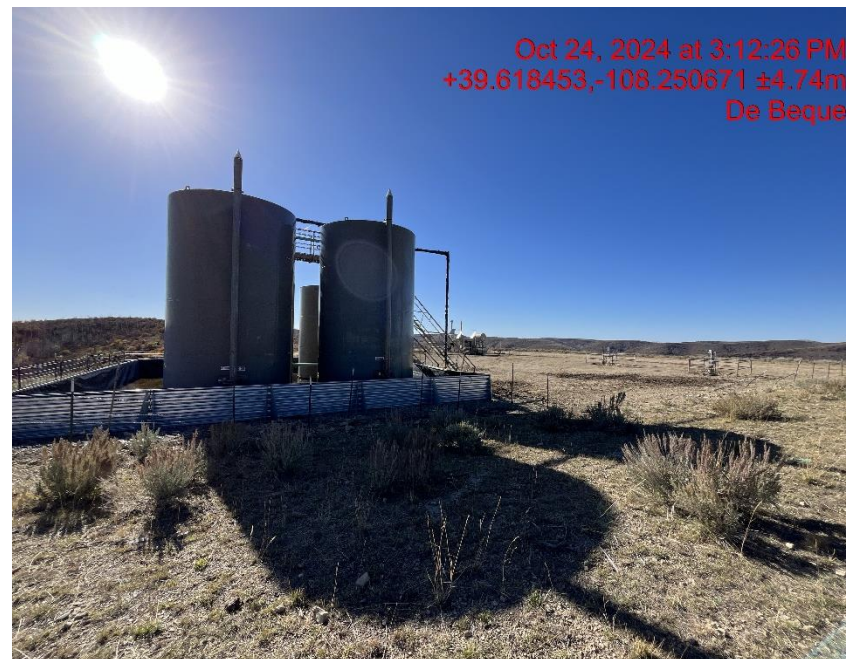
Photo # 8085 SE corner of location

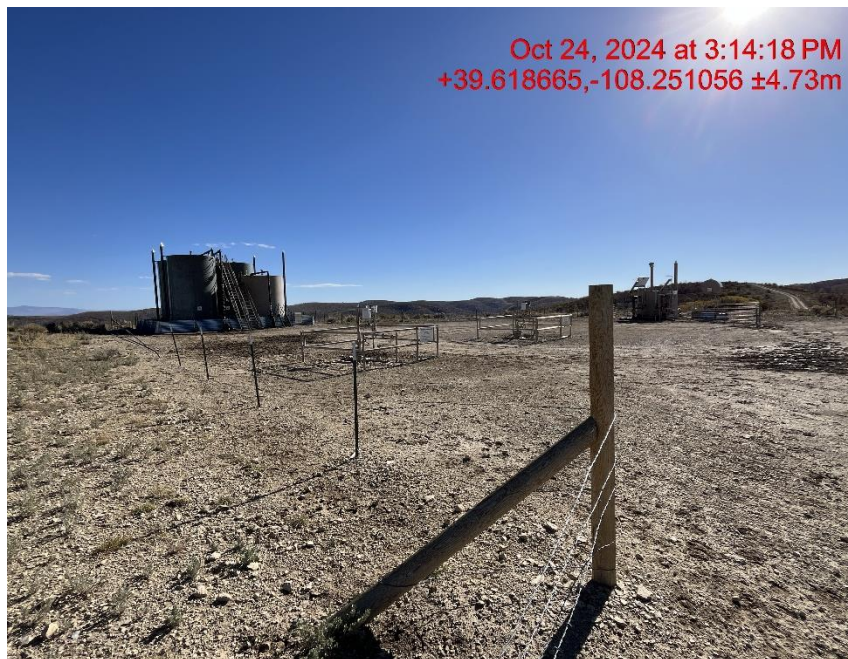
Photo # 8086 NE corner of location

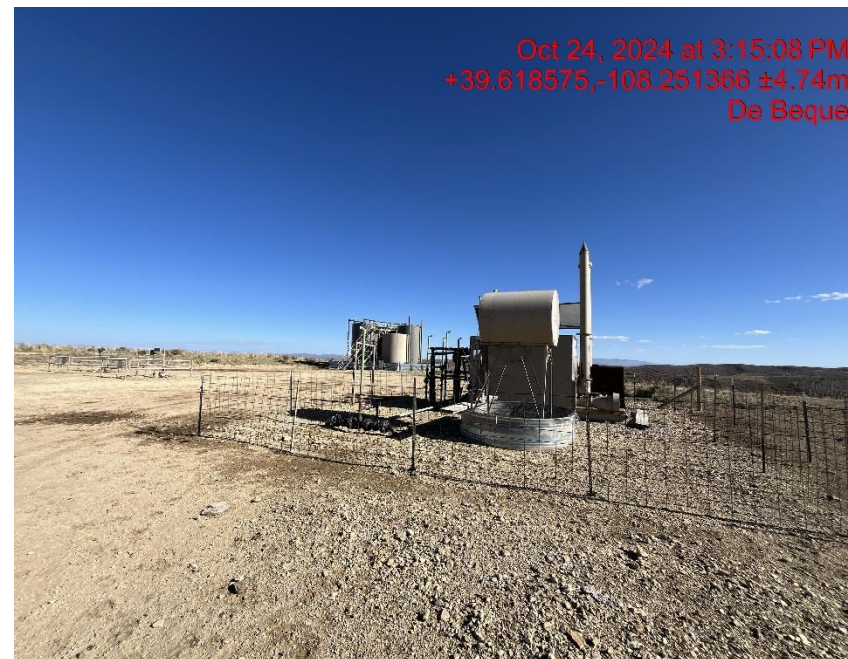
Photo # 8087 NW corner of location

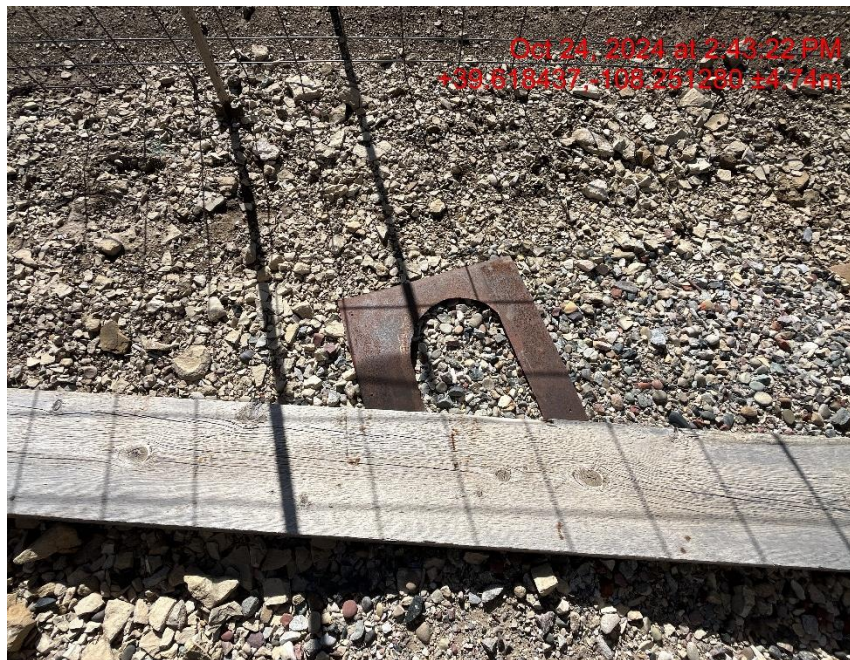
Photo # 8044 Debris

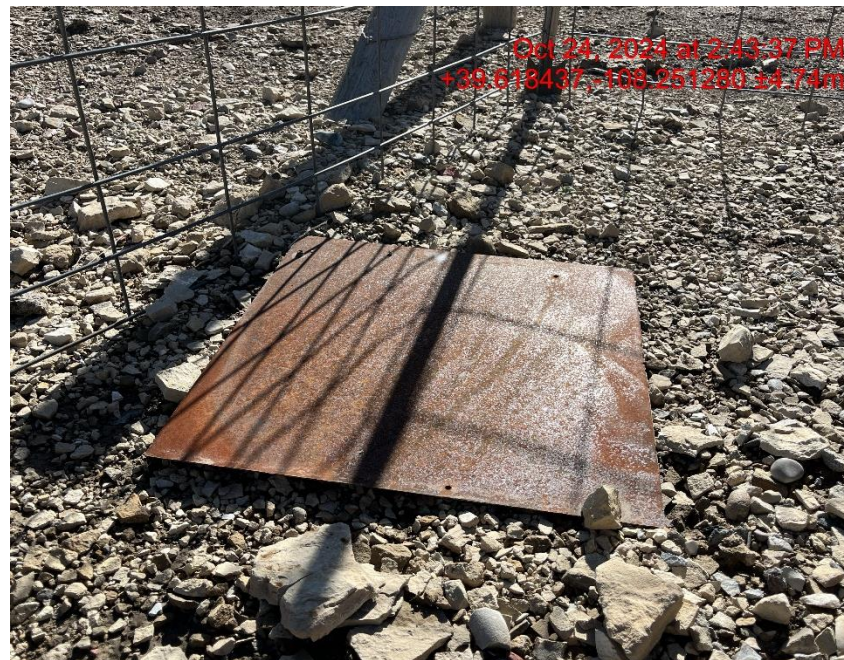
Photo # 8045 Debris

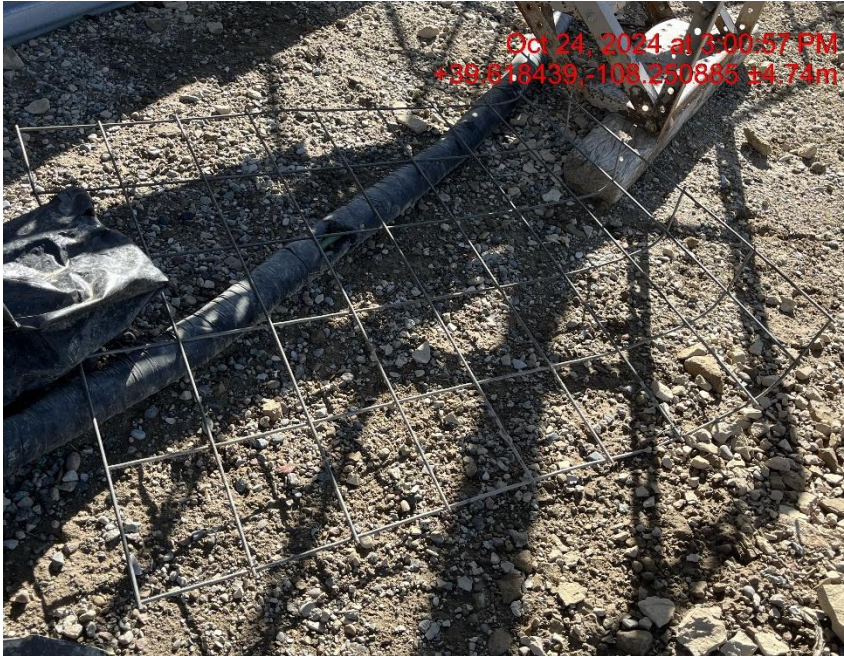
Photo # 8073 Debris

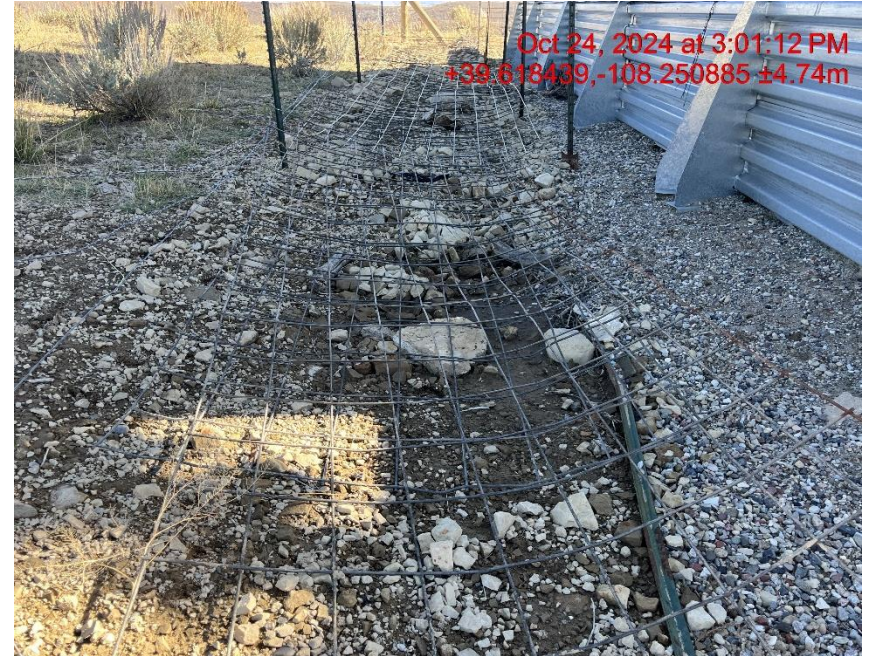
Photo # 8074 Debris

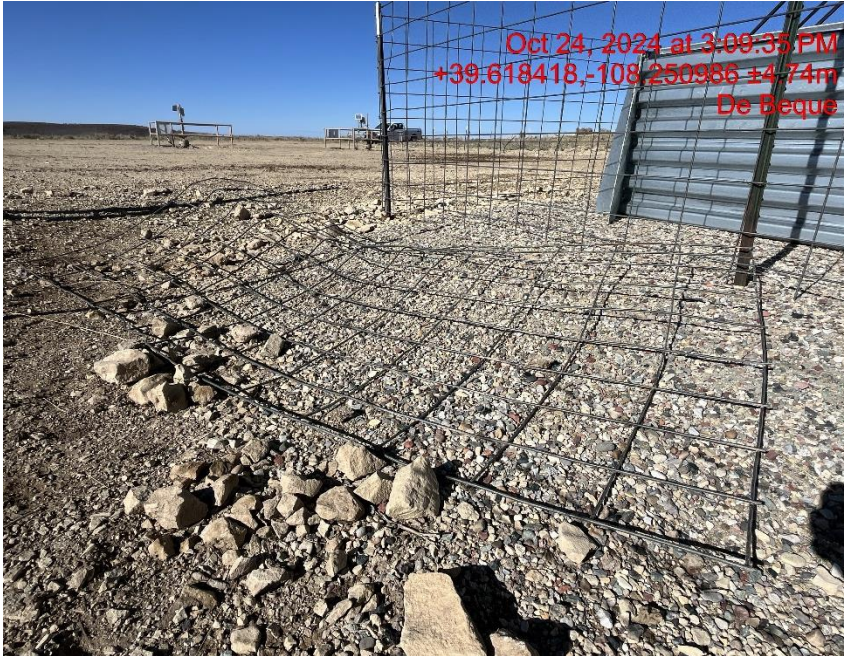
Photo # 8083 Debris

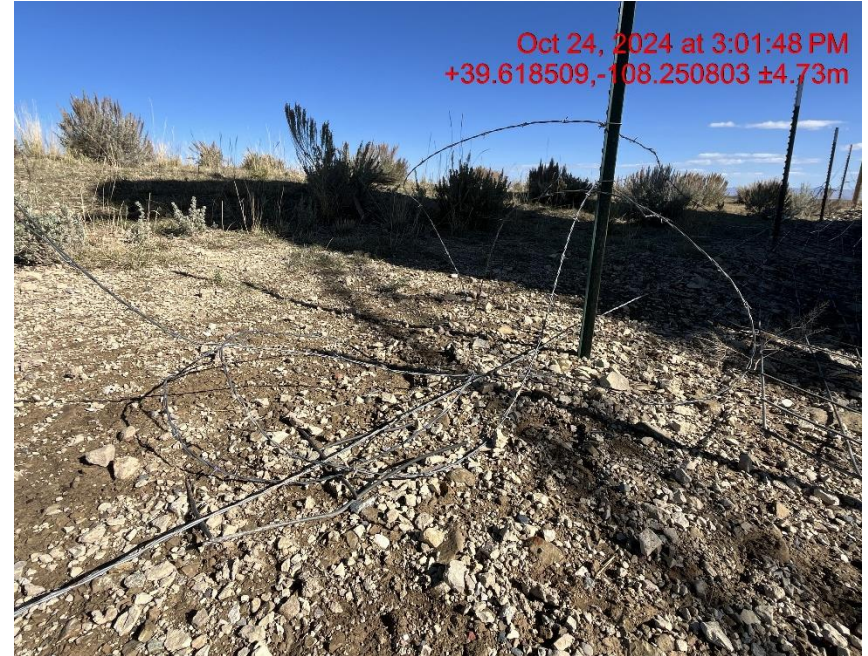
Photo # 8075 Wildlife hazard

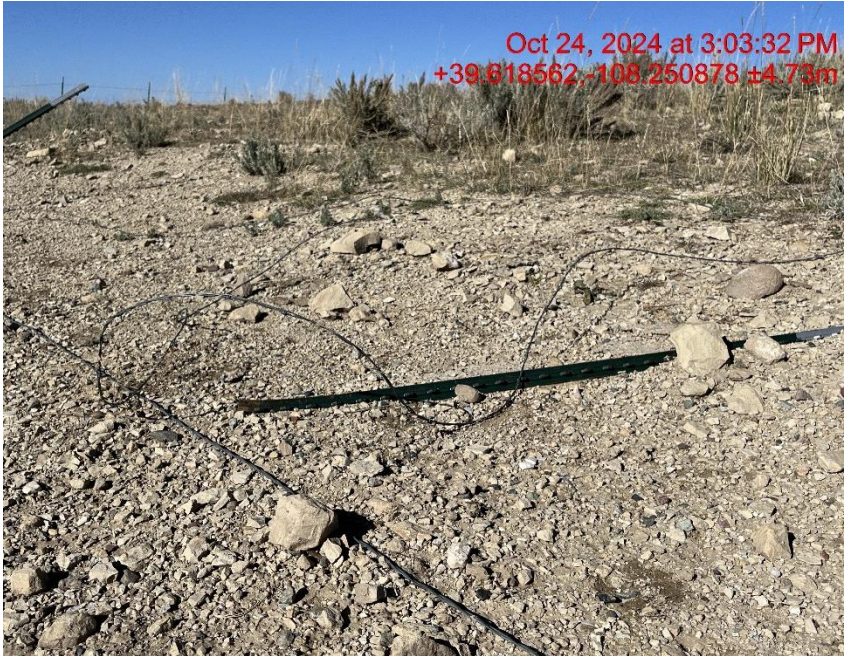
Photo # 8076 Wildlife hazard

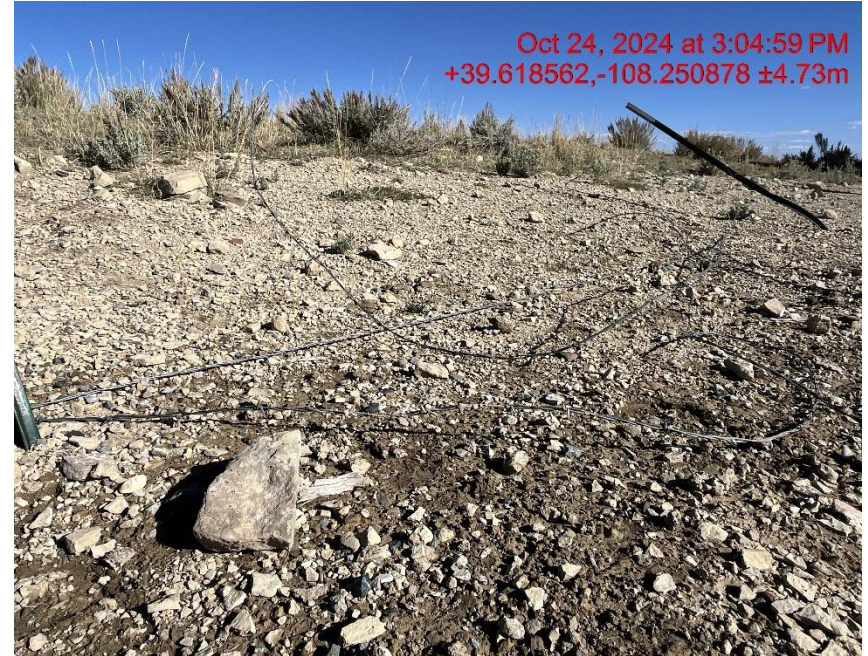
Photo # 8077 Wildlife hazard

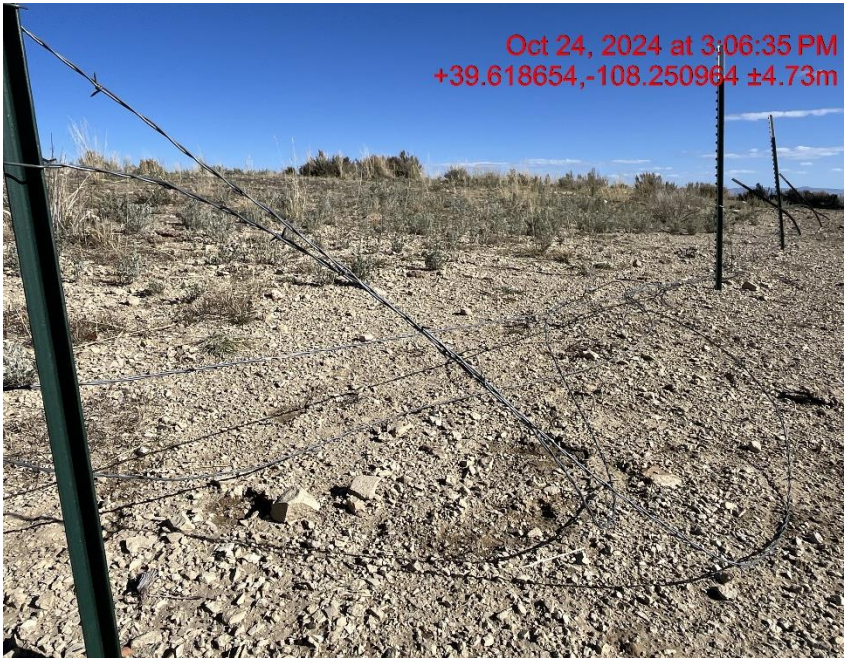
Photo # 8080 Wildlife hazard

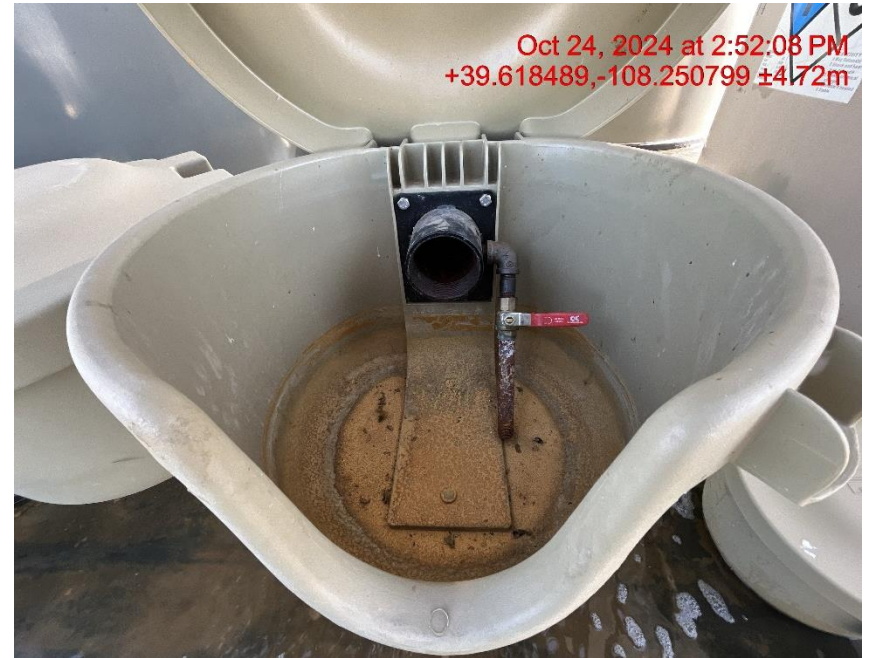
Photo # 8060 Open ended load line

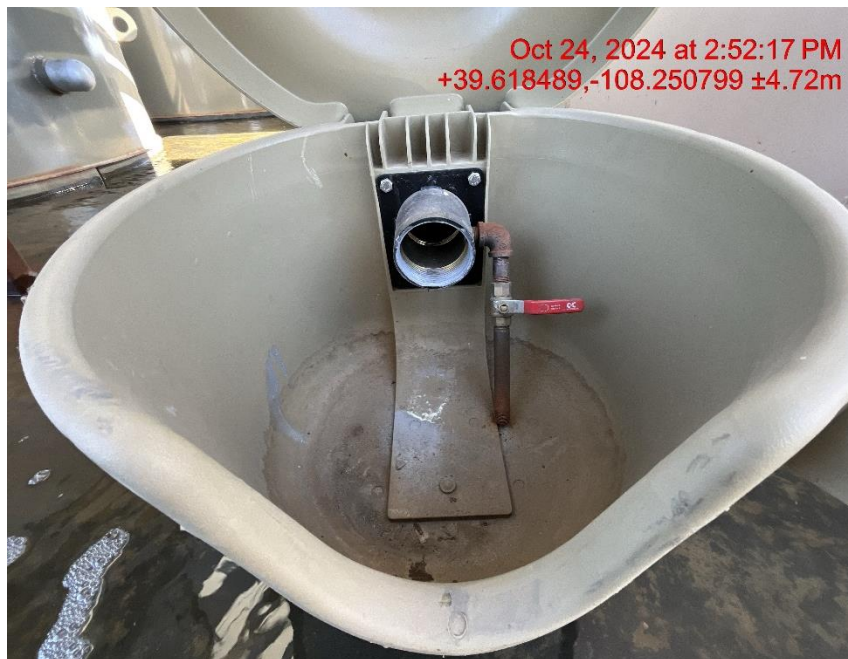
Photo # 8061 Open ended load line

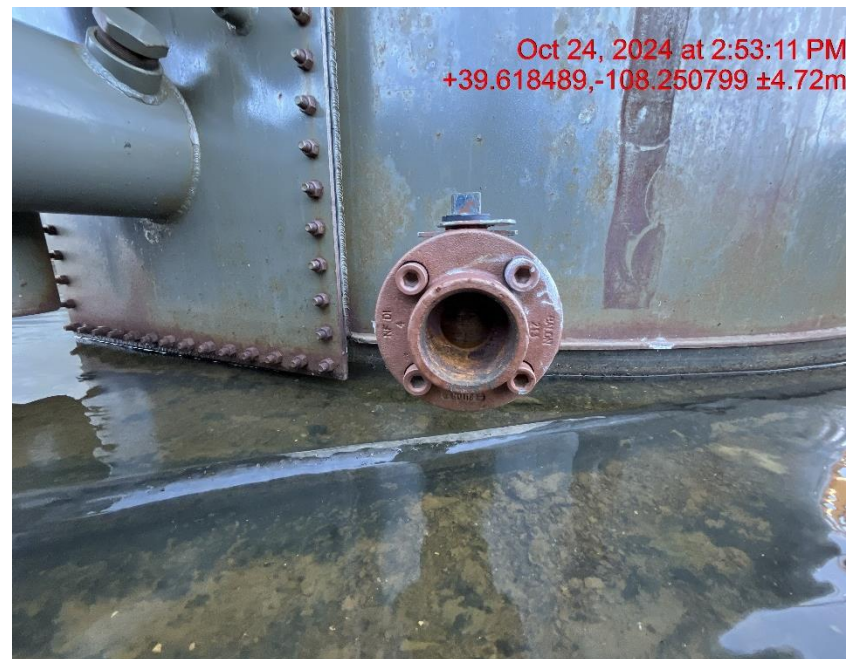
Photo # 8063 Open ended load line

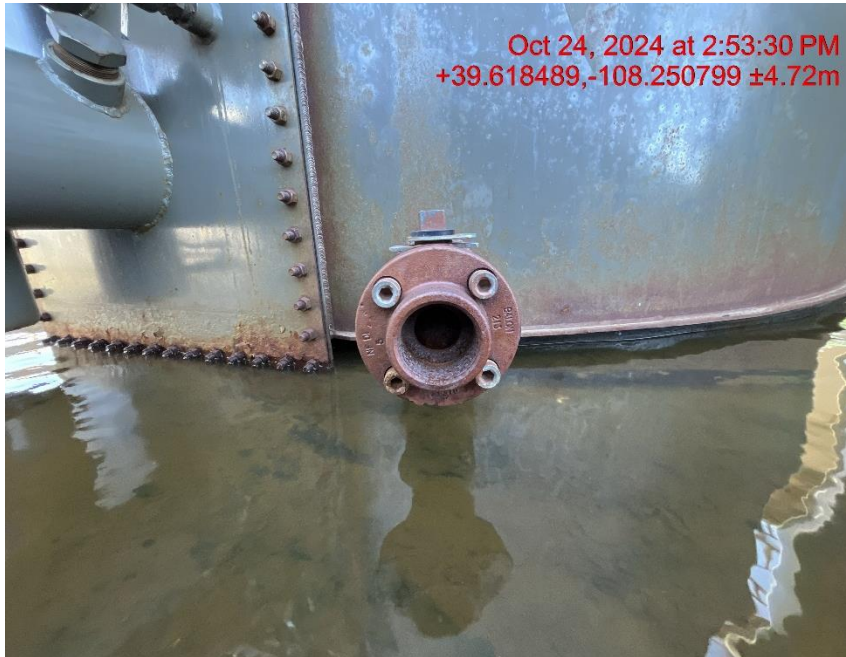
Photo # 8064 Open ended load line

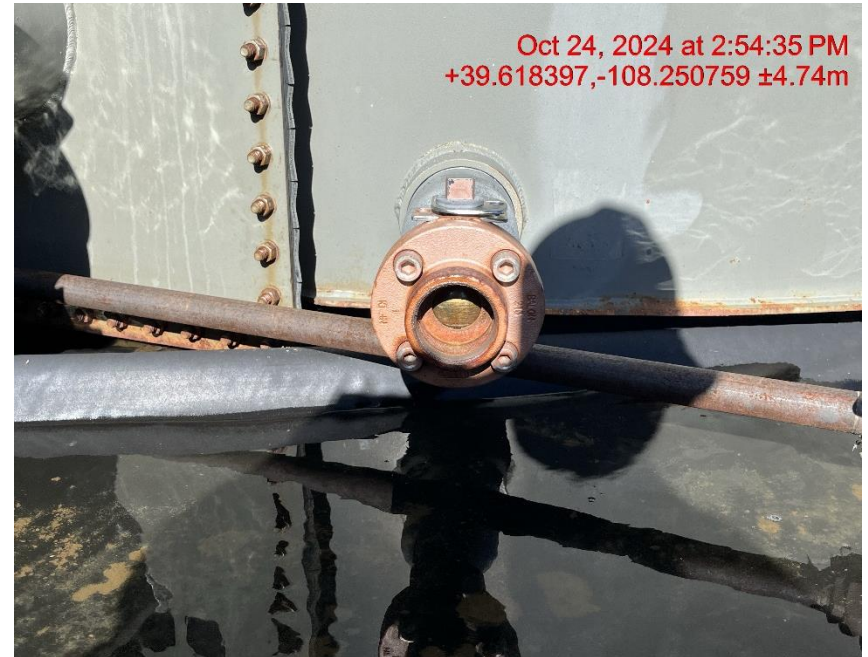
Photo # 8065 Open ended load line

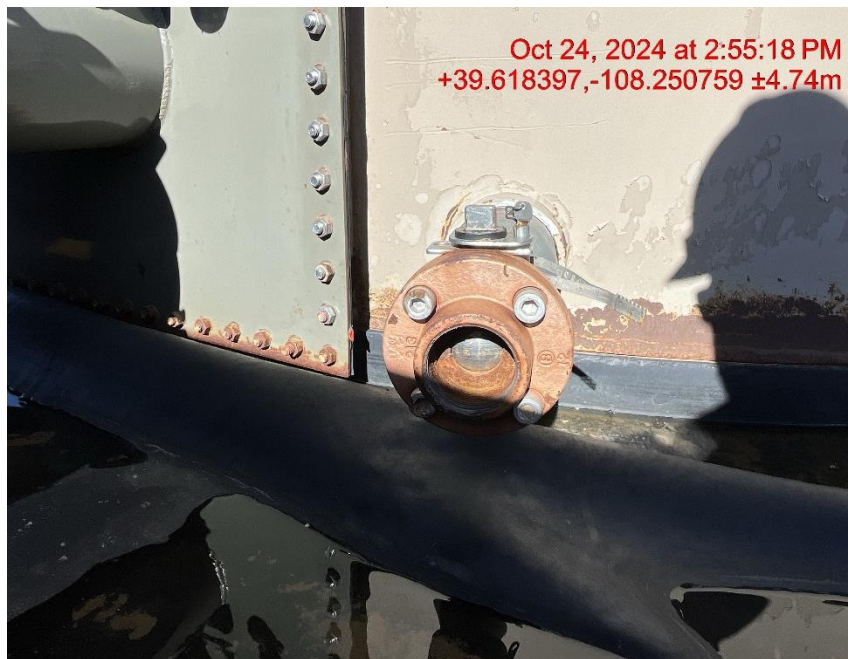
Photo # 8066 Open ended load line

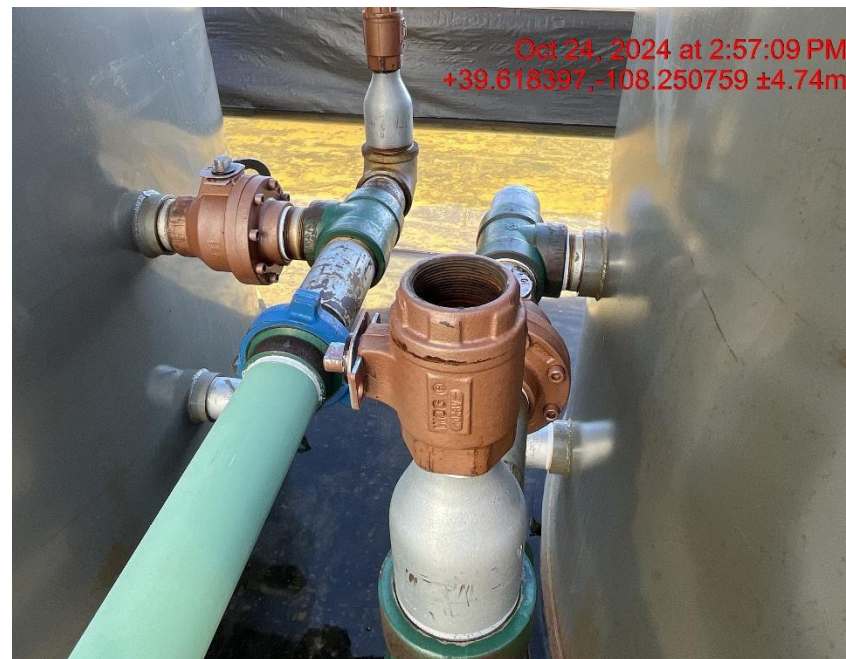
Photo # 8069 Open ended load line
