# Final Reclamation and Stormwater Inspection

Operator: BONANZA CREEK ENERGY OPERATING  
COMPANY - 8960

Location ID: 305141

Inspection Photos  
Location Name: Pronghorn 11-17  
Location ID: 305141

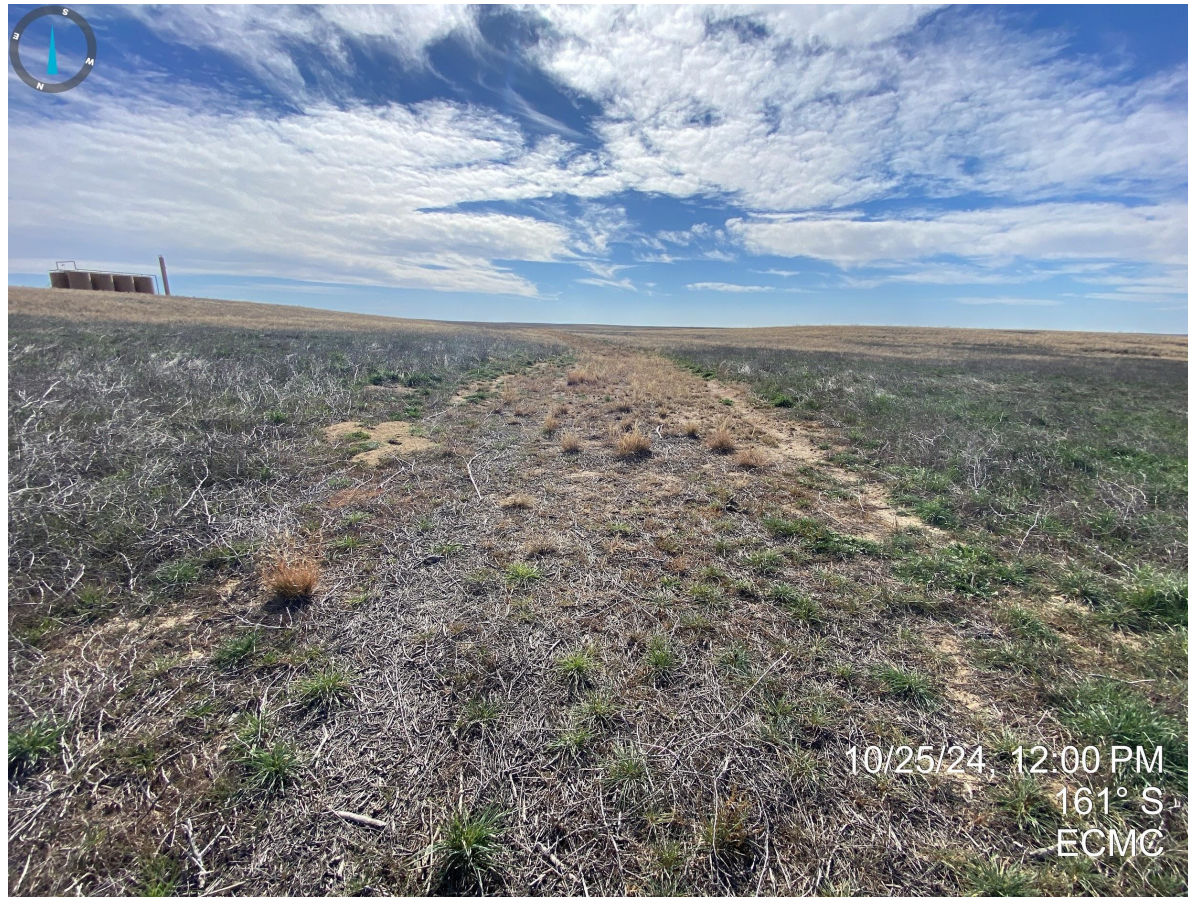
**Photo 1.** Facing south along the start of the access road. It does not appear that the access road has been recontoured/graded to reflect the adjacent topography.

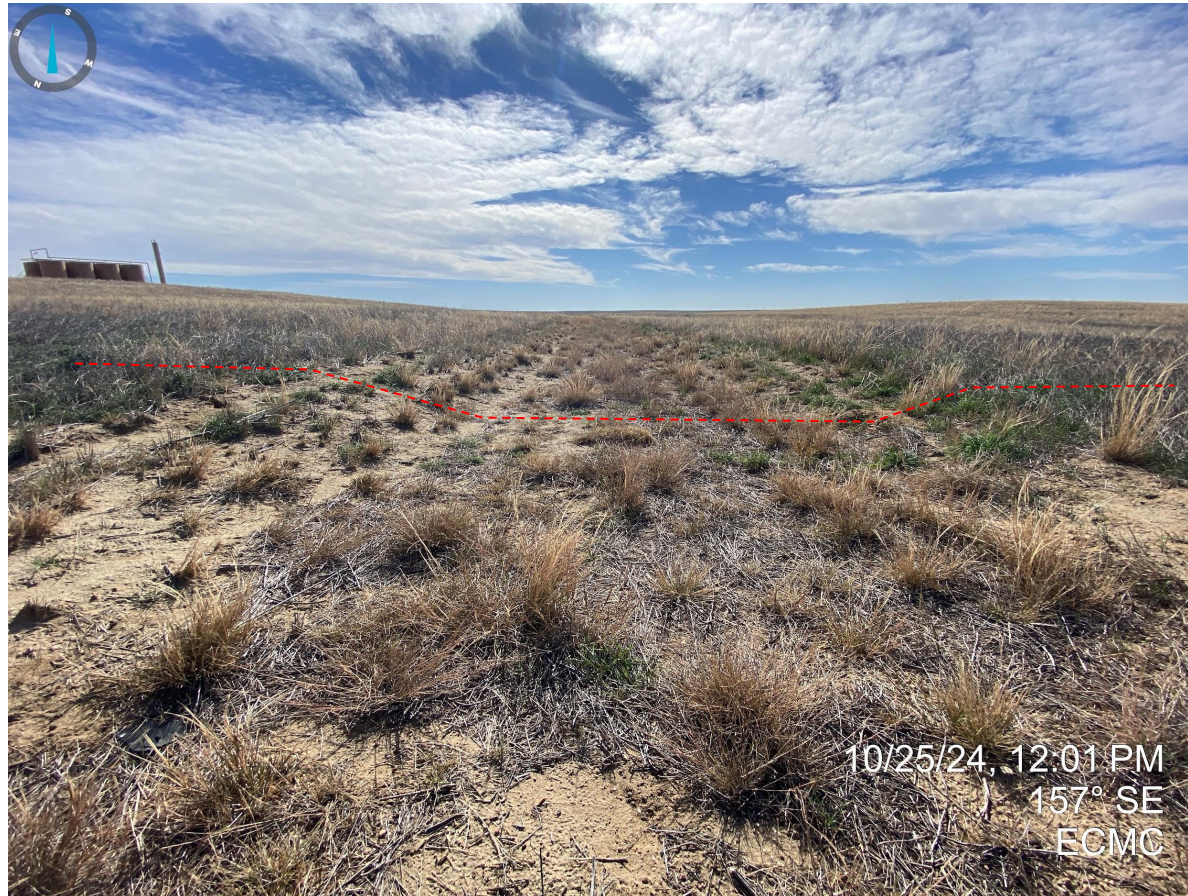
**Photo 2.** Continued from Photo 1. Red dotted line illustrates the approximate contour of the former access road.

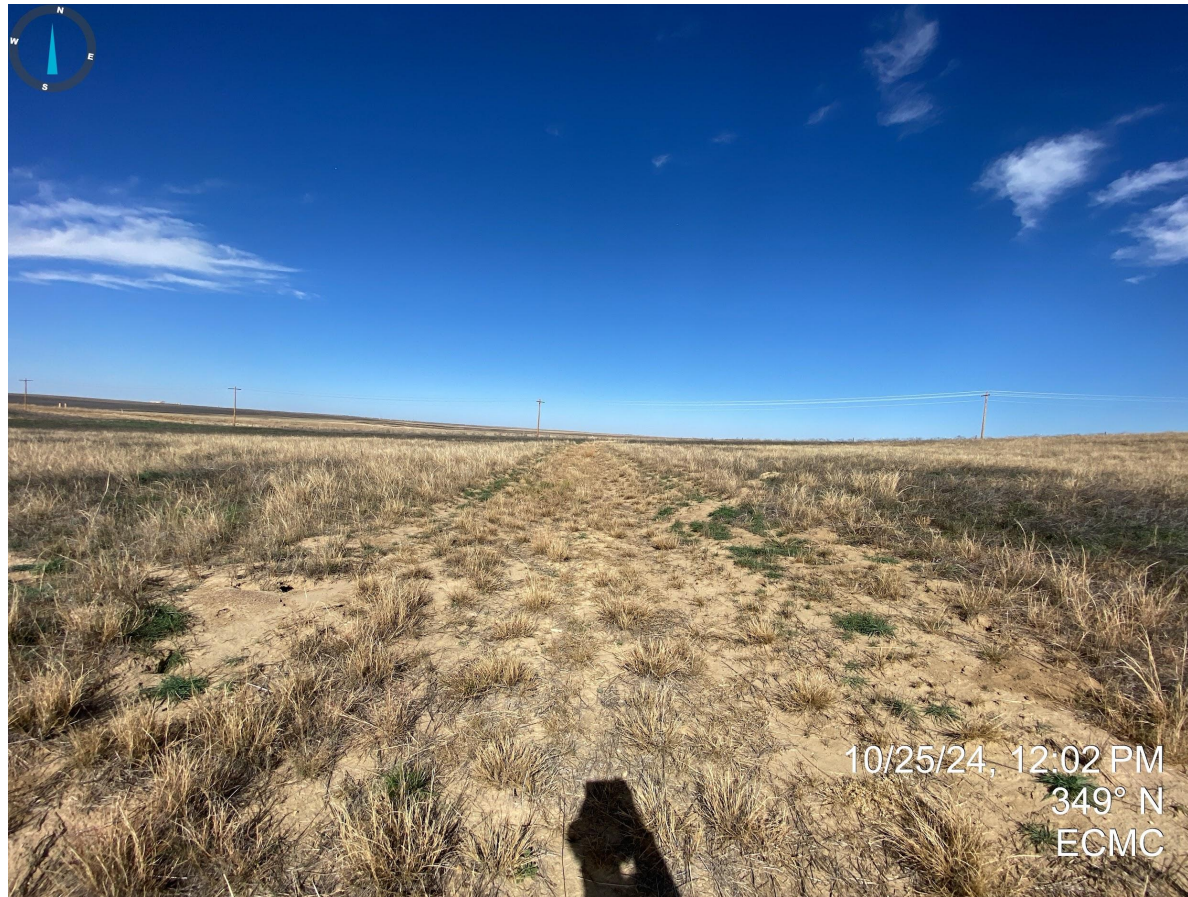
**Photo 3.** Facing north along the access road near the former location. The access road is “trough” shaped and will require additional reclamation activities to restore to the original grade.

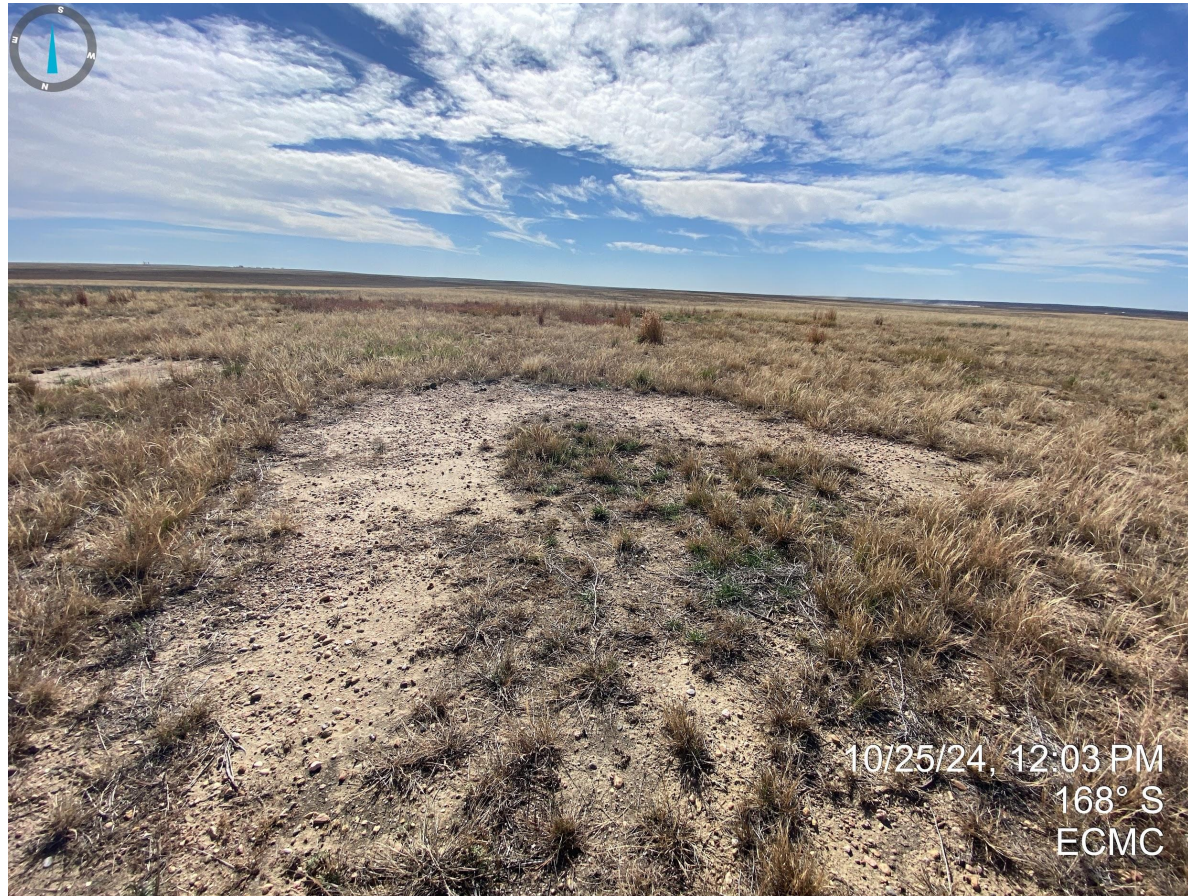
**Photo 4.** The former well location has evidence of road base material and non-uniform vegetation cover.

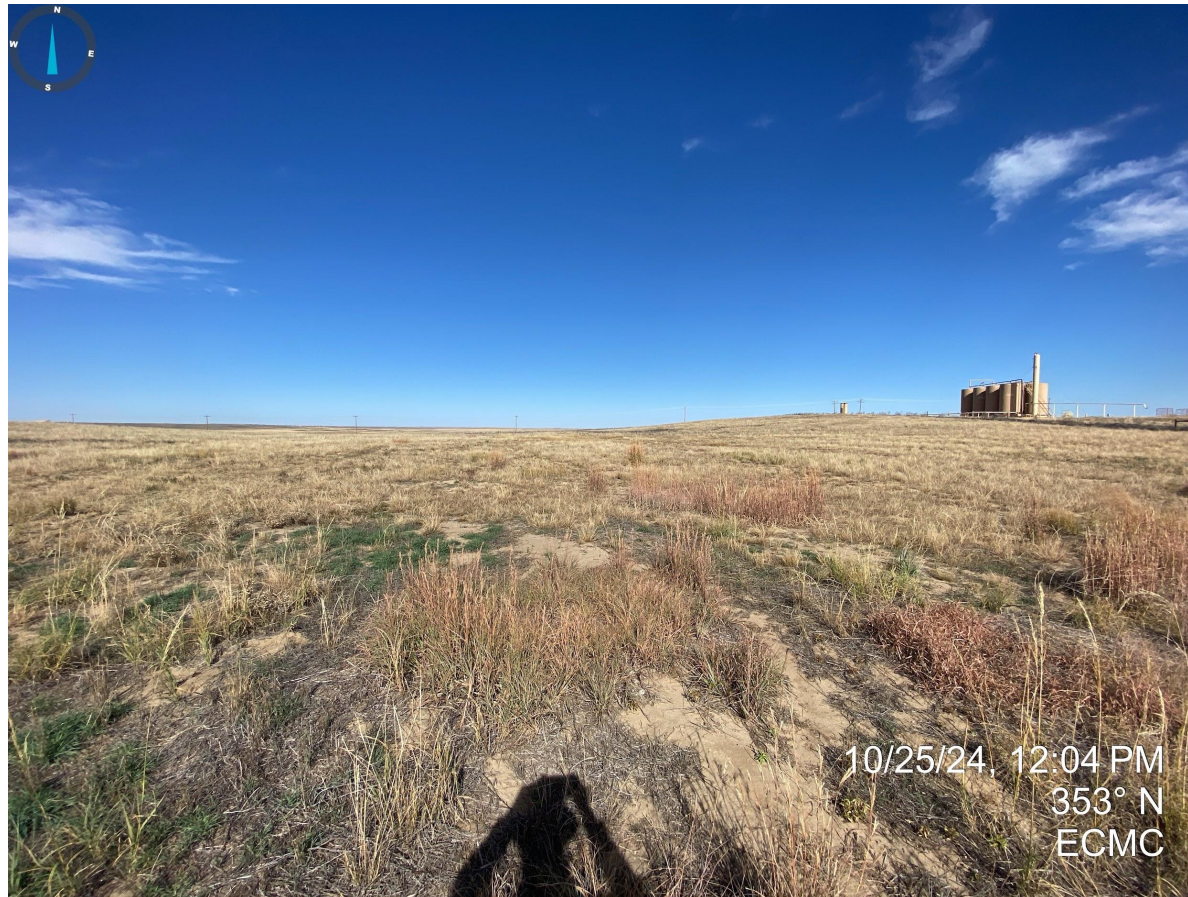
**Photo 5.** The southern reclaimed area (former tank battery) appears to be progressing towards reclamation standards with desirable vegetation observed.

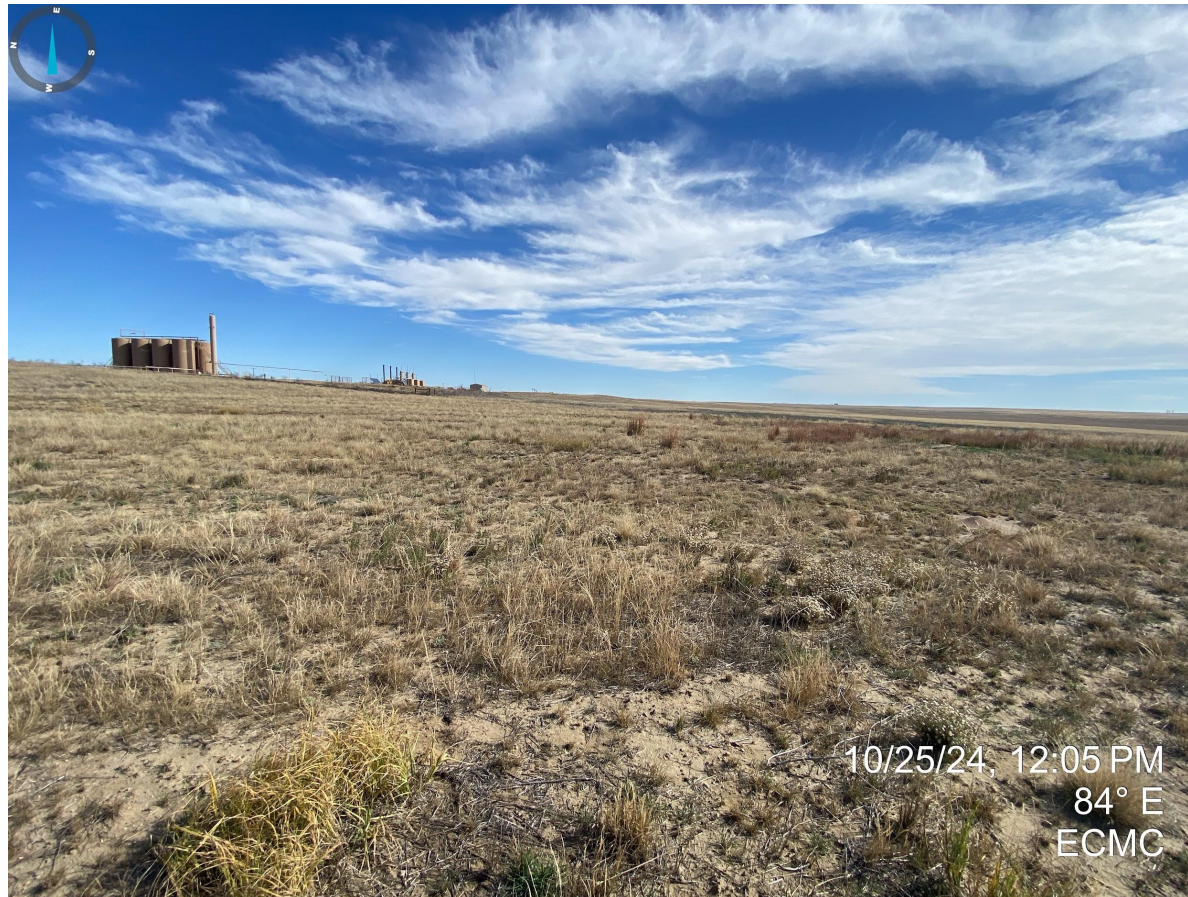
**Photo 6.** Facing east from the western portion of the the former location. Reclaimed portions appear to be progressing towards vegetative standards with desirable vegetation observed.

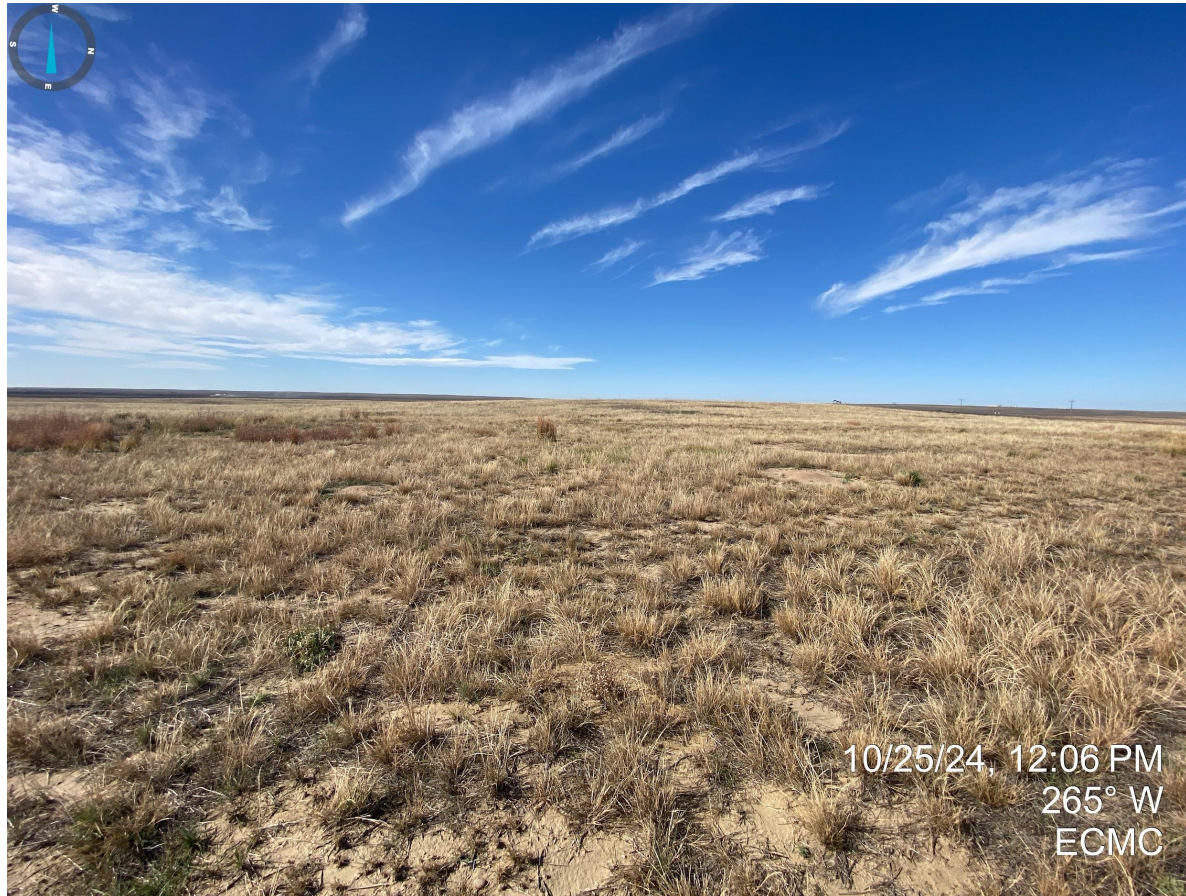
**Photo 7.** Facing west from the eastern portion of the the former location. Reclaimed portions appear to be progressing towards vegetative standards with desirable vegetation observed.

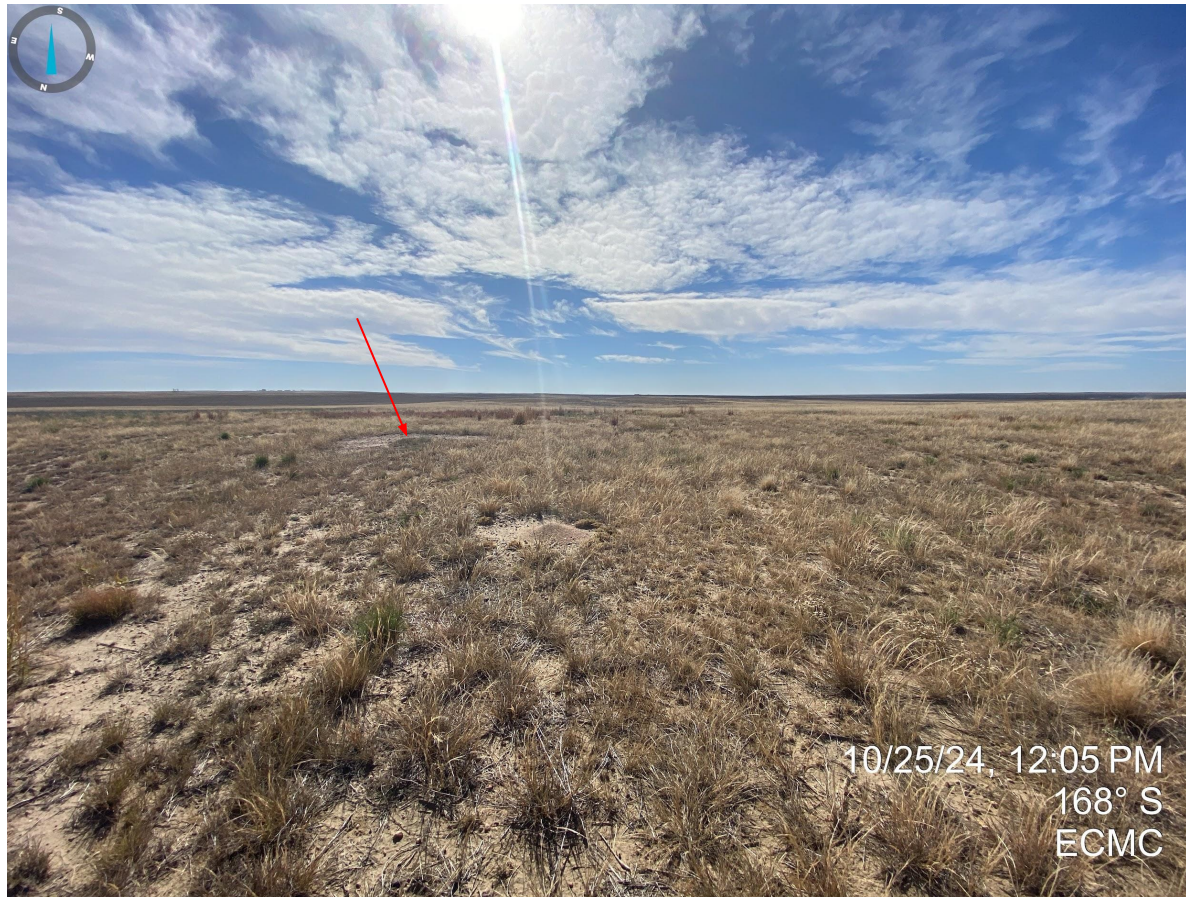
**Photo 8.** Facing south from the northern portion of the the former location. Reclaimed portions appear to be progressing towards vegetative standards with desirable vegetation observed. (Red arrow indicates former well location).
