Interim Reclamation and Stormwater Inspection

Date: 10/23/24

Operator: Verdad Resources LLC - 10651

Inspection Photos
Location Name: Kiwi 2920
Location ID: 483467

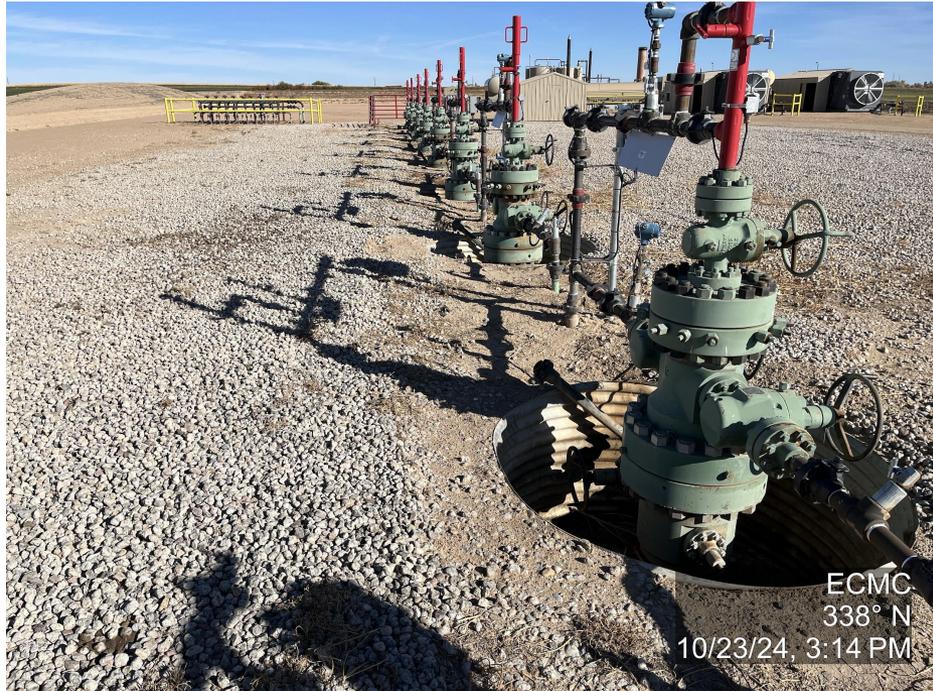
Photo 1. The photo was taken at the well location facing North. The photo illustrates the wellhead cells are missing wildlife protection.

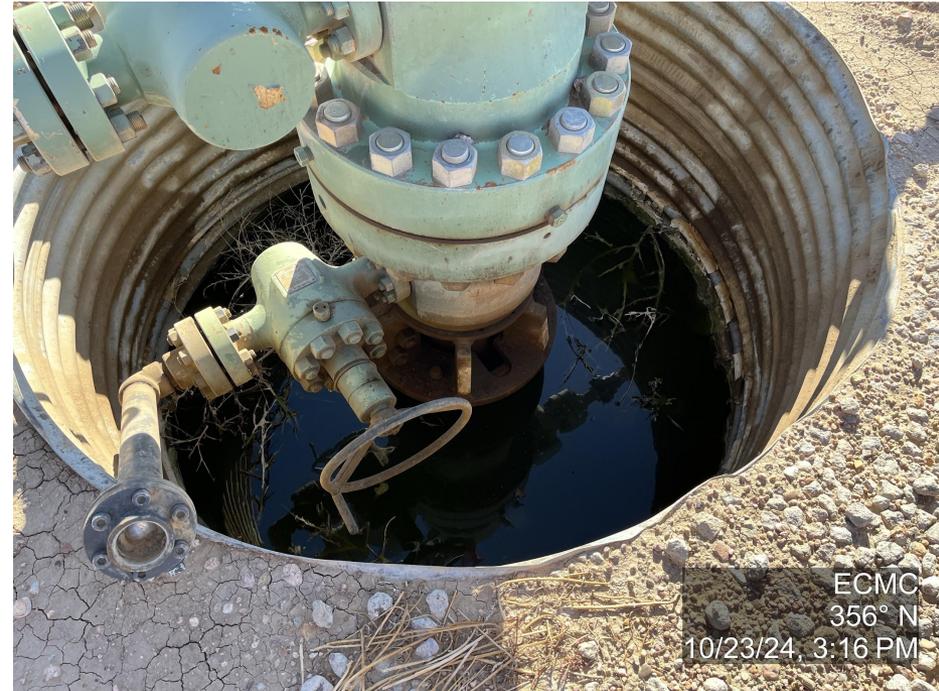
Photo 2. The photo was taken at the well location facing North. The photo illustrates two wellhead cells are partially full of liquid.

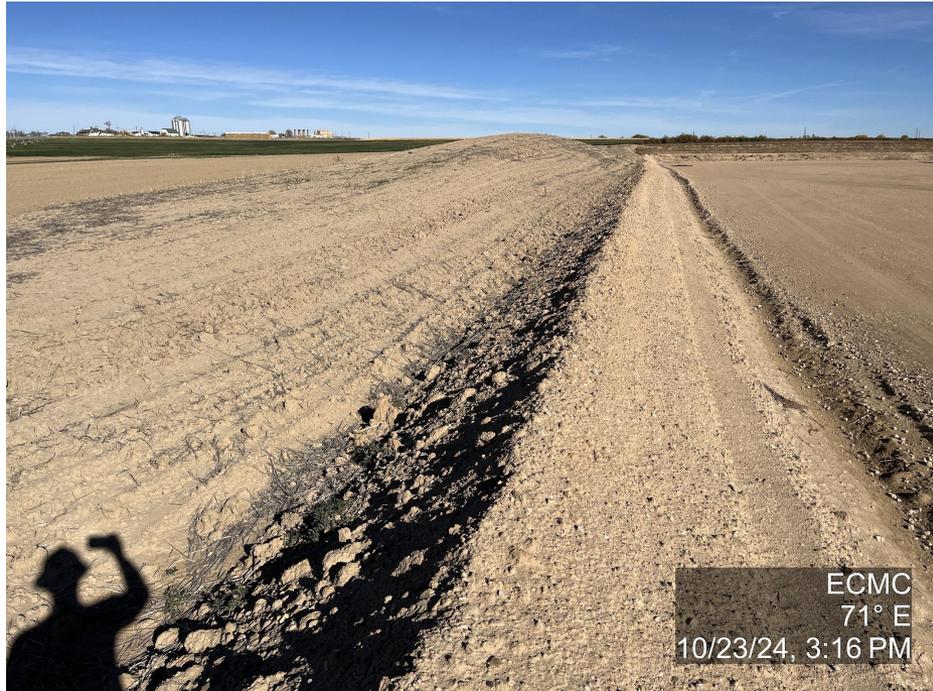
Photo 3. The photo was taken at the well location facing East. The photo illustrates the topsoil stockpile is bare of vegetation.

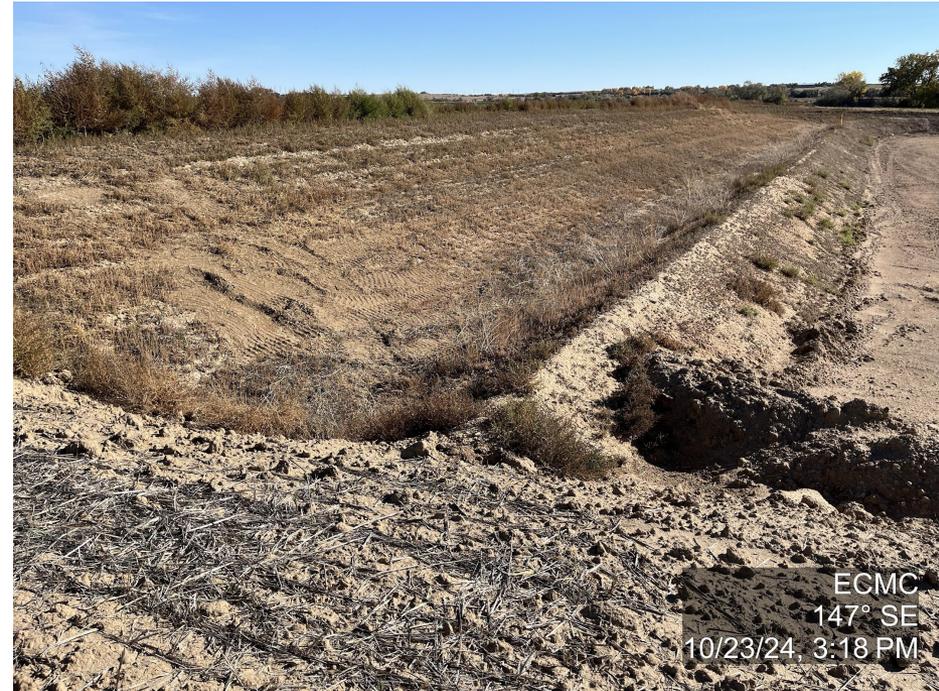
Photo 4. The photo was taken at the well location facing Southeast. The photo illustrates the East side of the location.

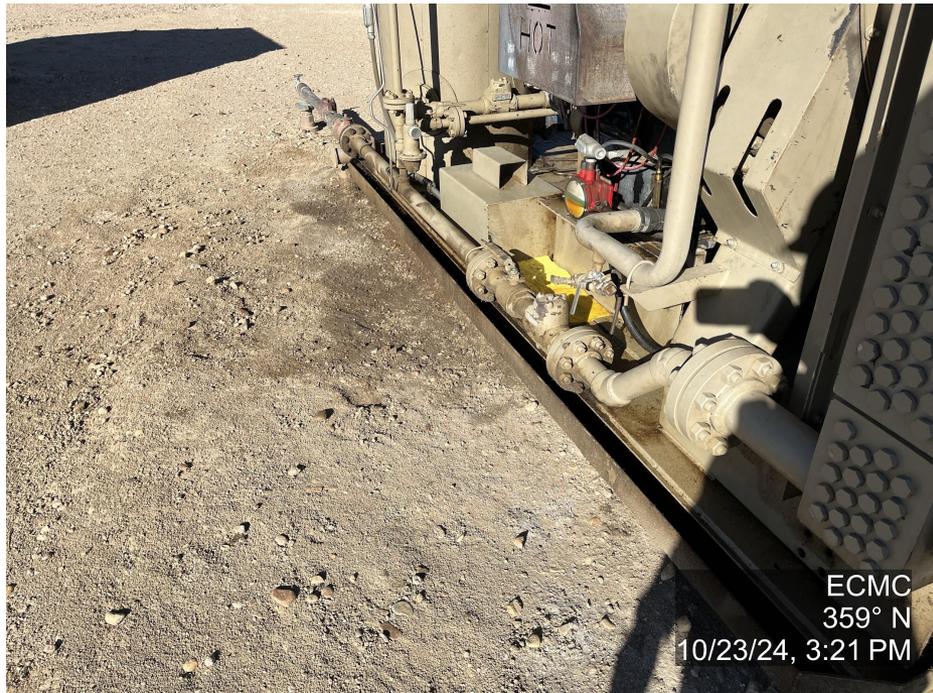
Photo 5. The photo was taken at the well location facing North. The photo illustrates soil staining around the skid.

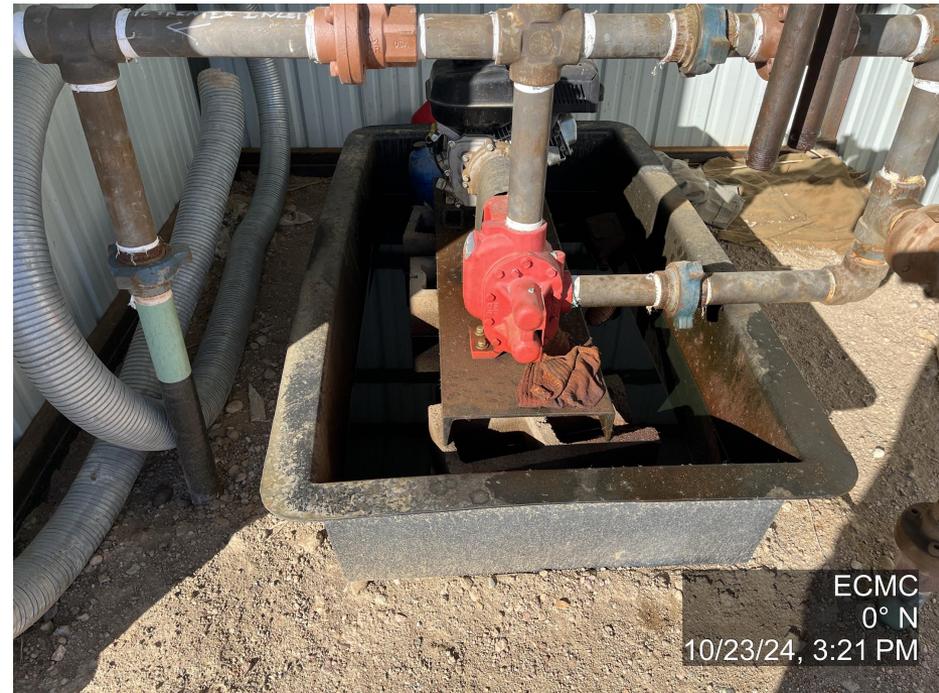
Photo 6. The photo was taken at the well location facing North. The photo illustrates free fluids within the secondary containment.

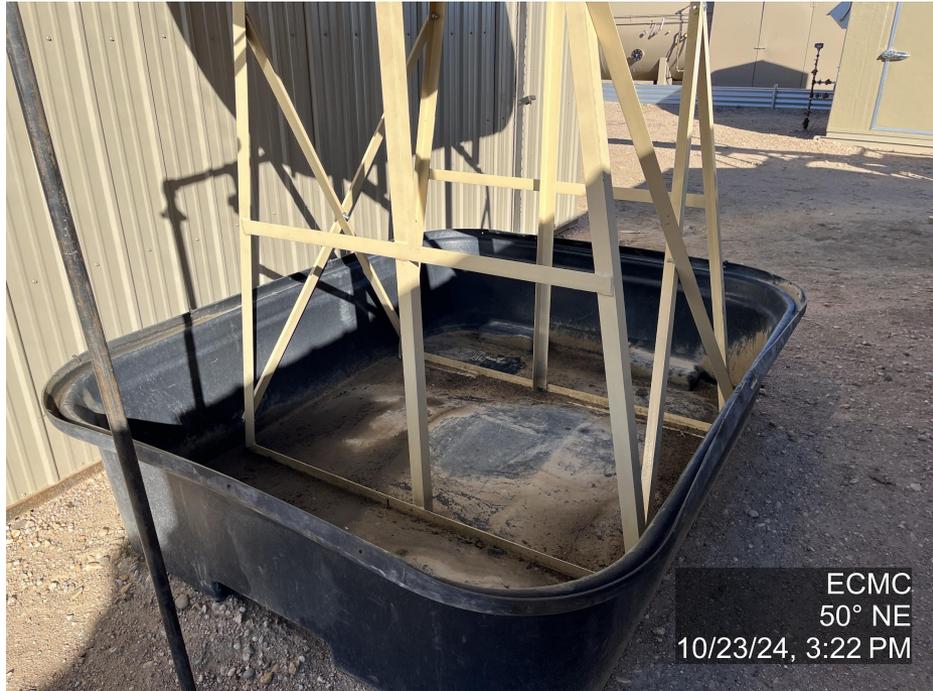
Photo 7. The photo was taken at the well location facing Northeast. The photo illustrates there is no wildlife screen on the secondary containment.

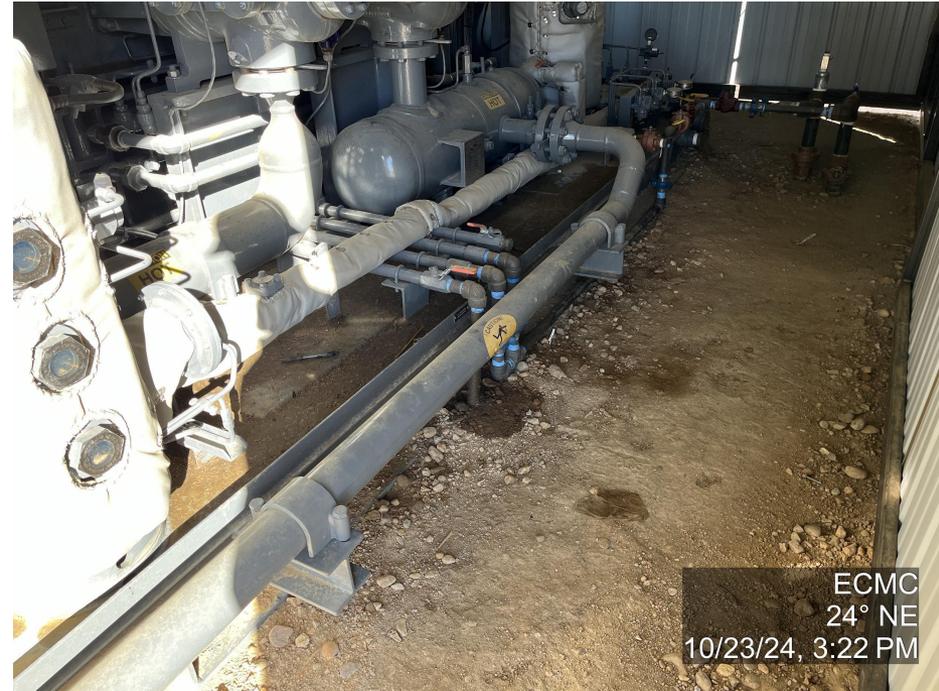
Photo 8. The photo was taken at the well location facing Northeast. The photo illustrates soil staining around production equipment.

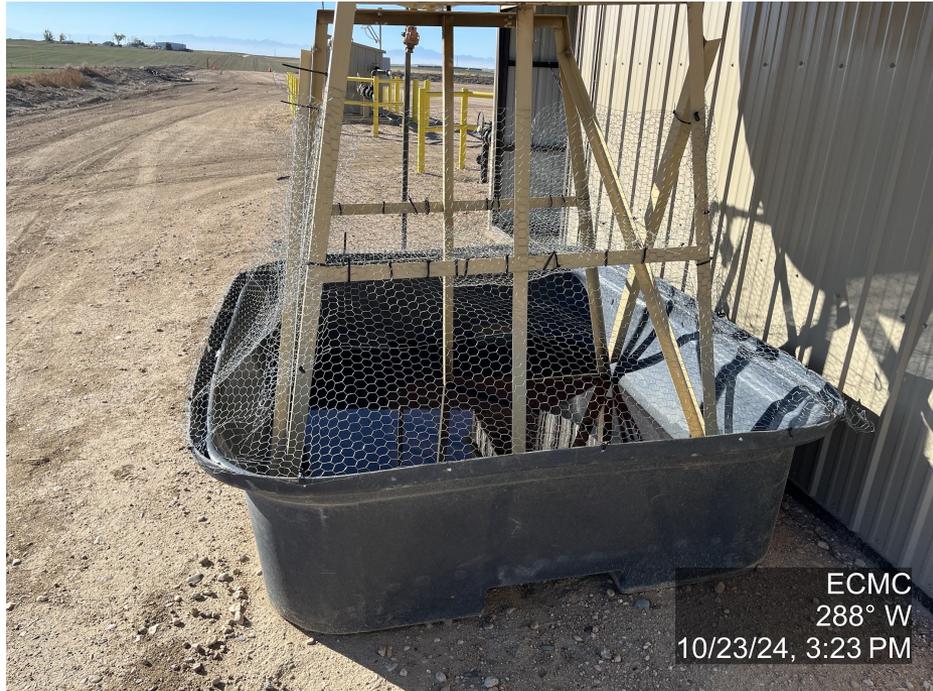
Photo 9. The photo was taken at the well location facing West. The photo illustrates free fluids within the secondary containment.

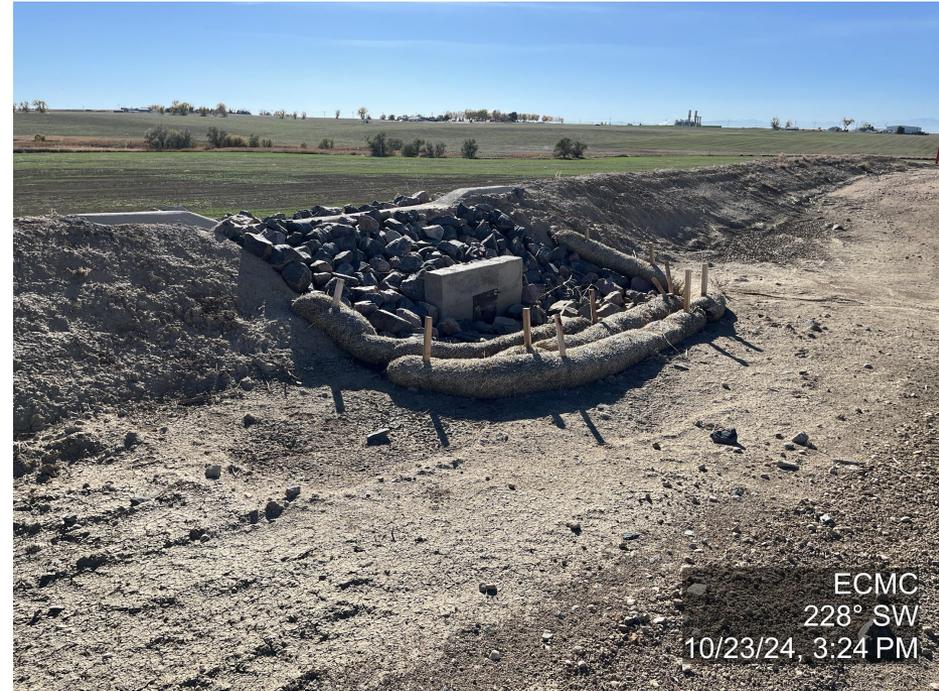
Photo 10. The photo was taken at the well location facing Southwest. The photo illustrates the stabilized stormwater outlet for the retention area.

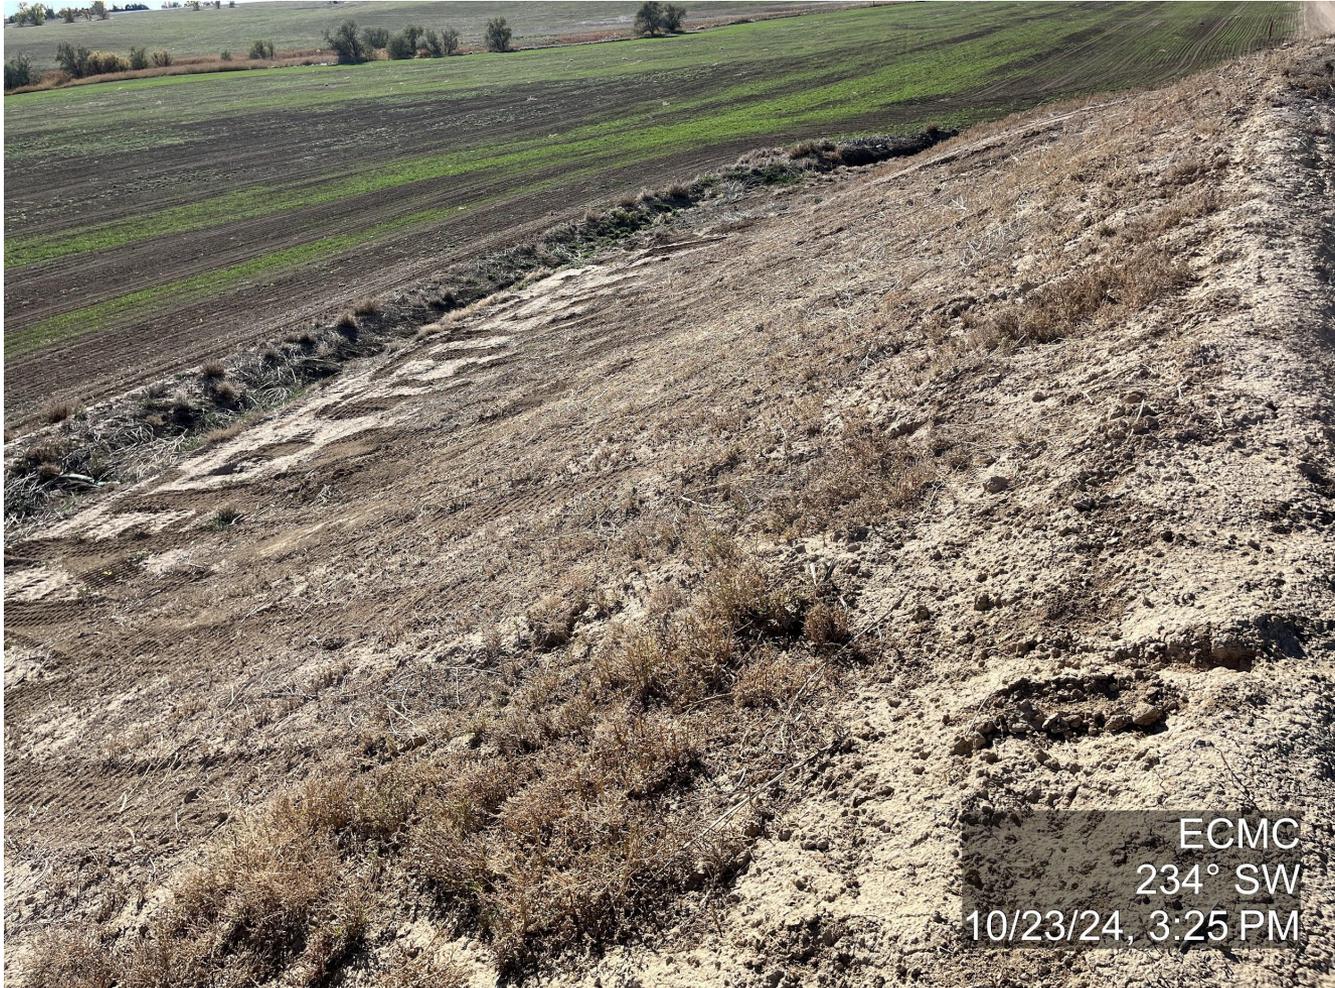
Photo 11. The photo was taken at the well location facing Southwest. The photo illustrates steep slopes along the pad edge have limited vegetation and stormwater controls.
