# Inspection Photos

ID: 312120

Operator: XTO ENERGY INC

Inspection Date: 10/28/2024

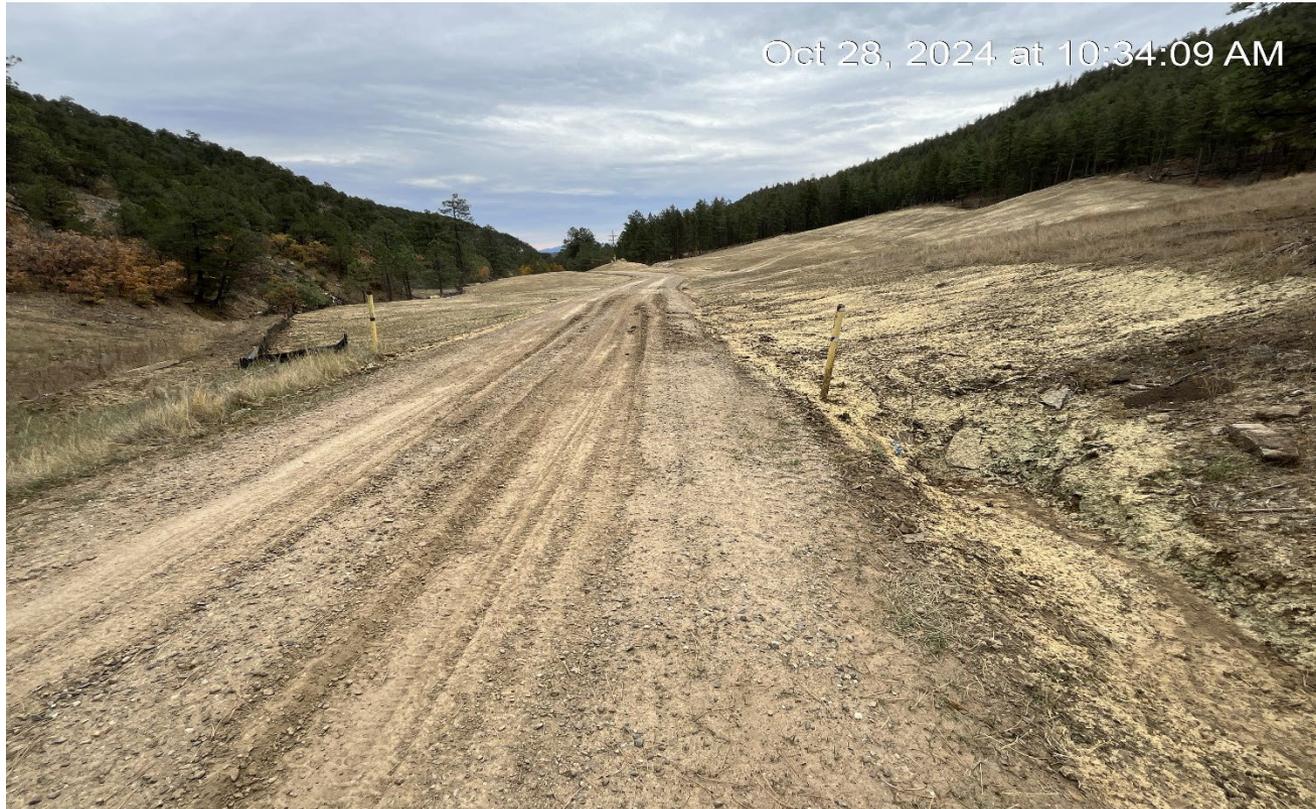
**Photo 1.** Facing east along the access road.

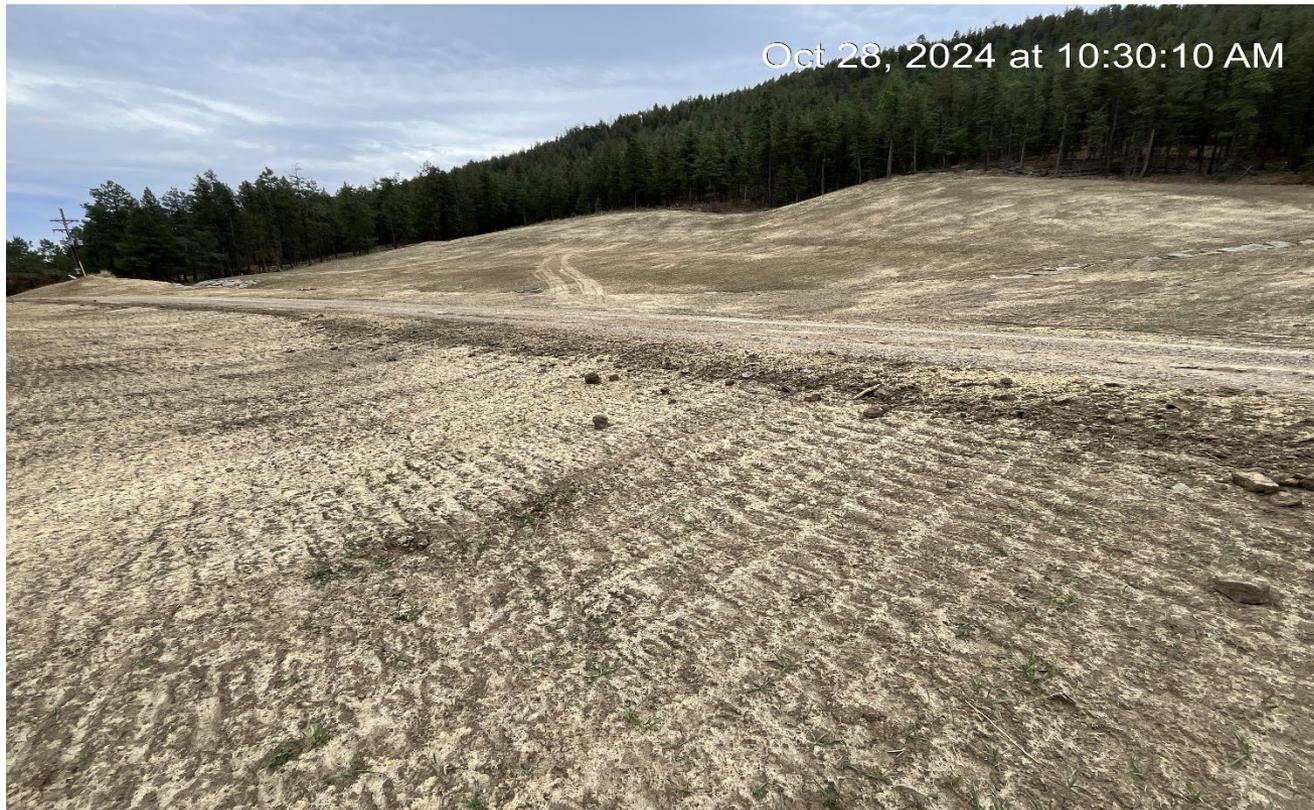
**Photo 2.** Facing southeast. The location has been recontoured and reclaimed. Soils have been tracked and lightly hydromulched.

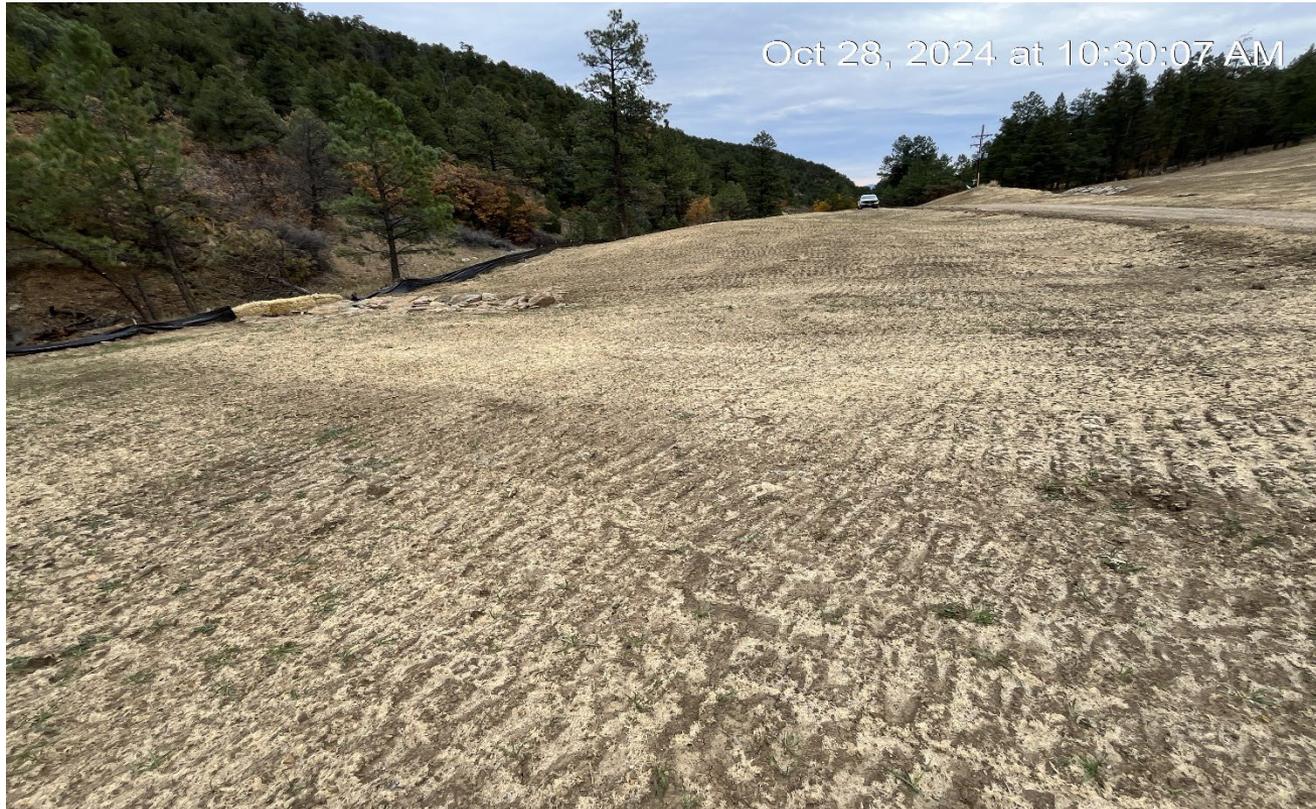
**Photo 3.** Facing east at the north side of the location.

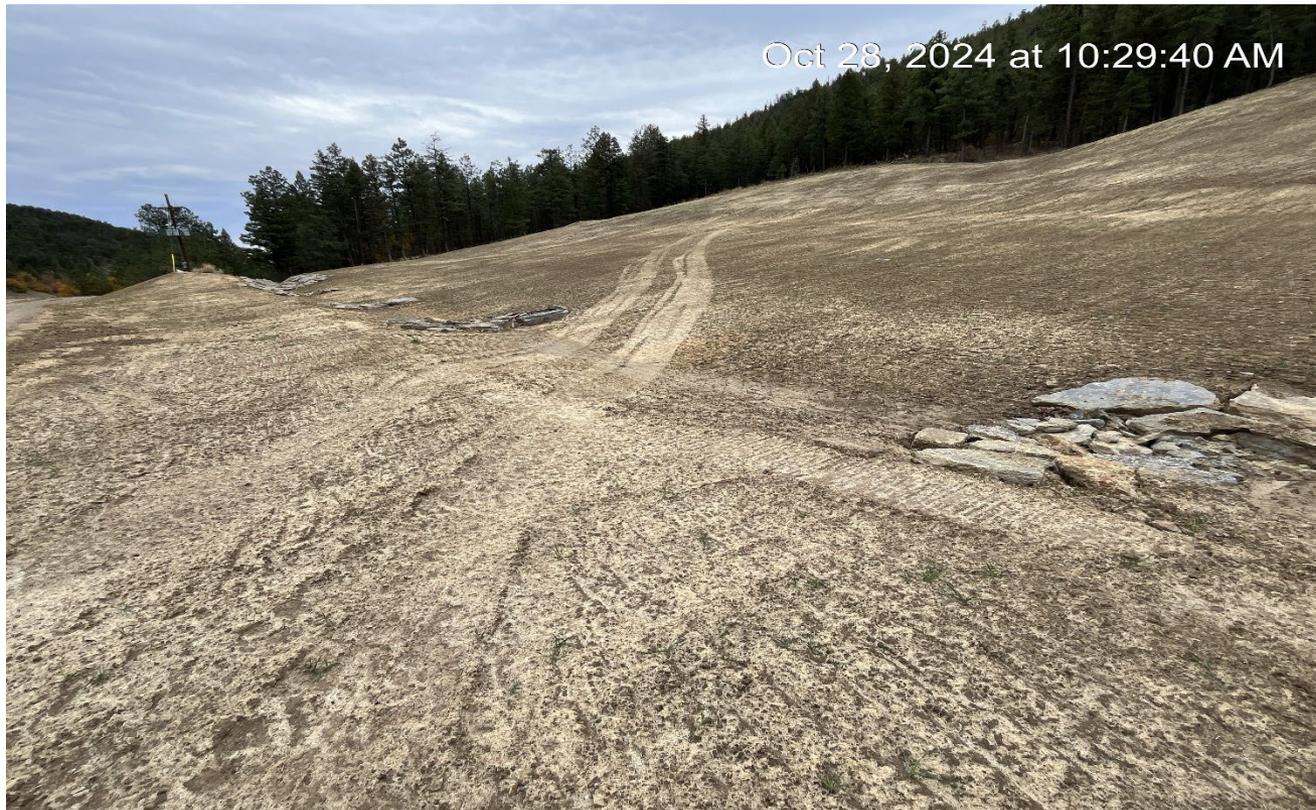
**Photo 4.** Facing east at the center of the location. A berm was installed with rock dams.

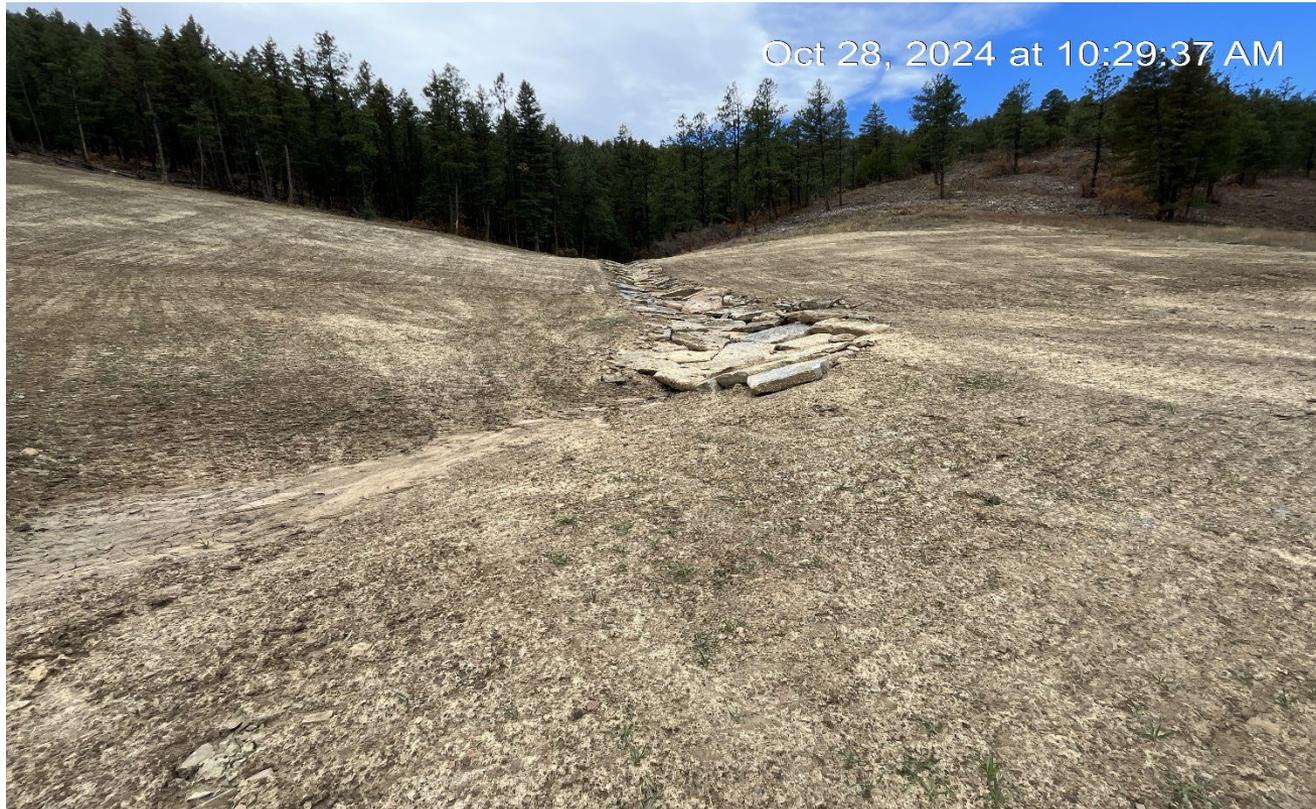
**Photo 5.** This drainage was stabilized with rock rip/rap for stormwater run-on..

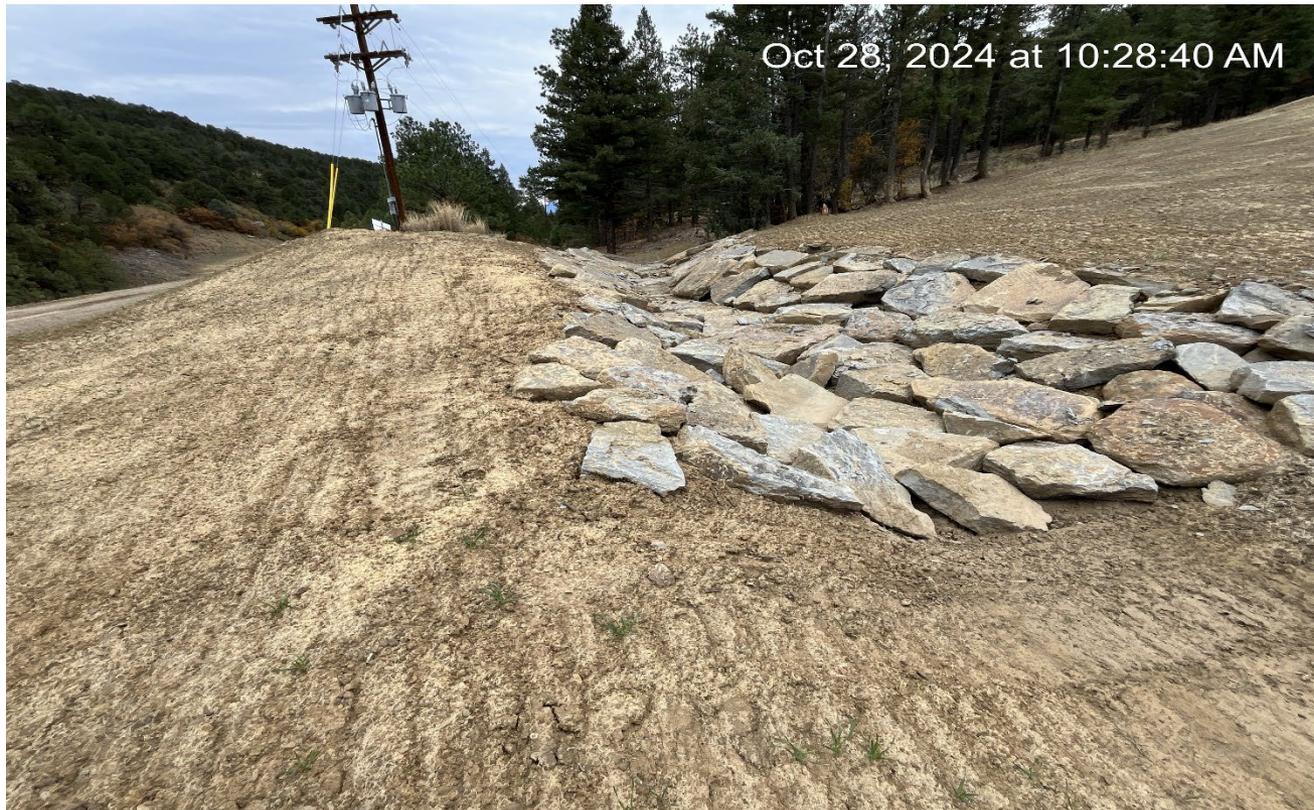
**Photo 6.** Facing toward the east side of the location. This rip/rap outlet appears to have too much rip/rap and may affect drainage as it appears to be slightly higher gradient.

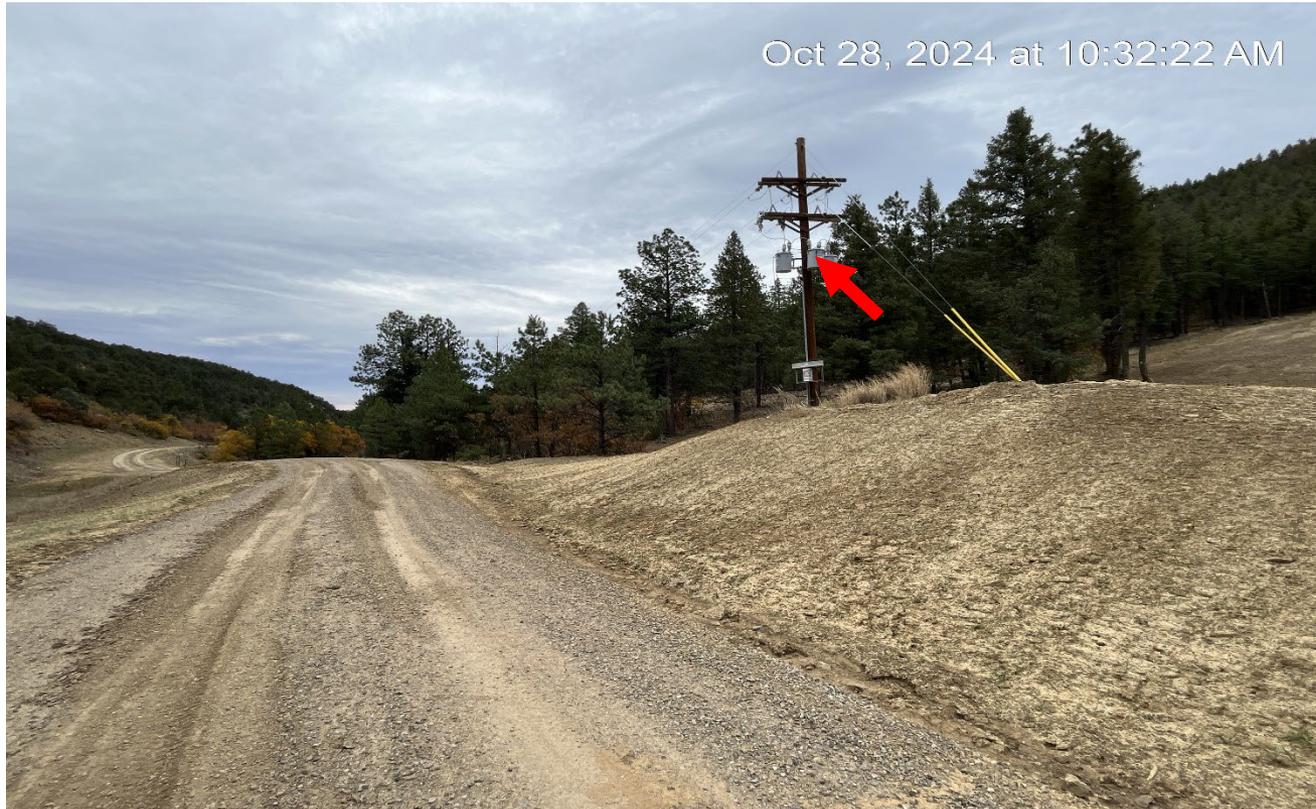
**Photo 7.** This electric utility line needs to be removed by coordinating removal with utility company.

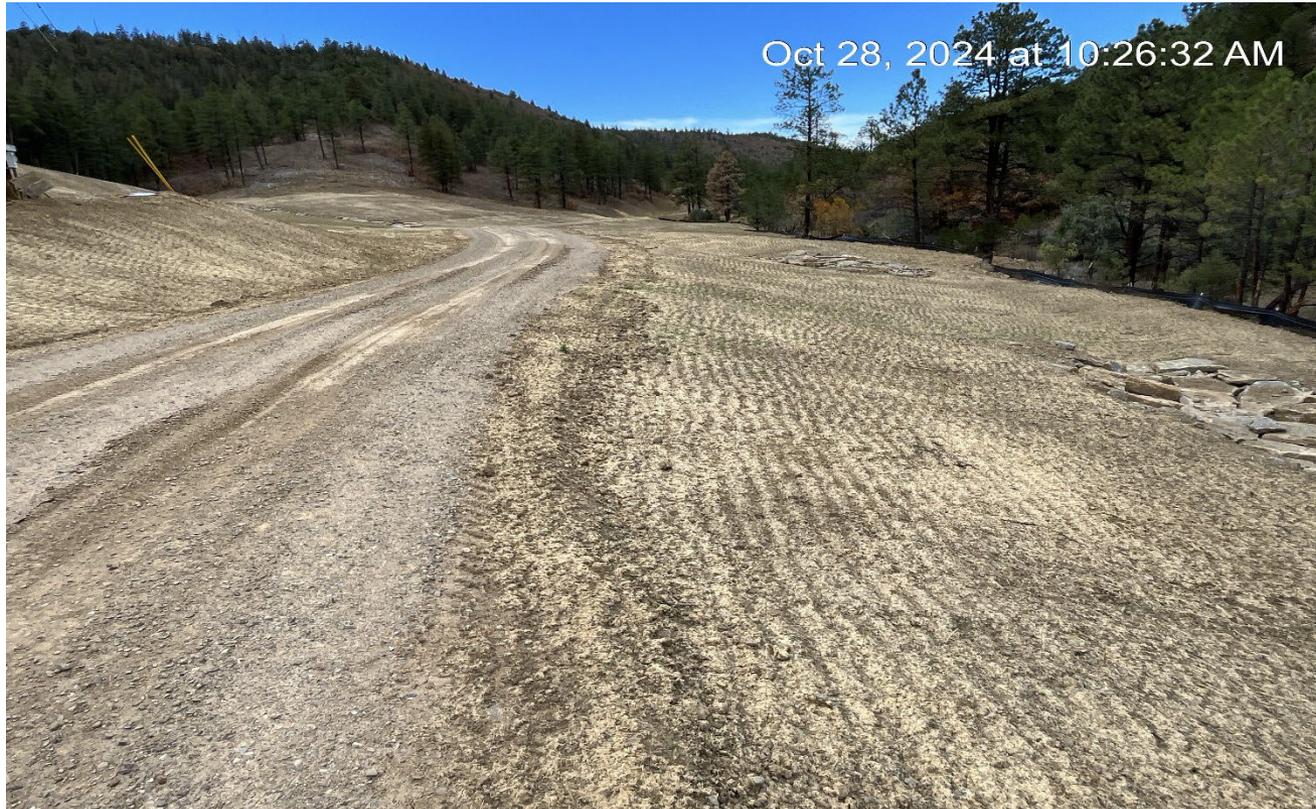
**Photo 8.** Facing back west at the reclaimed location..
