## Inspection Photos

Location Name: TEP ROCKY MOUNTAIN LLC FEDERAL RMV 63-19 Pad

Location #: 335176

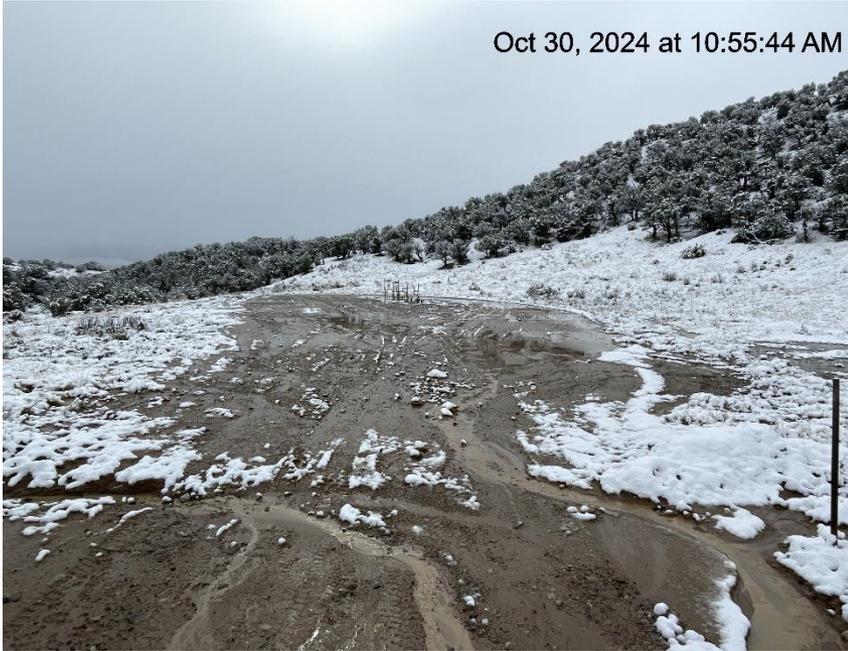
Photo # 8149 From entrance to location

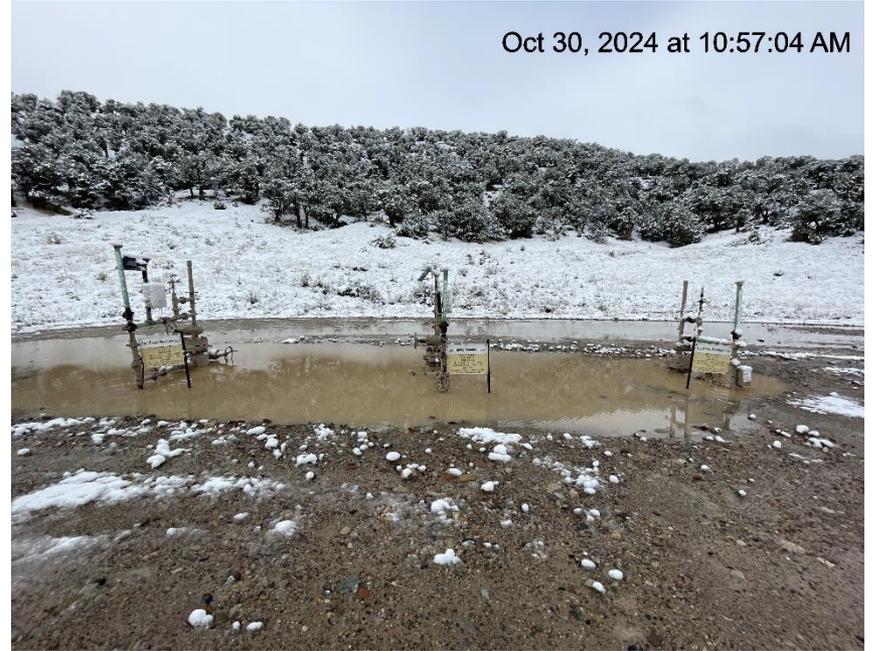
Photo # 8150 Location

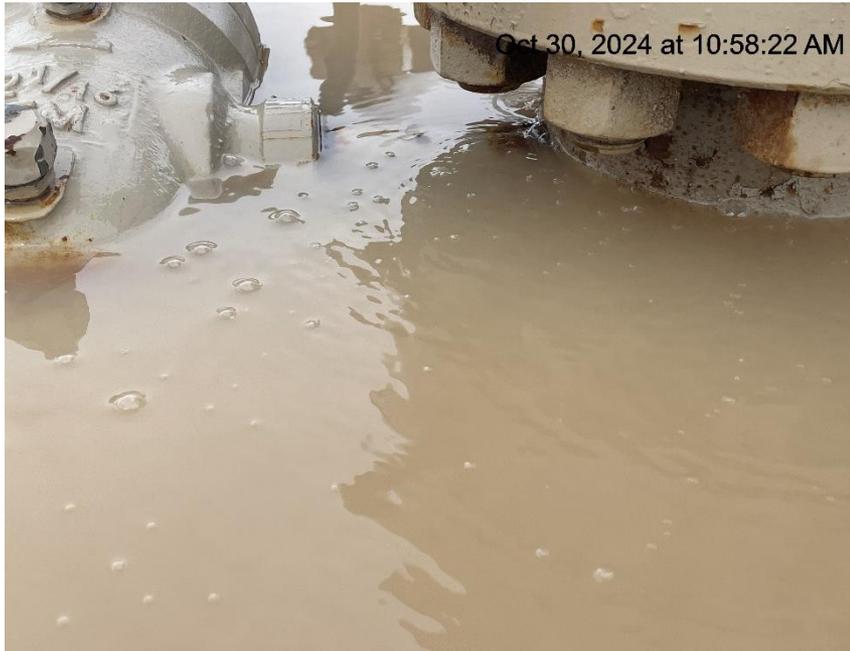
**Photo # 8151 Possible wellhead leak/gas bubbling up through water around wellhead (FEDERAL RMV 63-19 well)**

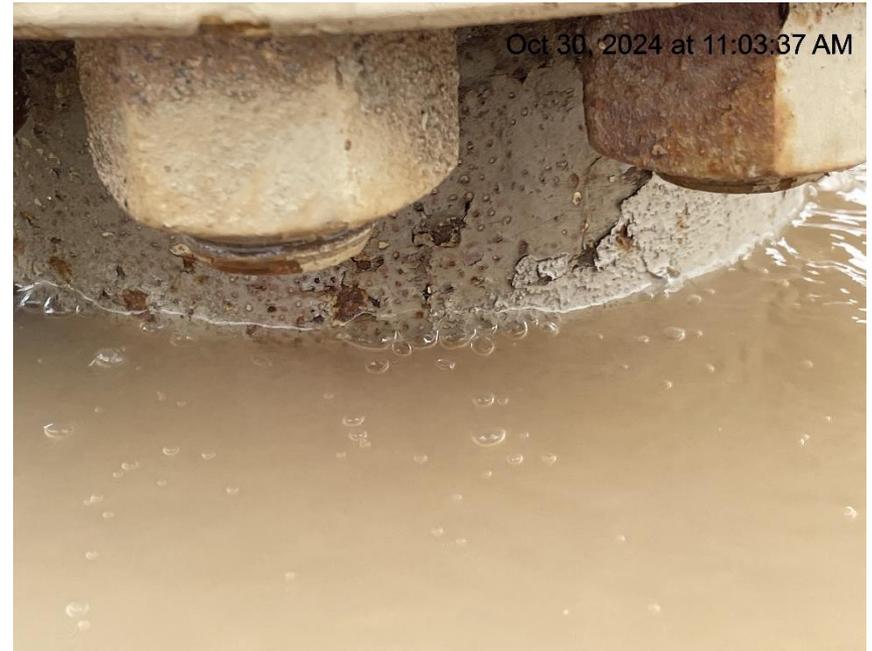
**Photo # 8152 Possible wellhead leak/gas bubbling up through water around wellhead (FEDERAL RMV 63-19 well)**

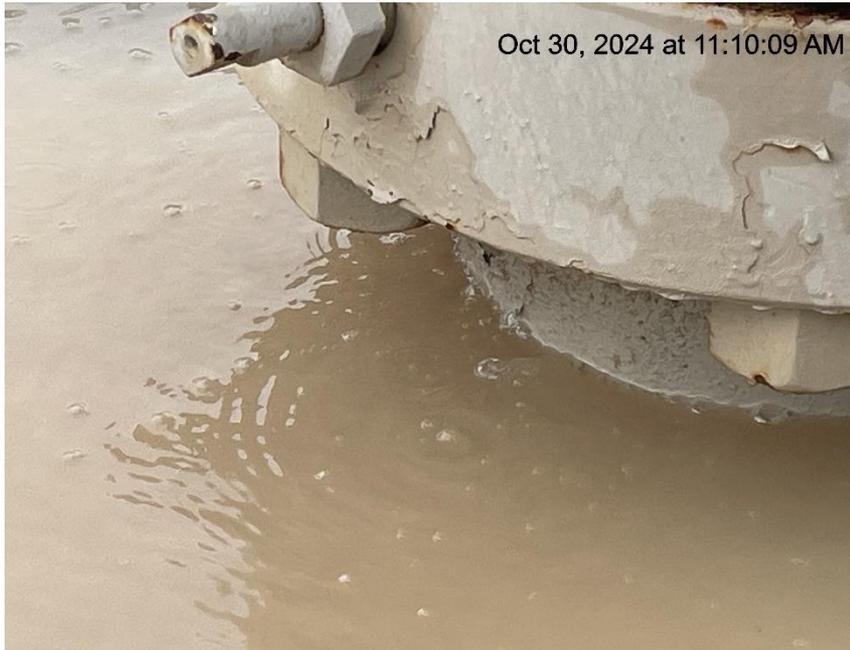
**Photo # 8153 Possible wellhead leak/gas bubbling up through water around wellhead (FEDERAL RMV 63-19 well)**

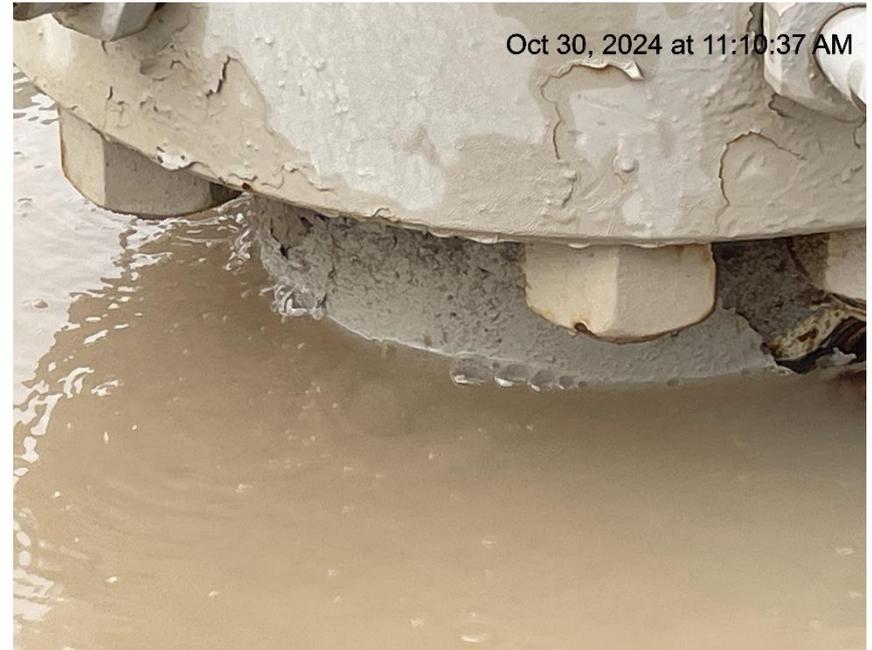
**Photo # 8154 Possible wellhead leak/gas bubbling up through water around wellhead (FEDERAL RMV 63-19 well)**

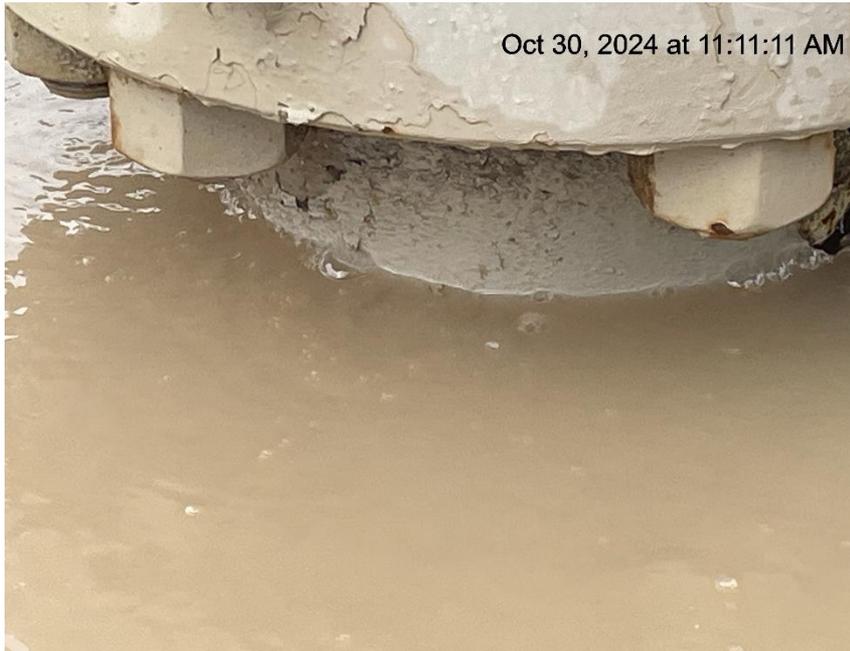
**Photo # 8155 Possible wellhead leak/gas bubbling up through water around wellhead (FEDERAL RMV 63-19 well)**

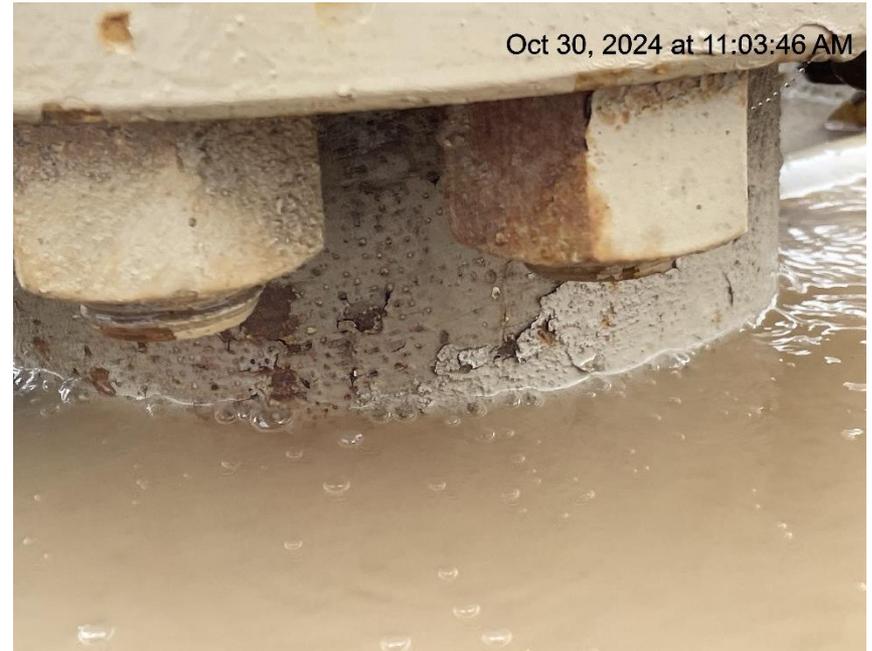
**Photo # 8156 Possible wellhead leak/gas bubbling up through water around wellhead (FEDERAL RMV 63-19 well)**

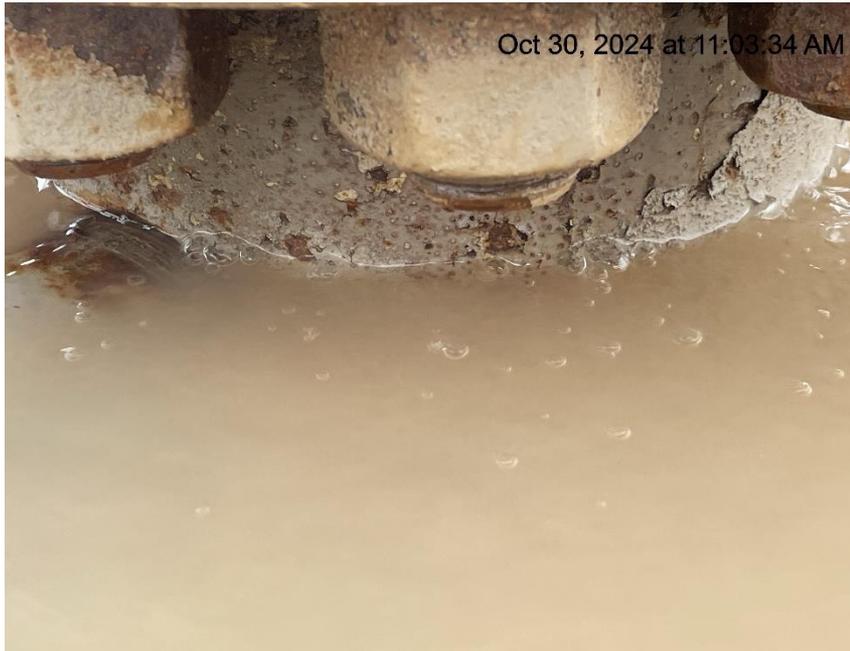
**Photo # 8157 Possible wellhead leak/gas bubbling up through water around wellhead (FEDERAL RMV 63-19 well)**

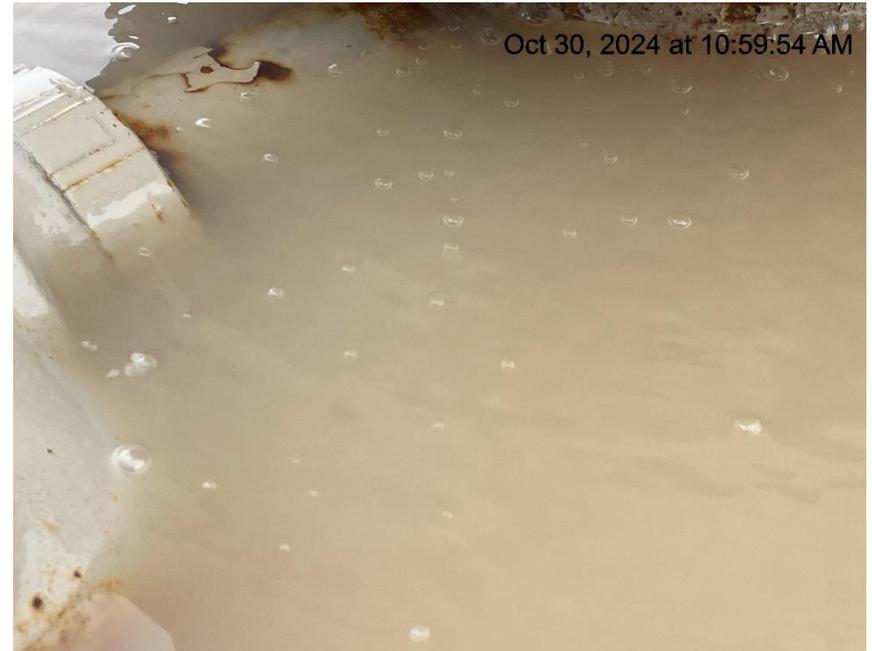
**Photo # 8158 Possible wellhead leak/gas bubbling up through water around wellhead (FEDERAL RMV 63-19 well)**
