## Inspection Photos

Location Name: CAERUS PICEANCE LLC, G. JONES-67S96W/35SESE

Location ID: 334355

Date: 10/31/2024

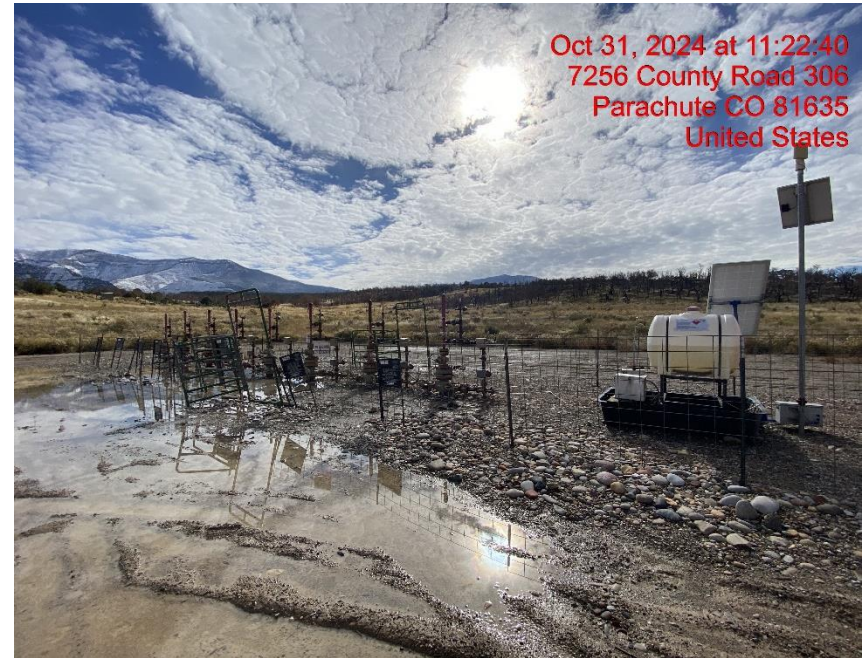
Location/Lack of Stabilization – Photo #04590

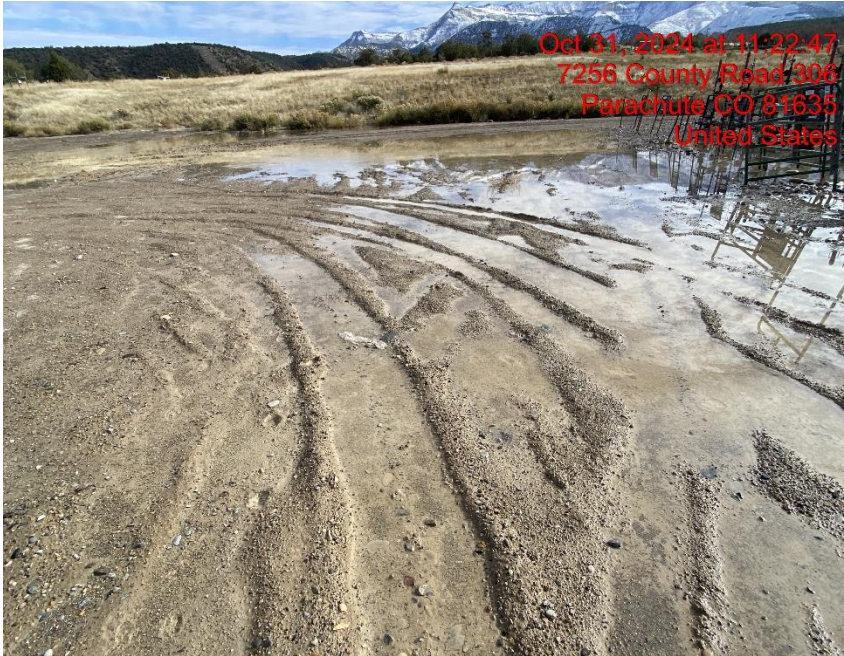
Lack of Stabilization – Photo #04591

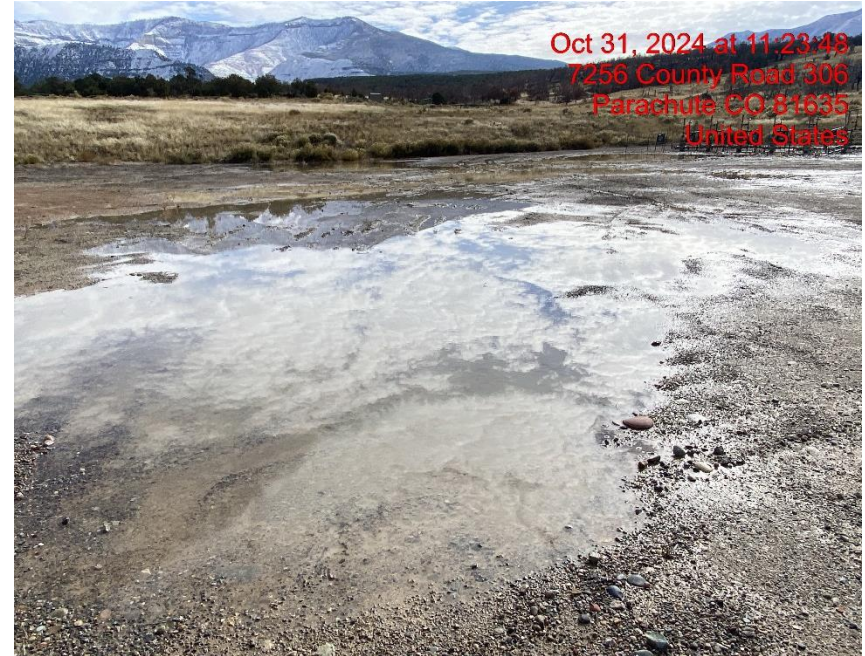
Lack of Stabilization/Degradation – Photo #04593

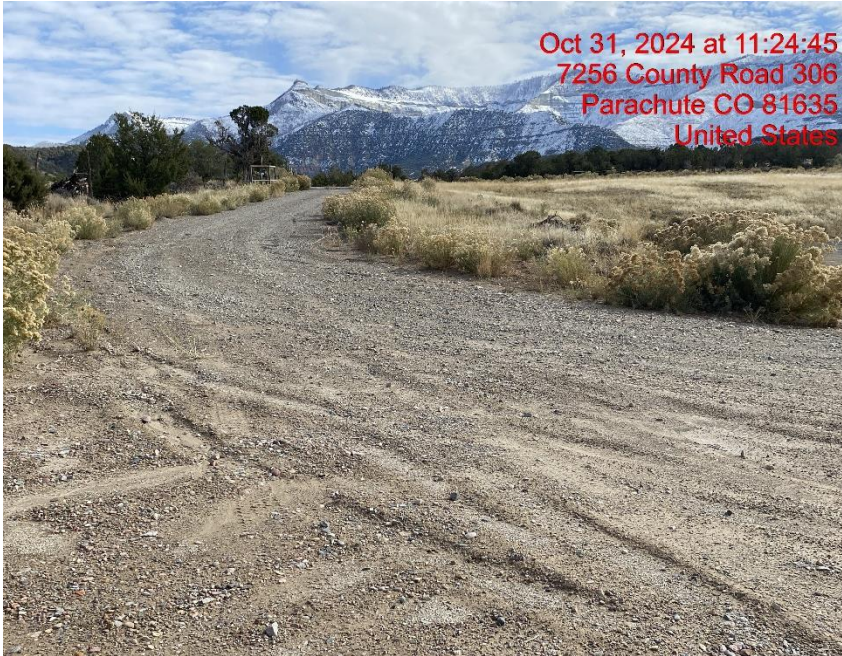
**Insufficient Tracking BMPs – Photo #04595**
