Inspection Photos

Location Name: TEP ROCKY MOUNTAIN LLC Jonsson 19-08 Pad

Location ID: 335195

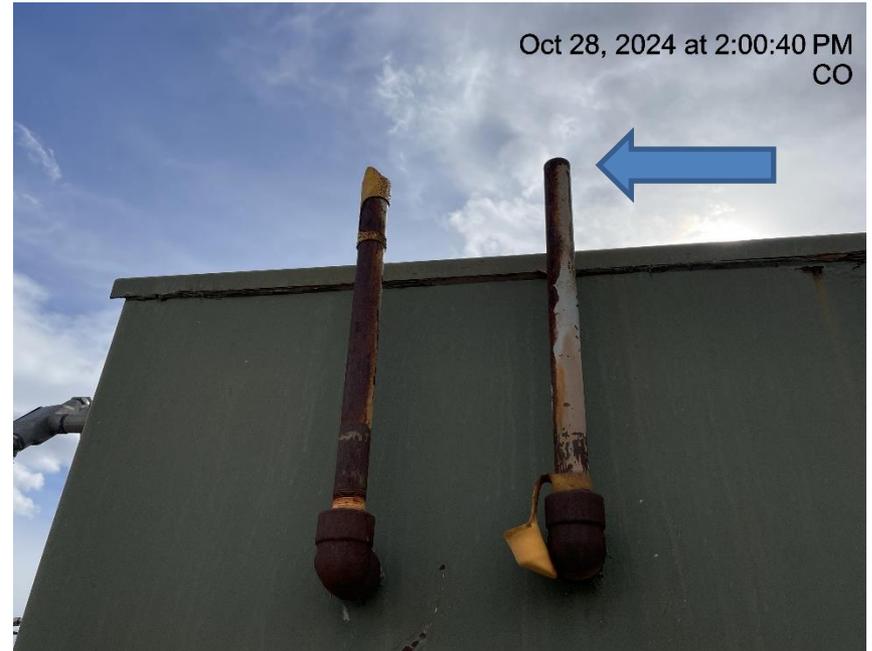
Photo # 7759 Rupture disc vent line does not comply with CECMC pressure safety device rules

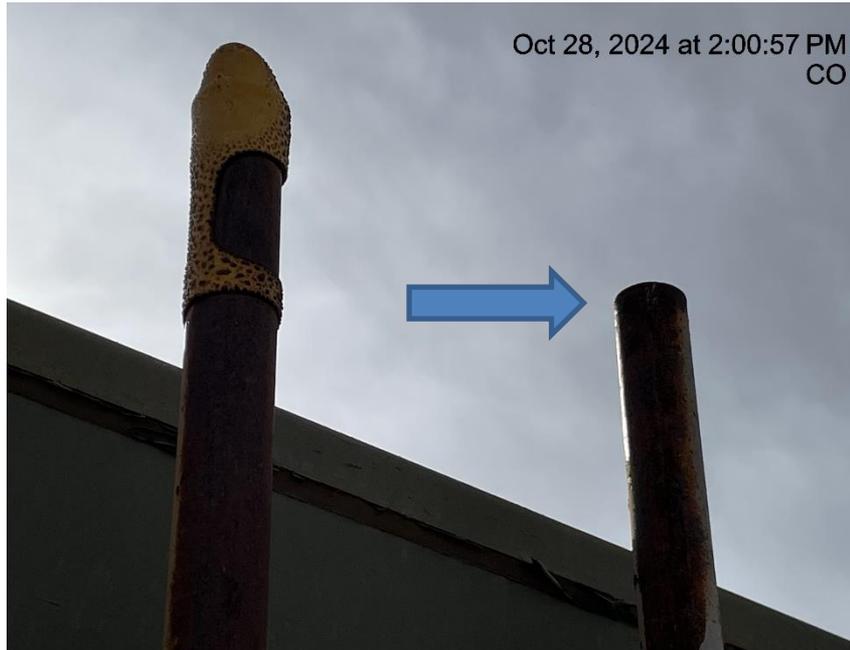
Photo # 7760 Rupture disc vent line does not comply with CECMC pressure safety device rules
