Inspection Photos

Location Name: VISION ENERGY LLC BALDY CREEK UNIT 1-17

Location #: 322404

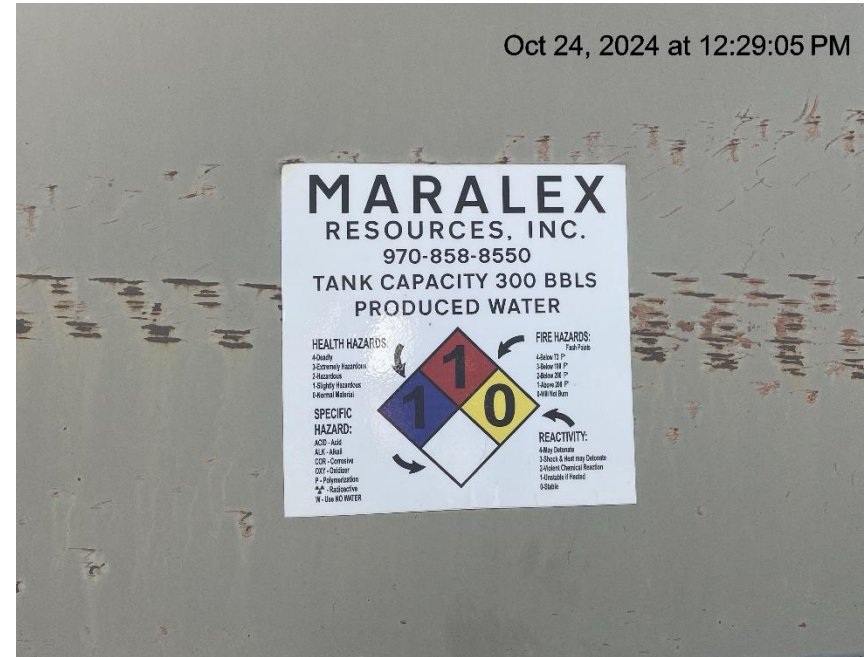
Photo # 7068 Tank label contains inaccurate info/does not comply with CECMC rules

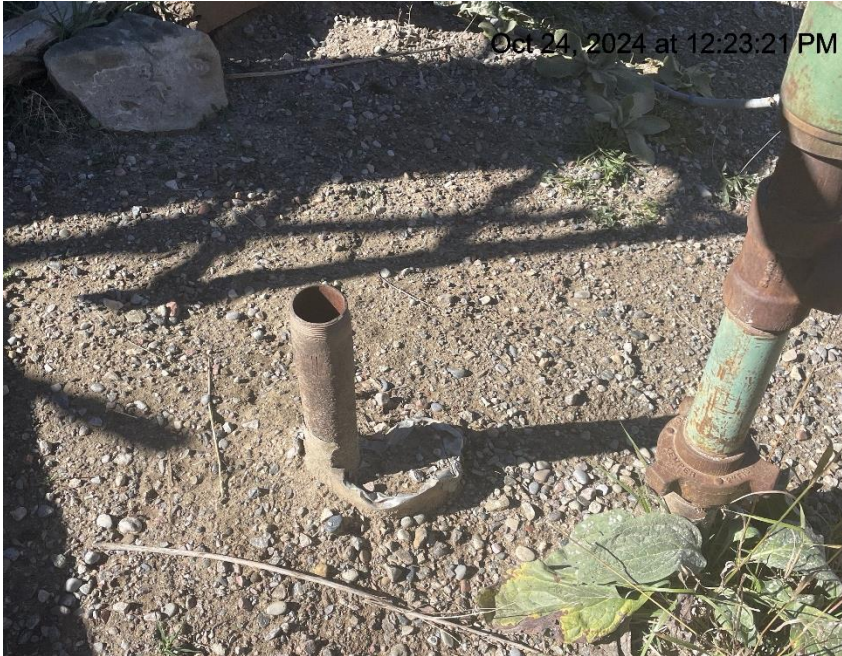
Photo # 7069 Open ended piping/available for entry by wildlife/wildlife hazard

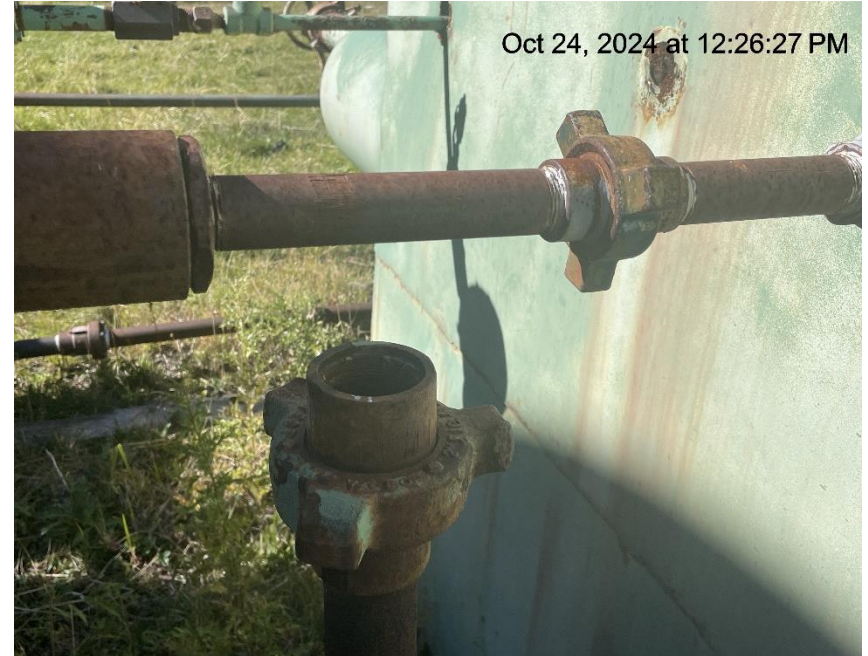
Photo # 7070 Open ended piping/available for entry by wildlife/wildlife hazard

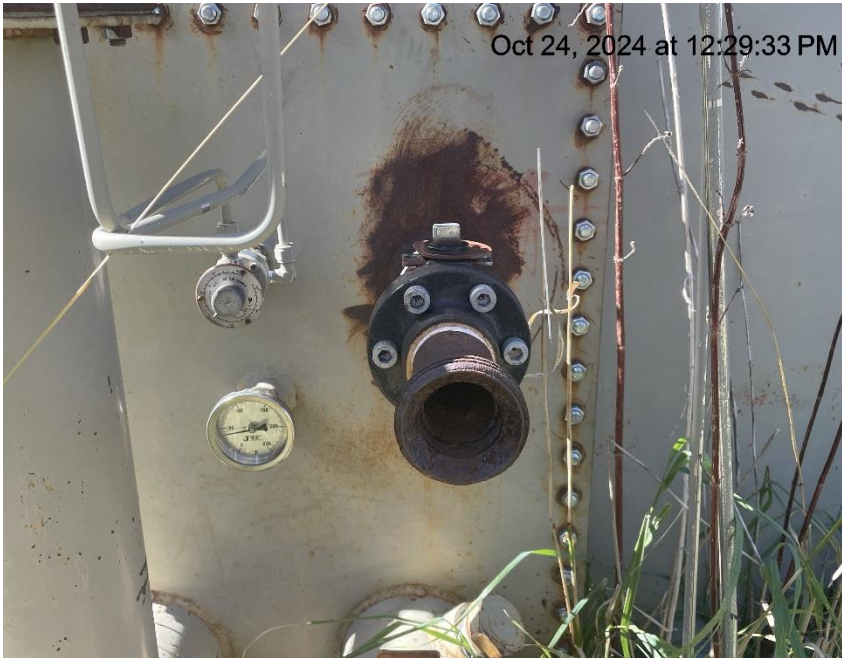
Photo # 7071 Open ended load line

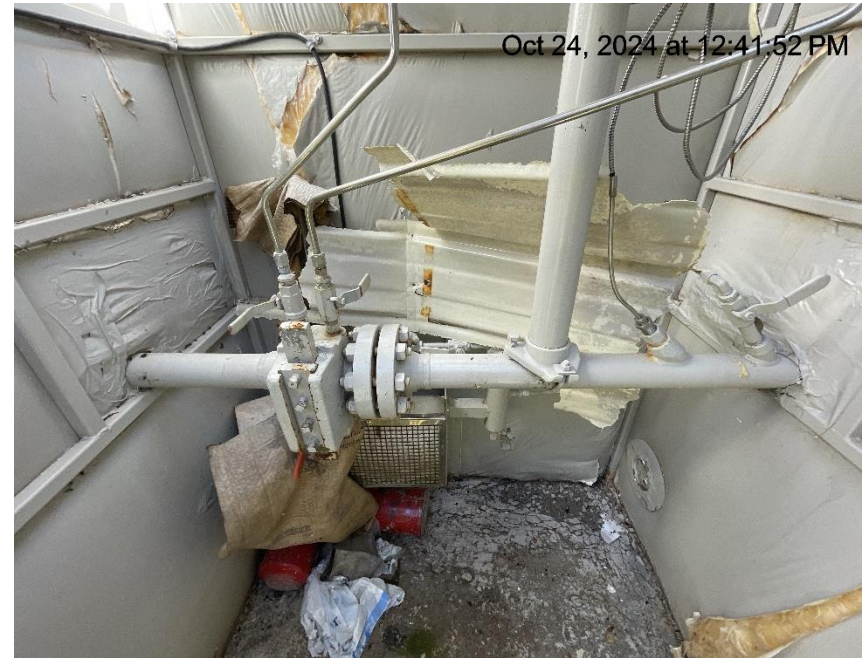
Photo # 7072 Meter calibration info not conspicuously posted

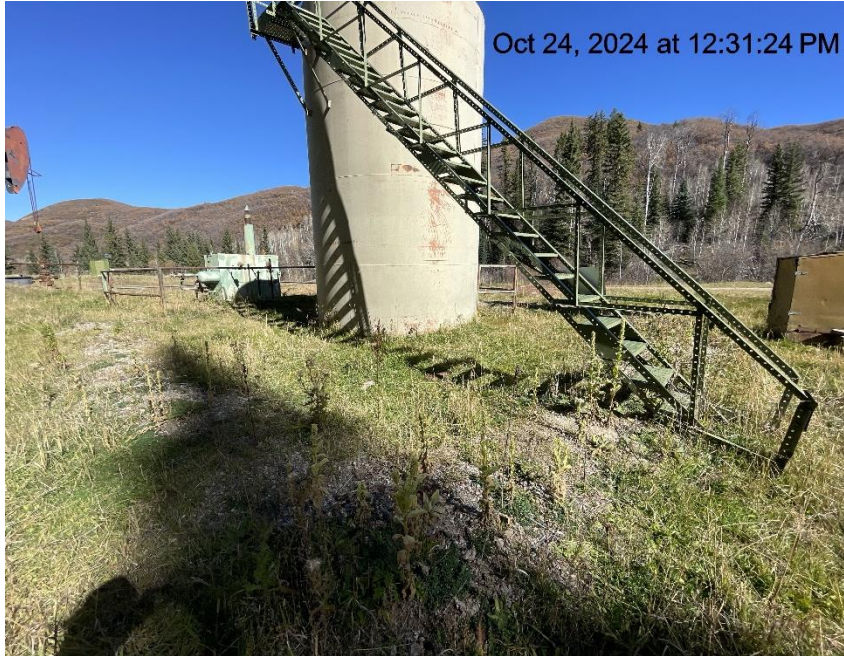
Photo # 7073 Secondary containment is insufficient/does not comply with CECMC secondary containment rules. Secondary containment is also overrun with vegetation & compromised.

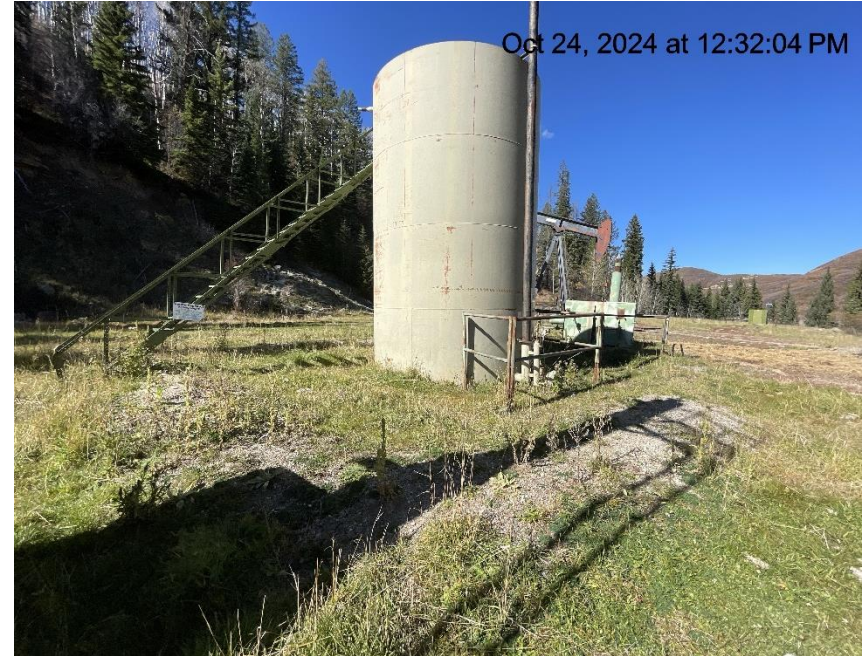
Photo # 7074 Secondary containment is insufficient/does not comply with CECMC secondary containment rules. Secondary containment is also overrun with vegetation & compromised.
