**Final Reclamation Complete Notice – Cropland Drone Imagery**

**PERMIT CLOSURE REPORT – CROPLAND**

**Location ID** 323253

**Location Name** BERGER-62N68W/23SENE

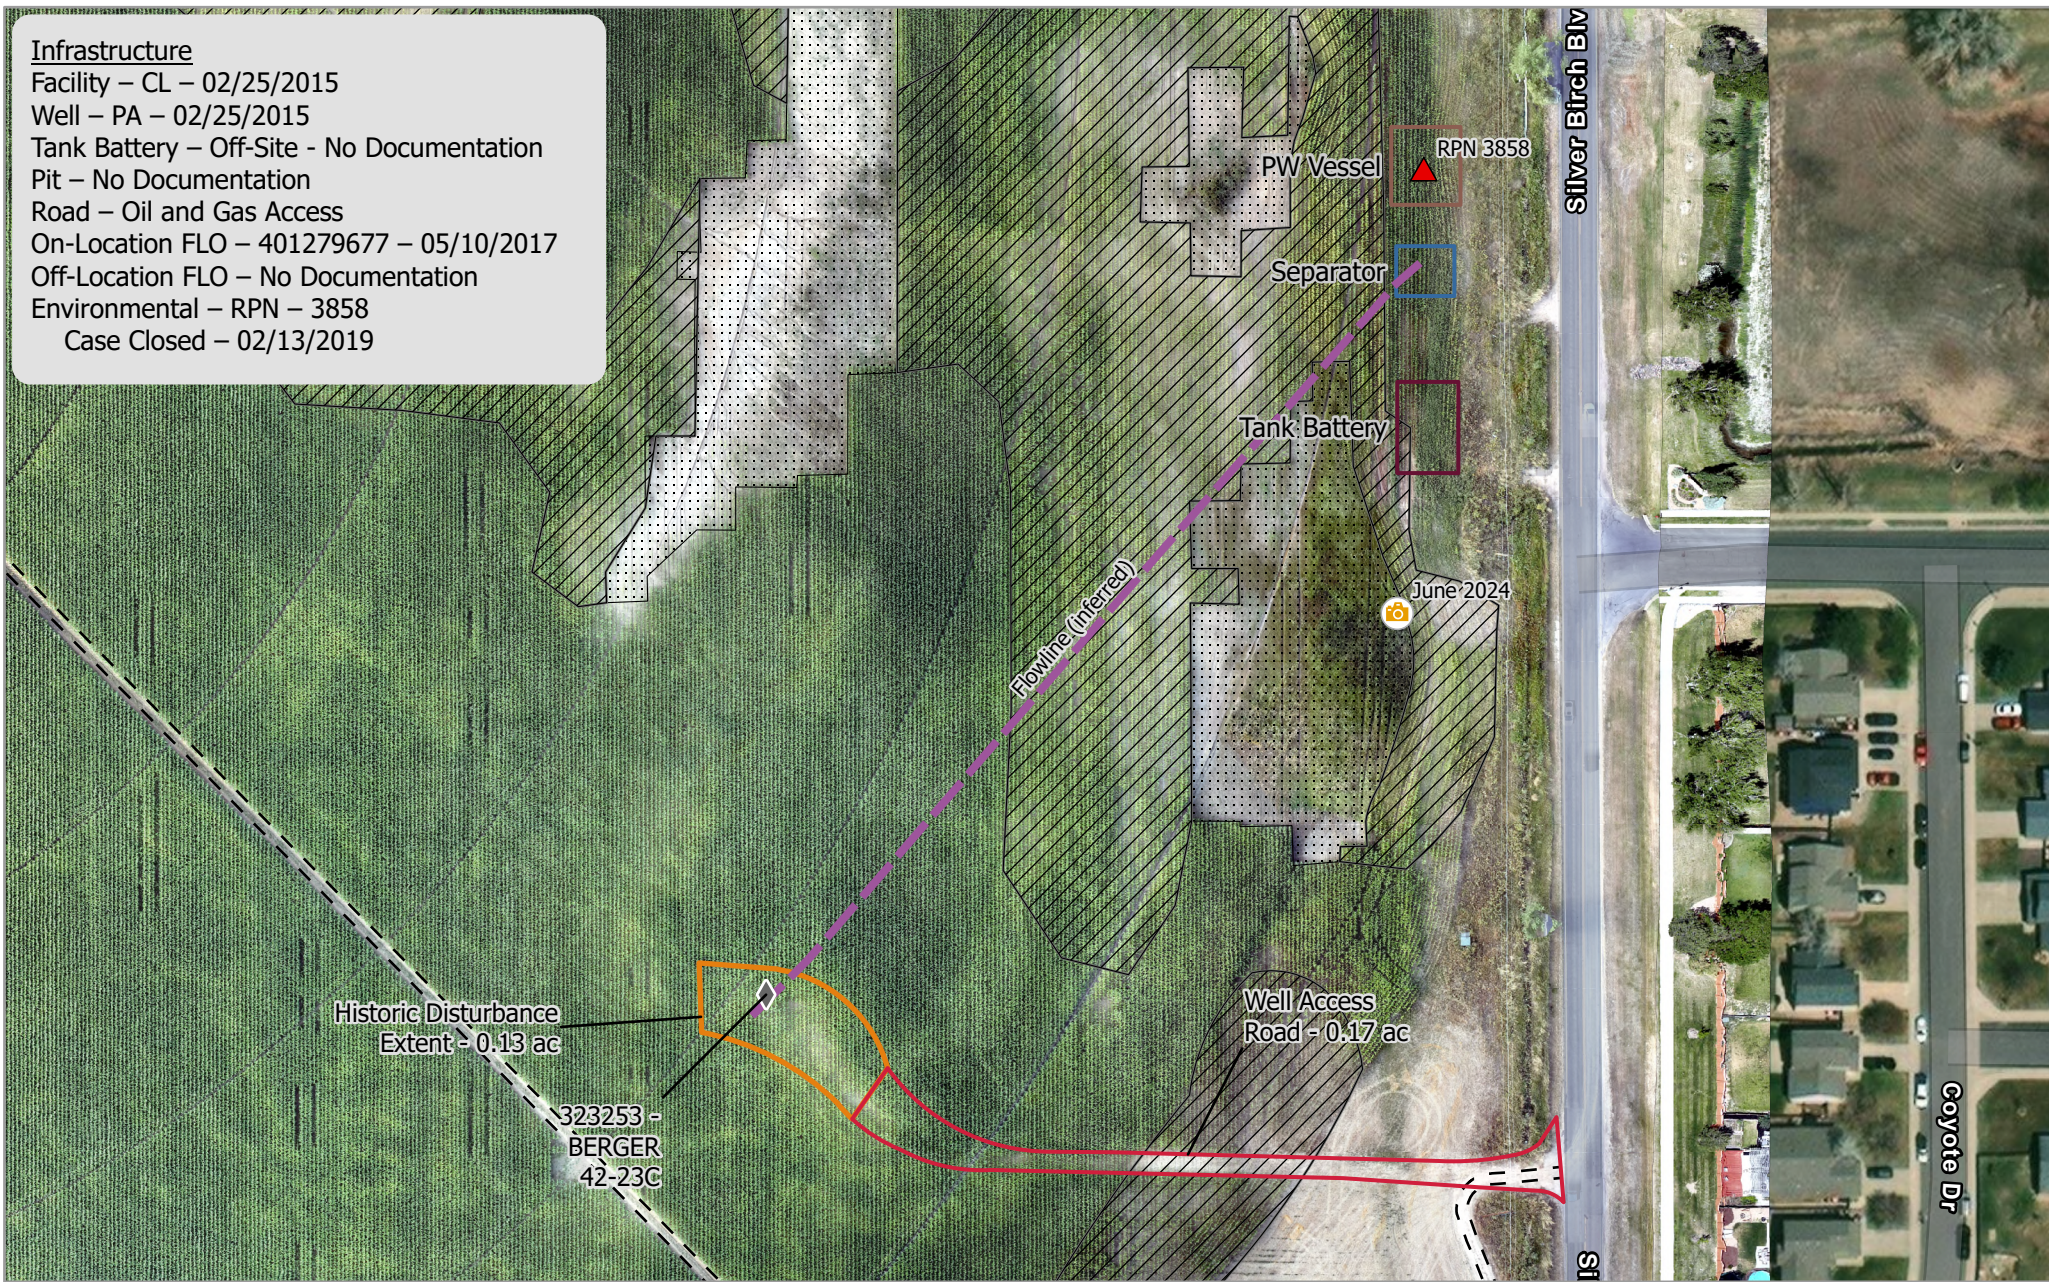
**CIV - 323253- BERGER 42-23C**  
**Map Extent - Post-Plugging Overview**

Soils at this site are being affected by **saline, sodic, and saline-sodic soil\*** conditions. While they do not cover the entire reclamation area there is some overlap. These soils are affecting the entire property, and they have been mapped to show how prolific they are.

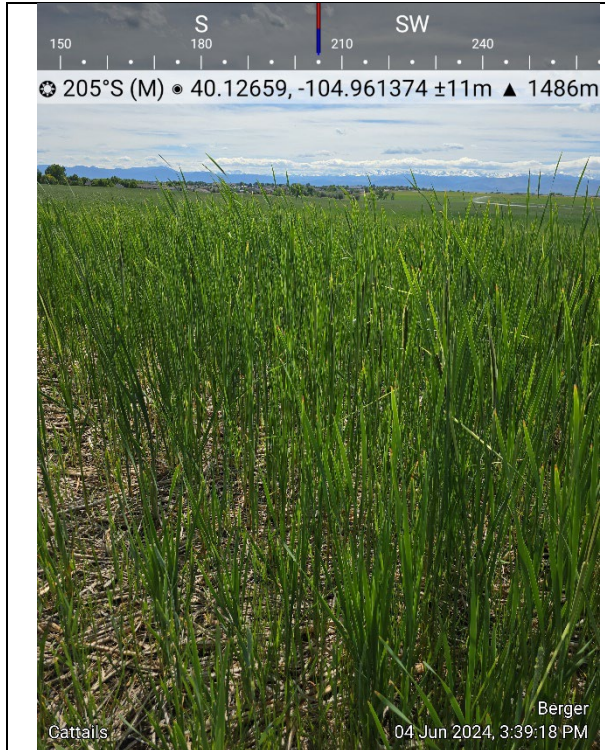
Looking South – Cattails – 40.12659/-104.961374

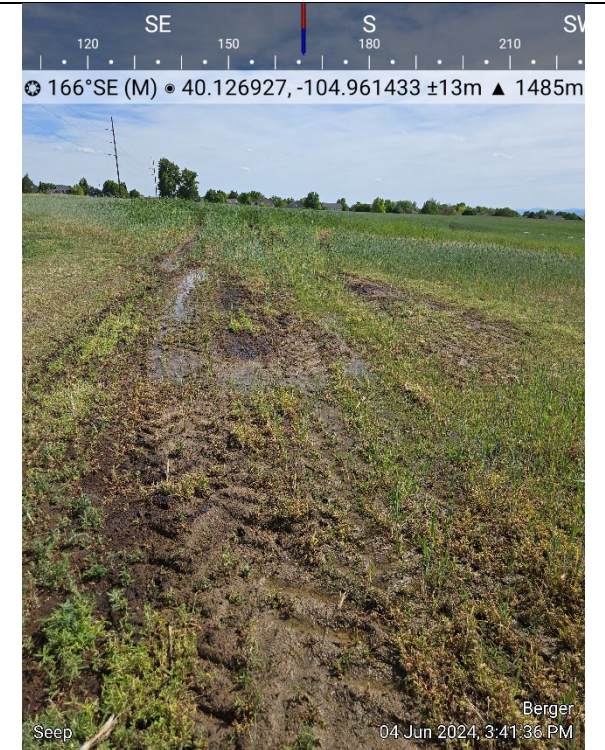
Looking South – Seep – 40.126927/-104.961433

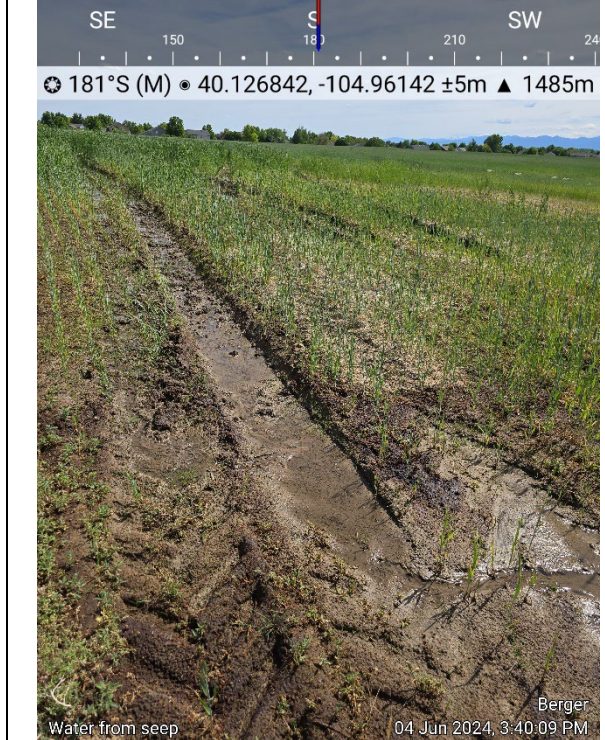
Looking South – Water from Seep – 40.126842/ -104.96142

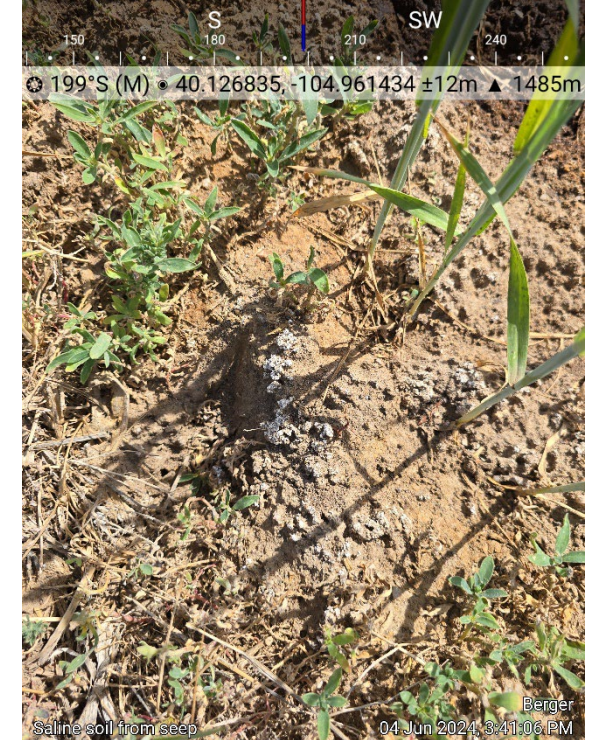
Looking South – Saline Soil from Seep – 40.126835/-104.961434

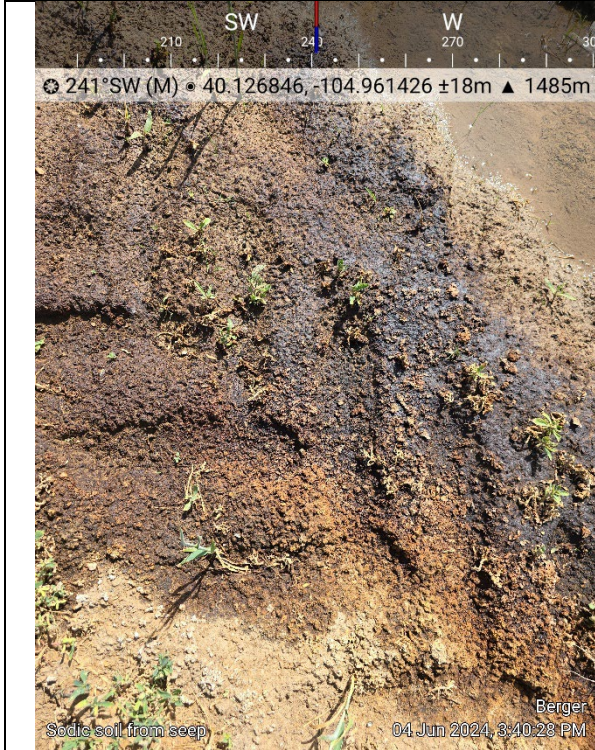
Looking Southwest – Sodic Soil from Seep –  
40.126846/-104.961426

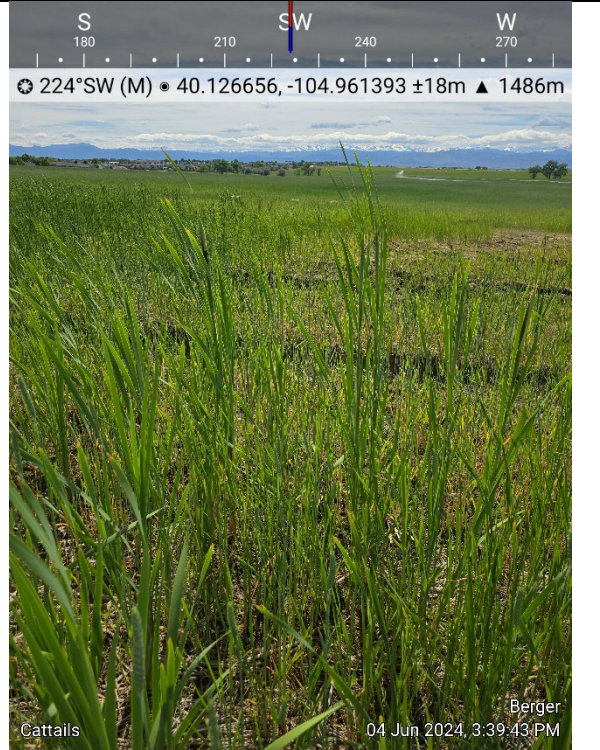
Looking Southwest – Cattails –  
40.126656/-104.961393
